Engineroom Fire On Board U.S. Small Passenger Vessel
Queen of the West
Columbia River, near Rufus, Oregon
April 8, 2008

Accident Summary Report

NTSB/MAR-09/04/SUM
PB2009-916404

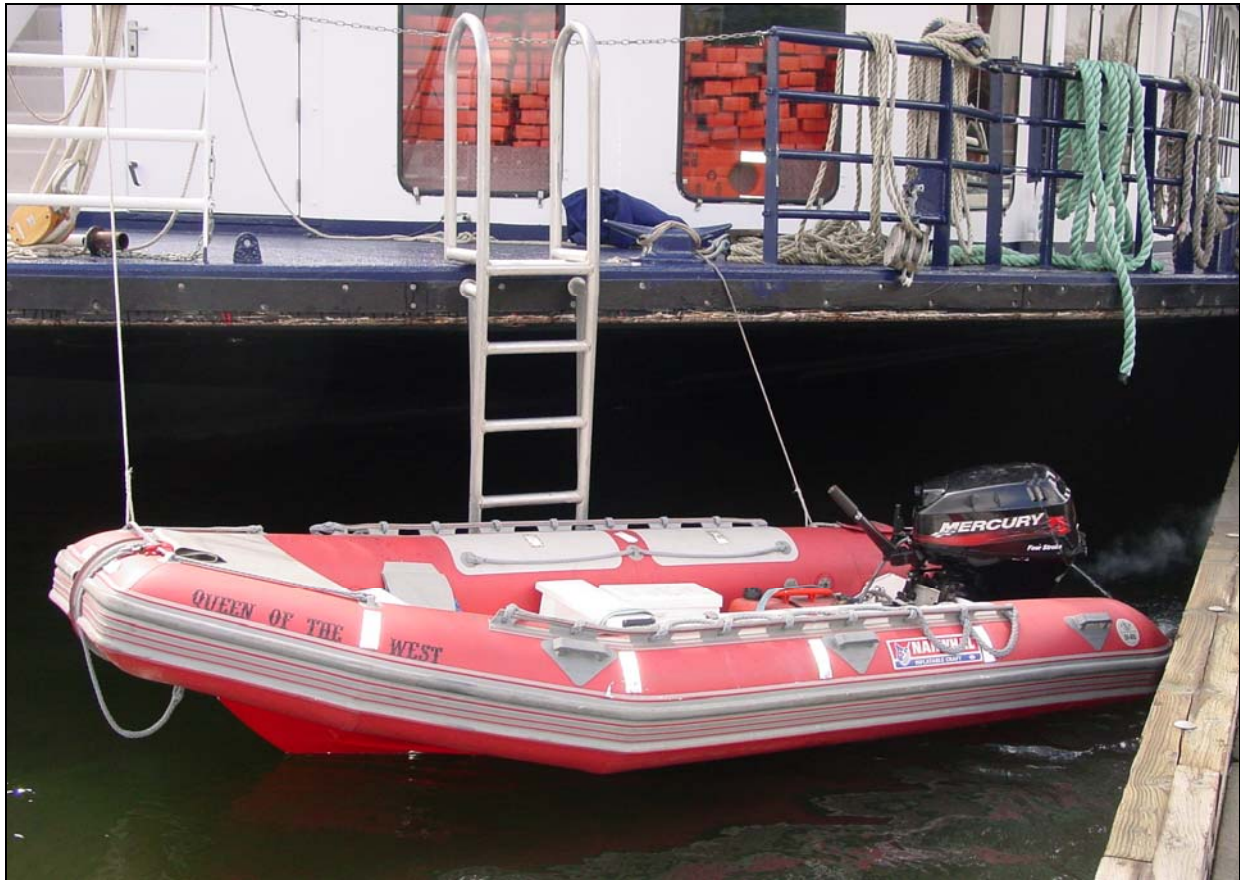
The riding captain was standing by to evacuate the passengers from the vessel. An evacuation to shore,¹² if necessary, would have had to use the vessel's sole rescue boat (figure 6), which, according to the vessel master, could accommodate six persons at a time, two of whom had to be crewmembers. Therefore, the rescue boat would have had to make numerous trips—conveying four passengers at a time—unless other help became available. Because the fire was later suppressed and because the towboat *Challenger* was en route to assist, the *Queen of the West* did not need to be evacuated in the rescue boat, and the passengers were so informed.

Figure 6. The rescue boat positioned at the *Queen of the West's* port forward side.

The only compulsory craft on board the vessel was this rescue boat, required by Sector Portland's Officer in Charge of Marine Inspection (OCMI) and identified on the vessel's certificate of inspection (COI) in accordance with Title 46 *Code of Federal Regulations* (CFR) 117.208. In carrying the rescue boat, the *Queen of the West* was in compliance with Coast Guard regulations (also see "Certificate of Inspection and Regulatory Status" section).
