Collision Between U.S. Passenger Ferry M/V *Block Island*
and U.S. Coast Guard Cutter *Morro Bay*
Block Island Sound, Rhode Island
July 2, 2008

Accident Report

NTSB/MAR-11/01
PB2011-916401

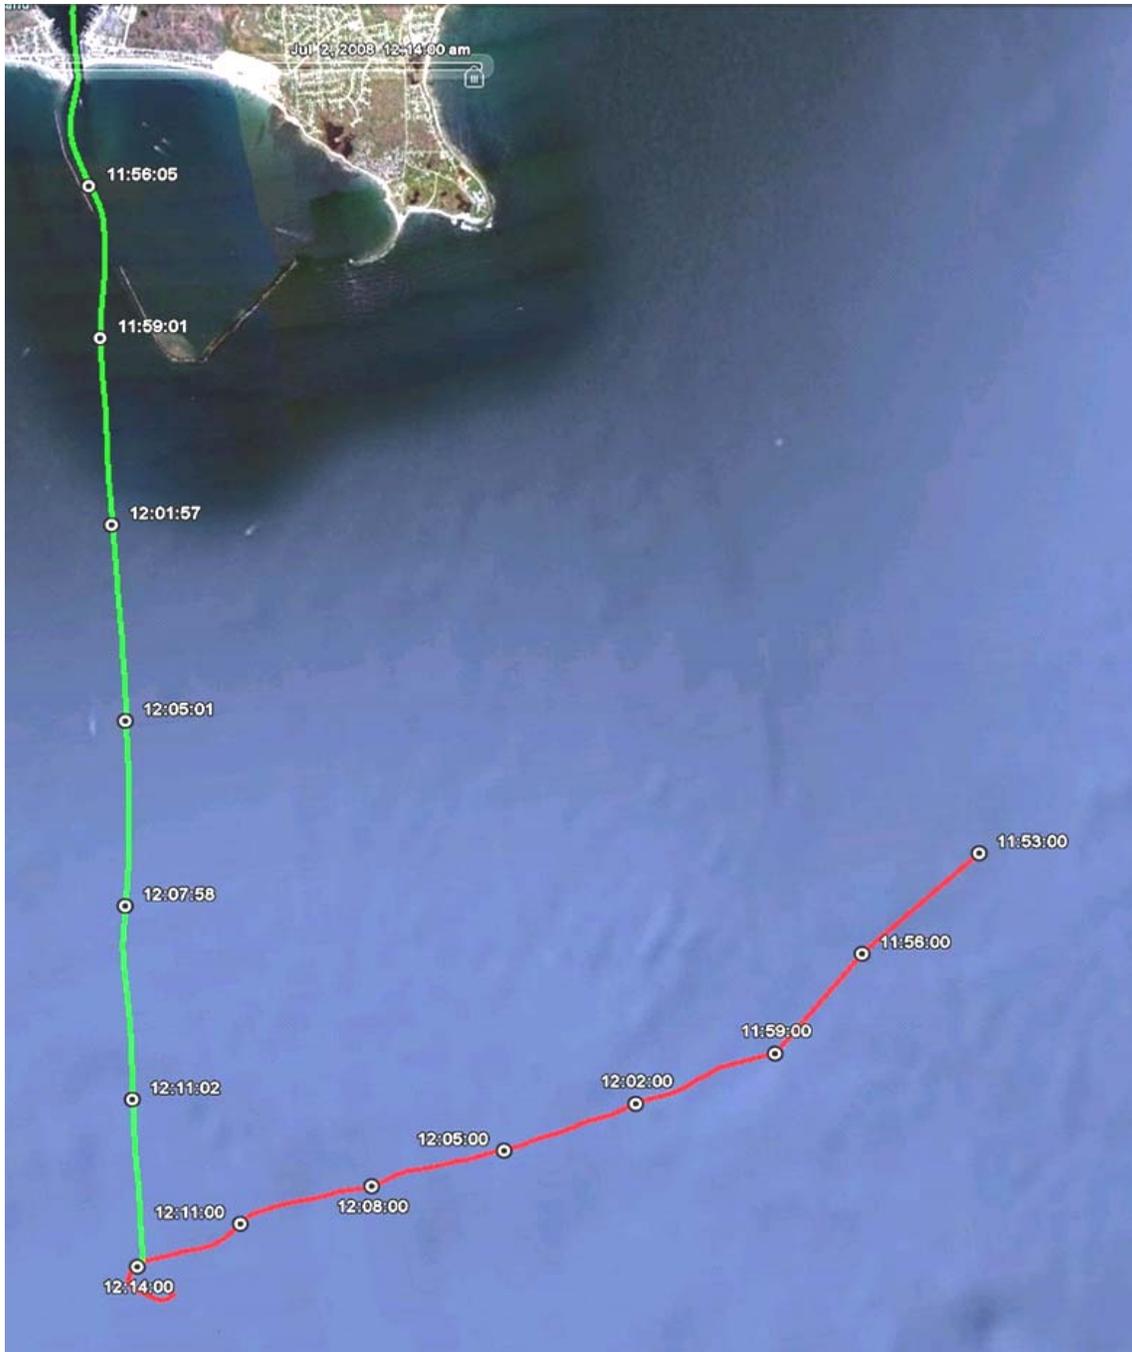
About 1208, the *Block Island* and the *Morro Bay* were about 1.6 miles from each other; the *Block Island* approaching from the north on the cutter's starboard side, and the *Morro Bay* approaching from the east on the ferry's port side (figure 5). Neither vessel's crew was aware of the other vessel.

Figure 5. The two vessels' tracklines in the minutes leading up to the collision. The *Block Island*'s path is shown on the left in green, running south; the *Morro Bay*'s path is shown on the right in red, running west-southwest. Point Judith is shown in the upper left corner. The tracklines were plotted using available global positioning system (GPS) data. Background by Google Earth.

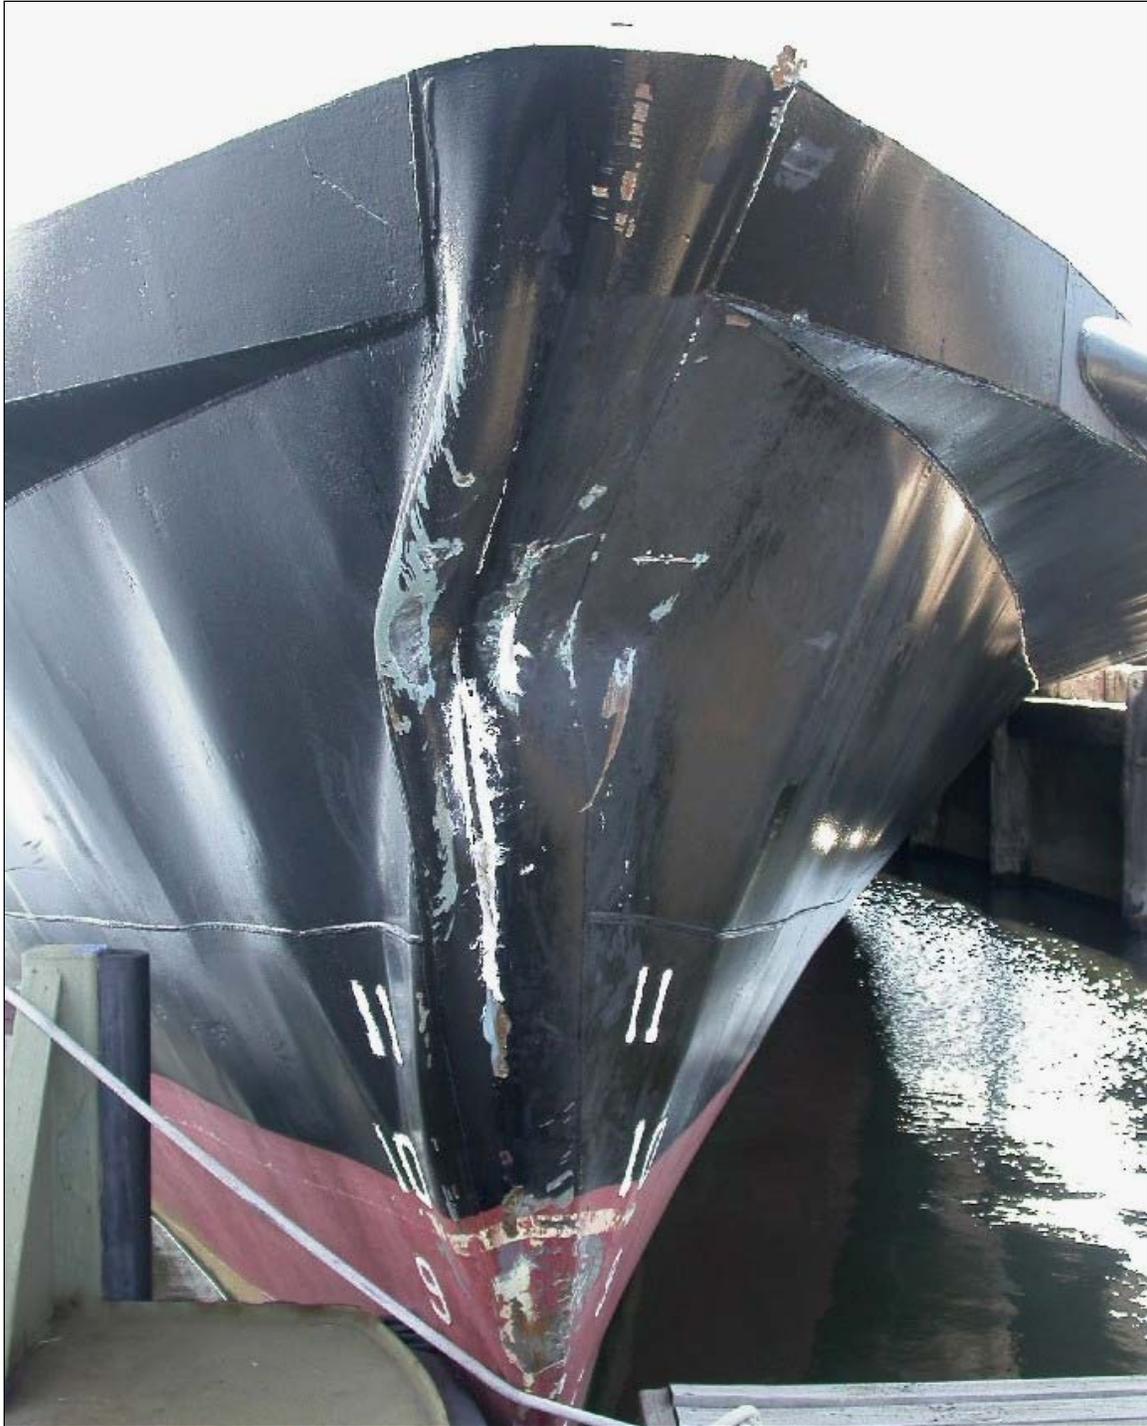
The ferry sustained a fracture and deformation to its bow hull plate. Internal frames and stiffeners were buckled at the vessel's stem above the waterline (figure 6). The final cost for temporary and permanent repairs was about \$45,000. Repairs were completed and the Coast Guard cleared the ferry to return to service in September 2008.

Figure 6. Scraped and inset bow on the *Block Island*.

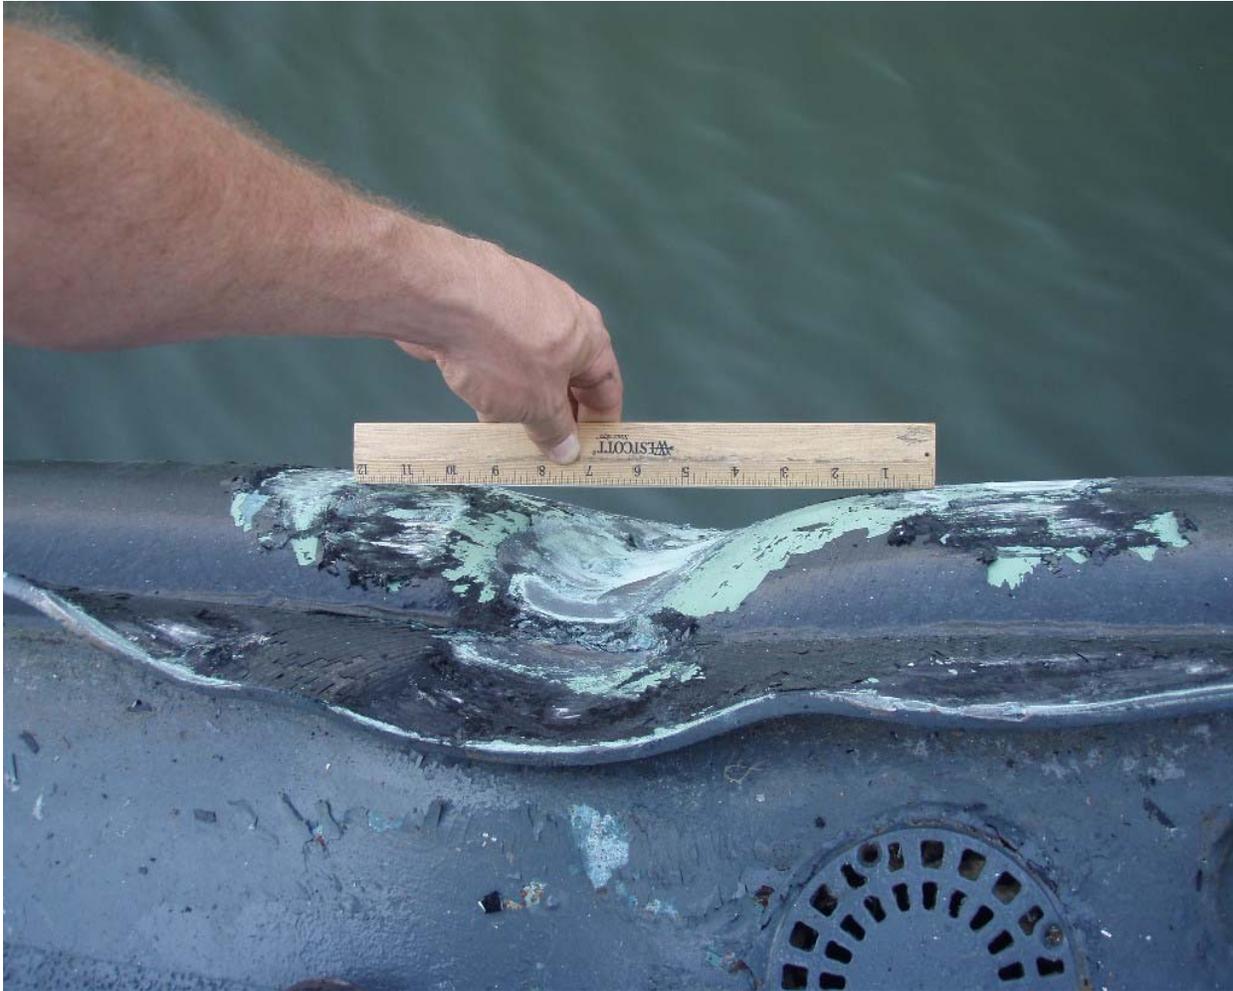
The cutter sustained minor impact damage to its starboard-side deck edge about midship (figure 7). The damage repair was estimated at \$15,000.

Figure 7. Scraped and inset deck edge on the *Morro Bay's* starboard side (looking down). Photo by the Coast Guard.

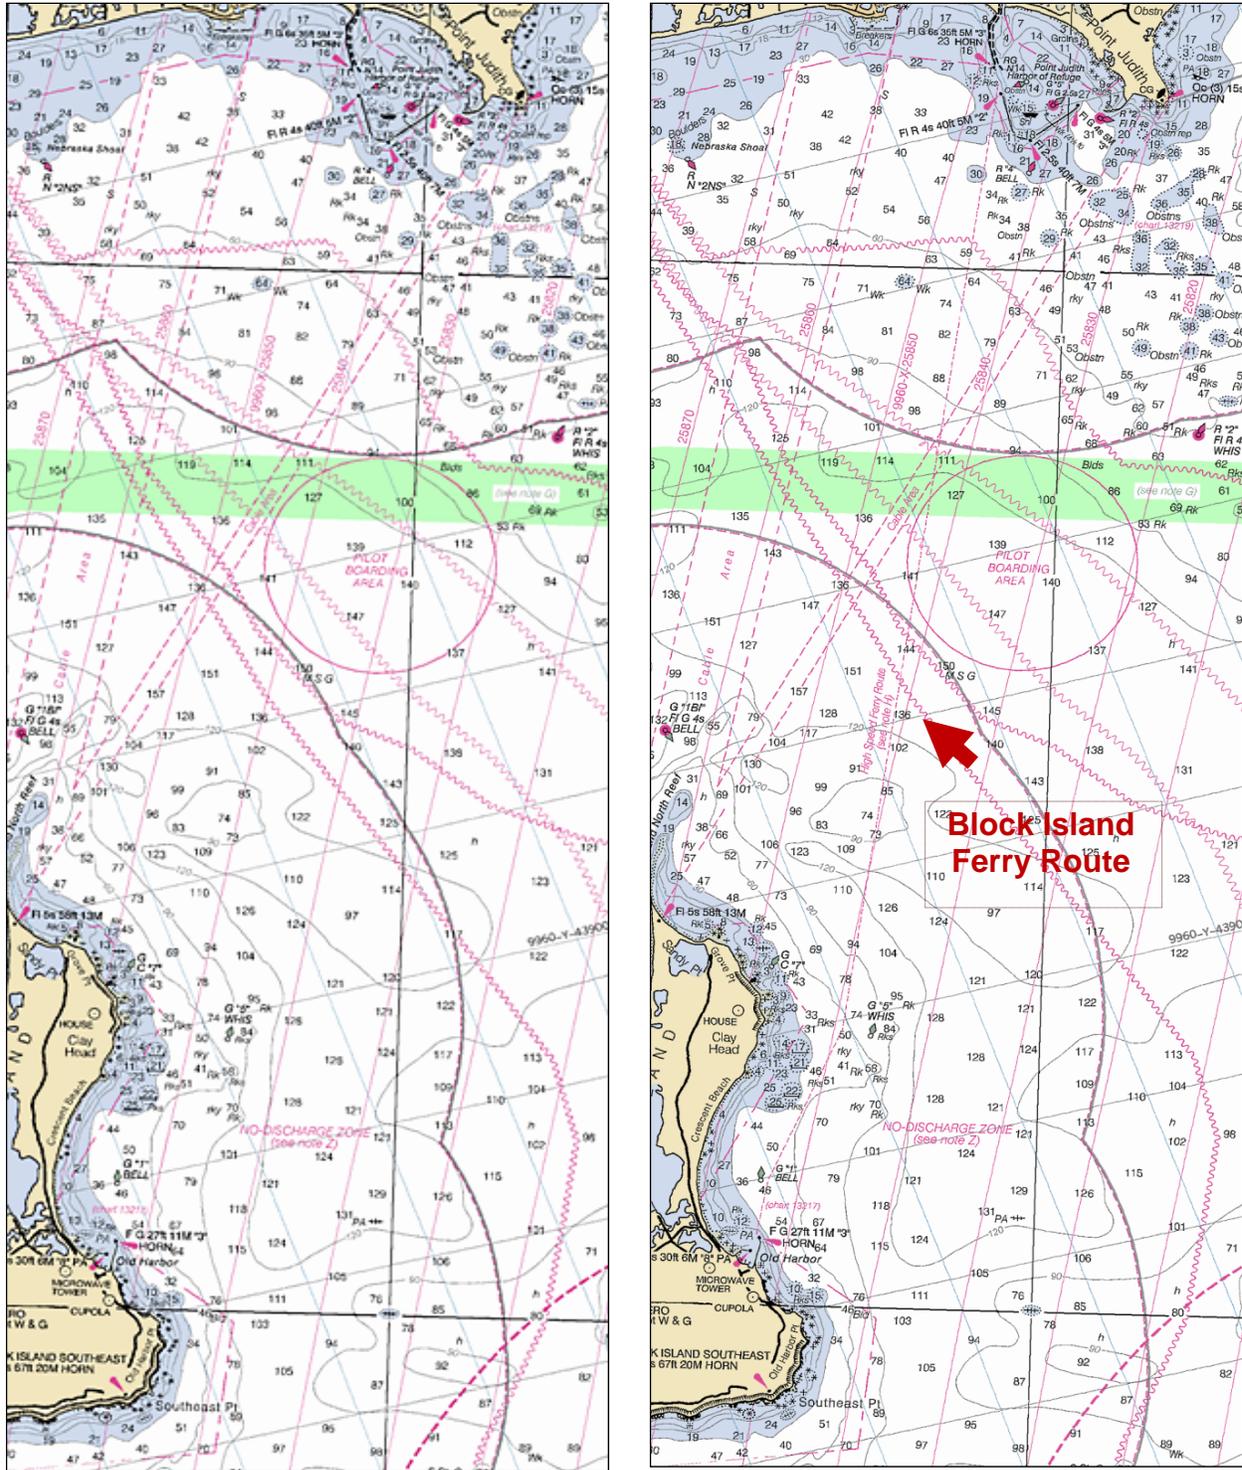
The *Morro Bay* bridge team used National Oceanic and Atmospheric Administration (NOAA) chart 13218, "Martha's Vineyard to Block Island," for the start of the transit from Newport to New London, and the *Block Island* crew used NOAA chart 13215, "Block Island Sound Point Judith to Montauk Point," on board the ferry. At the time of the accident, the Block Island ferry route was not marked on any charts of the area. As a result of the accident, NOAA updated the charts to depict the ferry route (figure 8).

Figure 8. Preaccident and postaccident sections of NOAA Chart 13218 (the chart used by the Morro Bay bridge team), showing Point Judith in the upper right corner and Block Island in the bottom left corner. The horizontal green band denotes the east-west traffic scheme between Block Island and the mainland. At the time of the accident, charts of the area did not show the ferry route between Point Judith and Old Harbor (left image). NOAA has since revised the charts, and the ferry route is now marked (center of right image).
