Allision of Passenger Ferry *Andrew J. Barberi*  
With St. George Terminal  
Staten Island, New York  
May 8, 2010

NTSB/MAR-12/01  
PB2012-916401

Allision of Passenger Ferry *Andrew J. Barberi*  
With St. George Terminal, Staten Island, New York  
May 8, 2010

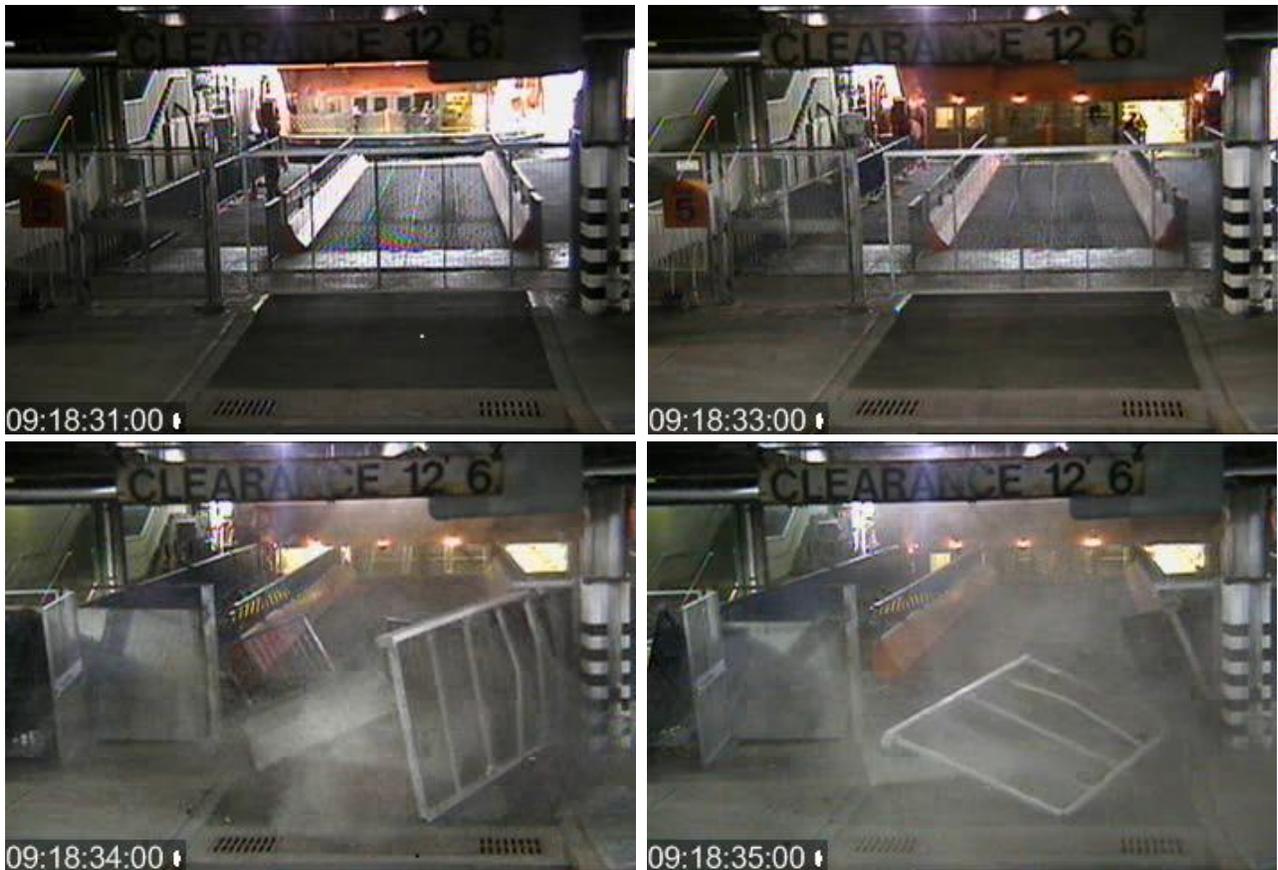
**Figure 6.** Video images of the impact.

The video footage also showed that, as a result of the allision, the shoreside transition bridge—which was designed to absorb some impact by being unfixed and able to float—was lifted up and displaced several yards into a security-perimeter fence. The bridge came to rest about 5 feet above the *Andrew J. Barberi*'s main deck, overlapping it by about 3 feet. The two aprons were lifted up and landed on the vessel's hurricane deck, two decks above their normal connecting level.

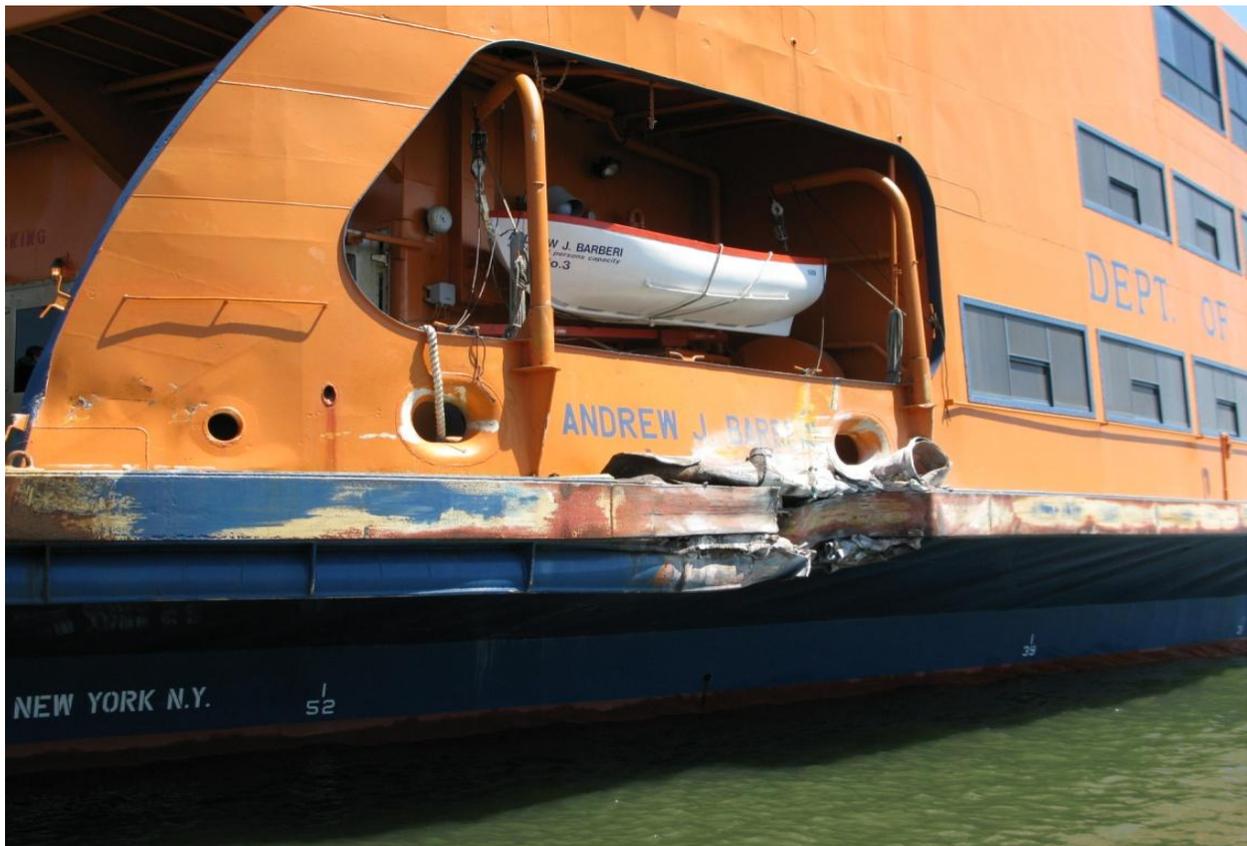
sides where the vessel impacted the rack pilings and concrete structure of the terminal (figures 7 and 8). On both sides, the hull was breached beneath the main deck, at the rub rail level,<sup>9</sup> in the space that contained the cycloidal propulsion unit. The damage included about 15 feet of tearing and deformation to the port and starboard main deck plating and bulwarks,<sup>10</sup> as well as tearing and deformation to the rub rails on both sides.

On the main deck, the portside mooring chock<sup>11</sup> was displaced. The watertight bulkhead separating the cycloidal propulsion space from the end-most ballast tank was buckled on both the port and starboard sides, and the immediate transverse web frames on each side of this watertight bulkhead were deformed. The survey also noted minor damage at the bridge deck, port and starboard of the pilohouse, resulting from the vessel striking the aprons.

**Figure 7.** Damage to the vessel's port side (Staten Island-end).

The cost to repair the *Andrew J. Barberi*'s allision damage was \$168,625, according to Ferry Division officials.

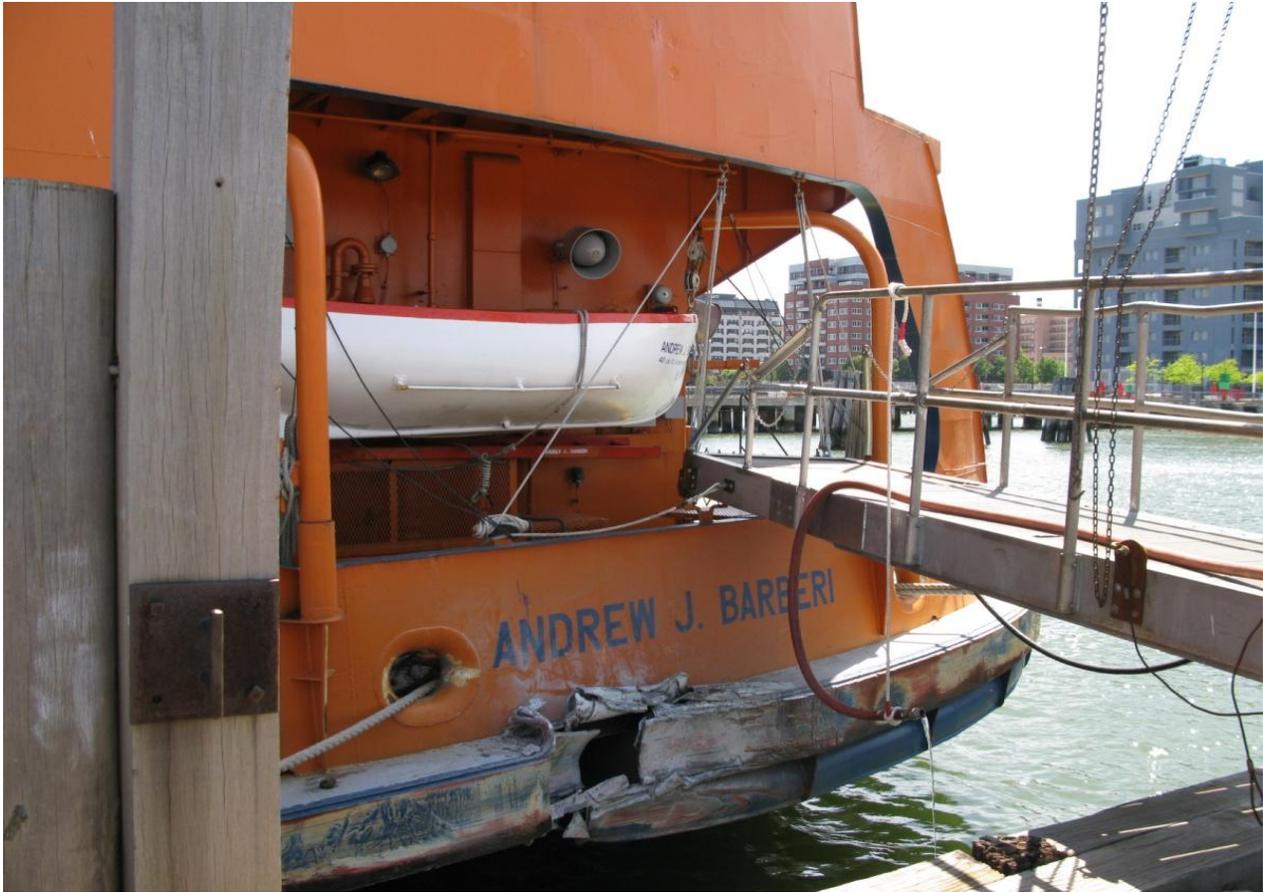
**Figure 8.** Damage to the vessel's starboard side (Staten Island-end).

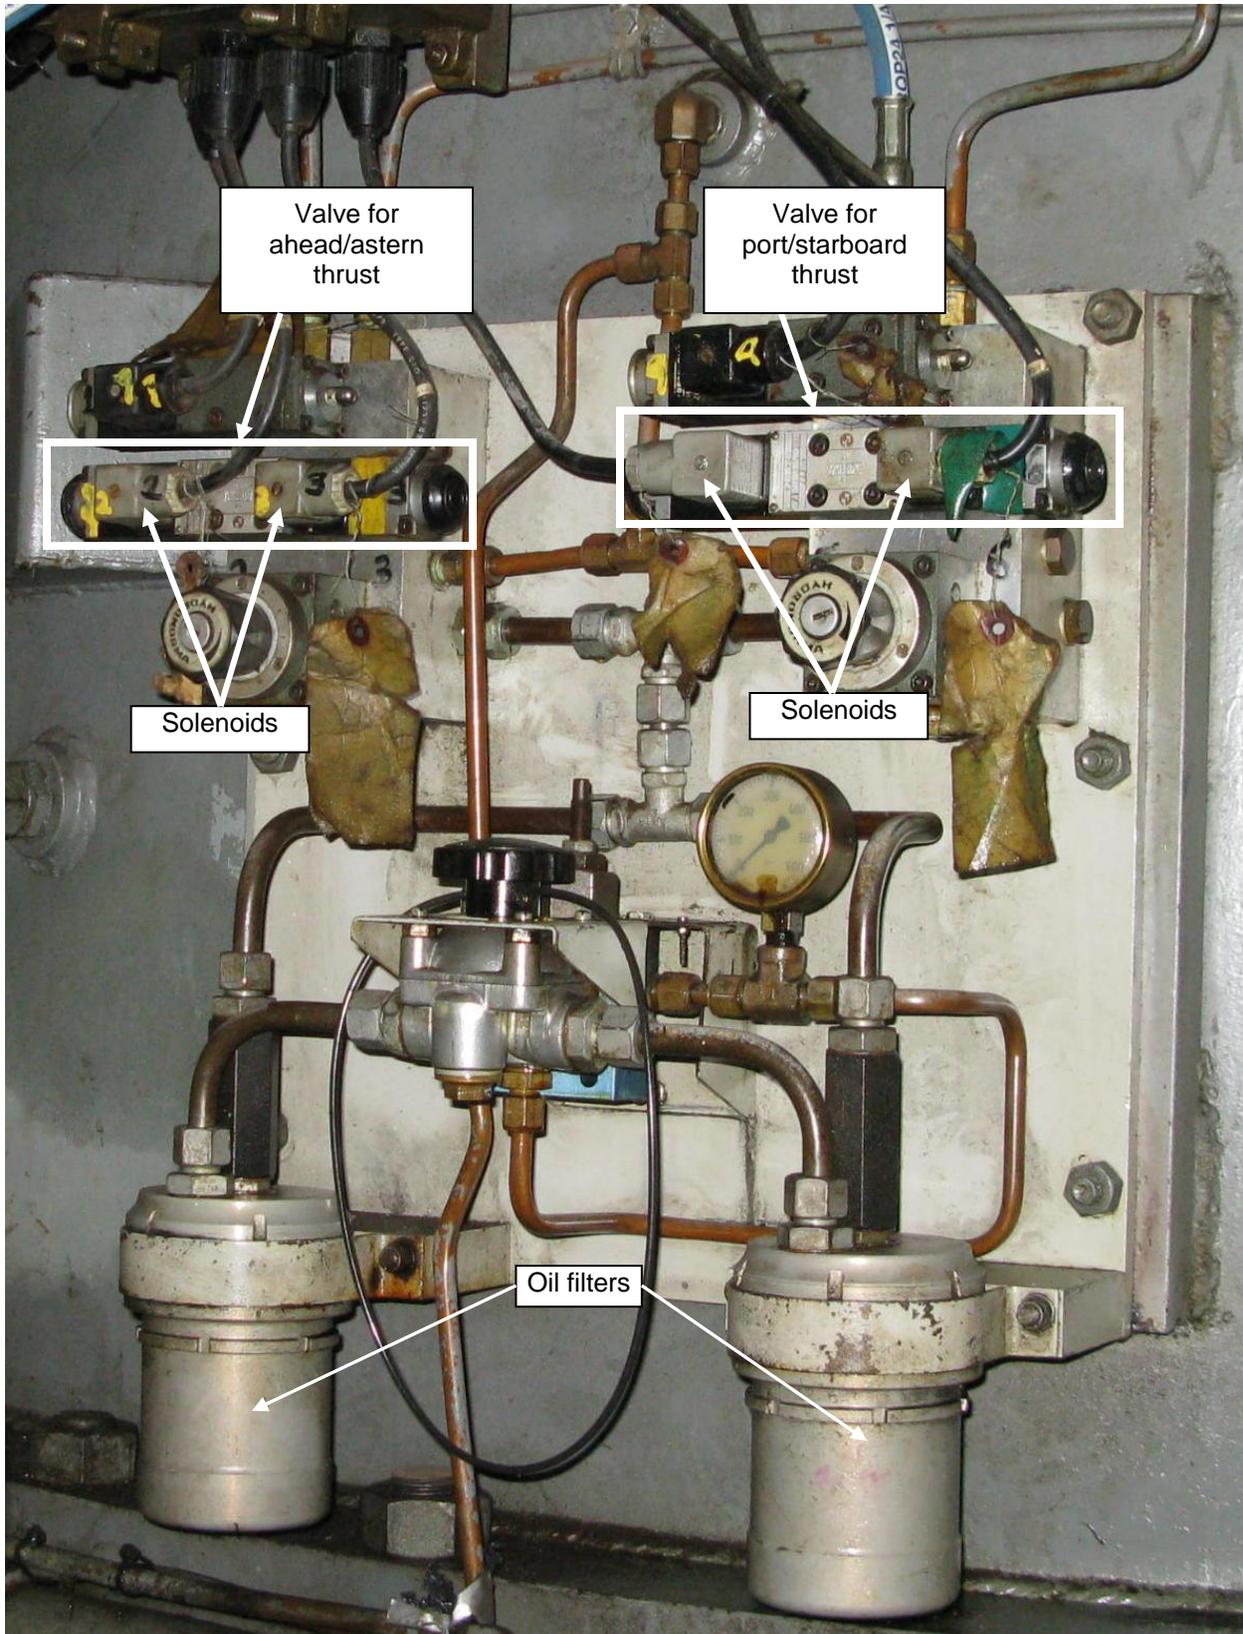
The engineering group then focused on the New York-end propulsion unit's control panel itself (figure 11) as the probable point of failure. The control panel transformed the electrical signal from the pilothouse to a hydraulic oil flow output, which controlled the pitch of the propeller blades and resultant thrust. The panel had two electro-hydraulic propulsion control valves (valves), one for controlling port/starboard thrust, the other for controlling ahead/astern thrust. Thrust control was achieved by using two electrically actuated solenoids, one located on each side of each valve, to mechanically move the valves between three positions (depending on the valve, either "ahead," "neutral," or "astern," or "port," "neutral," or "starboard").

Figure 11. The hydraulic control panel located at the vessel's New York-end propulsion unit.

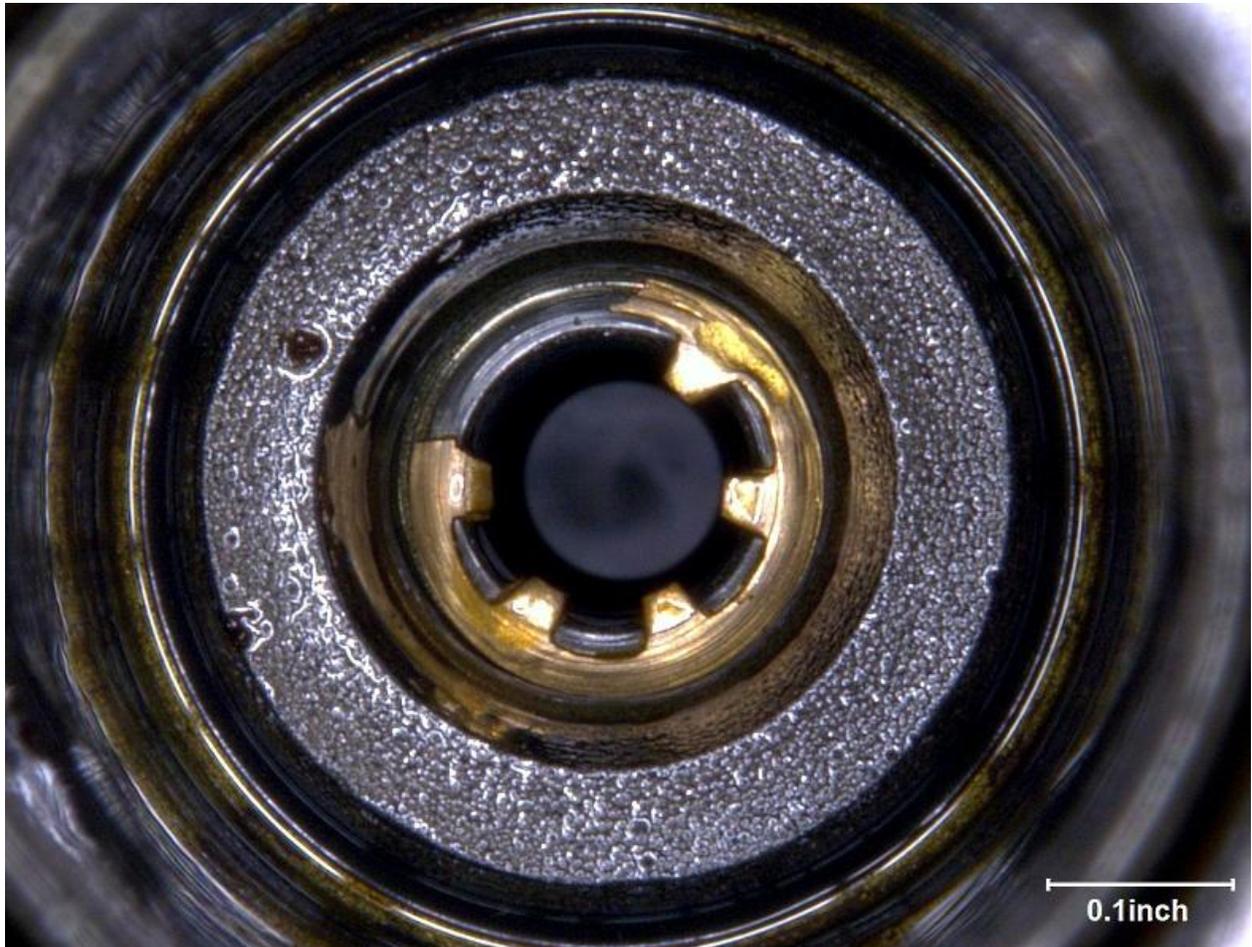
**Figure 12.** Fractured bronze ring in one of the two solenoids controlling ahead/astern thrust.

Investigators determined that the bronze rings in both of the solenoids controlling ahead/astern thrust had fractured, which allowed ring fragments to dislodge and interfere with the proper operation of the solenoids. The interference caused one of the solenoids to “stick” in a single position, which resulted in the inability of the New York-end propulsion unit to respond to pilothouse control. Investigators found no other anomalies.<sup>15</sup>

Although investigators examined the components to determine the mode of failure, damage to the fracture surfaces on the bronze ring fragments precluded investigators from determining the cause of the failure. Investigators noted that the rings in the ahead/astern-thrust solenoids—which had six tabs—were of a different design than the rings in the port/starboard-thrust solenoids, which had three tabs and were intact.<sup>16</sup>

<sup>16</sup> The tabs of the fractured six-tab rings were 0.030 inches at their widest point. The tabs of the intact three-tab rings were 0.065 inches at their widest point. For further information, see the NTSB’s Materials Laboratory Factual Report No. 11-063, available in the NTSB public docket on this accident.

When the accident occurred, the Ferry Division was already in the process of replacing the control panels on its Barberi-class ferries with new and similar hydraulic control panels. The Ferry Division's senior port engineer told NTSB investigators that the control panels were not being replaced because they were problematic, but rather to simply "upgrade the system." To confirm this, NTSB investigators examined the maintenance records, engine logbooks, and Coast Guard incident report forms, and nothing in these documents indicated that the control panel replacement resulted from maintenance issues or failures. The control panels on the other vessel in the Barberi class, the *Samuel I. Newhouse*, had already been replaced during its previous scheduled maintenance period in spring 2010. The *Andrew J. Barberi* was scheduled to have its control panels replaced later that year during its maintenance period. However, because the vessel was taken out of service as a result of the allision, the Ferry Division replaced the control panels in the week following the accident. On May 13, after the new control panels were in place, the engineering group tested both end propulsion units for pilothouse command response, and both ends performed satisfactorily. The *Andrew J. Barberi* returned to service on June 23, 2010, following completion of all repairs.

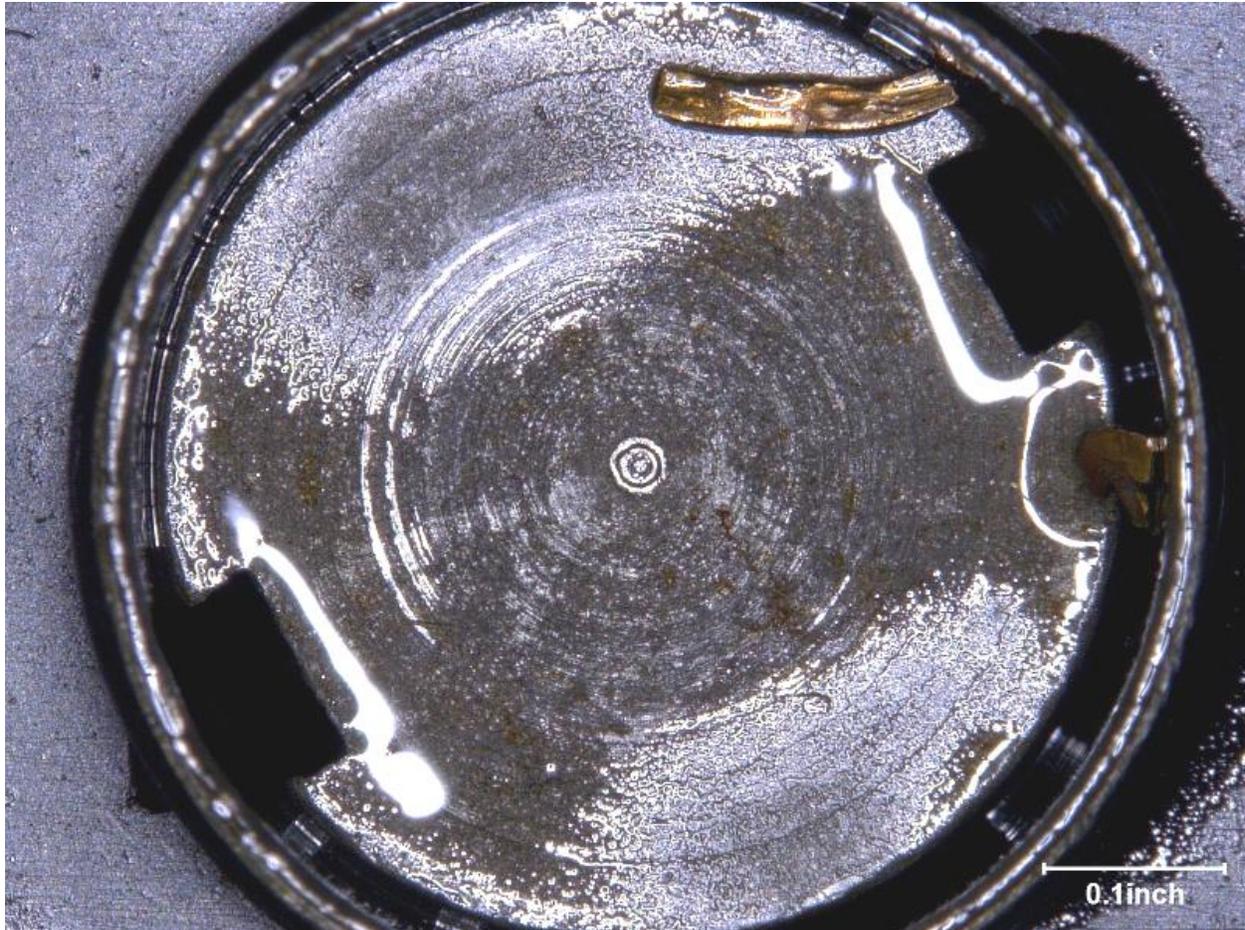
**Figure 13.** Bronze ring fragments in the second solenoid controlling ahead/astern thrust.
