Collision of the Tankship *Elka Apollon*
With the Containership *MSC Nederland*
Houston Ship Channel, Upper Galveston Bay, Texas
October 29, 2011

NTSB/MAR-12/02
PB2012-916402

Marine Accident Report

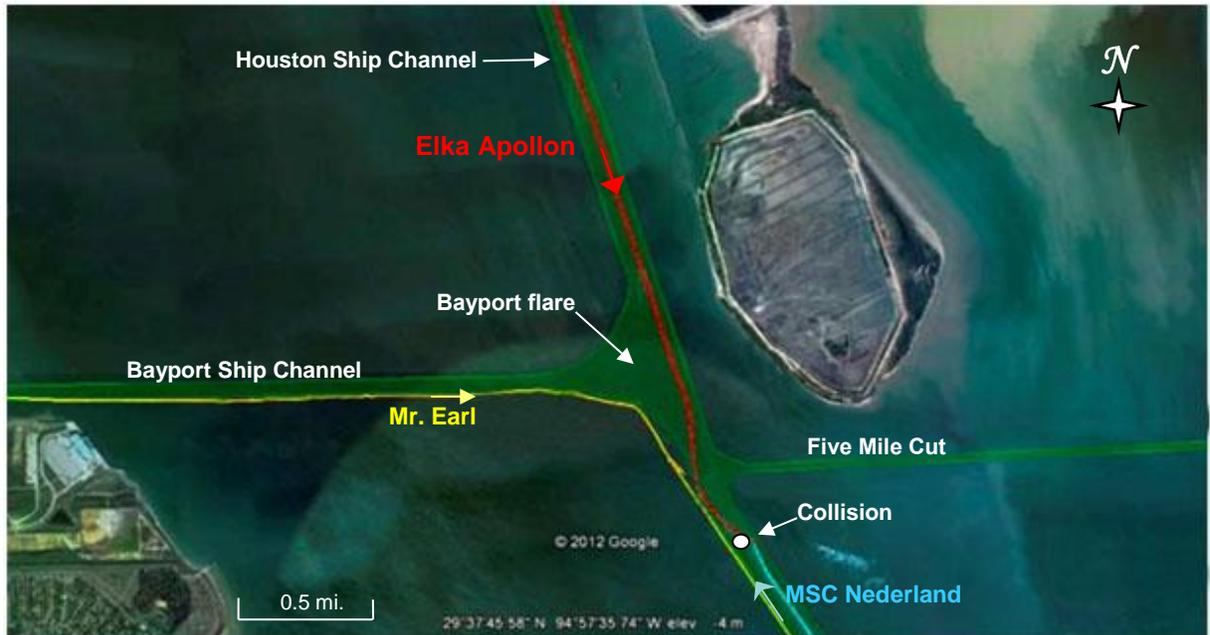
Figure 4. Aerial view of the accident area indicating the vessels' movements up to and following the collision. The *Elka Apollon*'s trackline is labeled in red, the *MSC Nederland* is in light blue, and the *Mr. Earl*'s is in yellow. (Image created by overlaying electronically captured position data on Google Earth image.)

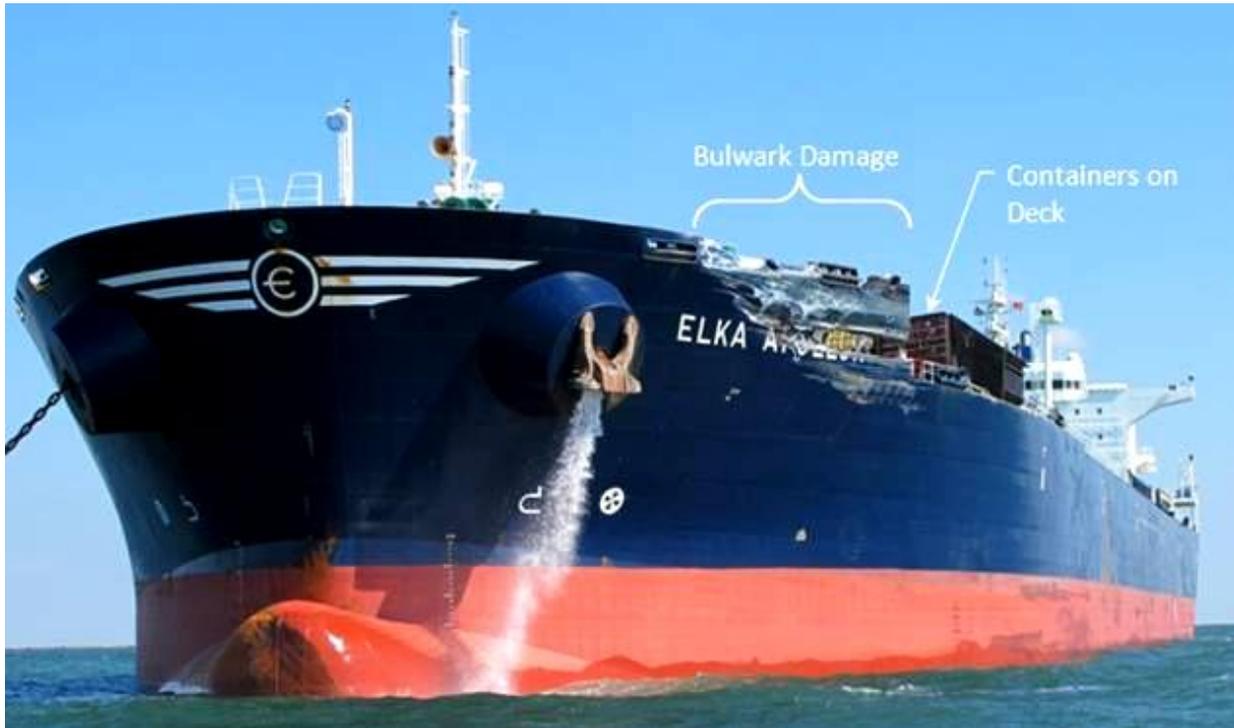
All damage to the *Elka Apollon* was above the vessel's waterline, primarily to the port hull side plating and bow bulwark⁶ from 5 feet below the main deck upward to the top of the bulwark (figure 5) and extending about 40 feet. The bulwark in this area was severely bent with

an open tear approximately 3 feet high and about 20 feet long. The structural support in the area of the tear was also distorted.

Figure 5. Damage to *Elka Apollon* port bow and partial view of containers that fell to its deck from the *MSC Nederland*.

Upon impact, three containers fell from the *MSC Nederland* onto the portside foredeck of the *Elka Apollon*. Two containers held three agricultural tractors each, and one contained stoves. None of the *Elka Apollon*'s cargo piping was damaged, but the fallen containers damaged the vessel's cargo tank fittings to the no. 1 port cargo tank on the main deck immediately above the cargo tank.

The total cost of repairs to the *Elka Apollon* was approximately \$1.5 million.⁷

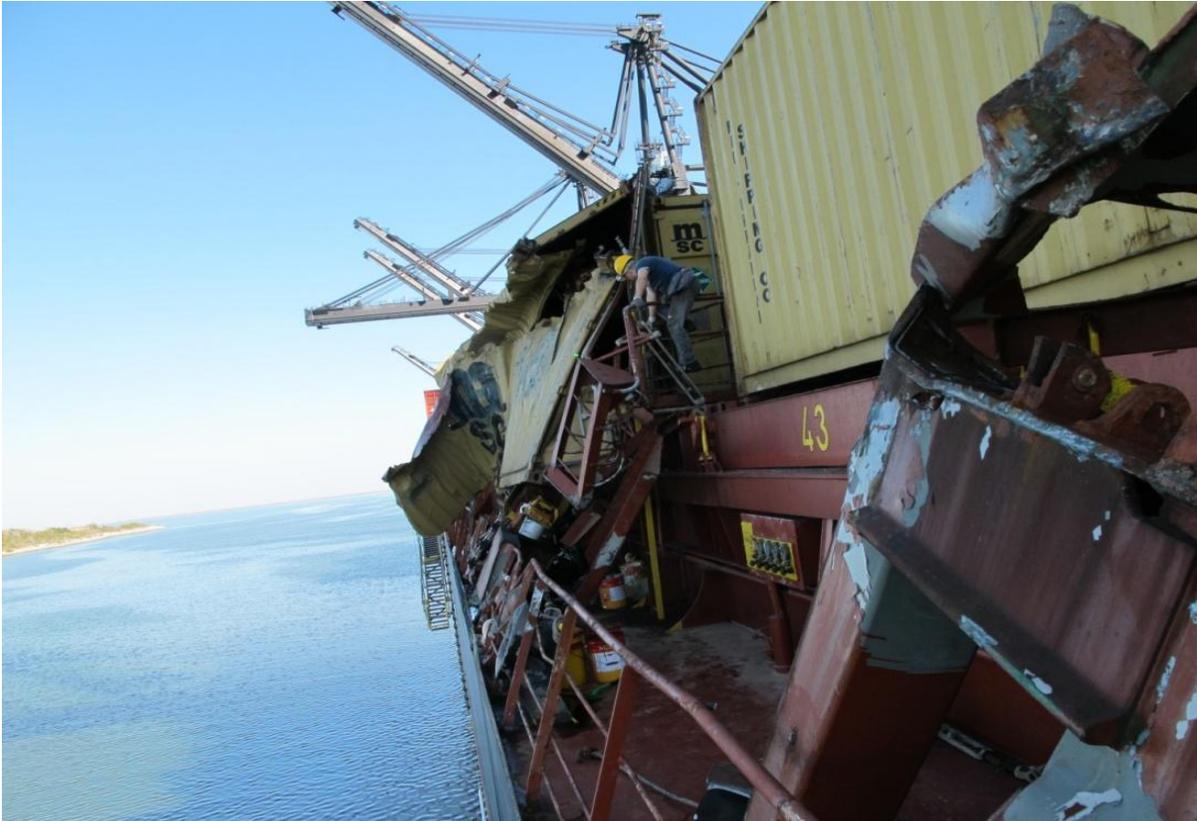
The *Elka Apollon*'s port bow struck the port side of the *MSC Nederland* about 98 feet forward of the vessel's superstructure and scraped along the side of the ship above its main deck for about 148 feet. (Partial damage to the port side is shown in figure 6.) The main deck was punctured in one location. The puncture was approximately 18 inches long and several inches high and led into the longitudinal passageway outboard on the deck below the main deck. Damage to the *MSC Nederland* extended vertically from the main deck about 12 feet up the port side.

Figure 6. *MSC Nederland* damage, looking forward from superstructure at main deck.

Following the accident, the vessel continued its transit into Bayport and moored at the Bayport Container Terminal. A representative of the Germanischer Lloyd classification society surveyed the vessel the next day to ascertain damages and necessary repairs.⁹ The total cost of repairs to the *MSC Nederland* was estimated to be \$1.3 million.¹⁰

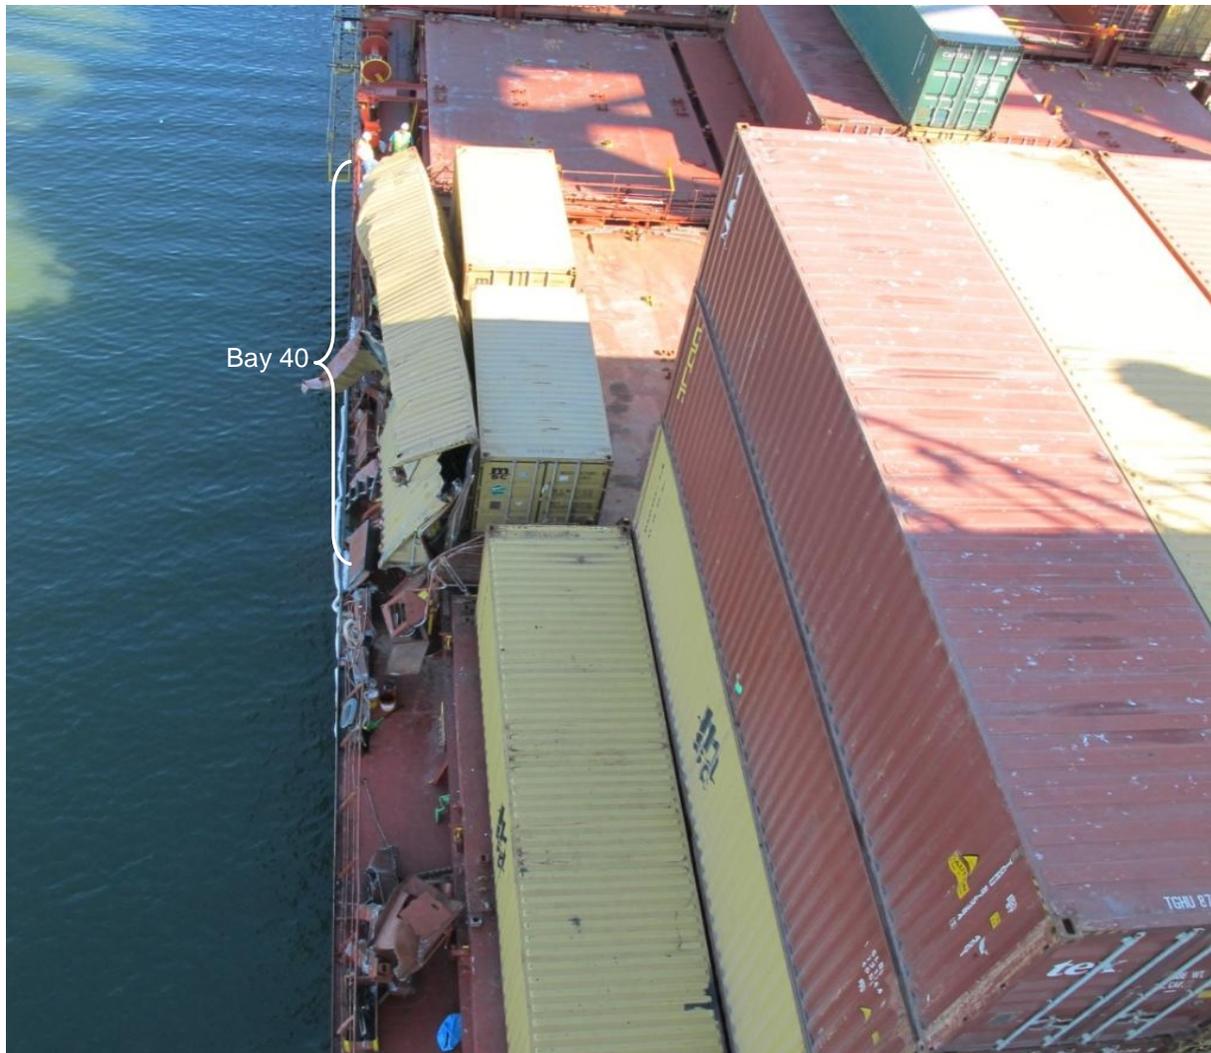
According to the Marine Field Survey Report,⁸ six containers stowed on the port side just forward of the superstructure also were damaged. The *Elka Apollon's* port bow crushed the outermost 40-foot container stowed just over the *MSC Nederland* main deck in bay 40 and tore three similar containers stacked on top of it from the vessel. These three containers fell to the foredeck of the *Elka Apollon*. (Damage to containers is shown in figure 7.)

Figure 7. Damaged containers on *MSC Nederland*, photographed forward from bridge wing.

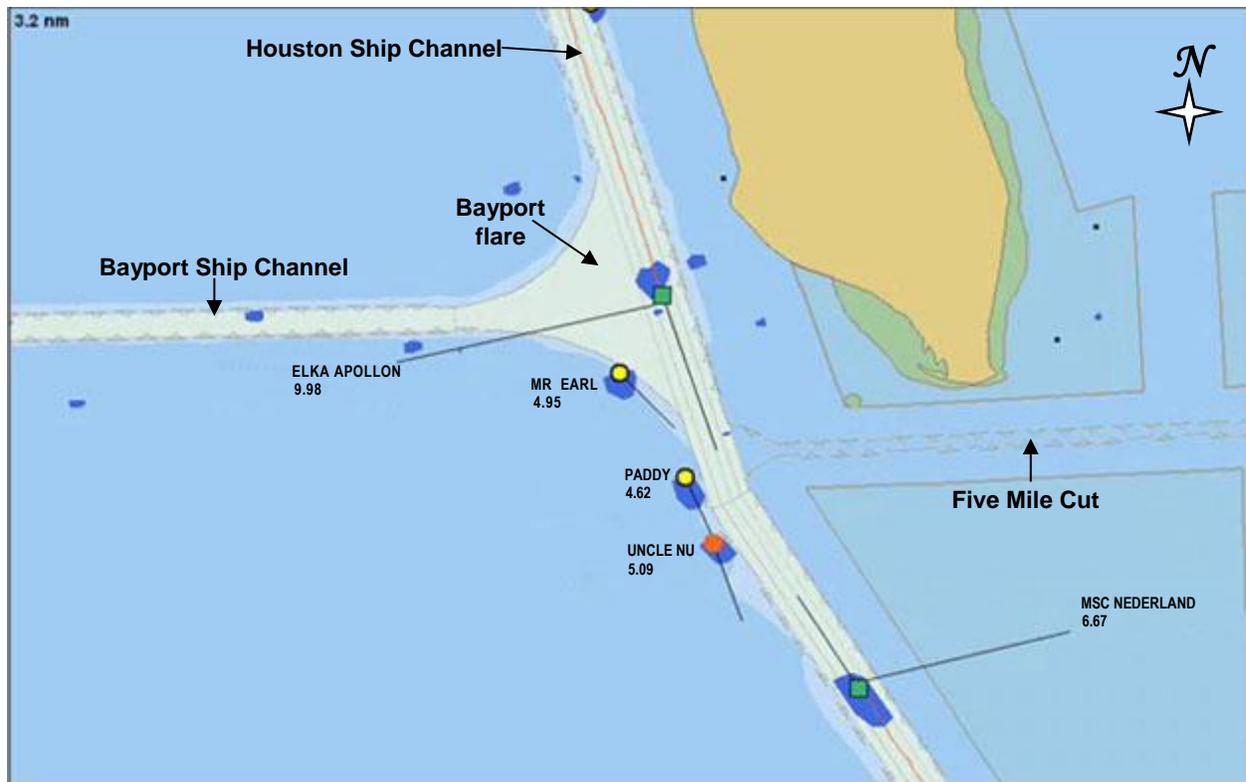
Figure 10. Portion of VTS AIS display at 0902 on October 29, 2011, showing the *Elka Apollon* outbound and the *MSC Nederland* inbound (green squares near center and bottom right of screen, respectively) as they approach each other near the slight bend in the Houston Ship Channel and Five Mile Cut. The *Mr. Earl* is indicated by the uppermost yellow circle. The two other tows in the barge lane are labeled *Paddy* (yellow circle) and *Uncle Nu* (orange circle). Below the vessel name is its speed in knots. The dark blue areas near the vessel locations are radar images. (Original AIS vessel labels have been simplified for readability.)

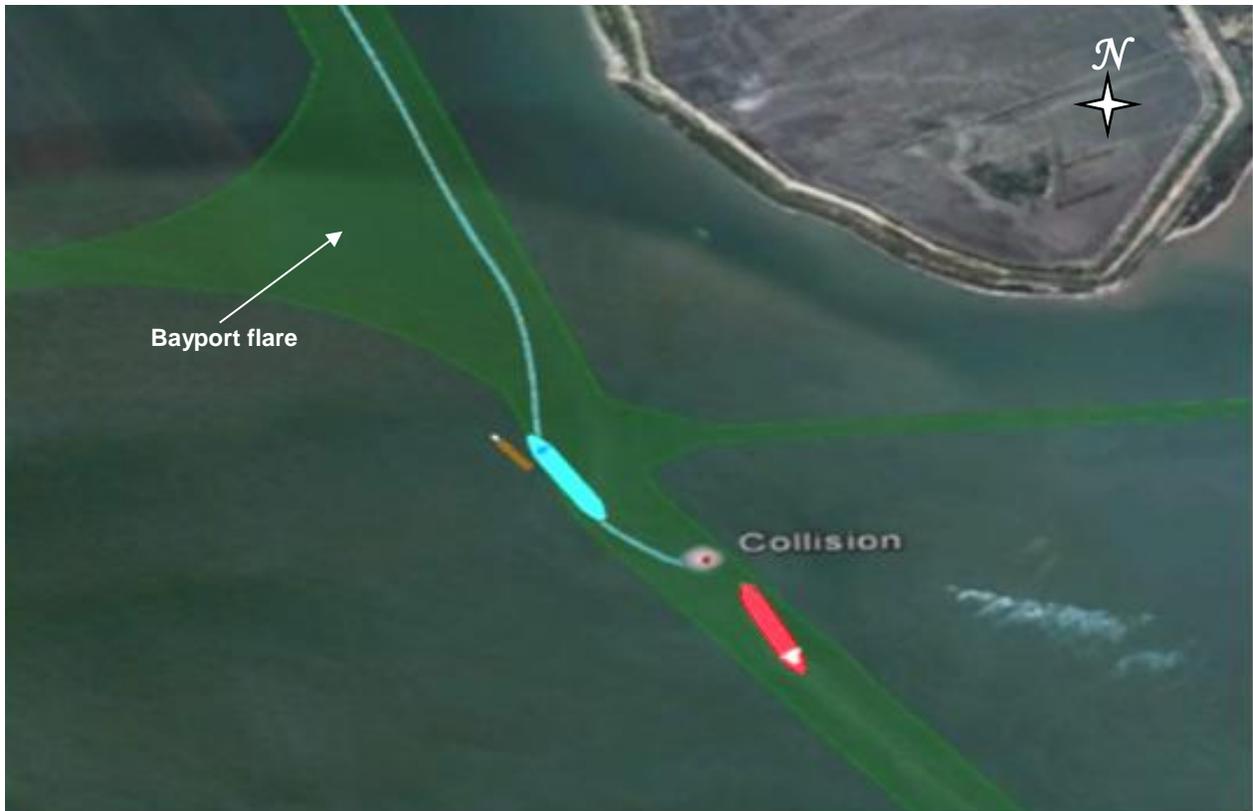
As described in the previous section, the pilot on the *Elka Apollon* ordered a series of rudder commands as the tanker transited the Bayport flare. As illustrated in figure 11, the ship responded by turning to starboard, toward the right bank of the Houston Ship Channel south of the flare, and then turning toward the left side of the channel and colliding with the *MSC Nederland*. To determine the cause of this motion and assess the role of channel hydrodynamic bank effects,³⁸ the NTSB conducted a study to examine the forces and moments³⁹ on the *Elka Apollon* extracted from the ship's recorded motion.⁴⁰

Figure 11. Trackline of the *Elka Apollon* (blue) and positions of the *MSC Nederland* (red) and the *Mr. Earl* (brown) at 0904:29, about 1 minute before the accident.

As the *Elka Apollon* progressed through the channel north of the Bayport flare, it was exposed to bank effects from both sides, which largely balanced each other out. However, because the vessel was slightly to the left of the channel centerline, the forces affecting its left side, trying to turn the vessel to starboard, dominated. As a result, the helmsman was applying primarily port rudder, averaging an angle of about 4 degrees, to maintain a steady course of 161 degrees over the last 2 minutes of that course order. When the vessel entered the relatively open waters of the Bayport flare, the forces acting on the vessel's right side diminished and no longer counteracted those of the left bank that had been causing and continued to cause a starboard yawing moment on the vessel.⁴¹

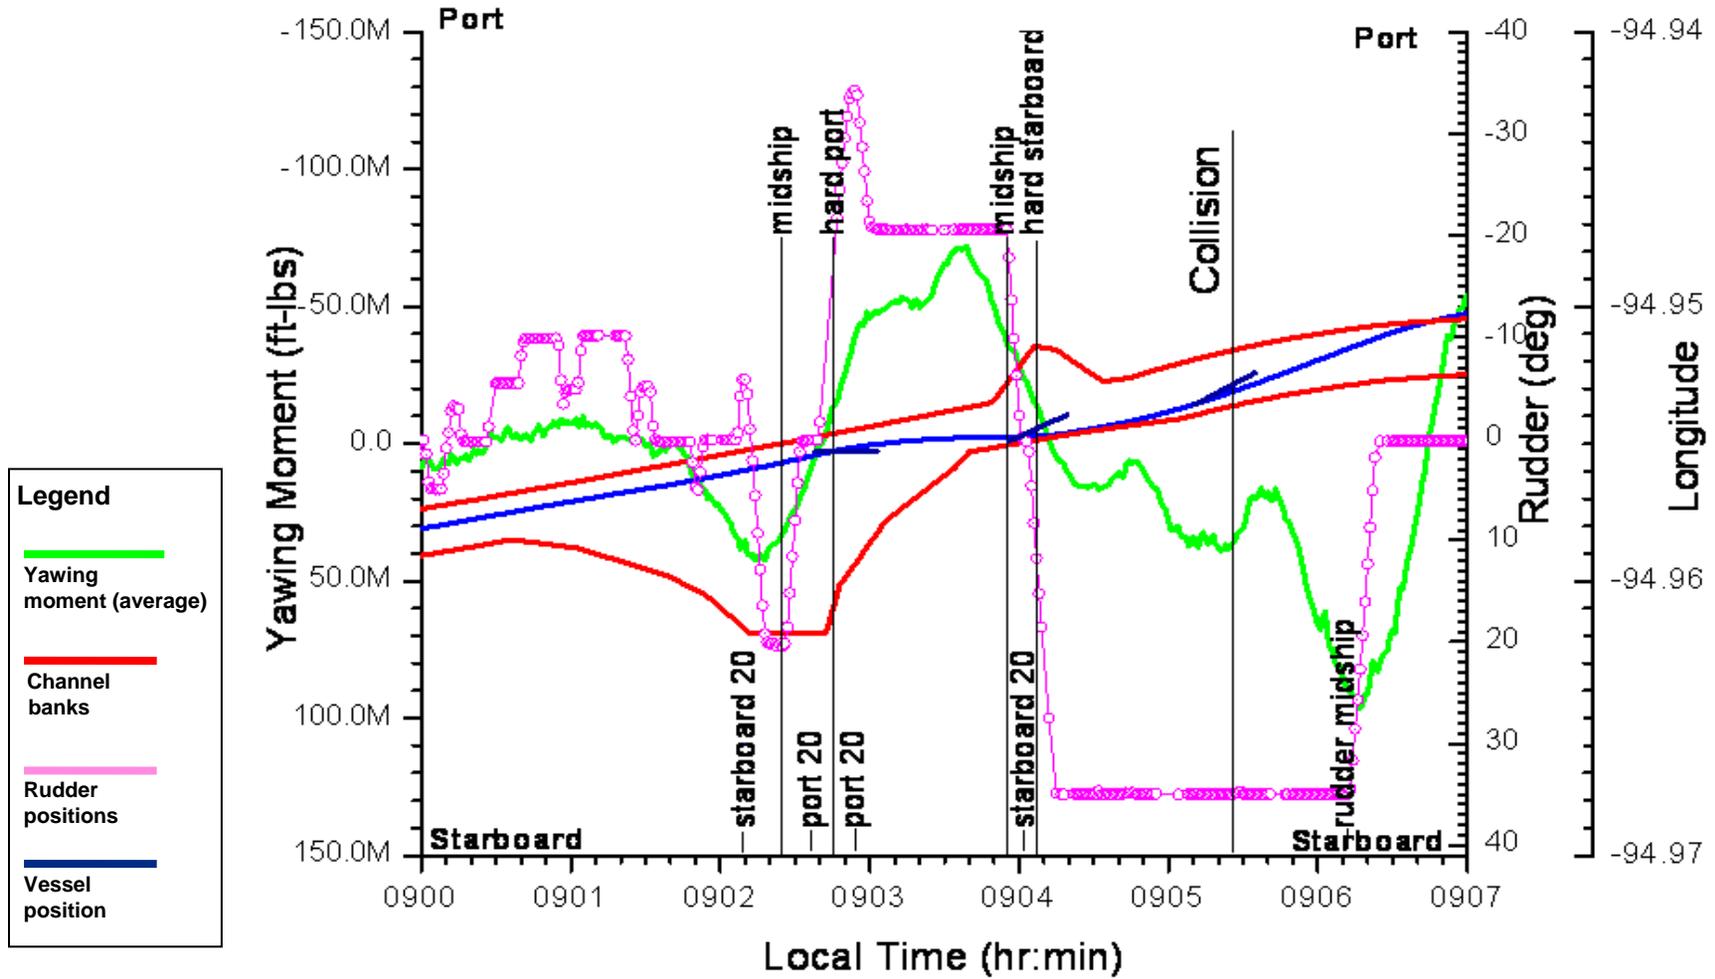
Figure 12. Rudder positions, average yawing moment, and position of the *Elka Apollon* over time as the vessel traveled south (from left to right on the plot) through the Bayport flare in the minutes prior to and just after the collision.
