Collision between Bulk Carrier *Conti Peridot* and Tanker *Carla Maersk*
Houston Ship Channel near Morgan's Point, Texas
March 9, 2015

Marine Accident Report

NTSB/MAR-16/01
PB2016-103277

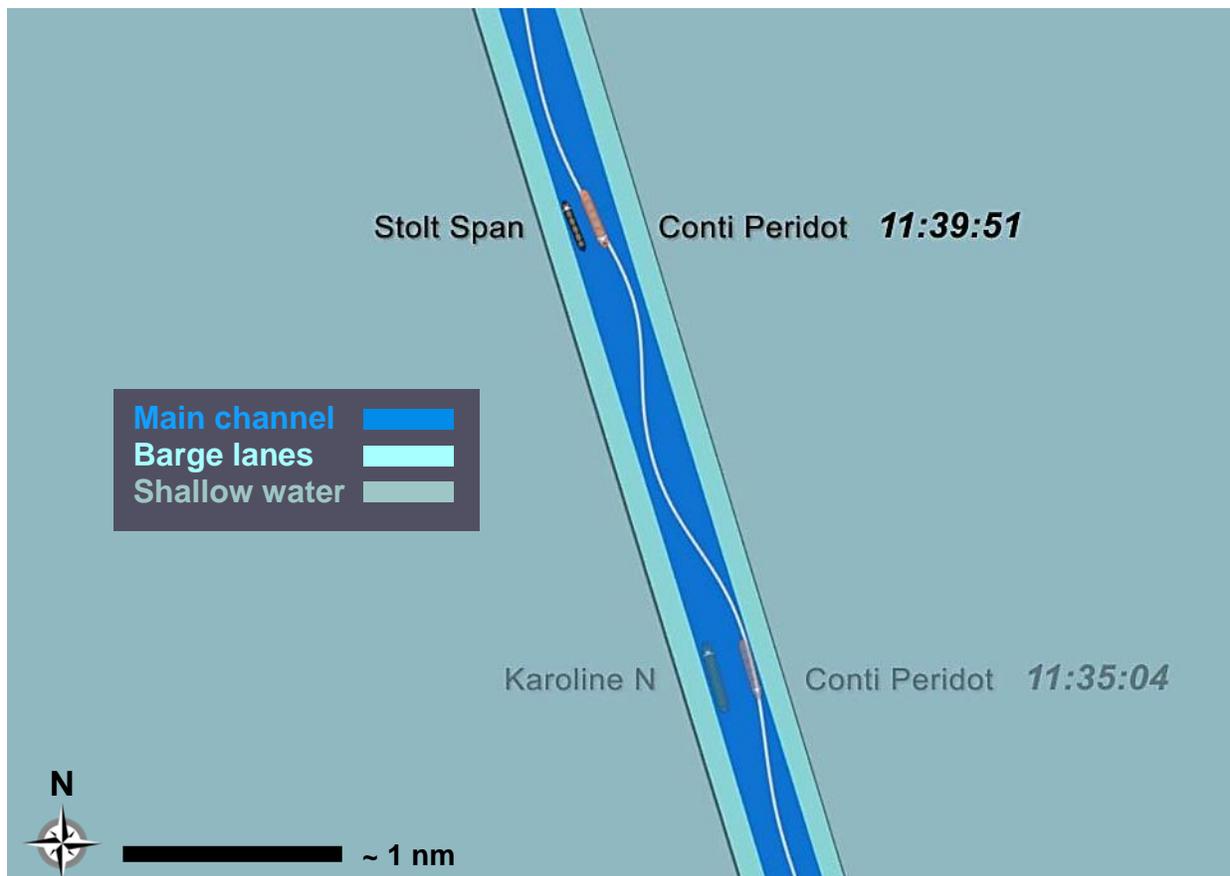
A replay of the pilot’s portable pilot unit (PPU) confirmed that, after the *Conti Peridot* dove to the left, bank effect off the main channel’s left bank (in relation to the travel direction of the vessel) forced the bulk carrier’s bow toward the right bank.¹² According to his postaccident interview, before meeting the next vessel, tanker *Stolt Span*, the pilot on the *Conti Peridot* felt that the bulk carrier’s sheer toward the right bank was cause for concern.¹³ He said that the visibility at the time was an estimated 400 to 600 feet, and that he could barely see the bow of his ship. He radioed the pilot on the *Stolt Span*, saying, “pay attention, watch me, I’m coming off the bank.” A review of the bridge audio recording from the *Conti Peridot*’s voyage data recorder (VDR) revealed that the pilot on the *Stolt Span* asked, “You all right?”¹⁴ No intelligible response can be heard on the VDR. About 1140, as the vessels met, the *Stolt Span* was forced to the far right side of the channel (in relation to the travel direction of the *Stolt Span*) as the *Conti Peridot* sheered to the left, crossing the center of the channel. The pilot on the *Conti Peridot* told investigators that for a distance of about 2 miles during meeting and passing the *Karoline N* and the *Stolt Span*, he was struggling to get the bulk carrier under control, including for about half a mile after passing the *Stolt Span* (figure 4). He said that although his PPU was helpful, he really needed to see the “head” of the ship and its true motion to have good situation awareness.

Figure 4. Animation image showing the oscillating trackline of the *Conti Peridot* after the bulk carrier passed the *Karoline N* and before meeting the *Stolt Span*, about 1 hour before the collision. Image compiled using automatic identification system (AIS) and VDR data.¹⁵

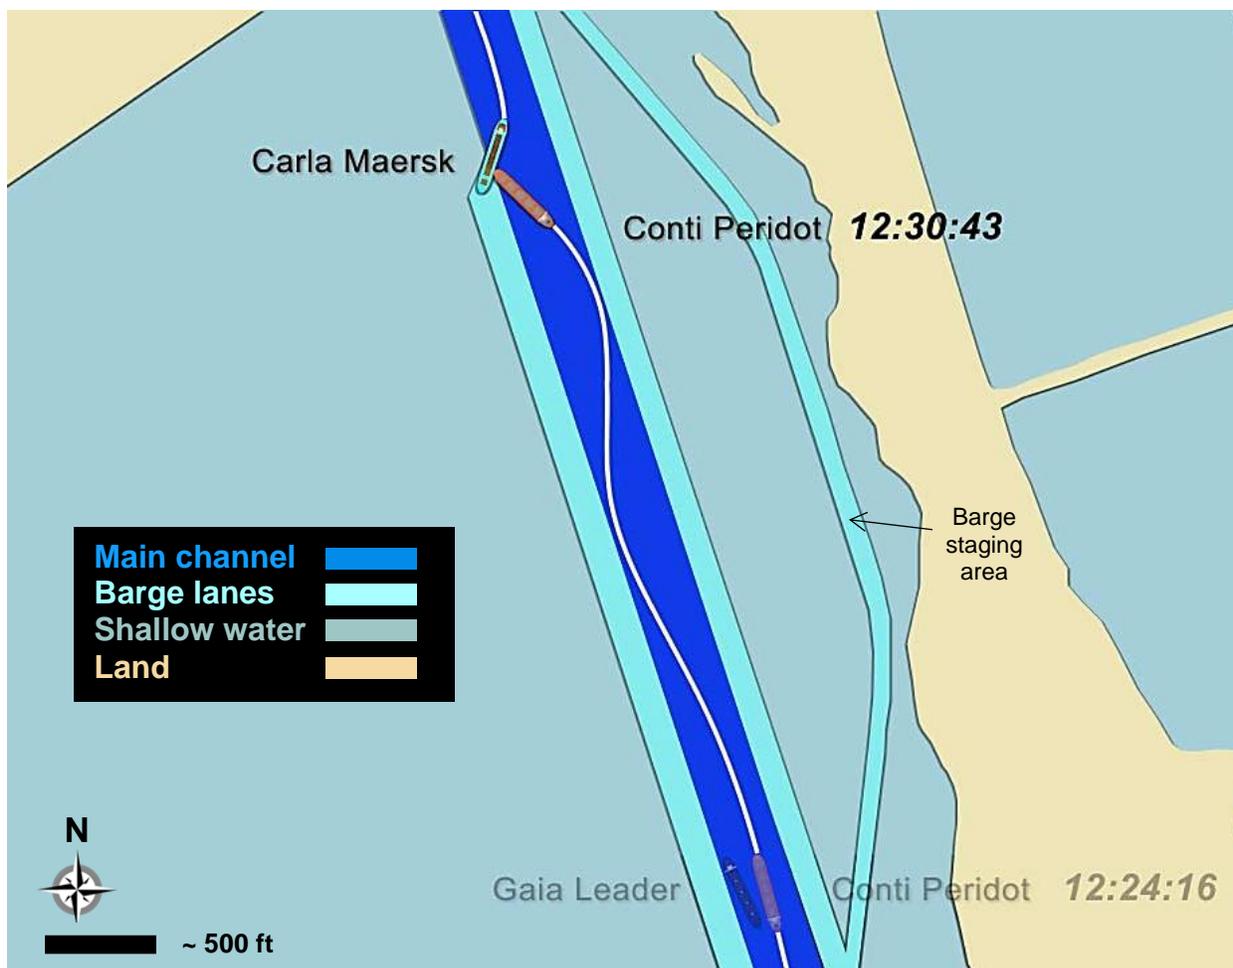
At this point, about 1229, the pilot on the *Conti Peridot* did warn the pilot on the *Carla Maersk* via radio, saying in part, “Try to miss me, coming across the channel.” He also asked the other pilot to come left with the *Carla Maersk* in the waterway. This requested direction was counter to the port-to-port meeting arrangement to which the pilots had previously agreed, but the pilot on the *Conti Peridot* explained to investigators that, because the bulk carrier was sheering to the left (toward the *Carla Maersk*), he was hoping that the pilot on the *Carla Maersk* could come left to avoid the collision. The pilot on the *Carla Maersk* replied that he could not come left as he had already committed to moving to starboard in preparation for the meeting (figure 8).

Figure 8. Animation image of the *Conti Peridot's* oscillating trackline after the bulk carrier passed the *Gaia Leader* and as it approached the meeting with the *Carla Maersk*. Image compiled using AIS and VDR data.

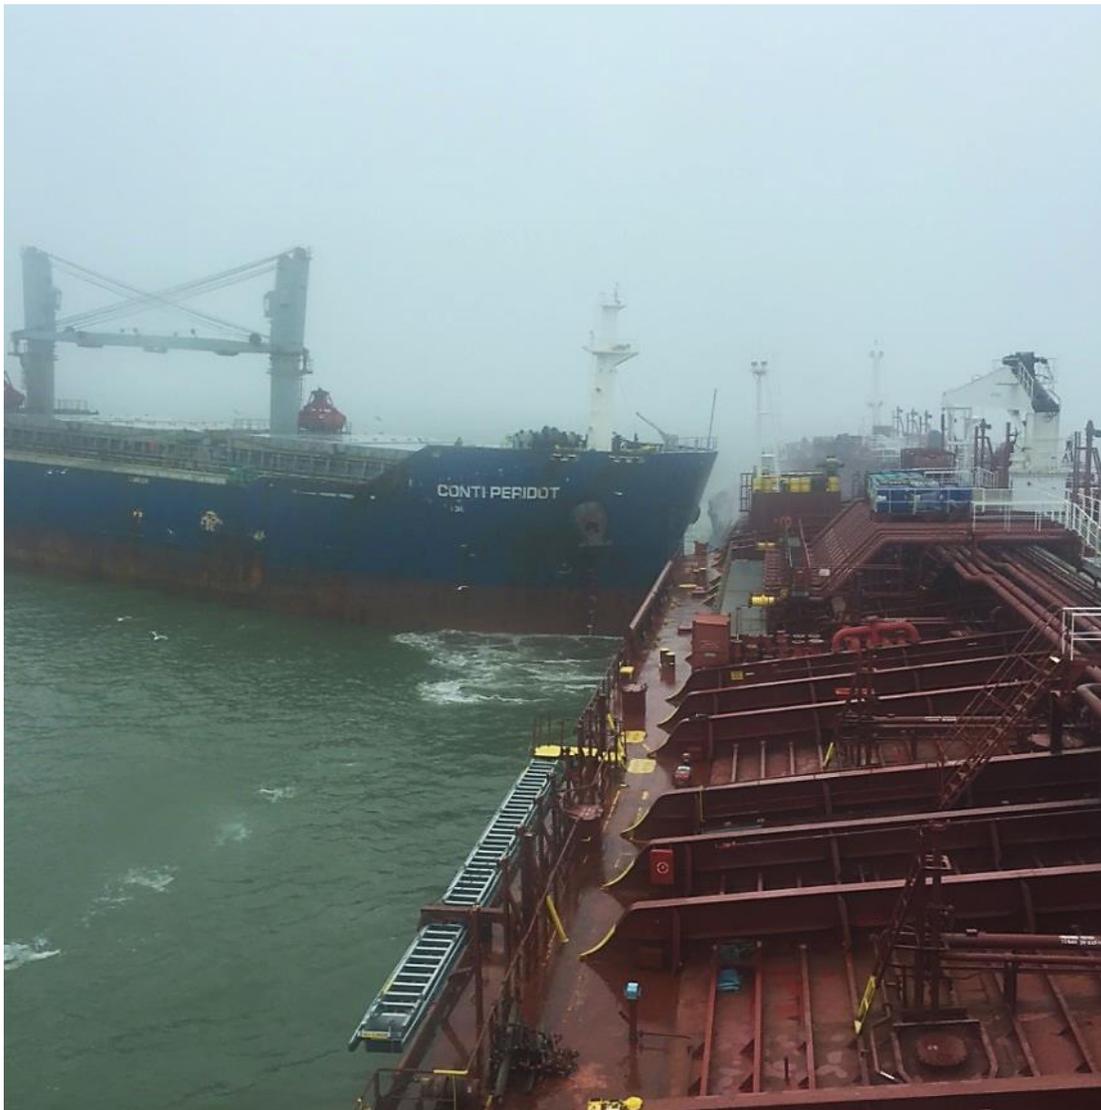
At 1230, the bow of the *Conti Peridot* struck the port side of the double-hulled *Carla Maersk* just forward of midship (figure 9). The collision damaged several ballast tanks and cargo tanks on the *Carla Maersk*, including breaching cargo tank no. 4, and damaged the bow on the *Conti Peridot* (also see sections “1.4 Damage,” “1.5 Emergency Response,” and “1.6 MTBE Information”). The vessels separated shortly after the collision and anchored in the vicinity.

Figure 9. The two vessels moments after the collision. (Photo by *Carla Maersk* crewmember)

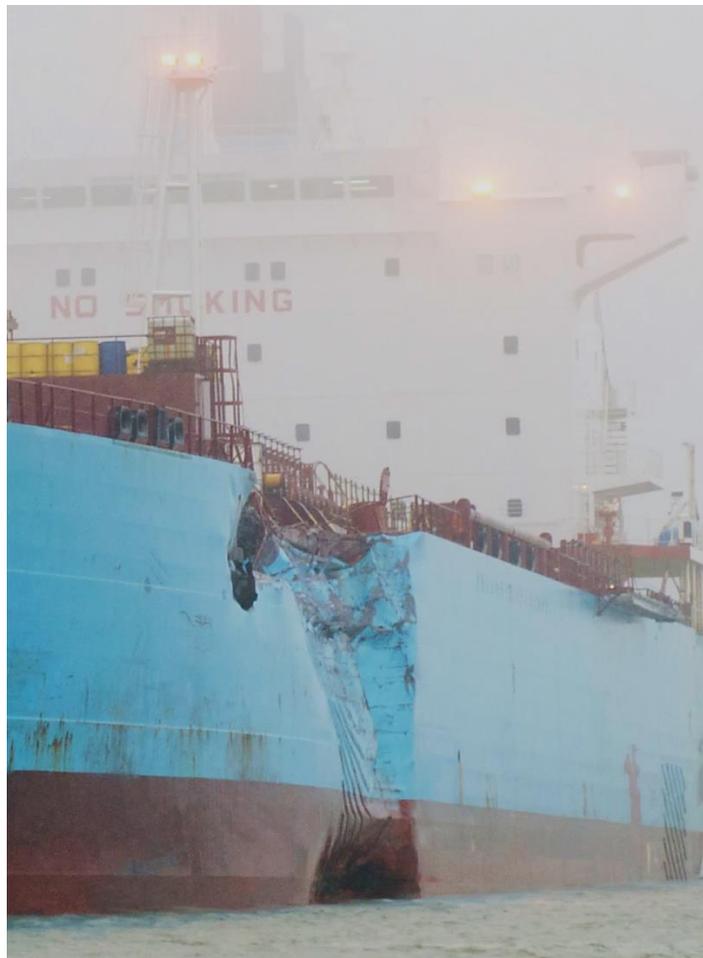
Carla Maersk. The damage to the *Carla Maersk* totaled \$5.6 million, according to the vessel's classification society Det Norske Veritas-Germanischer Lloyd.²¹ The initial impact point was the port side forward of midship, between frames 69 and 78. Portside cargo tank no. 4 was breached, and portside cargo tank no. 3 was damaged (figures 10 and 11). Portside ballast tanks nos. 2 and 3 port were breached as well.

Figure 10. The damaged port side of the *Carla Maersk*. (Photo by the Port of Houston Authority Fire Department)

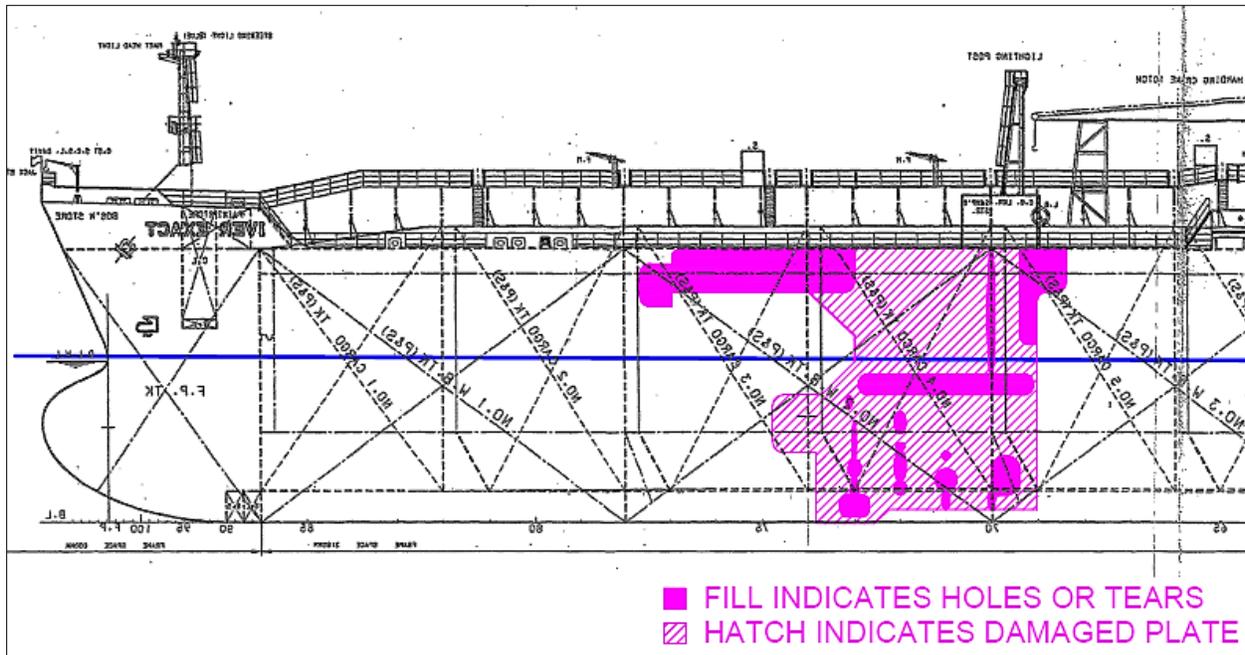
Figure 11. The portside damage to the *Carla Maersk* highlighted in magenta. (Image provided by Titan-Svitzer Salvage; reverse mirror image drawing)

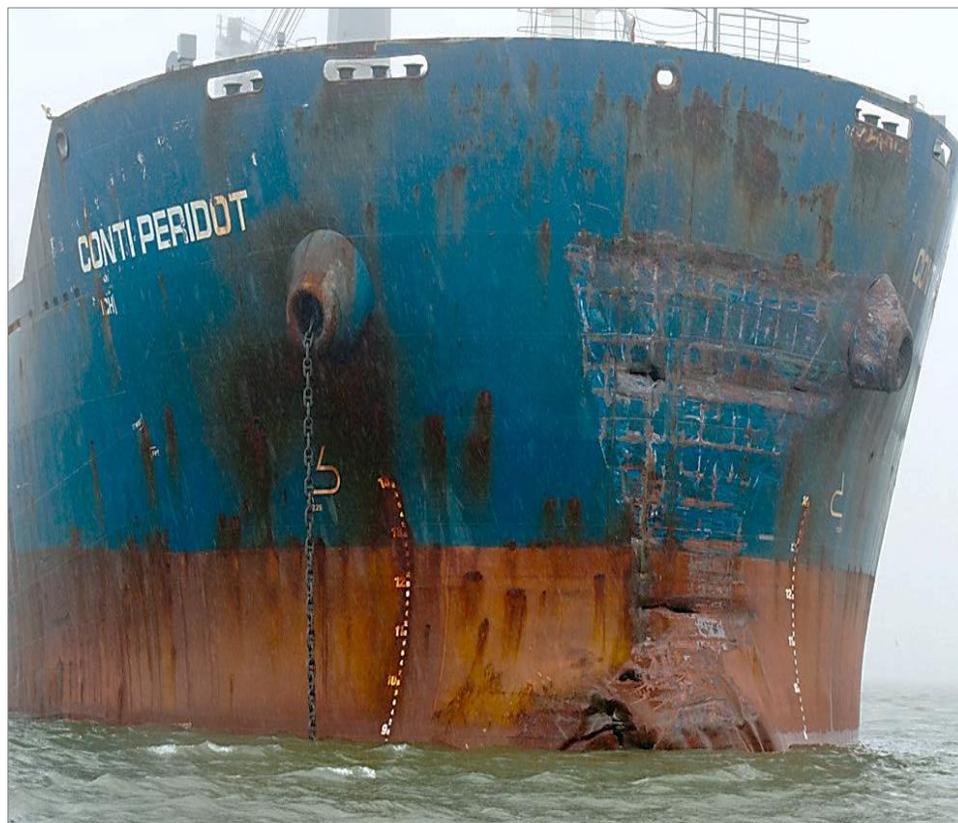
Conti Peridot. The damage to the *Conti Peridot* totaled \$2.6 million, according to the damage survey conducted by the bulk carrier's classification society, the American Bureau of Shipping. The bow was scraped and inset in an area about 30 feet high and 15 feet wide, and the portside anchor was lost in the collision (figure 12).

Figure 12. The damaged bow of the *Conti Peridot*. (Photo by Port of Houston Authority Fire Department)

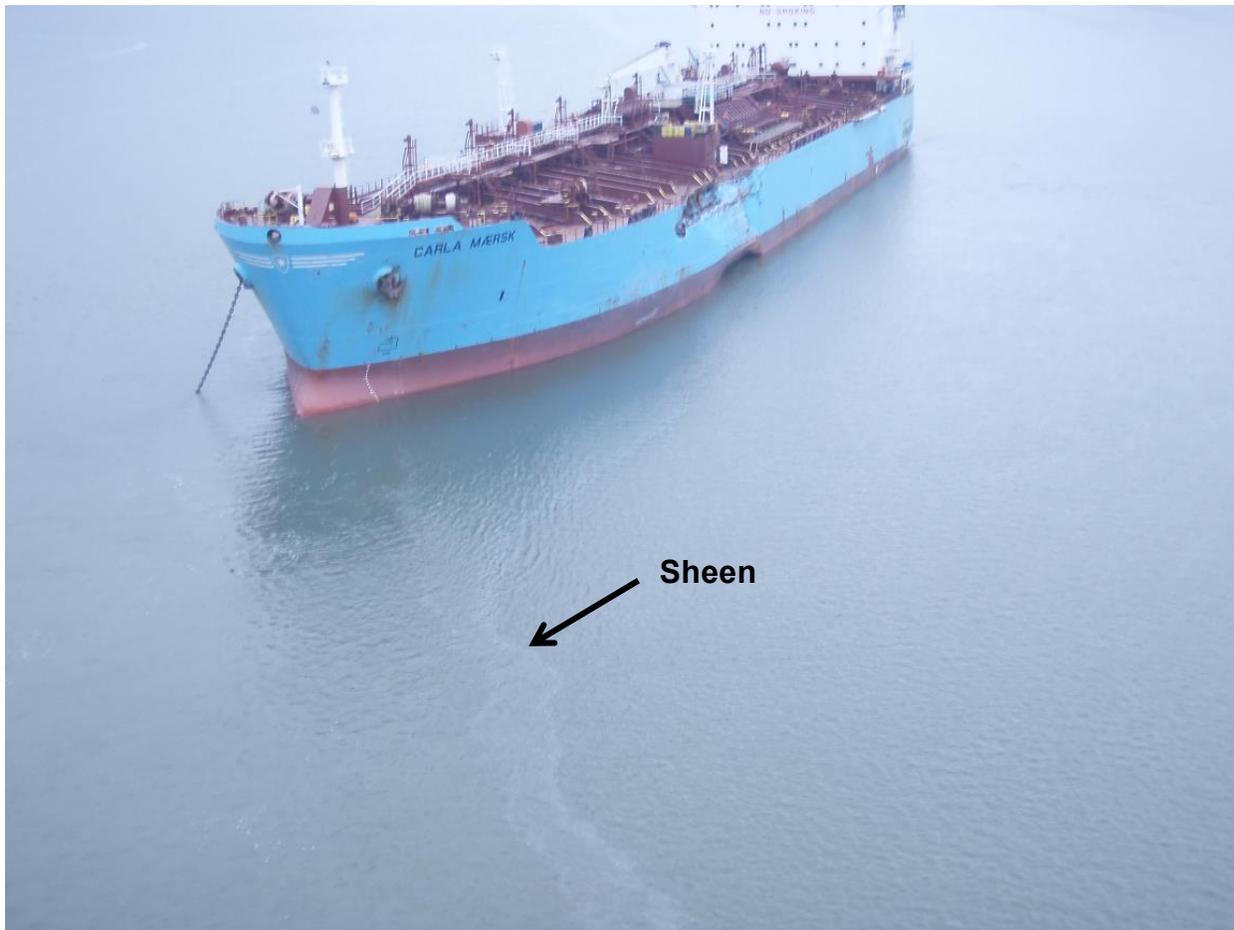
A Coast Guard team that boarded the *Carla Maersk* after the accident reported that three ballast tanks and two cargo tanks were ruptured on the port side. An oil sheen about 1 mile long by one-half mile wide and an odor were reported in the vicinity of the *Carla Maersk* (figure 13).

Figure 13. Sheen on the water near the *Carla Maersk*. (Photo by the Coast Guard)
