Sinking of Amphibious Passenger Vessel
Stretch Duck 7
Table Rock Lake, near Branson, Missouri
July 19, 2018

Marine Accident Report

NTSB/MAR-20/01
PB2020-101002

National
Transportation
Safety Board

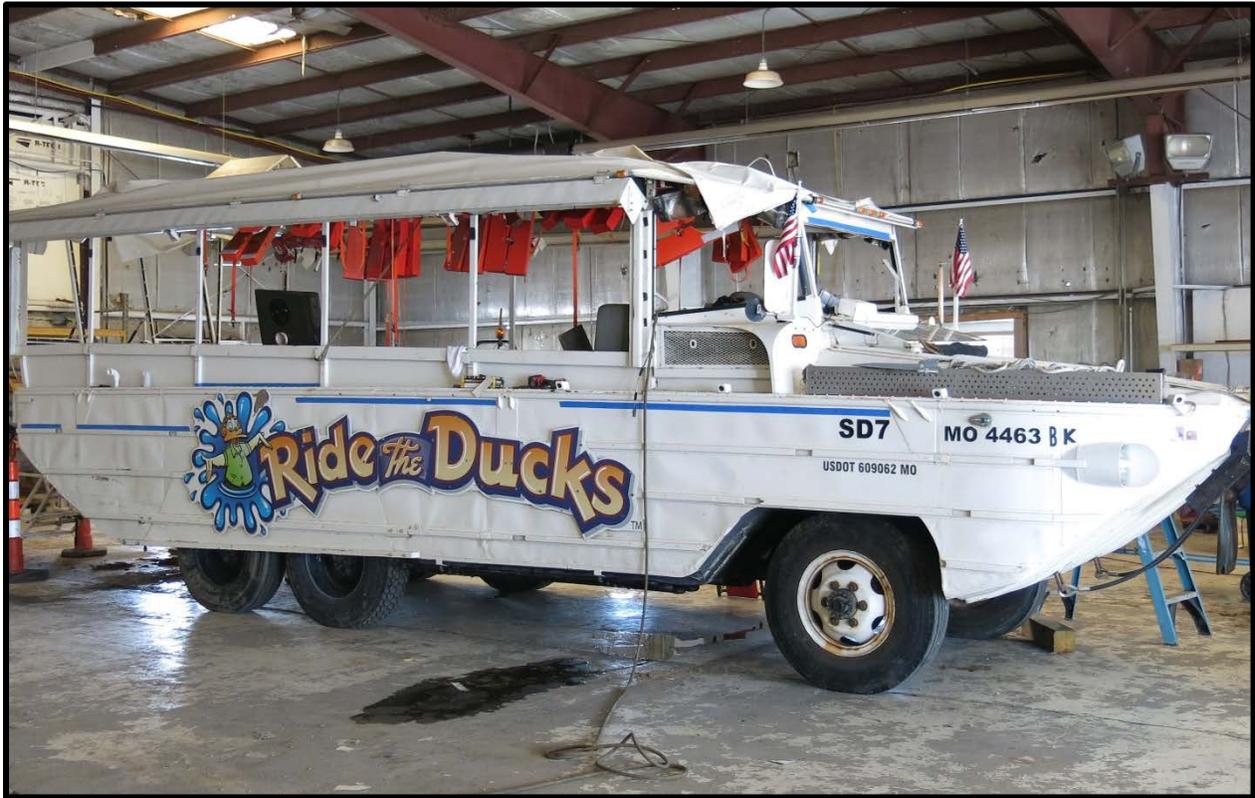
Figure 1. *Stretch Duck 7* after being recovered from Table Rock Lake following the sinking.

On July 23, 4 days after the accident, the *Stretch Duck 7* was recovered from Table Rock Lake by a crane barge. It was found in an upright position on the bottom of the lake at a depth of 85 feet. The condition of the vessel was documented immediately after it was removed from the water and transported to a secure facility.

Investigators found the canopy was torn along the center support beam for most of the length of the vessel and peeled back to the outboard sides. The starboard-side curtain was found closed, and the portside curtain, which had been released, was recovered separately. The “sea chest” was inspected and found to be in good condition.²¹ Postaccident testing and inspection of the vessel is covered in [section 1.12](#). The engine was presumed to be full of water and was not tested postaccident.

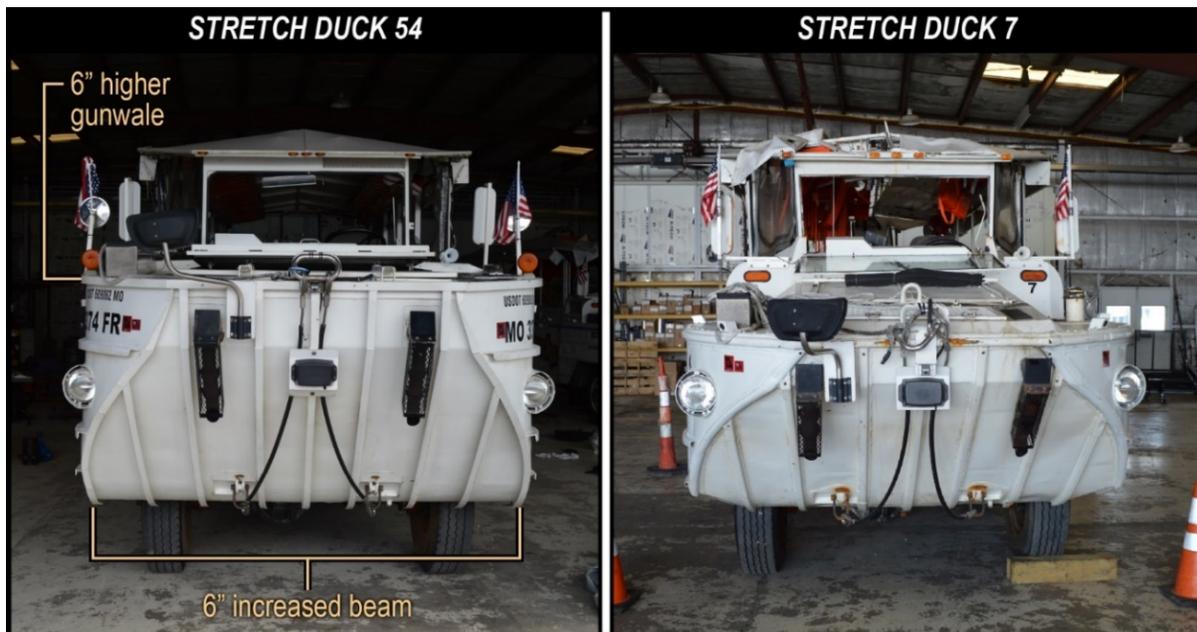
12. The *Stretch Duck 54* was able to exit the lake while exposed to the same conditions as the *Stretch Duck 7* due to the increased freeboard, greater reserve buoyancy, and a securable bow hatch that prevented the ingress of water.

Figure 9. As shown in these photos taken postaccident, the *Stretch Duck 54*, a later model of the stretch duck known as a master jig, had a larger beam and higher gunwale than the *Stretch Duck 7*.

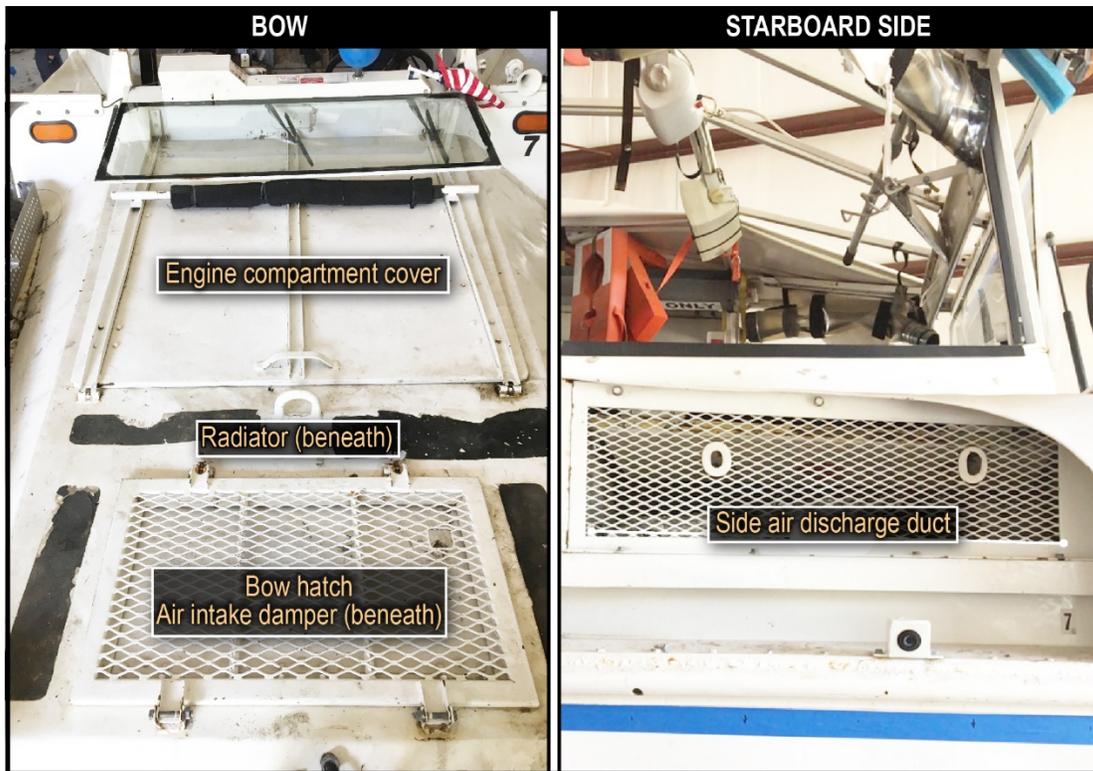
Figure 10. *Left:* Below the open windshield on the bow of the recovered *Stretch Duck 7* are the engine compartment cover and the air intake damper covered by grating, which are both closed. *Right:* Air discharge duct, opened and covered by grating, on the starboard side of the captain's station.

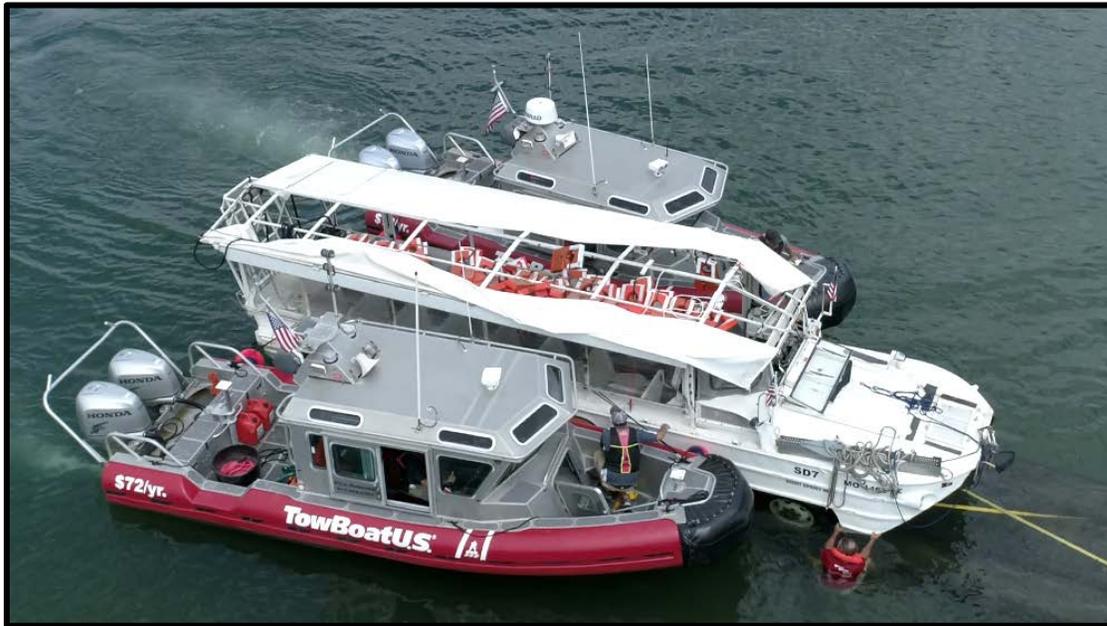
pressed into a seam along the horizontal support at the center of the vessel. On recovery of the *Stretch Duck 7*, the canopy was found torn from forward to aft: the starboard side was peeled back, but most of the port side remained intact ([figure 11](#)). Underneath, the vessel's PFDs were stored above the passenger area. Of the 56 lifejackets investigators counted postaccident, a total of 41 were still connected to the vessel's canopy framing by their straps. The remaining lifejackets were recovered from the lake's surface or within the vessel outside of their storage locations.

Figure 11. Torn canopy on the *Stretch Duck 7* during recovery at Table Rock Lake.

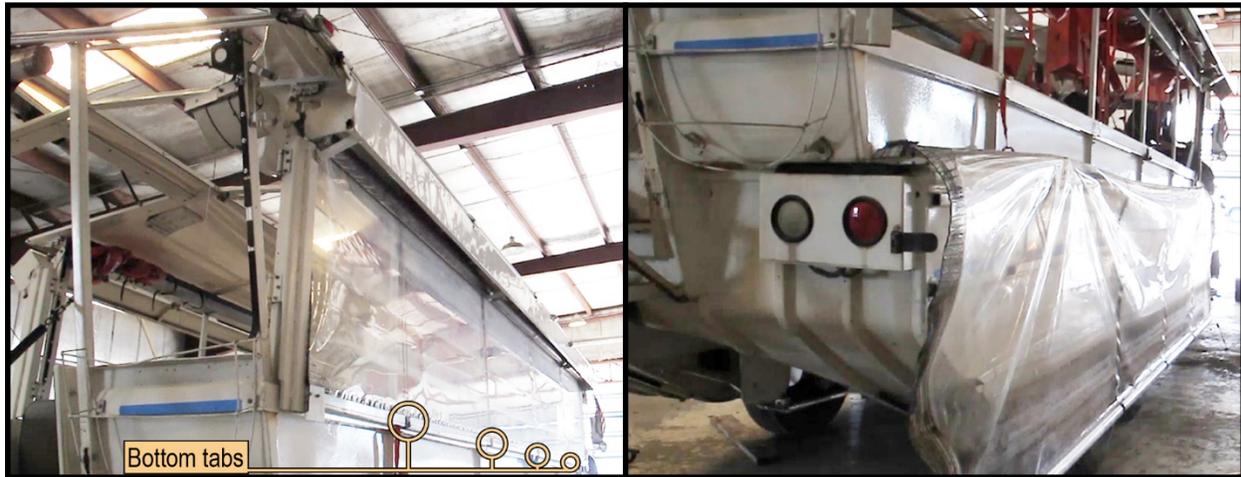
Additionally, in the captain's station, there were two smaller curtains on the port and starboard sides mounted to the vessel with Velcro that could be zippered opened and closed. Another two small curtains located at the passenger entrance on the stern and at a second entrance on the port quarter could also be manually opened (rolled, using Velcro straps to secure them in the open position) and closed (unrolled). Based on video evidence, the two smaller curtains at the captain's station were closed before the sinking.

Figure 12. Closed starboard-side curtain as found during recovery (*left*) and then released (*right*) during the postaccident investigation.

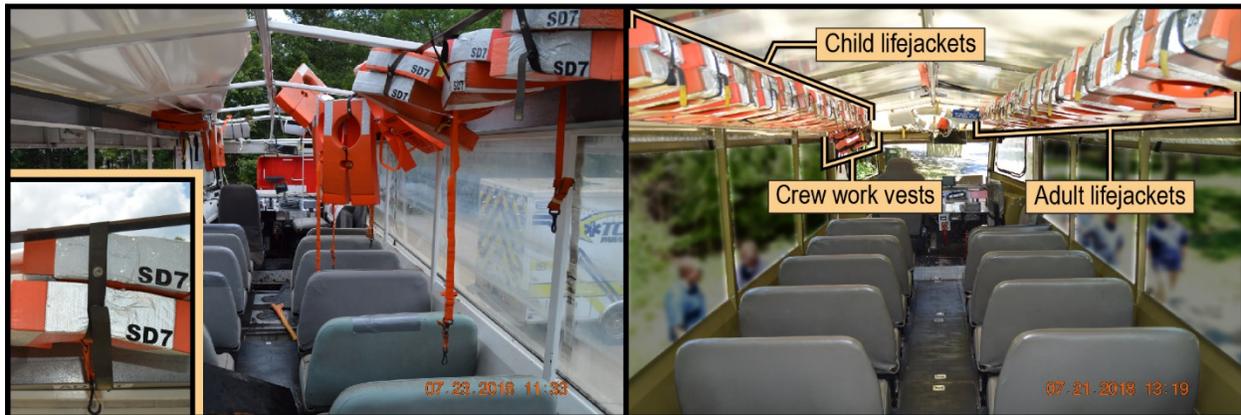
According to the Coast Guard’s NVIC 1-01, vessel operators should store lifejackets “in convenient places distributed throughout the accommodation space and be readily available. If practicable, the stowage should allow the life jackets to float free.” Following the accident, only three adult lifejackets belonging to the *Stretch Duck 7* were found floating on the lake’s surface. The majority of the lifejackets were found within the vessel still connected to the canopy’s frame by their straps. [Figure 13](#) shows the 30 adult and eight child lifejackets found on the starboard and port sides, respectively, strapped to the *Stretch Duck 7* after it was recovered (the three infant lifejackets are not visible).

Figure 13. Lifejackets recovered on the *Stretch Duck 7* (left) compared to how they would have been stowed, as shown on the similar vessel *Stretch Duck 9* (right). Infant lifejackets would have been stowed aft of the child lifejackets. (Source: Missouri State Highway Patrol)

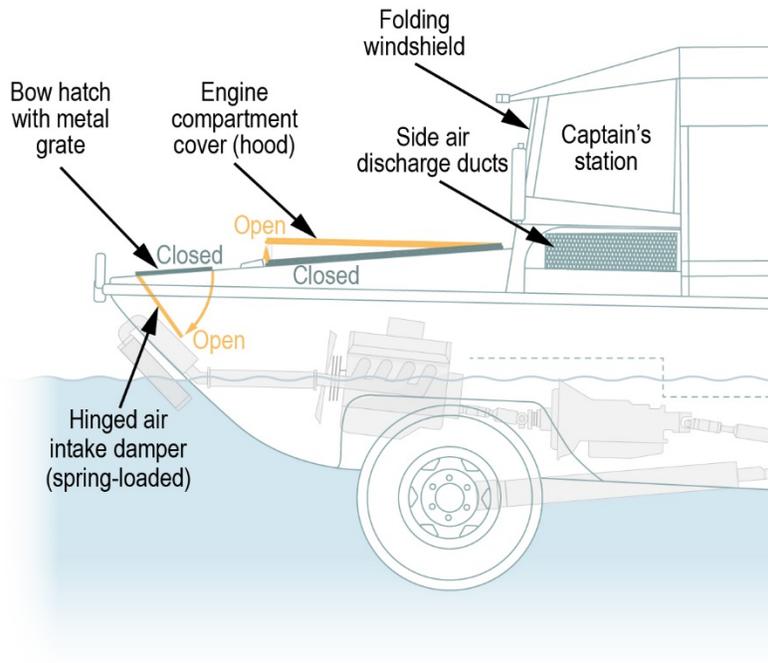
over the bow...to prevent engine water ingestion” or in the event of a fire. The *Stretch Duck 7*’s captain stated that he remotely “dropped the hood” after the winds increased, which, as he stated, “helps prevent water from going into the engine compartment.” Supporting his statement, investigators found the hood and air intake damper in the closed position after salvage, and the vessel’s DVR system detected a sound similar to the engine hood hatch slamming at 19:02:09.

Figure 19. Engine compartment ventilation closures on the *Stretch Duck 7*, including the bow hatch that was likely the initial source of water ingress.

As the bow dipped beneath successive waves, a substantial amount of water likely entered the vessel through it. As the water accumulated in the engine space, the *Stretch Duck 7*’s bow sank lower, and as relatively higher waves rolled across the air intake hatch, the rate of flooding would have increased. The NTSB concludes that initial water ingress to the *Stretch Duck 7* was likely from waves rolling over the air intake hatch’s spring-loaded damper and intermittently opening it, thereby allowing water into the engine compartment.

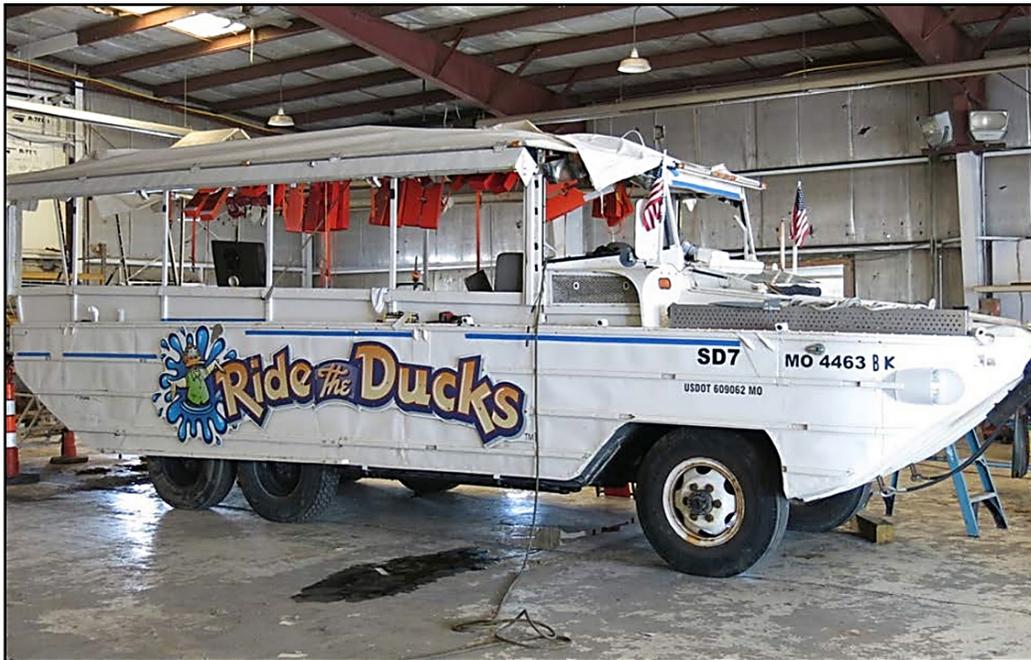
Figure 1. *Stretch Duck 7* after salvage from Table Rock Lake, July 2018.

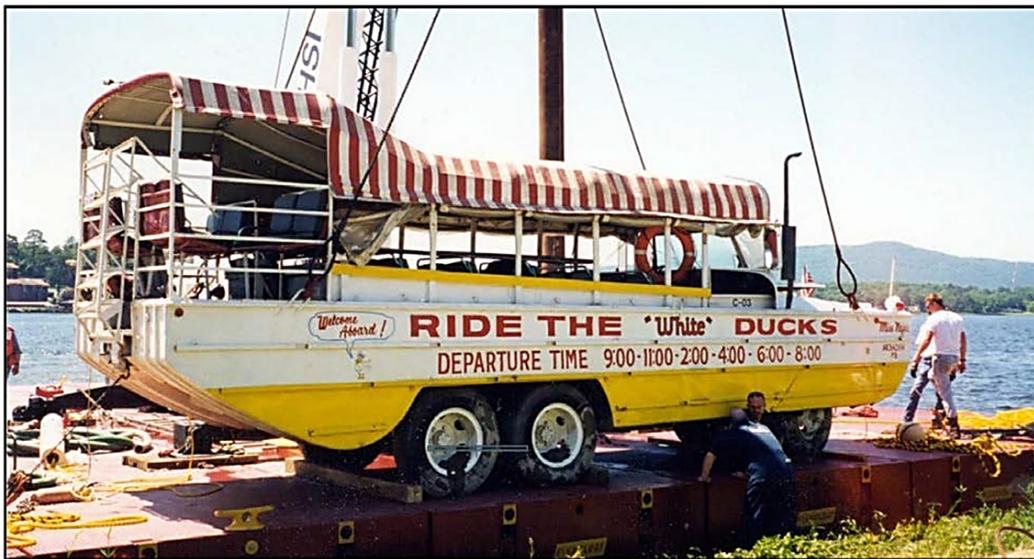
In one of the deadliest accidents involving a modified WWII DUKW at the time, 13 passengers lost their lives during an excursion tour aboard the *Miss Majestic* in Lake Hamilton near Hot Springs, Arkansas, shortly before noon on May 1, 1999.⁴ About 7 minutes after entering the lake, the 31-foot-long vessel (see **figure 2**) listed to port and rapidly sank by the stern in 60 feet of water. The operator and most of the 20 passengers were trapped by the vessel's canopy and drawn under water, except one passenger who escaped before it submerged. As the vessel descended to the bottom of the lake, six passengers and the operator were able to escape and, upon reaching the water's surface, were rescued by recreational boaters in the area. Damage to the *Miss Majestic* was estimated at \$100,000.

Figure 2. *Miss Majestic* post-salvage, 1999.

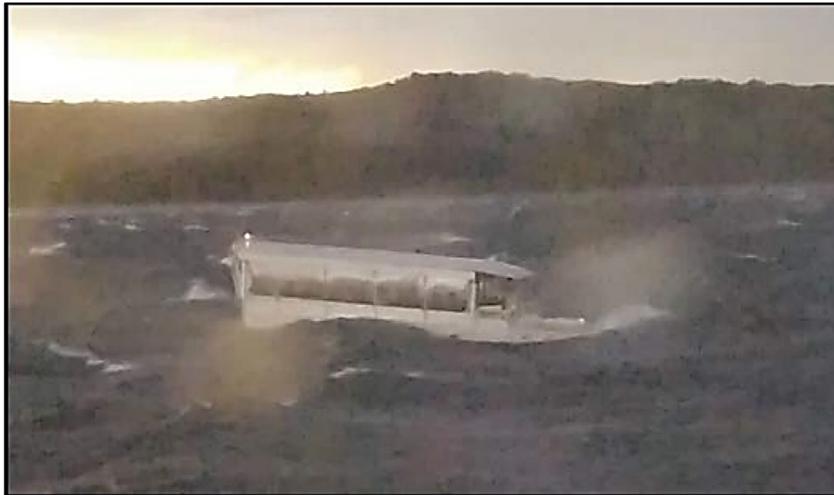
During the waterborne portion of its final voyage, the *Stretch Duck 7* was exposed to high winds and waves estimated at 3 to 5 feet. The video recorder on board captured bilge alarms sounding 4 minutes after the vessel encountered severe weather, signaling an ingress of water. About 4 minutes later, the *Stretch Duck 7* sank. Witness videos showed the vessel pitching in the storm with white-capped waves covering the bow several times (see **figure 4**). In the forward section of the vessel, the ventilation openings that supplied combustion and cooling air to and from the engine most likely permitted water to enter the engine compartment, from where it would have flowed freely throughout the rest of the hull. The additional water weight would have further lowered the vessel's freeboard and thereby subjected it to more rapid flooding.

Figure 4. *Stretch Duck 7* moments before sinking. (Source: Jennie Carr)

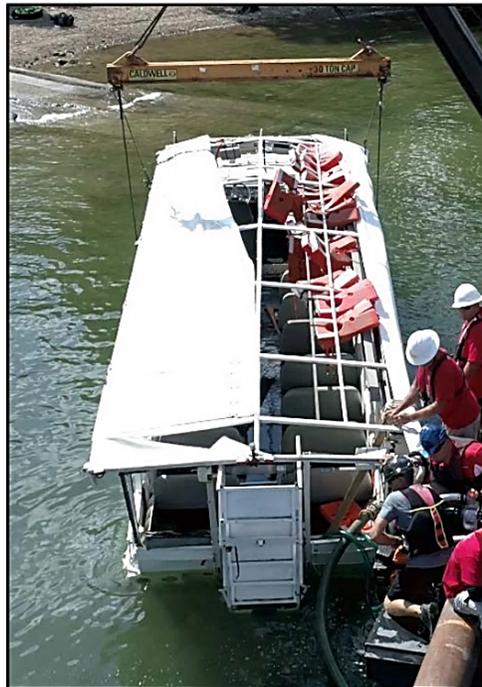
The entire passenger and crew space of the *Stretch Duck 7* had been covered by a fixed canopy. Upon recovery of the vessel, the canopy was found torn from front to back (see **figure 5**). It was peeled back over the starboard side but largely remained intact on the port side. The canopy was constructed of vinyl measuring .032 inches thick and pressed into a seam along the horizontal support at the center of the vessel. Underneath the canopy, the *Stretch Duck 7*'s personal flotation devices (PFDs, commonly called lifejackets) were stored above the seating compartment. Of the 56 lifejackets investigators counted postaccident, the majority of them—a total of 41—were still connected to the vessel's canopy framing by their straps.¹⁶ With the PFDs in their storage locations above the passengers, vertical egress was blocked during the sinking, despite the canopy being peeled back over the starboard side.

Figure 5. Torn canopy of the *Stretch Duck 7* found during recovery operations.
