Collision between US Navy Destroyer *Fitzgerald* and  
Philippine-Flag Container Ship *ACX Crystal*  
Sagami Nada Bay off Izu Peninsula, Honshu Island,  
Japan  
July 17, 2017

NTSB/MAR-20/02  
PB2020-101007

# Marine Accident Report

Collision between US Navy Destroyer *Fitzgerald* and  
Philippine-Flag Container Ship *ACX Crystal*  
Sagami Nada Bay off Izu Peninsula, Honshu Island, Japan  
June 17, 2017

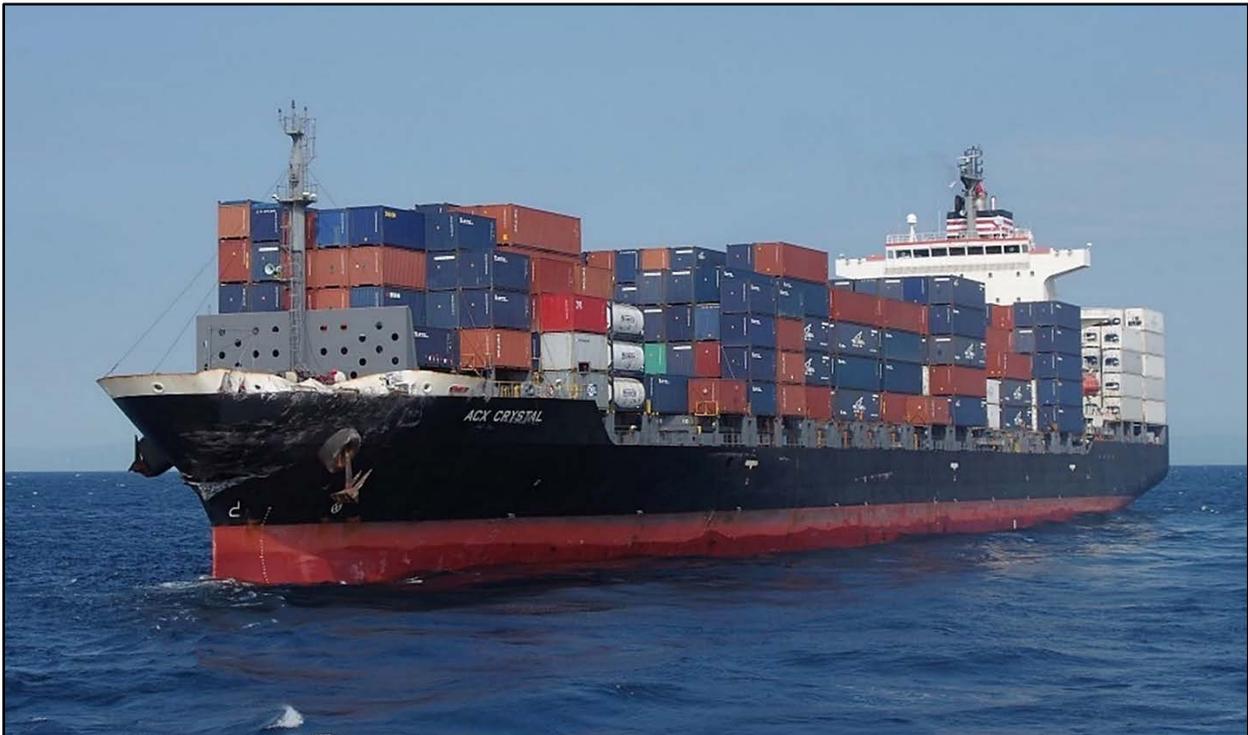
**Figure 5.** Container ship *ACX Crystal*, post collision. (Source: Sea Quest Management)

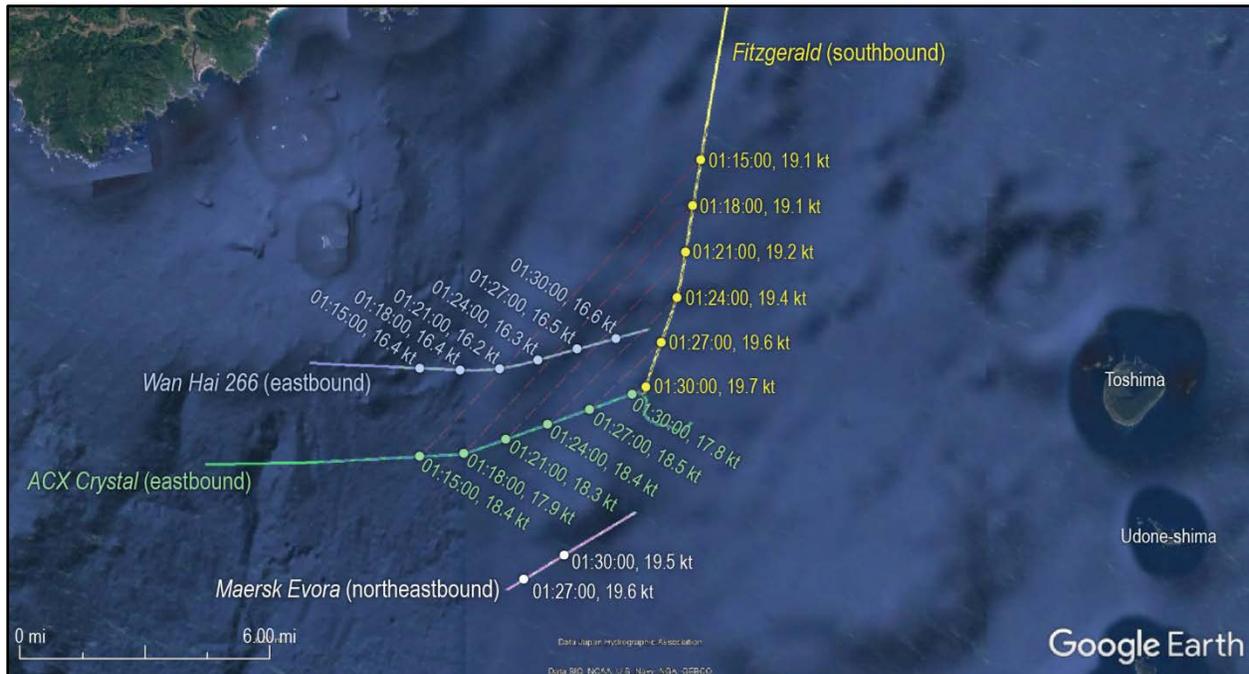
**Figure 7.** NTSB reconstruction of the paths of the *Fitzgerald*, *Wan Hai 266*, *ACX Crystal*, and *Maersk Evora*. (Background source: Google Earth)

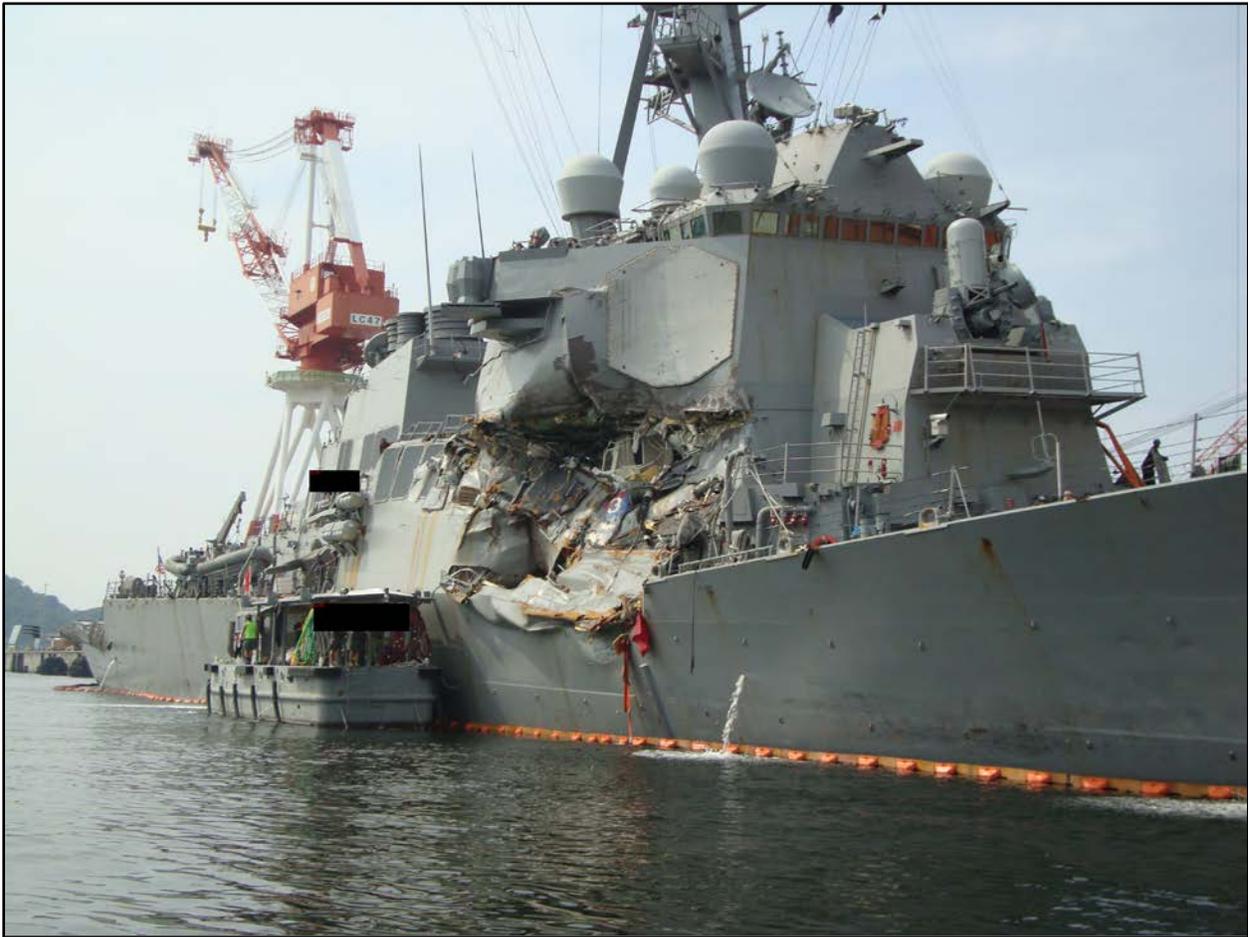
The *ACX Crystal*'s bow penetrated the *Fitzgerald*'s hull and superstructure, trapping numerous crewmembers aboard the destroyer, and the vessel took on a 7° starboard list. The *Fitzgerald*'s crew went to work to control the flooding, assist injured crew, and search for the missing. Seven crewmembers, trapped in their berthing compartment, perished. The destroyer sustained damage in excess of \$300 million.

**Figure 8.** Post collision damage to the *Fitzgerald*'s starboard side. (Source: US Navy)

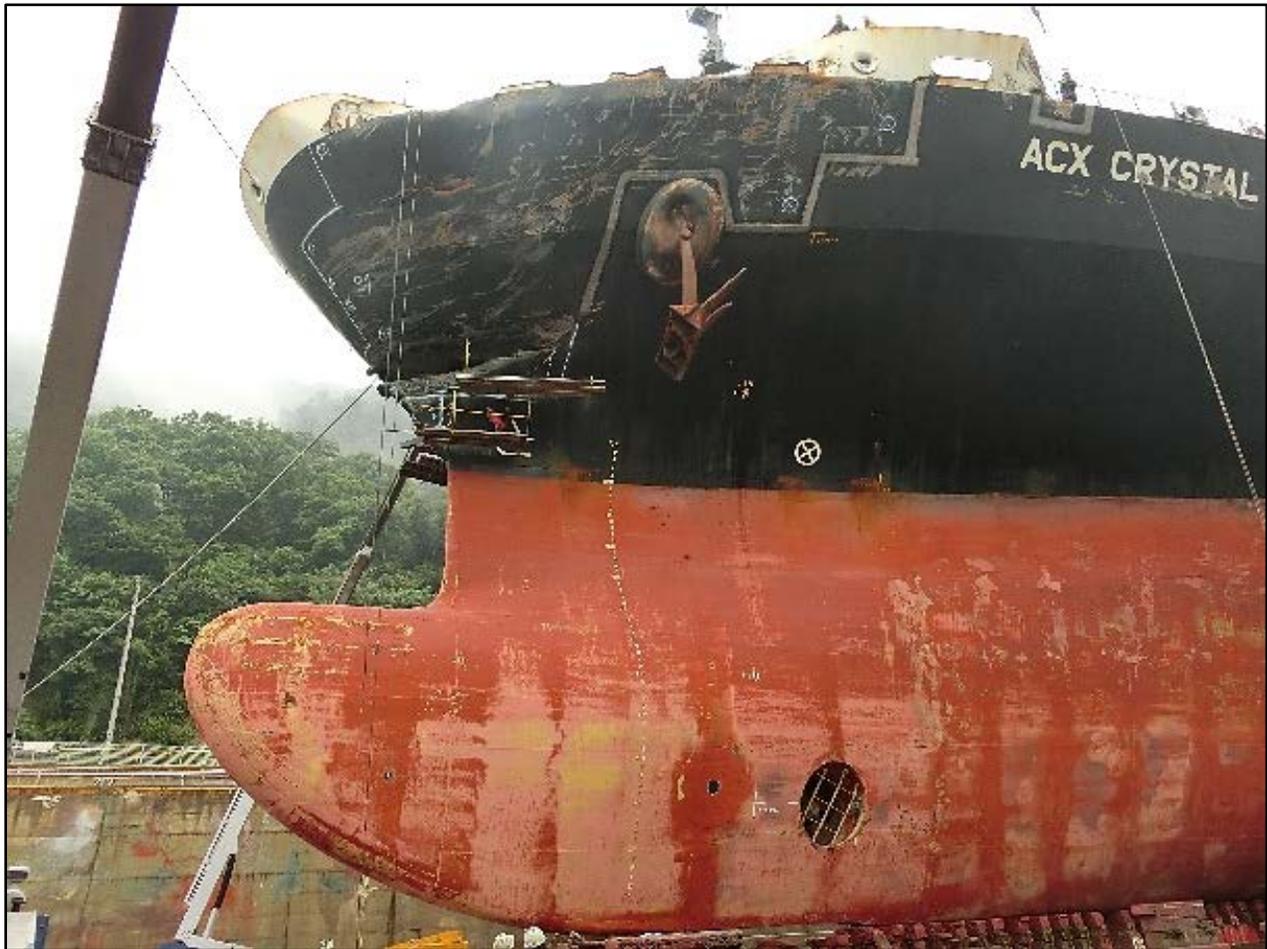
No one was injured on board the *ACX Crystal*, but the container ship sustained damage to its bow and forward compartments. The vessel's forepeak tank sustained a large gash, and a smaller gash was noted in the boatswain's stores compartment. Penetrations to the hull were above the waterline. The cost to repair the *ACX Crystal* was not reported to investigators.

**Figure 9.** Postaccident damage to the *ACX Crystal's* bow. (Source: Japan Transport Safety Board)

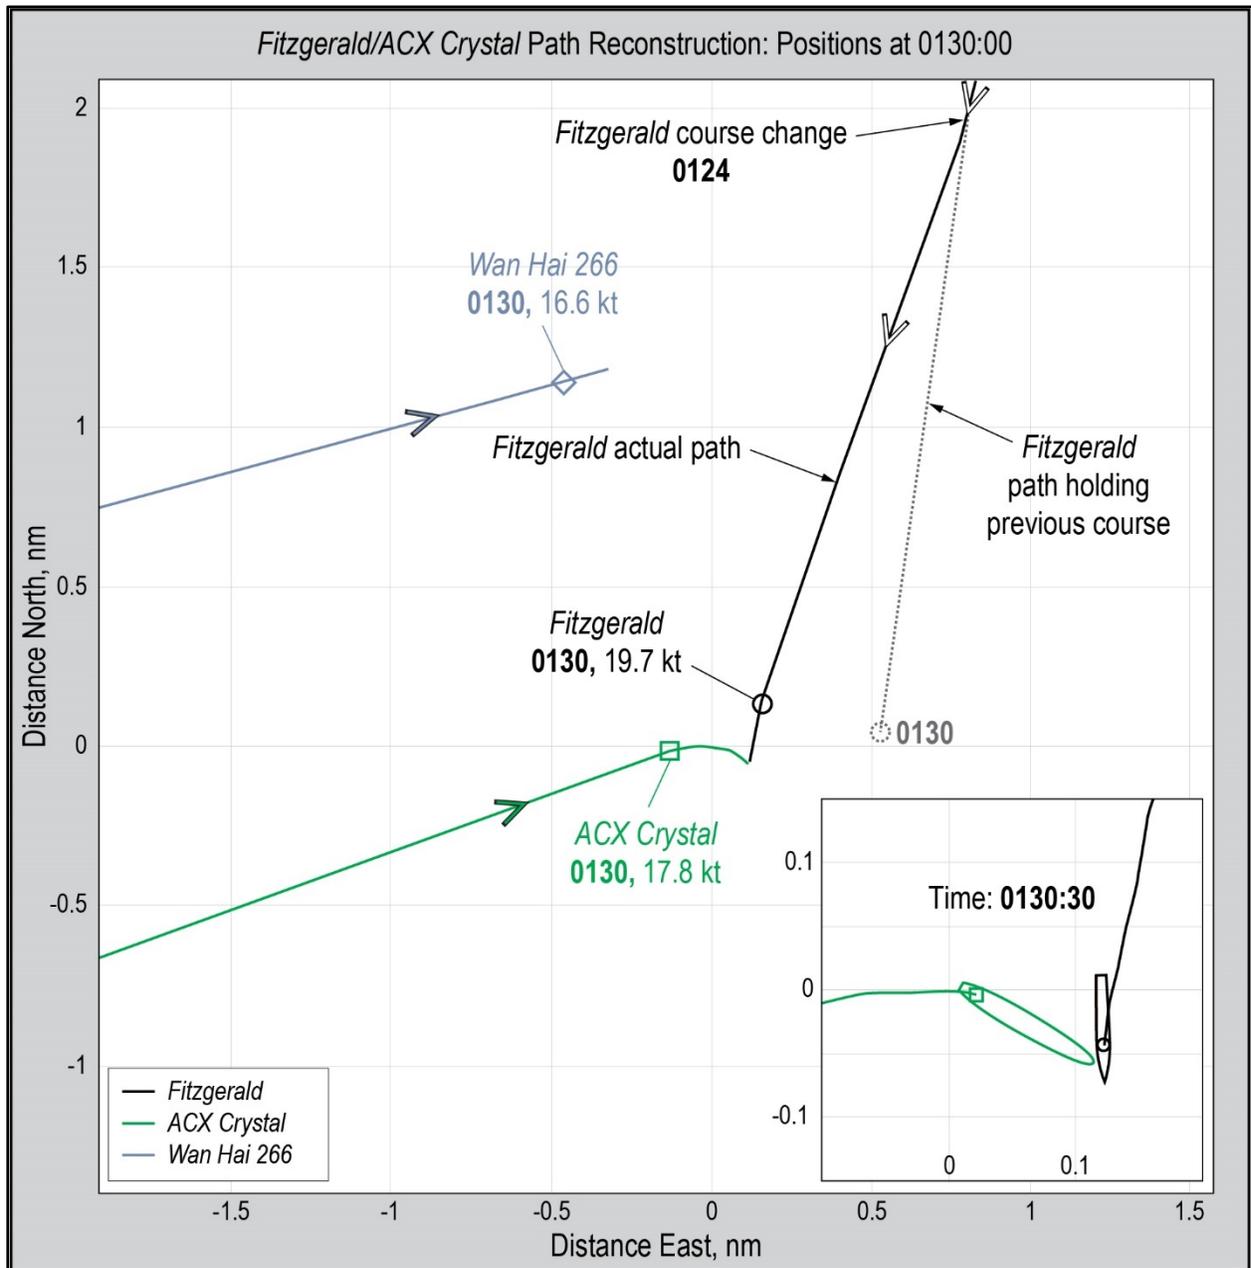
**Figure 10.** NTSB path reconstruction for *Fitzgerald* and *ACX Crystal*, from data compiled from NTSB Vehicle Performance Study.

The *Fitzgerald*'s deck log shows that a course change was ordered at 0122, and the vessel came right from 190° to 200°. They had steadied on the new course by 0124. This course change proved to be a critical error, and investigators were unable to determine the reason for it. The NTSB conducted a Vehicle Performance Study using GPS data as well as course and speed data for the *Fitzgerald*, *ACX Crystal* and *Wan Hai 266*, to recreate the tracks of the vessels leading up to the accident. The study found that if the *Fitzgerald* had not made the course change from 190° to 200° 8 minutes before the collision, the destroyer would have passed ahead of the *ACX Crystal* with a CPA of about 1,000 yards, or about 0.5 nautical mile. Therefore, the NTSB concludes that the
