Capsizing and Sinking of
Commercial Fishing Vessel *Scandies Rose*
Sutwik Island, Alaska
December 31, 2019

Marine Accident Report

NTSB/MAR-21/02
PB2021-100924

NTSB/MAR-21/02
PB2021-100924
Notation 67259
Adopted June 29, 2021

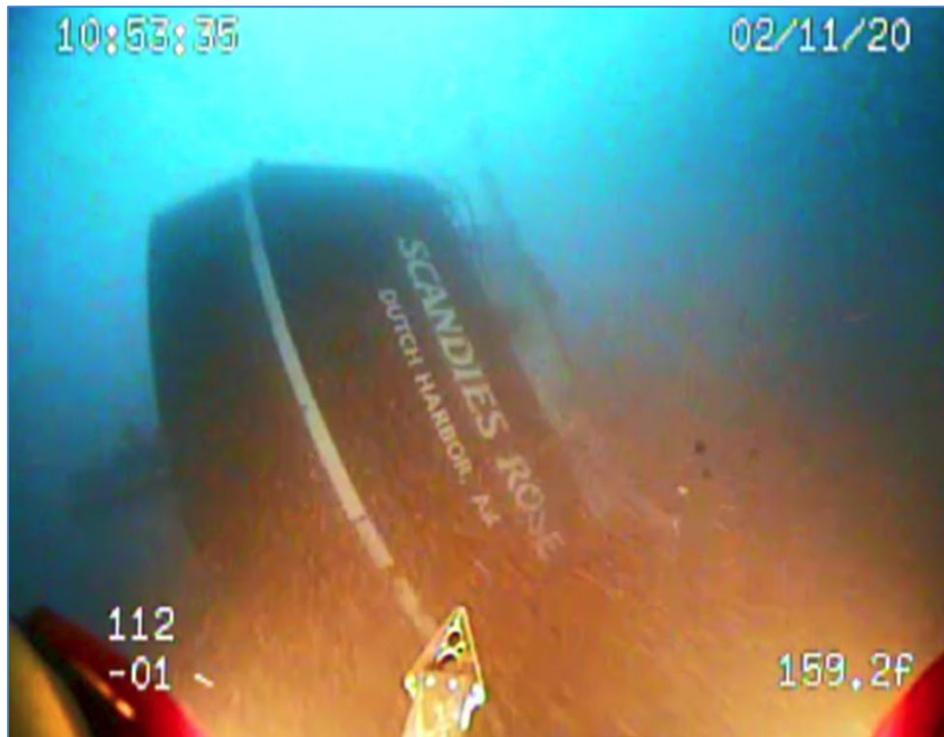
Figure 9. The *Scandies Rose* wreck, located on February 11.

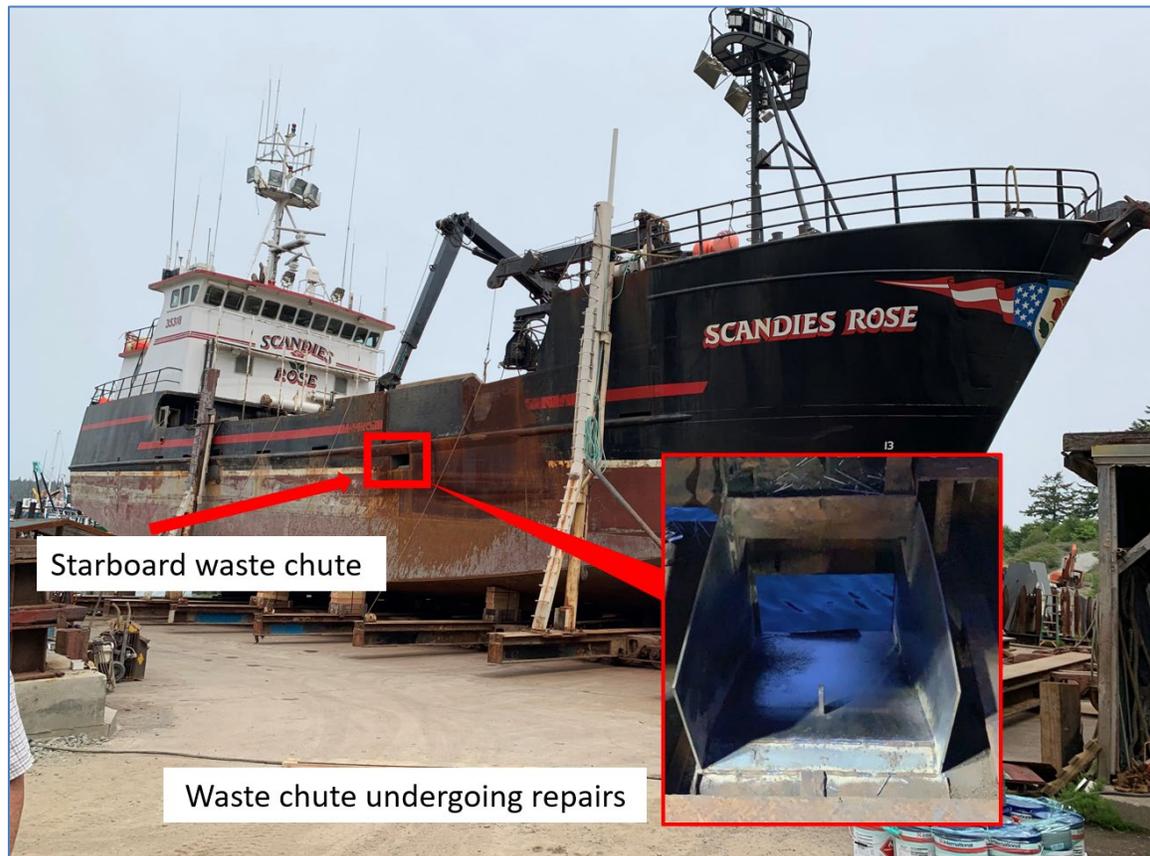
Figure 11. *Scandies Rose* on the blocks in May 2019. The starboard waste chute is highlighted, with inset photo showing waste chute undergoing repairs, as viewed from on board the vessel, looking outboard.

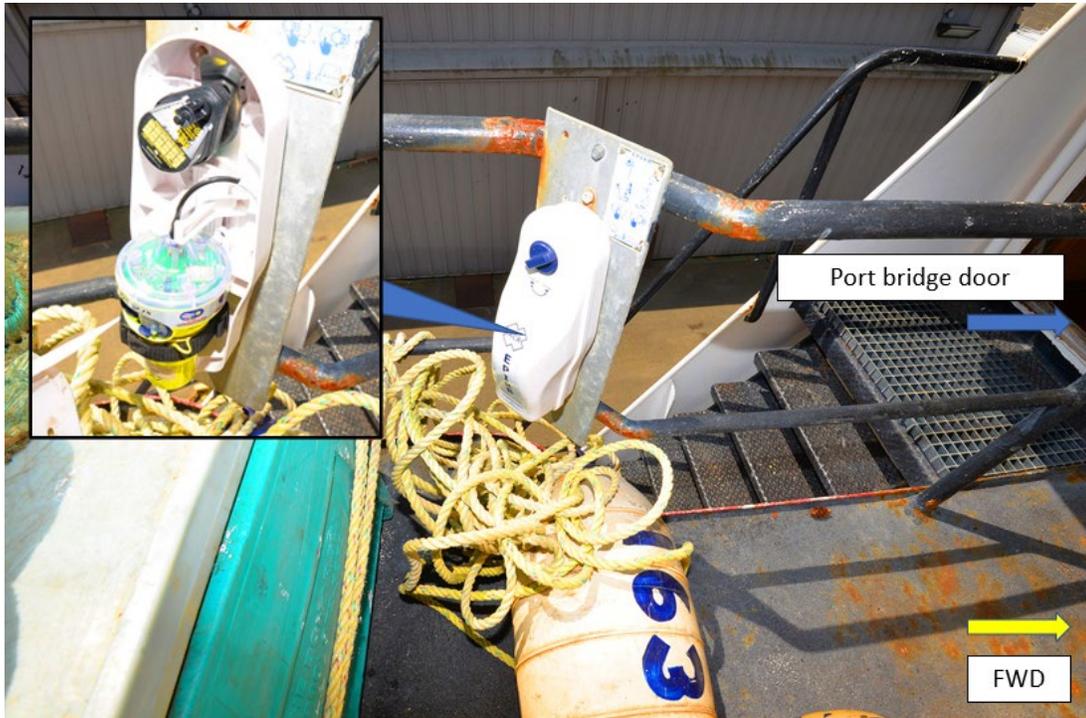
Figure 14. The *Scandies Rose* EPIRB mounted on the handrail aft of the bridge. Inset shows the float-free EPIRB with protective cover removed.

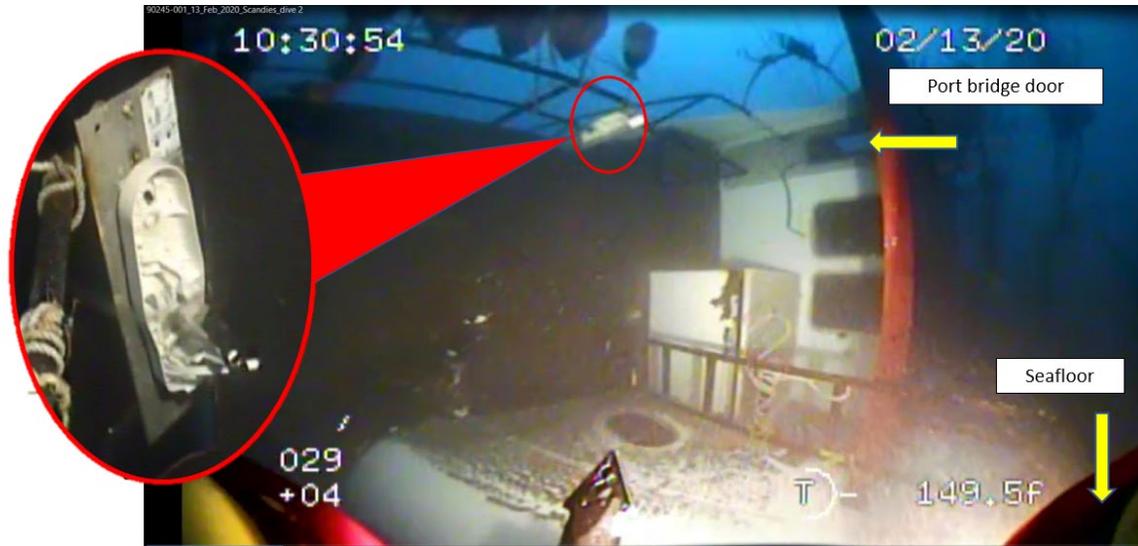
At no point after the sinking of the *Scandies Rose* was a signal received from the vessel's EPIRB. Neither of the surviving crewmembers saw the EPIRB while abandoning the vessel. The manufacturer of the EPIRB lists the unit as having an operating life of 48 hours and states that the unit is "waterproof" at 33 feet for 5 minutes. The manufacturer also states that for proper beacon operation, the antenna of the unit must have a "clear view to the sky."²⁷ The ROV survey video footage showed the empty EPIRB bracket mounted to the handrail aft of the port bridge door (see figure 15), but the EPIRB was not found.

Figure 15. Screen capture from ROV video taken of the *Scandies Rose* showing the portside third deck, aft of the bridge. Exploded view shows an empty EPIRB bracket, mounted to the port handrail.

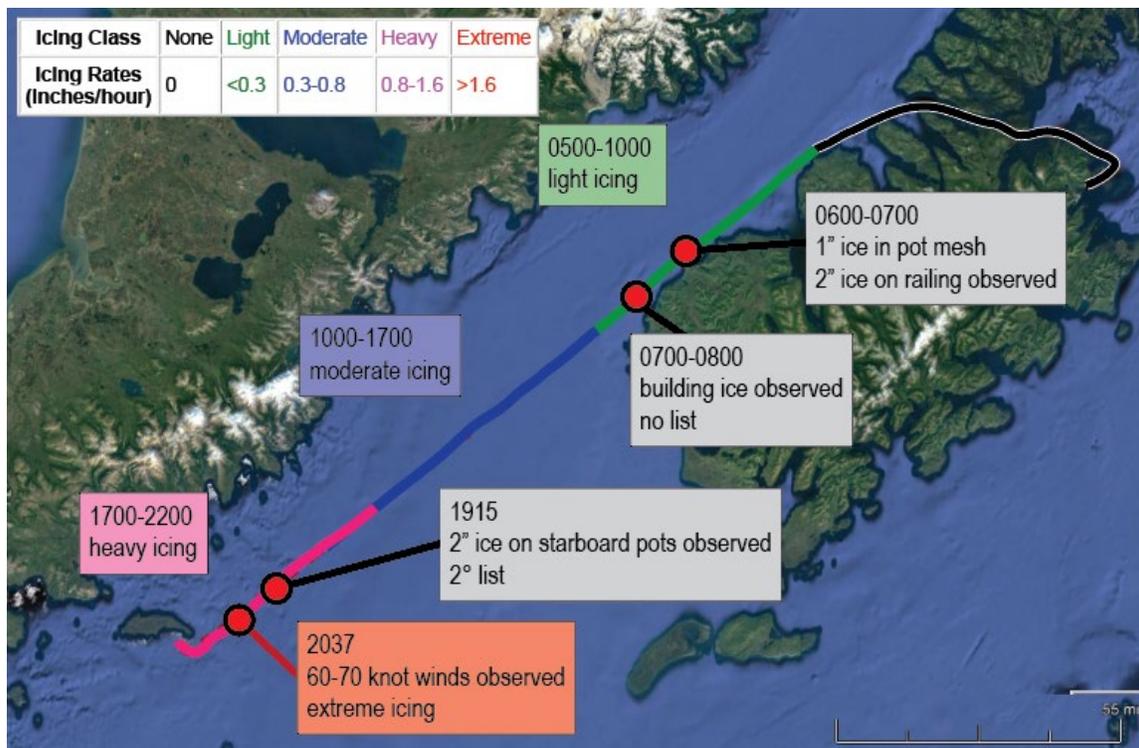
Based on the ice accretion rate obtained from the NTSB's weather model (which relied on weather conditions reported from the larger area's four weather stations) the *Scandies Rose* experienced progressively worse icing during the voyage.⁴³ Plotting the vessel's track, it is likely that the vessel first started accumulating ice around 0500 on December 31 (crew first observed icing at 0600). The vessel was then likely in light icing between 0500 and 1000, in moderate icing between 1000 and 1700, and in heavy icing between 1700 and 2200 (see figures 25 and 26). However, based on the localized weather conditions reported by the captain and crew, the *Scandies Rose* was likely experiencing ice accumulation greater than 1.6 inches per hour, which is categorized as extreme icing, over the final 2 hours of the voyage. The NTSB concludes that, based on the voyage timeline and the estimated ice accumulation over that period, the *Scandies Rose* likely accumulated between 6 and 15 inches of ice on surfaces exposed to wind and icing during the accident voyage.

Figure 26. NTSB-calculated icing conditions the *Scandies Rose* would have encountered along voyage route and observed conditions.

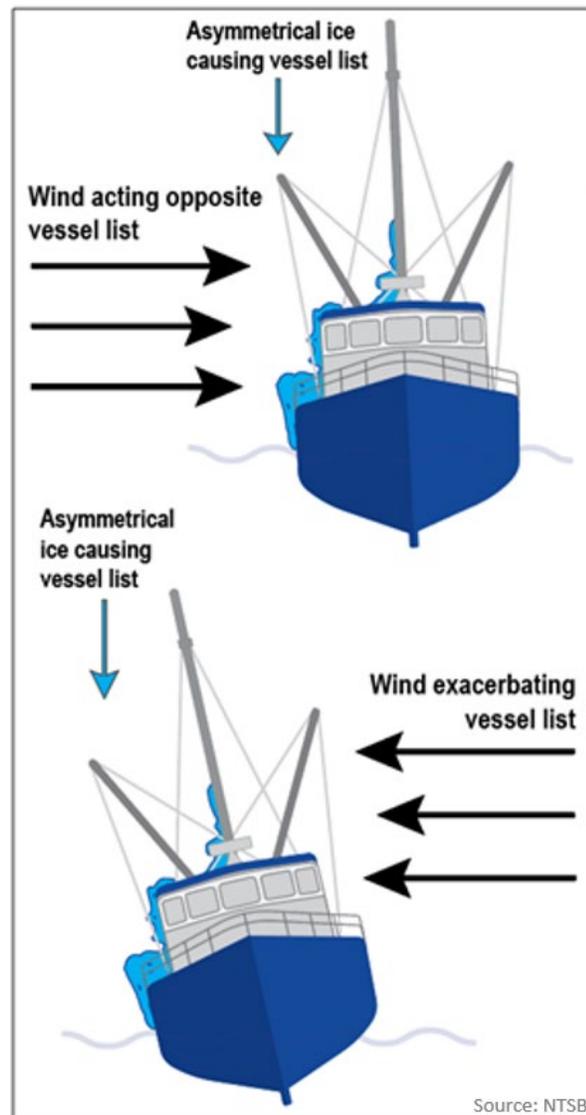
The weight of the asymmetrical icing on the starboard side of the *Scandies Rose* pot stack and structure caused the vessel to develop a starboard list, which grew worse leading up to the time of the accident. As stated earlier, the captain's course change toward Sutwik Island at 2145 brought the 60–70 knot winds onto the port

Figure 27. Diagram of ice and wind acting on the *Scandies Rose*.

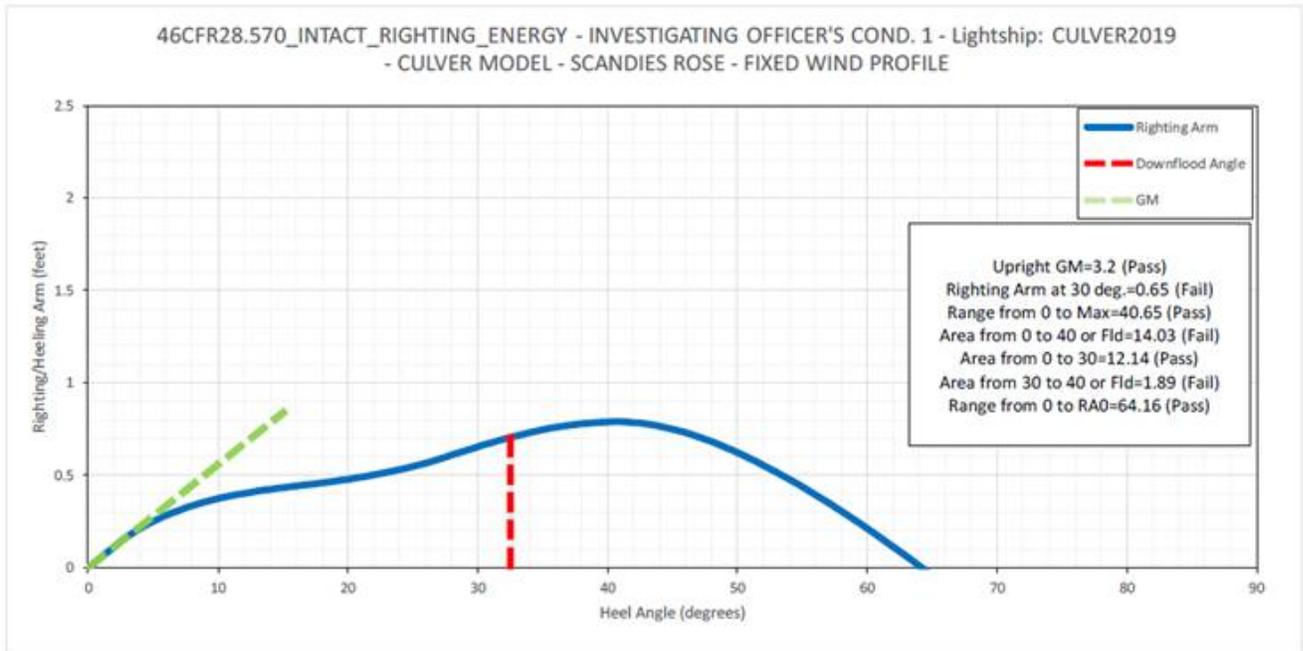
Figure 30. IO Condition 1, with 195 pots (ranging from 835, 844, 856 pounds) in tiers different than MSC Large Pots (4 tiers, 87, 39, 39, 30)

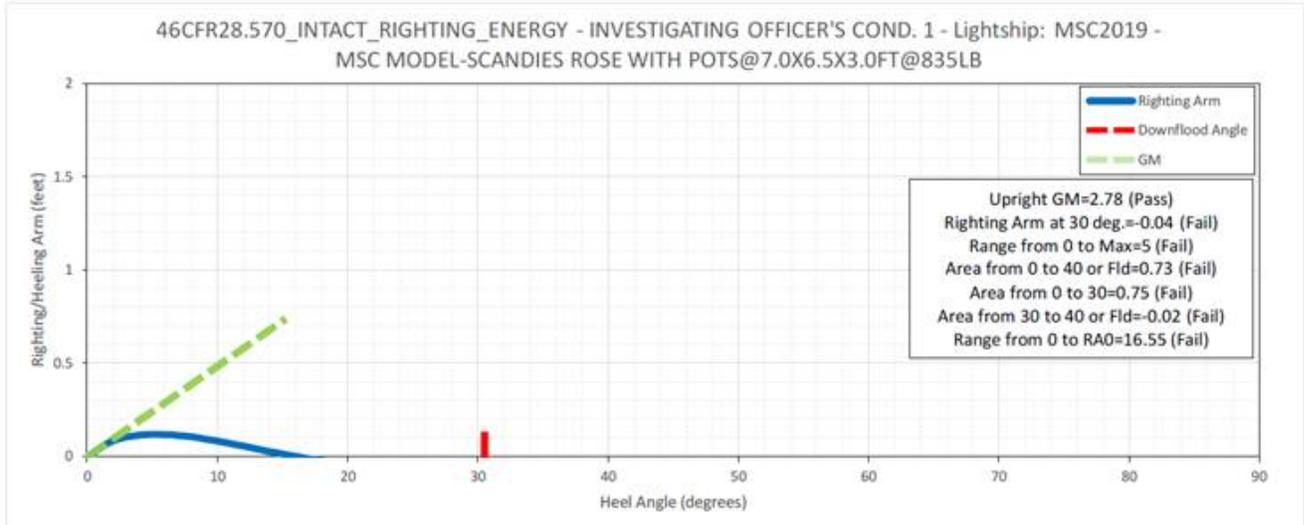
Figure 31. IO Condition 1, with 195 “small” 835 lb.-pots (4 tiers- 98, 44, 44, 9)

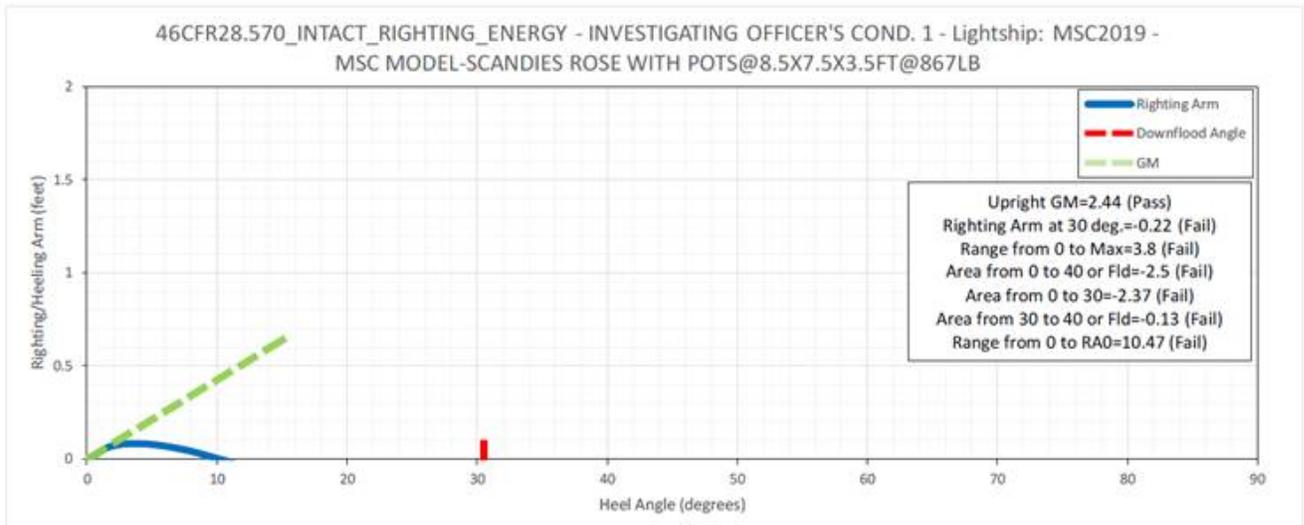
Figure 32. IO Condition 1, with “large” 867 lb.-pots (5 tiers, 72,32, 32, 32, 27)
