Fire aboard Roll-on/Roll-off Vehicle Carrier *Höegh Xiamen*

Pier 20, Blount Island

June 4, 2020

This report discusses the June 4, 2020, fire aboard the roll-on/roll-off cargo vessel *Höegh Xiamen*. None of the vessel's 21 crewmembers were injured, but nine shoreside firefighters responding to the accident were injured during firefighting efforts. The vessel and its cargo of 2,420 used vehicles were declared a total loss valued at \$40 million, and the vessel was later recycled. Safety issues identified in this report include training for and oversight of vehicle battery securement, regulatory exceptions for used and damaged flammable-liquid-powered vehicles, fire detection system deactivation during cargo loading, and effective emergency distress calls. One recommendation each was made to the Pipeline and Hazardous Materials Safety Administration, the US Coast Guard, and the National Maritime Safety Association; two recommendations were made to Grimaldi Deep Sea; and three recommendations were made to Höegh Technical Management.

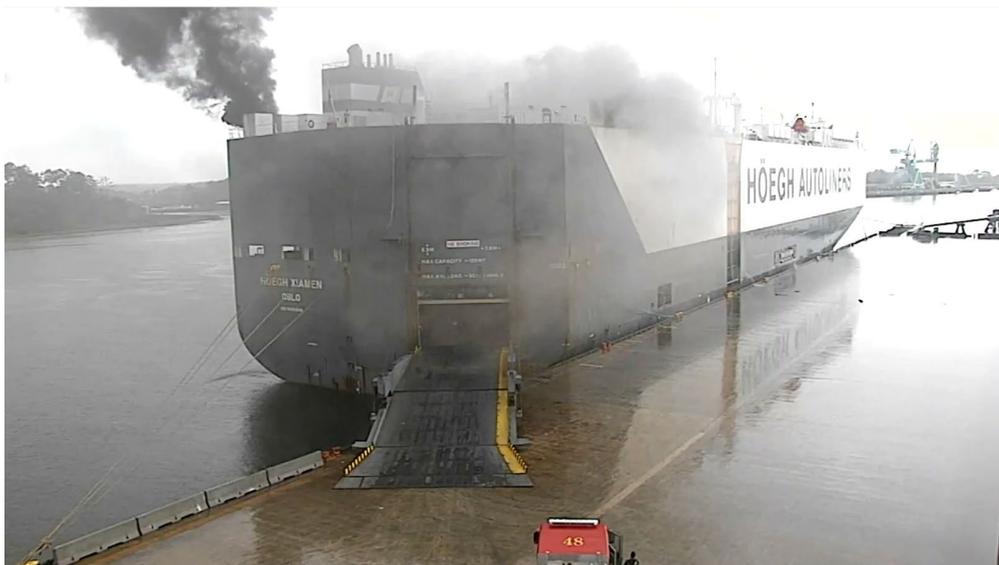
Figure 4. Smoke coming from aft cargo deck ventilation housing exhausts about 1603.

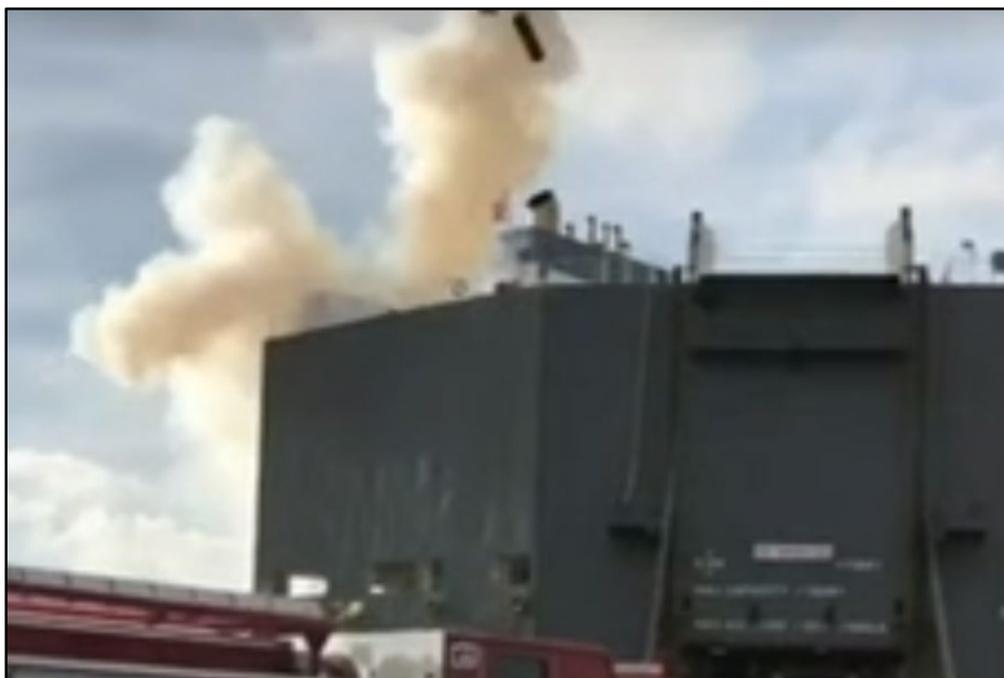
Upon opening the access door to the portside exhaust ventilation housing for deck 9, firefighters on deck 12 heard “a loud roar that sounded like a jet engine” as the exhaust housing “exploded” (see figure 5). The ventilation housing threw debris in the air. From the exterior of the ship, firefighters witnessed a tall column of grey-white smoke projecting from the stern on the weather deck and debris flying. According to firefighters, there may have been multiple explosions of varying magnitude. Firefighters in the port aft stairwell and on deck 5 described feeling intense heat and hearing a “roaring sound of rushing air.” Nine firefighters who were working in the stairwell or who had been staged on deck 5 were burned, five of them seriously, by the superheated air that rushed down the stairwell. Firefighters working on decks 7, 8, and 12 were unharmed.

Figure 5. Explosion of deck 9 ventilation exhaust housing. Note debris in air at top center of image. (Source: WJXT)

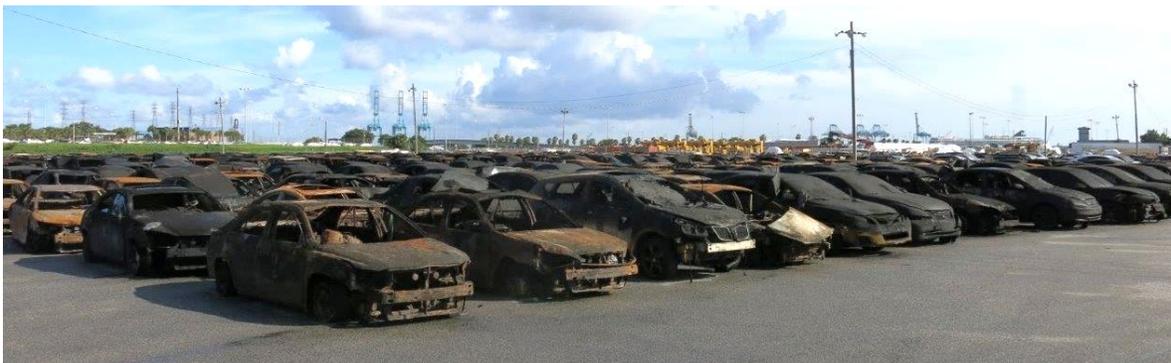
The *Höegh Xiamen* and its cargo of 2,420 used vehicles were declared a total loss valued at \$40 million (see figure 7). Salvage operations began on July 9, 2020. On August 30, after salvage operations were completed, the anchor-handling tug, *Alp Striker*, towed the ship from Jacksonville to Aliaga, Turkey, where the *Höegh Xiamen* was recycled.

Figure 7. Thermally damaged vehicles after removal from the *Höegh Xiamen*, Blount Island, Jacksonville, Florida, July 23, 2020.

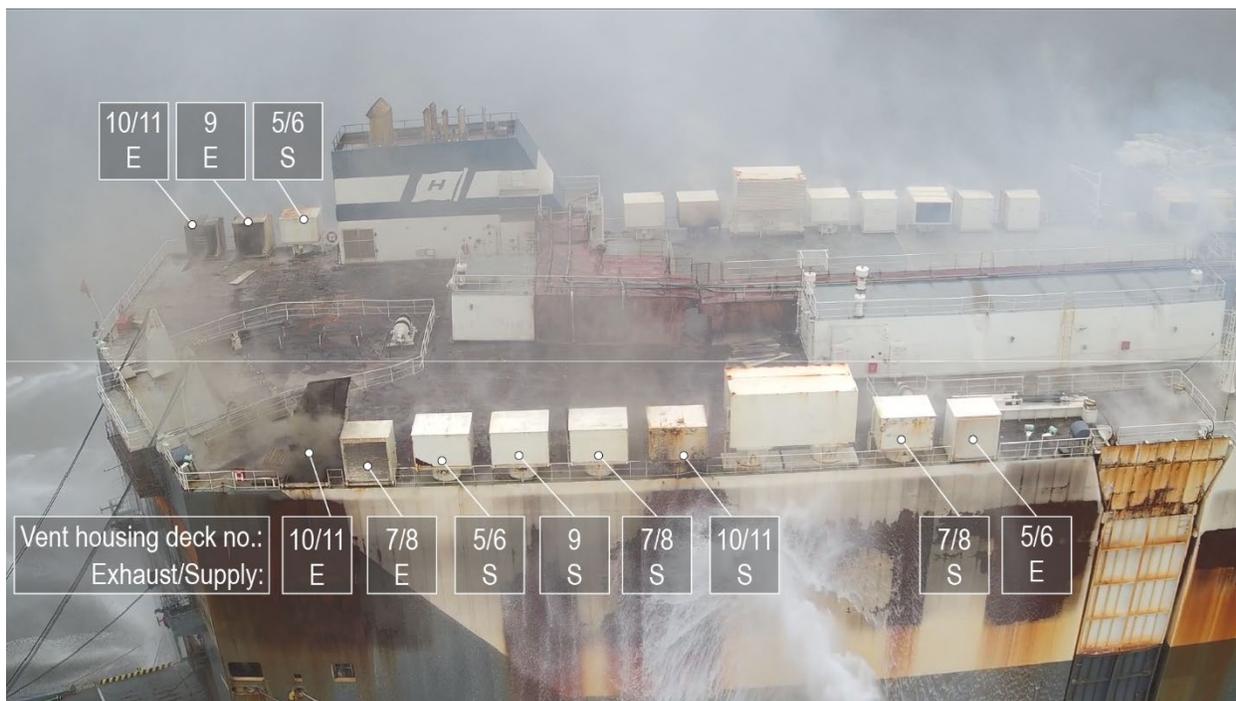
After the accident, the JFRD and the Coast Guard examined the vessel's ventilation housings during walkarounds of deck 12. (Figure 11 shows the damaged aft housings.) The condition of the housings fell into three categories: 43 had no signs of external sooting or mechanical damage; 8 exhibited external sooting but no mechanical damage; and 7 exhibited both external sooting and mechanical damage.

Figure 11. Damaged aft ventilation housings after the reported explosion of portside vent housing for deck 9 (9E in the photo). (Background source: JFRD)

The ventilation housings associated with decks 7/8, 9, and 10/11 exhibited sooting, and the housings associated with decks 9 and 10/11 exhibited mechanical damage. The ventilation housings for deck 10/11 exhibited greater levels of mechanical damage than those of deck 9.

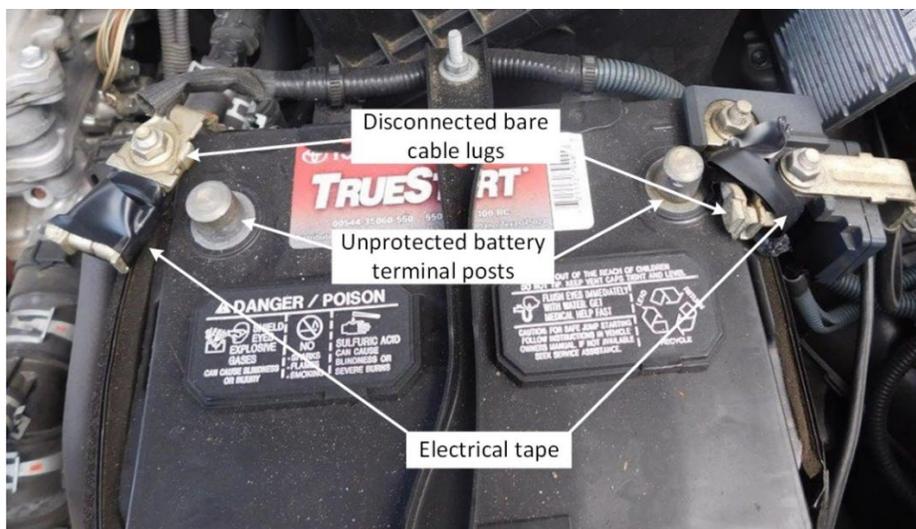
The sample of 39 forklift vehicles loaded in Jacksonville included 12 vehicles that did not have batteries and 3 vehicles with battery cables that had not been disconnected from the battery terminal posts. Of the 24 remaining vehicles, 22 had exposed battery terminal posts; none of these were protected with plastic caps. Instead, the battery cable lugs were partially wrapped with electrical tape, leaving exposed metal on the lug (see figure 14). Investigators also found 14 instances of disconnected and exposed battery cable lugs resting above or on top of the vehicle battery and touching or nearly touching the exposed battery terminal posts. All of the forklift vehicles examined (except those without batteries) were found to have batteries not secured in accordance with Grimaldi's procedures.

Figure 14. Battery in forklift vehicle removed from deck 5. The disconnected battery cable lugs were located near terminal posts, and the battery terminal posts were unprotected. (Source: Coast Guard)

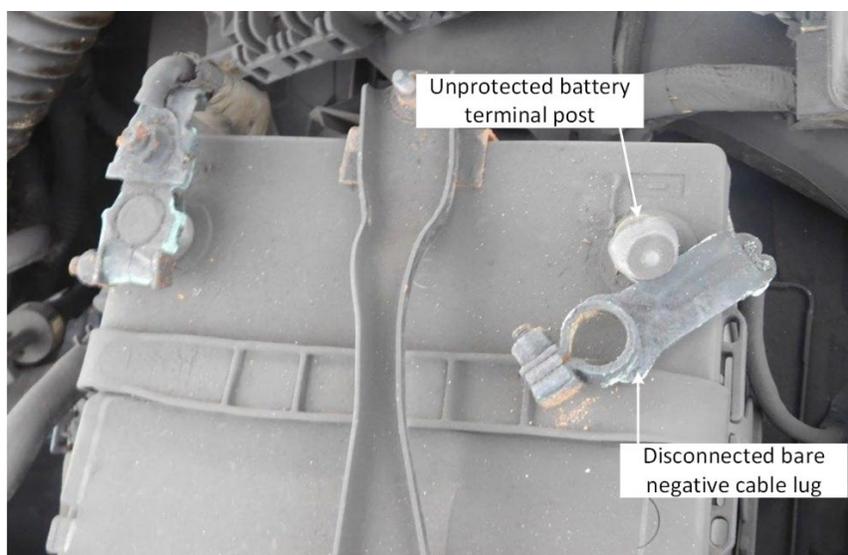
The sample of 20 towed vehicles loaded in Jacksonville included one vehicle that did not have any battery in the engine compartment and two vehicles with battery cables that had not been disconnected from the negative battery terminal posts. Sixteen of the remaining 17 vehicles were found with visibly exposed battery terminal posts that were not protected with plastic caps. Investigators also found 13 instances of disconnected and exposed battery cable lugs resting above or on top of the vehicle battery and touching or nearly touching the exposed battery terminal posts (see figure 15). All the towed vehicles examined (except the one without a battery) were found to have batteries not secured in accordance with Grimaldi’s procedures. Table 4 summarizes the towed vehicle examination.

Figure 15. Battery in towed vehicle removed from deck 7. The disconnected bare cable lug was in physical contact with unprotected battery terminal post. (Source: Coast Guard)

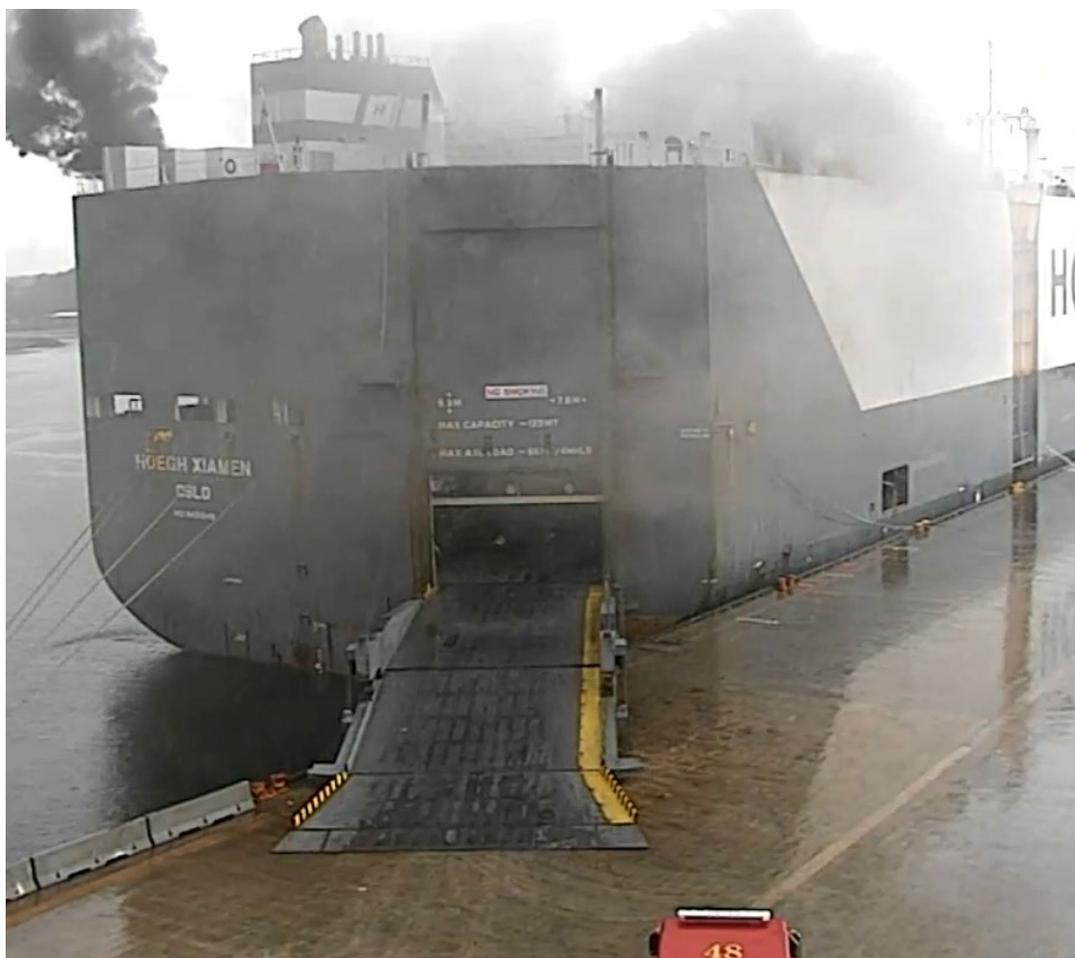
The video showed that when Engine 48 arrived, there was smoke flowing from the two aftmost exhaust vents on the port side (corresponding to decks 9 and 10/11) and the two aftmost exhaust vents on the starboard side (corresponding to decks 10/11 and 7/8) (see figure 16). At the time of Engine 48's arrival, the white paint on the starboard side of the *Höegh Xiamen* did not appear to have any thermal discoloration.

Figure 16. Engine 48 arriving on scene about 1603. Starboard vents 10/11E and 7/8E and port vents 10/11E and 9E exhibit smoke flow. (Source: Jacksonville Port Authority)

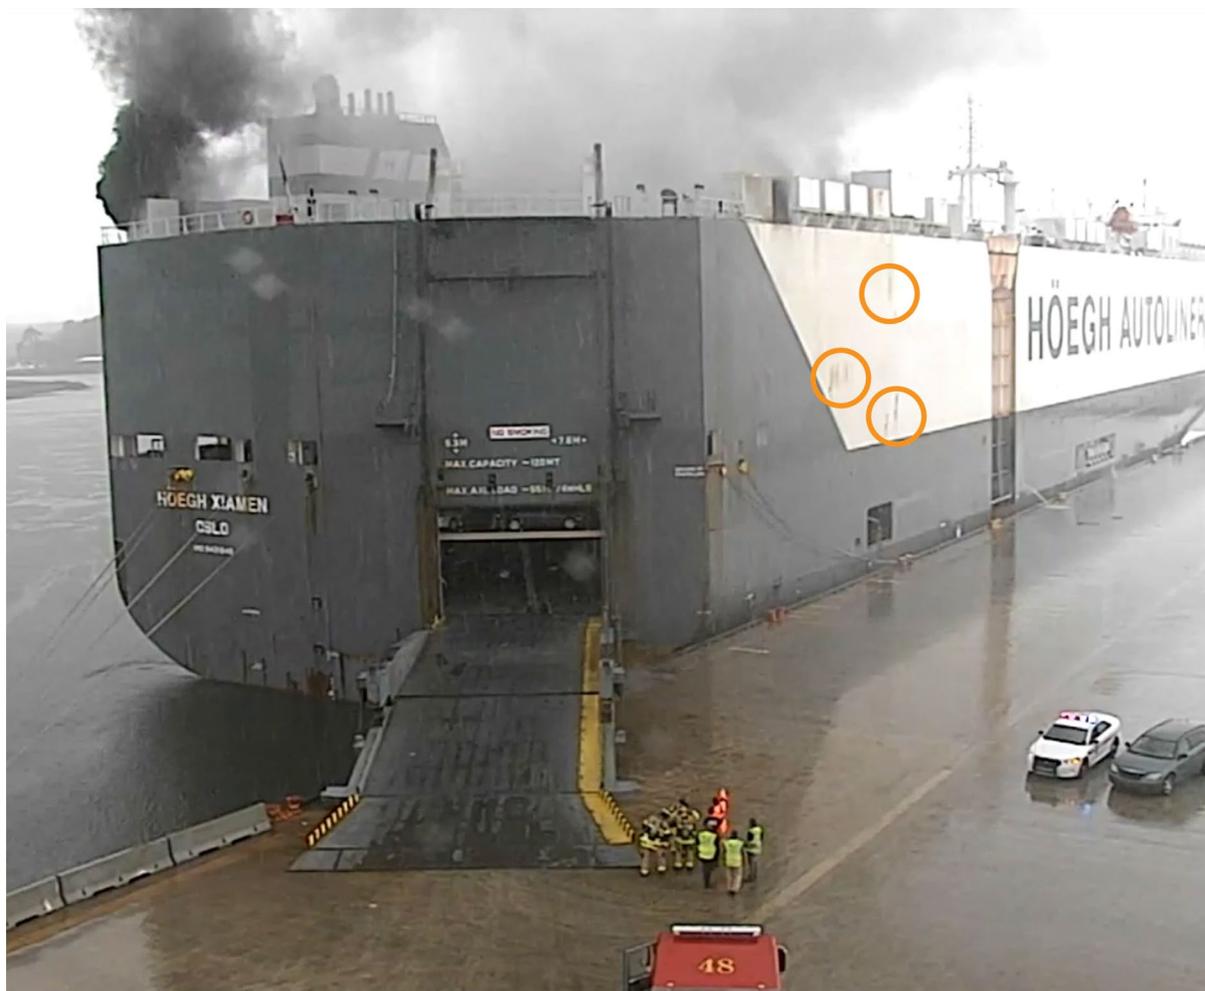
About 5 minutes after the fire department first arrived on scene, the video showed firefighters and one crewmember at the edge of the vessel's stern ramp. Smoke continued to rise from the vents on the ship's stern, with a much darker, thicker plume emitting from the port side. The video showed that, at this time, the white paint on the vessel's starboard side was beginning to exhibit thermal discoloration in areas corresponding to the fire zones associated with decks 7/8 and 10/11 (see figure 17). About 5 minutes later, the discoloration became more pronounced, and the discoloration continued to darken over the next 15 minutes.

Figure 17. About 1608, 5 minutes after Engine 48's arrival, the white paint on the starboard side of the vessel exhibits thermal discoloration (circled in orange). Starboard vents 10/11E and 7/8E and port vents 10/11E and 9E exhibit smoke flow. (Source: Jacksonville Port Authority)
