MAR 21/05

Hazardous Liquid Pipeline Strike and Subsequent Explosion and Fire aboard Dredging Vessel *Waymon Boyd*

EPIC Marine Terminal, Corpus Christi Ship Channel, Corpus Christi, Texas

August 21, 2020

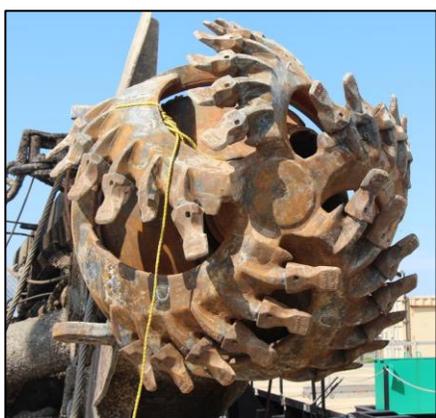
Figure 7. Waymon Boyd cutterhead postaccident. (Source: US Coast Guard)

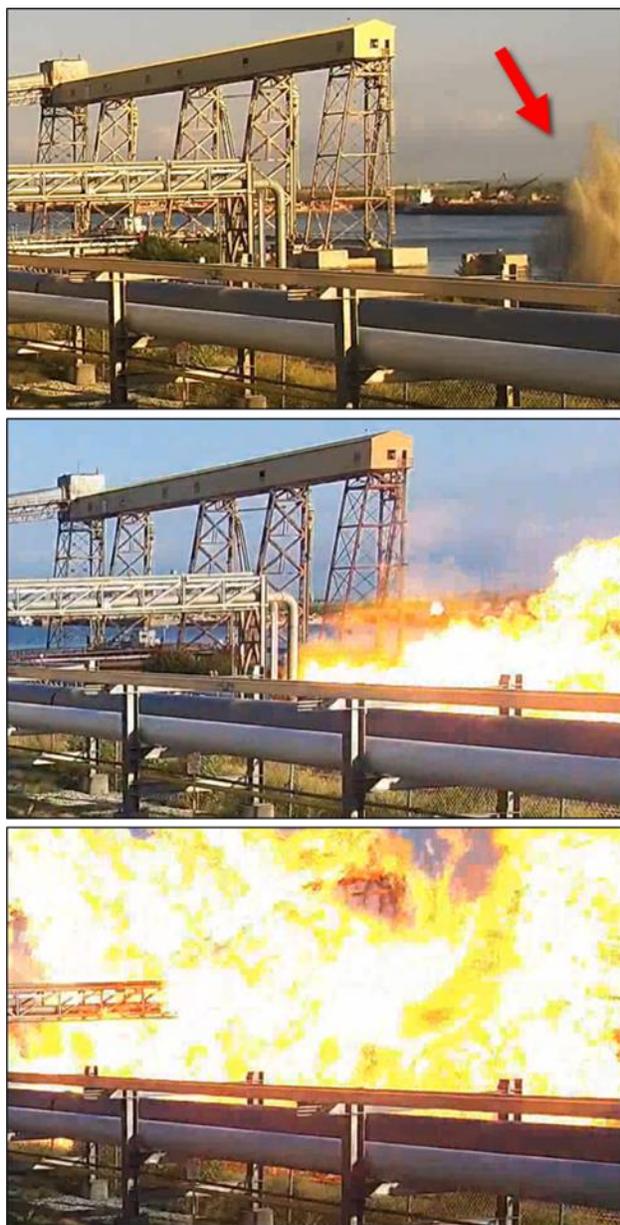
A shoreside security camera at the Interstate Grain Terminal partially captured the geyser of water witnessed by the leverman and dredge captain (see figure 10; the dredge is not within the frame of the camera view). One minute six seconds after the water eruption began, an explosion occurred, shaking the security camera violently. Personnel contracted by EPIC who were several hundred yards away stated that they heard a large "boom" and that it shook the ground and buildings in the area. In the security video, flames spread from the right of the screen following the explosion, consuming much of the shoreline and the West Dock.

Figure 10. Screen captures from security camera footage showing, from top to bottom, the water and gas eruption before the explosion (as noted by red arrow), the initial explosion, and the ensuing fireball. The *Waymon Boyd* is outside of the frame of the camera. (Source: EPIC Crude Terminal Company)

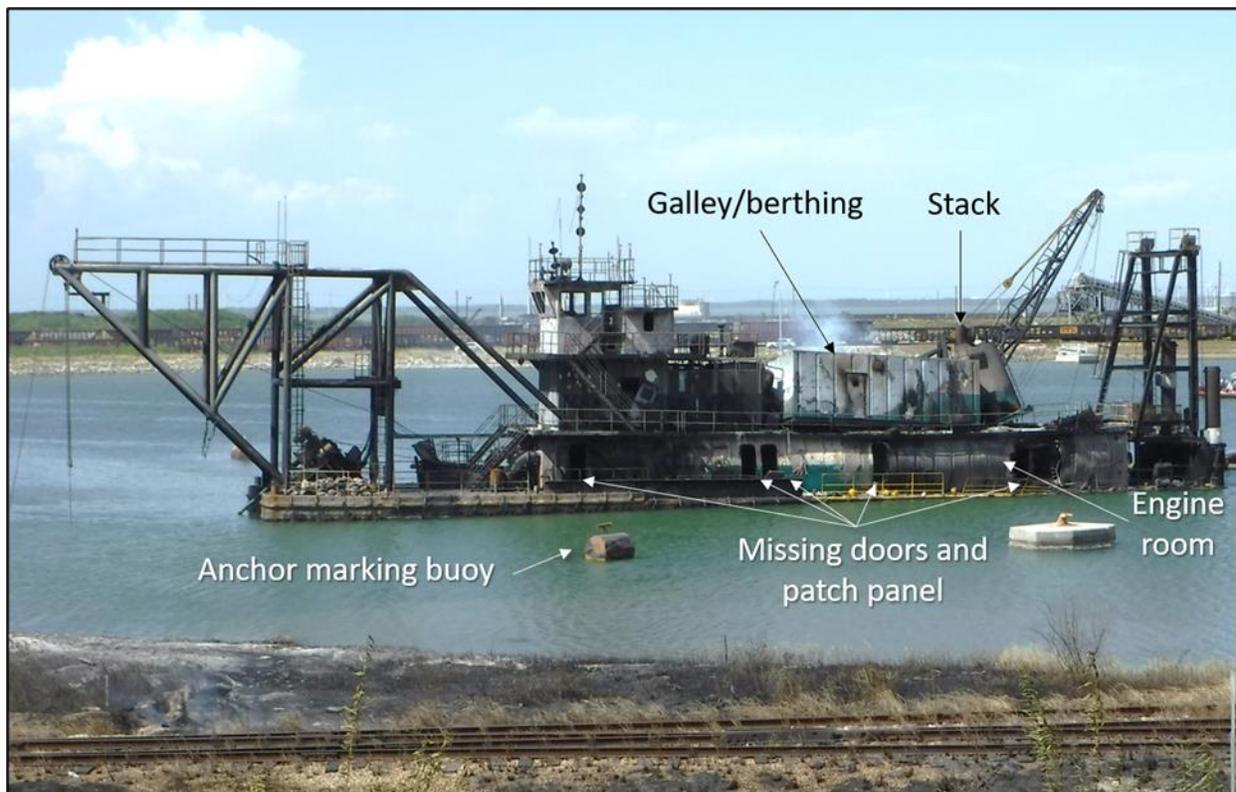
A photo of the *Waymon Boyd* taken after the fire had been extinguished and before the vessel sank shows the engine room bulkheads on the port side bowed outward (see figure 16). The draw works and engine room doors are missing, along with a bolted-on bulkhead patch panel. The main deck railing outboard of the opening created by the missing patch panel is bent outward. The aft deck above the first level of the superstructure, upon which the stack sits, is bent upward and forward. The galley and berthing compartment is displaced from its normal position on the

first level and sits at an angle on the deck. Fire and smoke damage is visible throughout the vessel.

Figure 16. Post-fire photo of the *Waymon Boyd*, before sinking. (Source: Coast Guard)

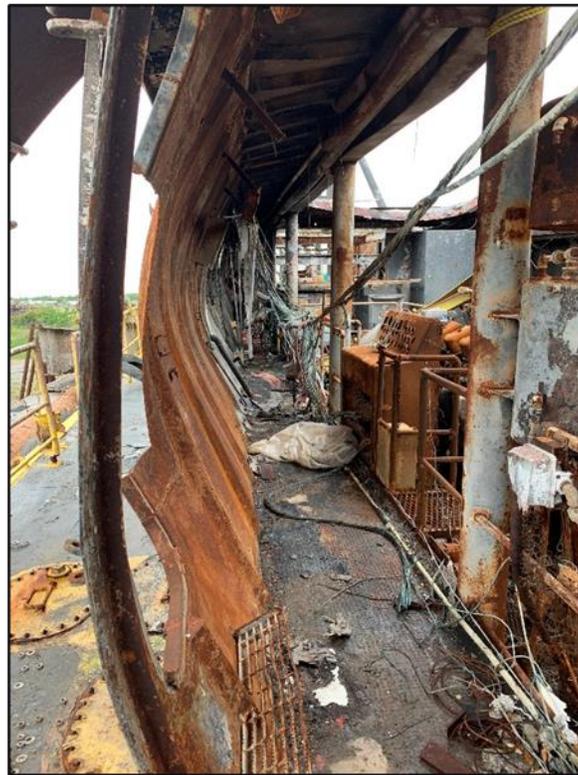
During a post-salvage examination, investigators confirmed that the bulkheads on both the port and starboard sides of the engine room were bowed outward (see figure 17). A beam in the overhead of the space above the engine's turbocharger and exhaust system was bent upward. Investigators also found that a door to an electrical equipment box forward and above the main generator alternator was caved inward. The standby generator aft of the main generator engine had been displaced from its mounts. The fuel system had no visible breaches in either the piping system or the tanks.

Figure 17. Post-salvage image of the *Waymon Boyd* engine room portside bulkhead, bowed outward.

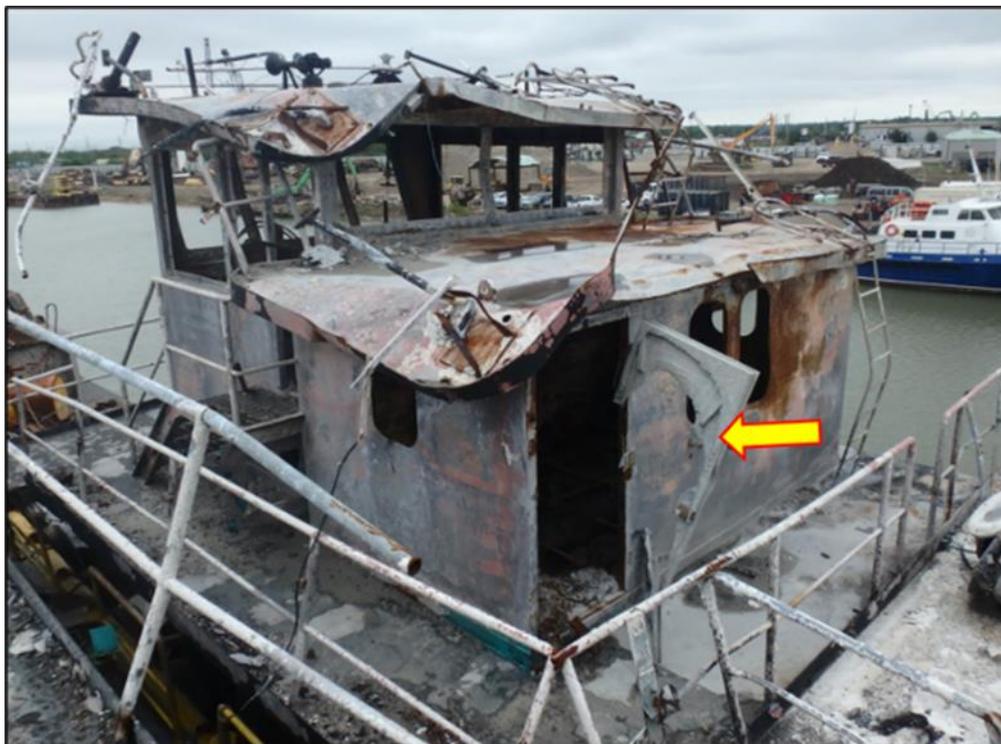
On the top two levels of the *Waymon Boyd*'s superstructure, which had broken free of the dredge when it sank, all exterior paint had been burned away, and the aluminum door to the captain's office was almost completely melted (see figure 18).

Figure 18. The lever room and captain's office post-salvage. The arrow shows the remnants of the office door, which had melted in the fire.

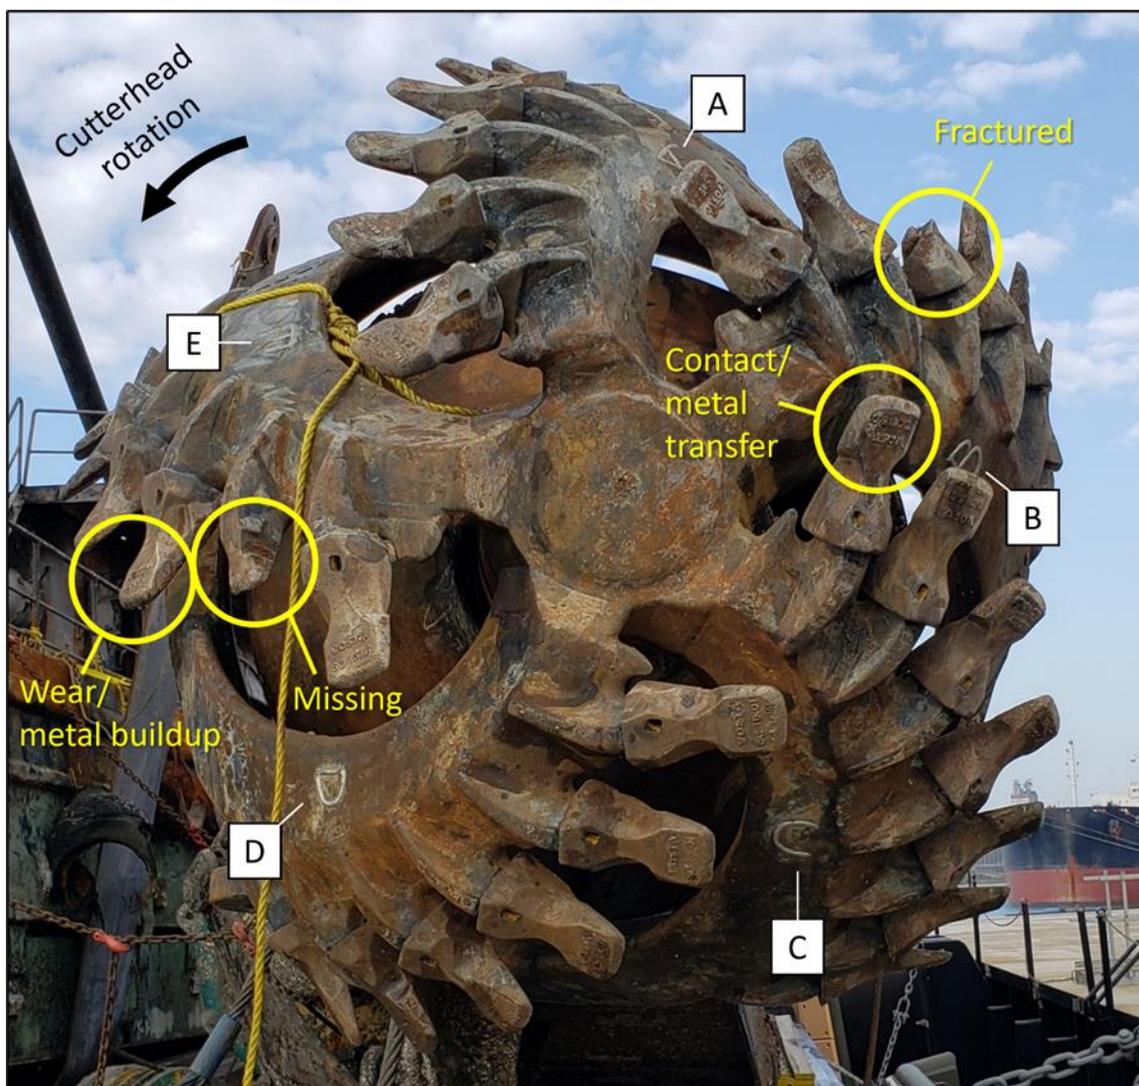
Preliminary on-site examination by the Coast Guard revealed that the second tooth from the center of the cutterhead on blade E was missing, and the third tooth from the center on blade B was fractured (see figure 19). The tooth nearest the center of the cutterhead on blade C appeared to have heavy contact damage and possible transfer of material at the tip portion (the material appeared different compared to the tooth). The tip of the third tooth from the center on blade E showed wear that was similar to the other blades, and possible metal buildup. The three affected teeth were submitted to the NTSB Materials Laboratory for detailed examination (see section 1.12).

Figure 19. Front view of cutterhead assembly after underwater recovery (looking aft).

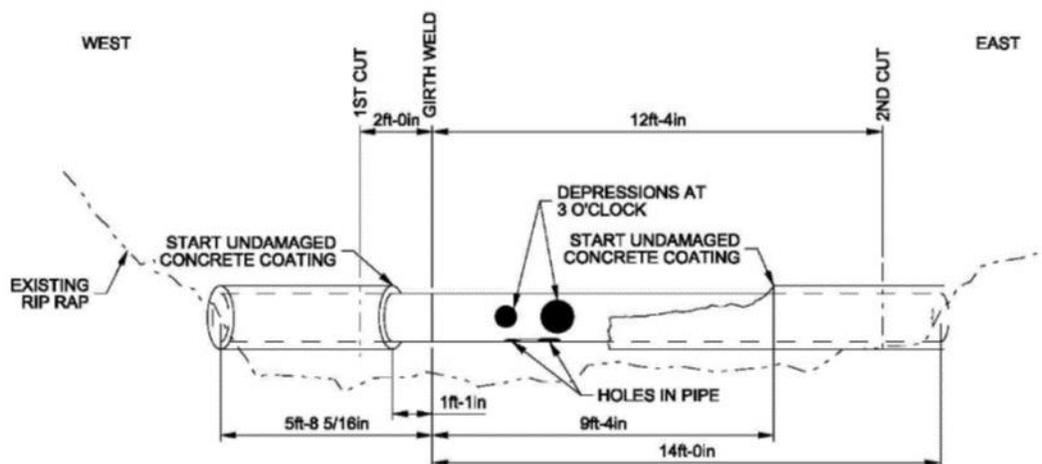
- The pipeline was exposed such that there was about 1 foot of water under the damaged pipe segment.
- Two holes in the pipeline were found near the 6 o'clock position.
- The larger hole (east) was about 7 inches long and about 5 inches across.

- The smaller hole (west) was about 5 inches long and about 2.5 inches across.
- The girth weld was about 2 feet 8 inches west of the smaller hole.¹⁵
- Exterior concrete sleeving was missing from the pipeline around the breach. The concrete coating was intact 13 inches west of the girth weld.

Figure 20. Drawing of the damaged pipeline segment and agreed-upon location for cuts.
(Source: Enterprise Products)

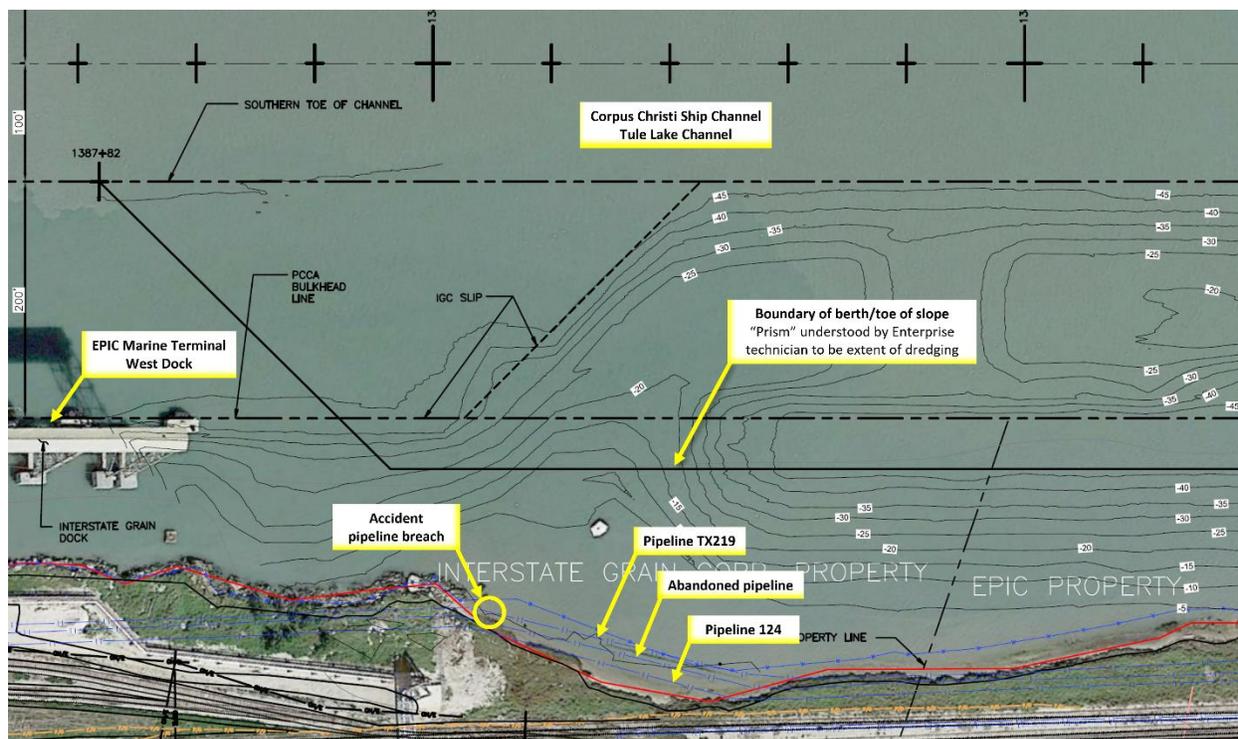
Figure 24. Annotated excerpt from the “Existing Site Plan,” drawing no. G2.1, in the Schneider Engineering EPIC Marine Terminal dredging construction plan. (Source: Orion Marine Group, annotated by NTSB)

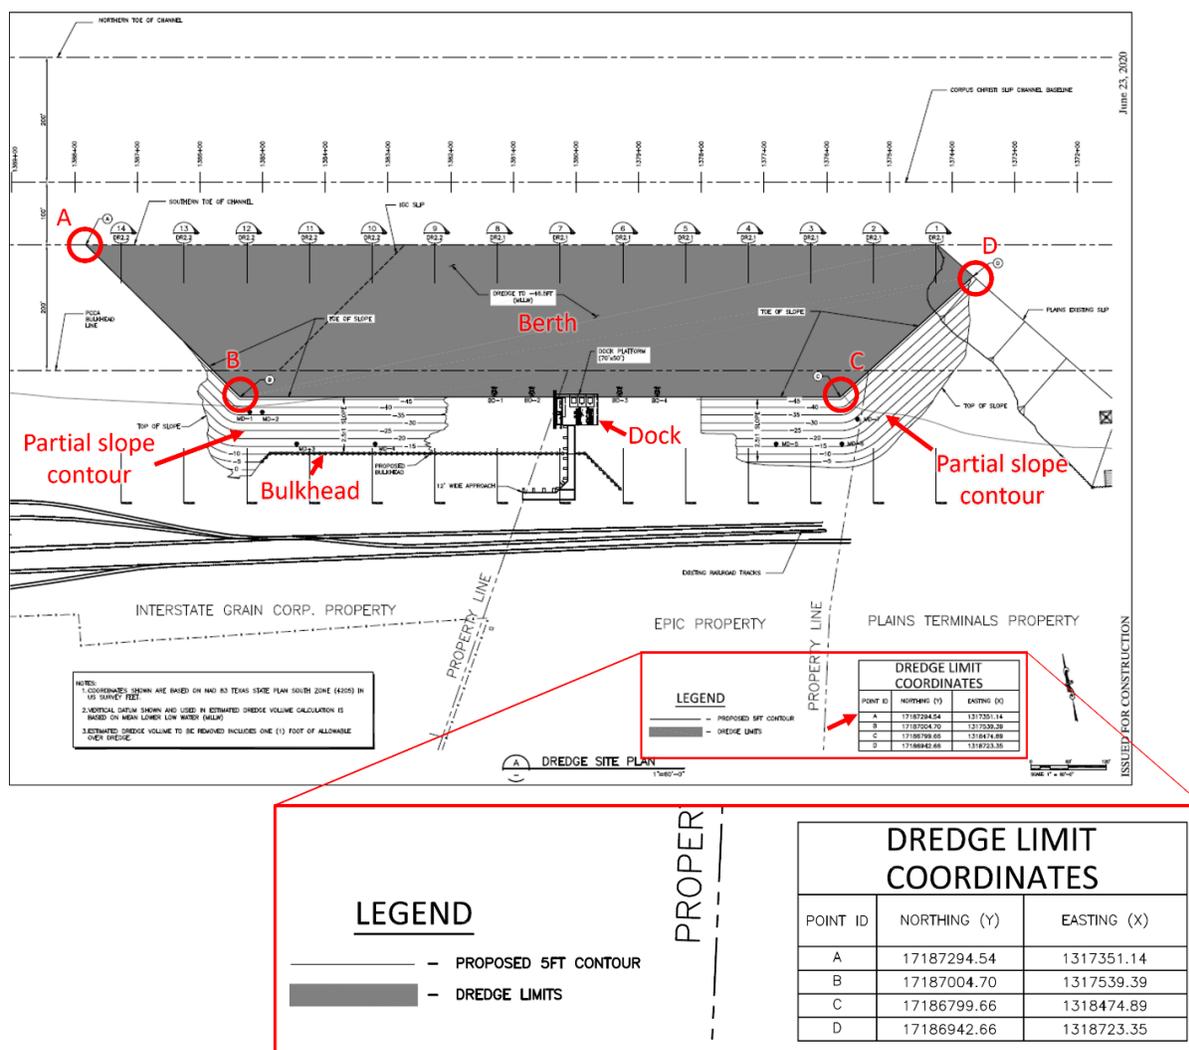
pipeline was required to be included in the plan. The location of the pipelines on the EPIC property, as determined by the 2018 TMI Solutions survey data, was not included in the Schneider Engineering Dredge Site Plan. Therefore, the project engineer stated that to determine the distance between the top of the sloped area and the pipelines, she “repeatedly just looked at [Dredge Site Plan] and then the [Existing Site Plan] that actually shows the approximate location of the blue lines.” When asked how close she thought the pipeline would be to the dredging template, she responded, “Far enough away.”

Figure 25. Annotated “Dredge Site Plan,” drawing no. DR 1.1, with exploded view of legend and coordinates table, from EPIC Marine Terminal dredging construction plan. Pipelines are not shown in the drawing. (Source: Orion Marine Group, annotated by NTSB)

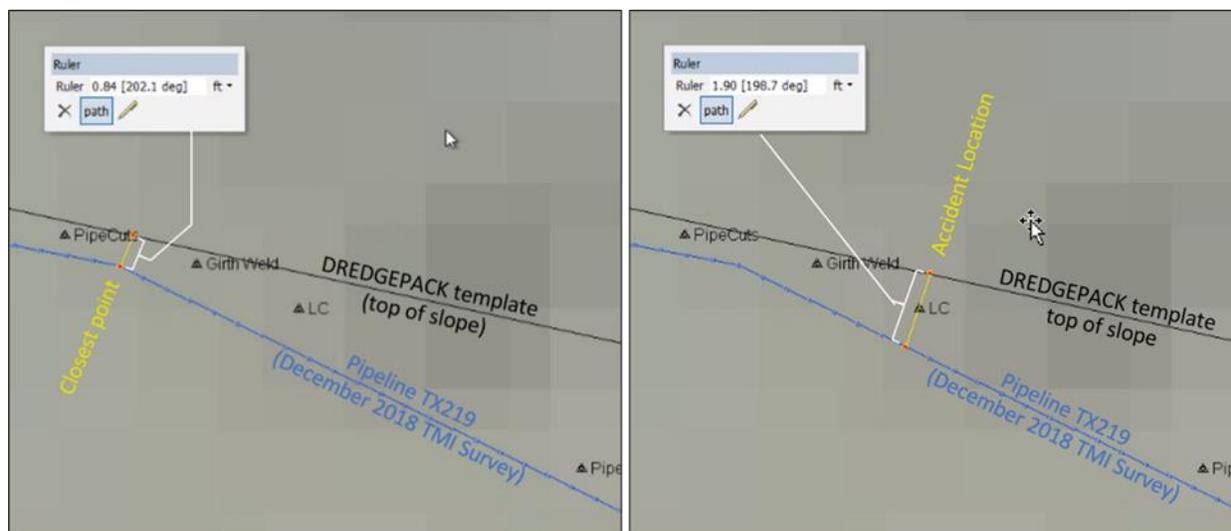
With the assistance of a HYPACK technical representative, the NTSB imported the TMI Solutions survey data (the data provided to Orion and Schneider for planning the EPIC dock project) into DREDGEPACK and used the system's tools to measure the distance between the center of pipeline TX219 and the southern edge (top of the slope) of the EPIC East Dock dredge template in use by the *Waymon Boyd* at the time of the accident (see figure 30). At its nearest point, the center of pipeline TX219 was shown as being 0.8 feet from the DREDGEPACK dredge template (left image), and at the accident location, the center of the pipeline was shown as being 1.9 feet from the template (right image).

Figure 30. Screen captures from DREDGEPACK dredge template for the EPIC dock project.

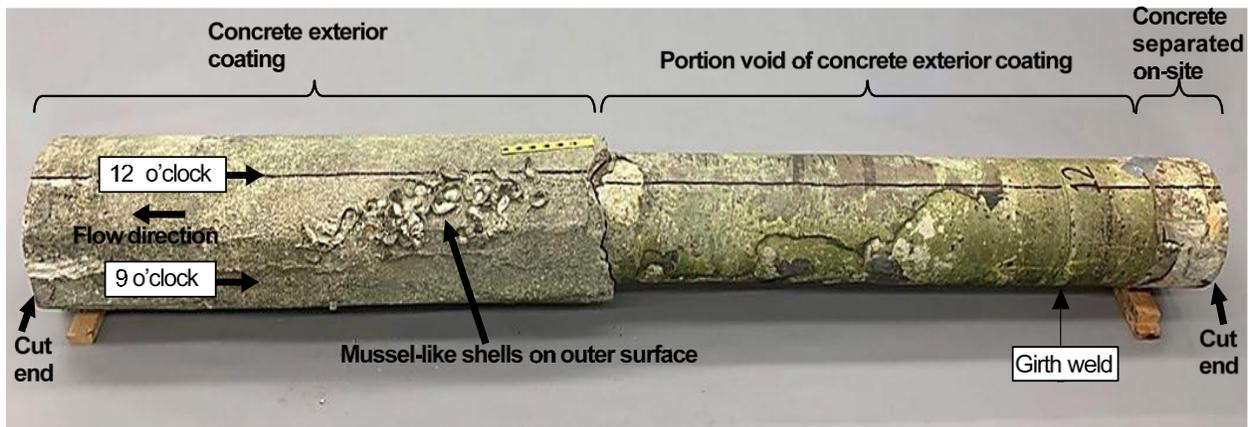
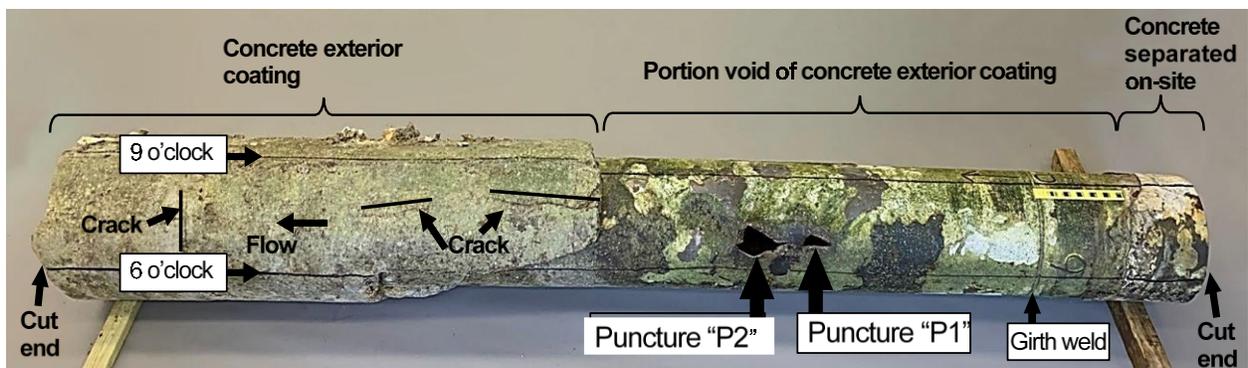
The punctures contained evidence of inward-bending deformation. All damage to the pipe, including punctures, gouges, dents, and the fracture, occurred within a region between 25.5 and 57.8 inches east of the girth weld. As much as a 10-foot 5-inch length of the concrete coating was missing from the pipe in the general area of the damage. Based on orientation marks found on the pipe, the two punctures were located approximately at the 7 o'clock position looking east.

Figure 31. Damaged pipe segment showing the top side (12 o'clock) and the bottom side (6 o'clock). Clock positions are while looking east.

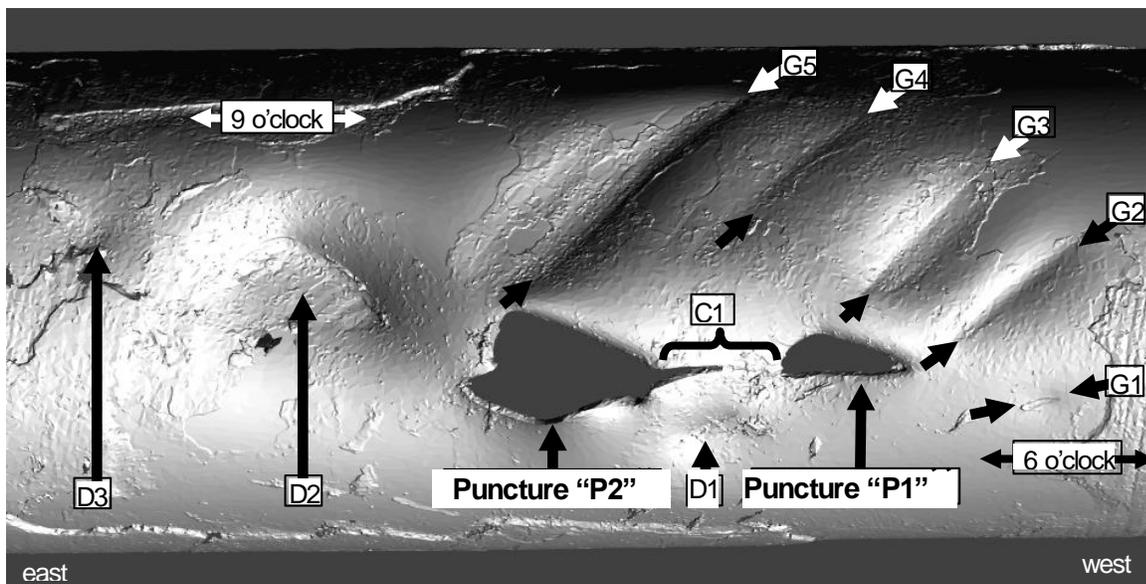
Figure 32. Three-dimensional laser-scanned image of the damaged pipe. Clock positions are while looking east. (Source: Enterprise Products, annotated by NTSB)

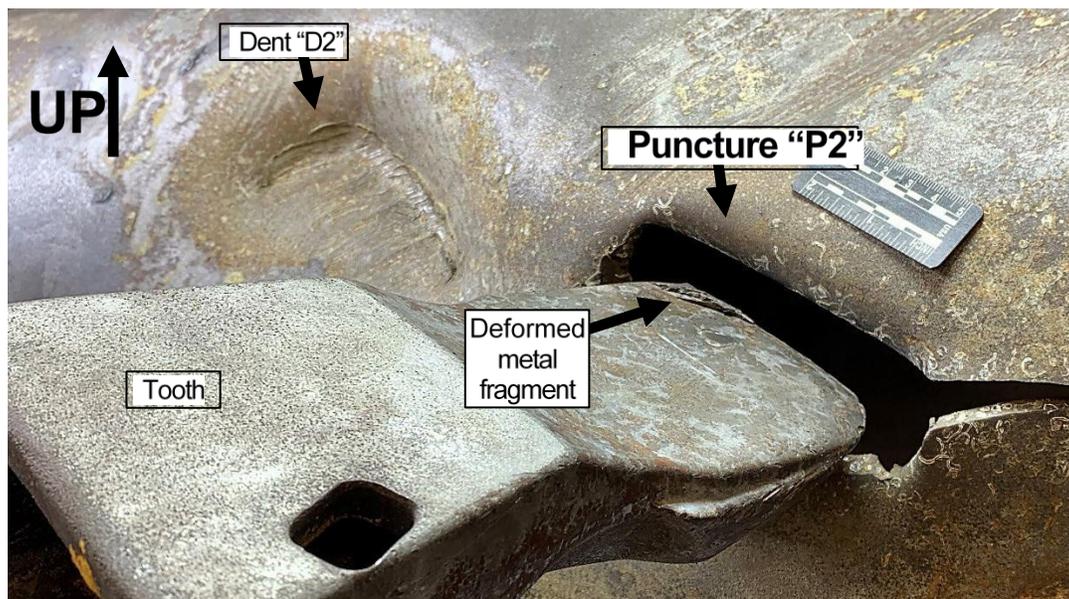
Fit Test (Inserting a Tooth into a Puncture). The tip portion of the tooth removed from blade C of the cutterhead was placed on the outer surface of the pipe in the area adjacent to the larger puncture "P2". The tip portion was then partially inserted into the puncture (see figure 33). When the tooth was inserted into the puncture, there was room for the entire width portion at the tip to enter the puncture.

Figure 33. Oblique view of puncture "P2" with the tip portion of the tooth from cutterhead blade C facing the puncture, after cleaning.

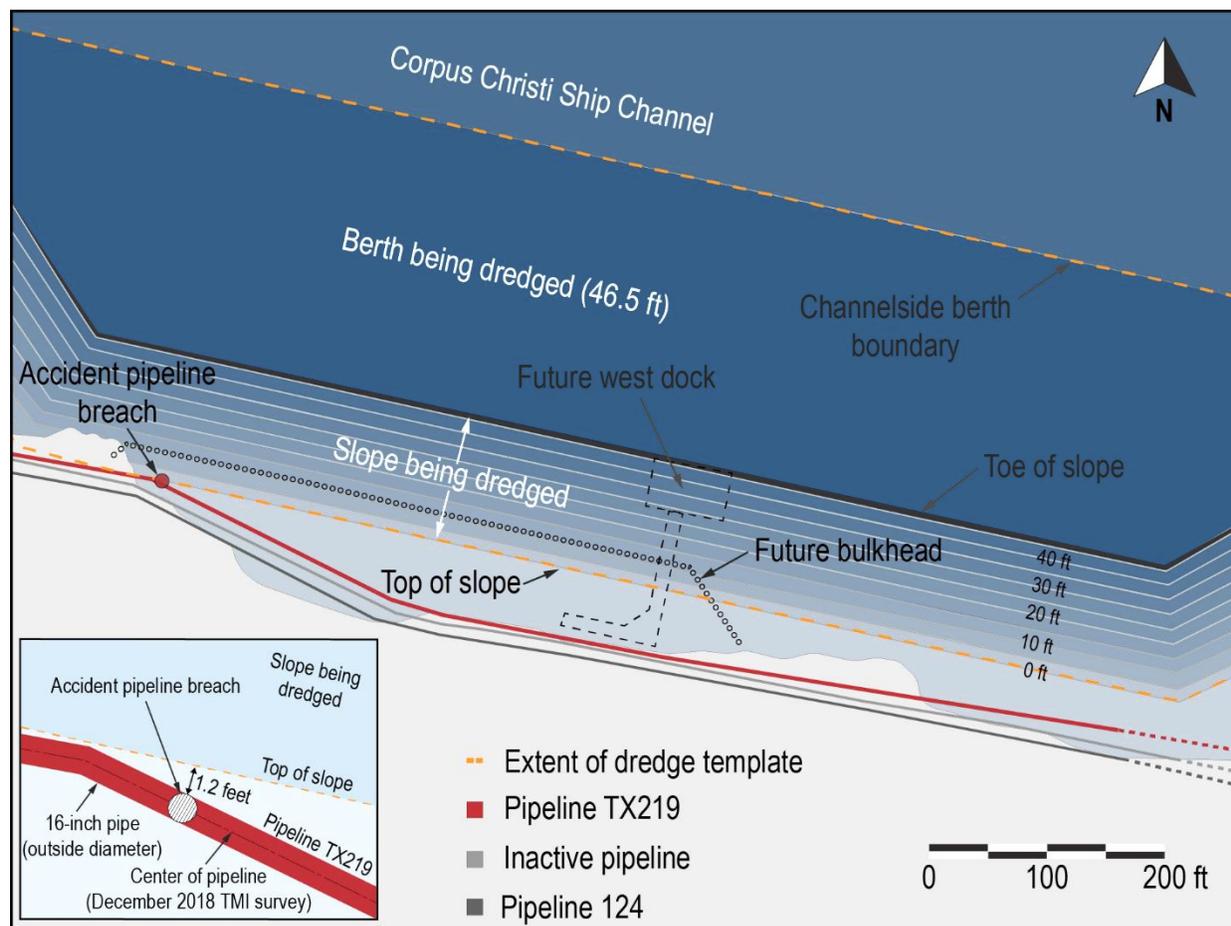
Figure 34 is an NTSB depiction of the dredge template, including the slope being dredged, along with the pipeline locations according to the 2018 TMI Solutions utility survey data. In this depiction, both the larger graphic and inset clearly identify the proximity of the dredge template at the top of the slope to pipeline TX219.

Figure 34. NTSB depiction showing comprehensive view of dredge template and pipeline locations.
