MARINE CASUALTY REPORT

SS AFRICAN NEPTUNE; COLLISION WITH THE
SIDNEY LANIER BRIDGE AT BRUNSWICK, GEORGIA
ON 7 NOVEMBER 1972 WITH LOSS OF LIFE

U.S. COAST GUARD
MARINE BOARD OF INVESTIGATION REPORT
AND COMMANDANT'S ACTION

REPORT NO. USCG/NTSB - MAR-74-4
RELEASED 22 JUL 1974

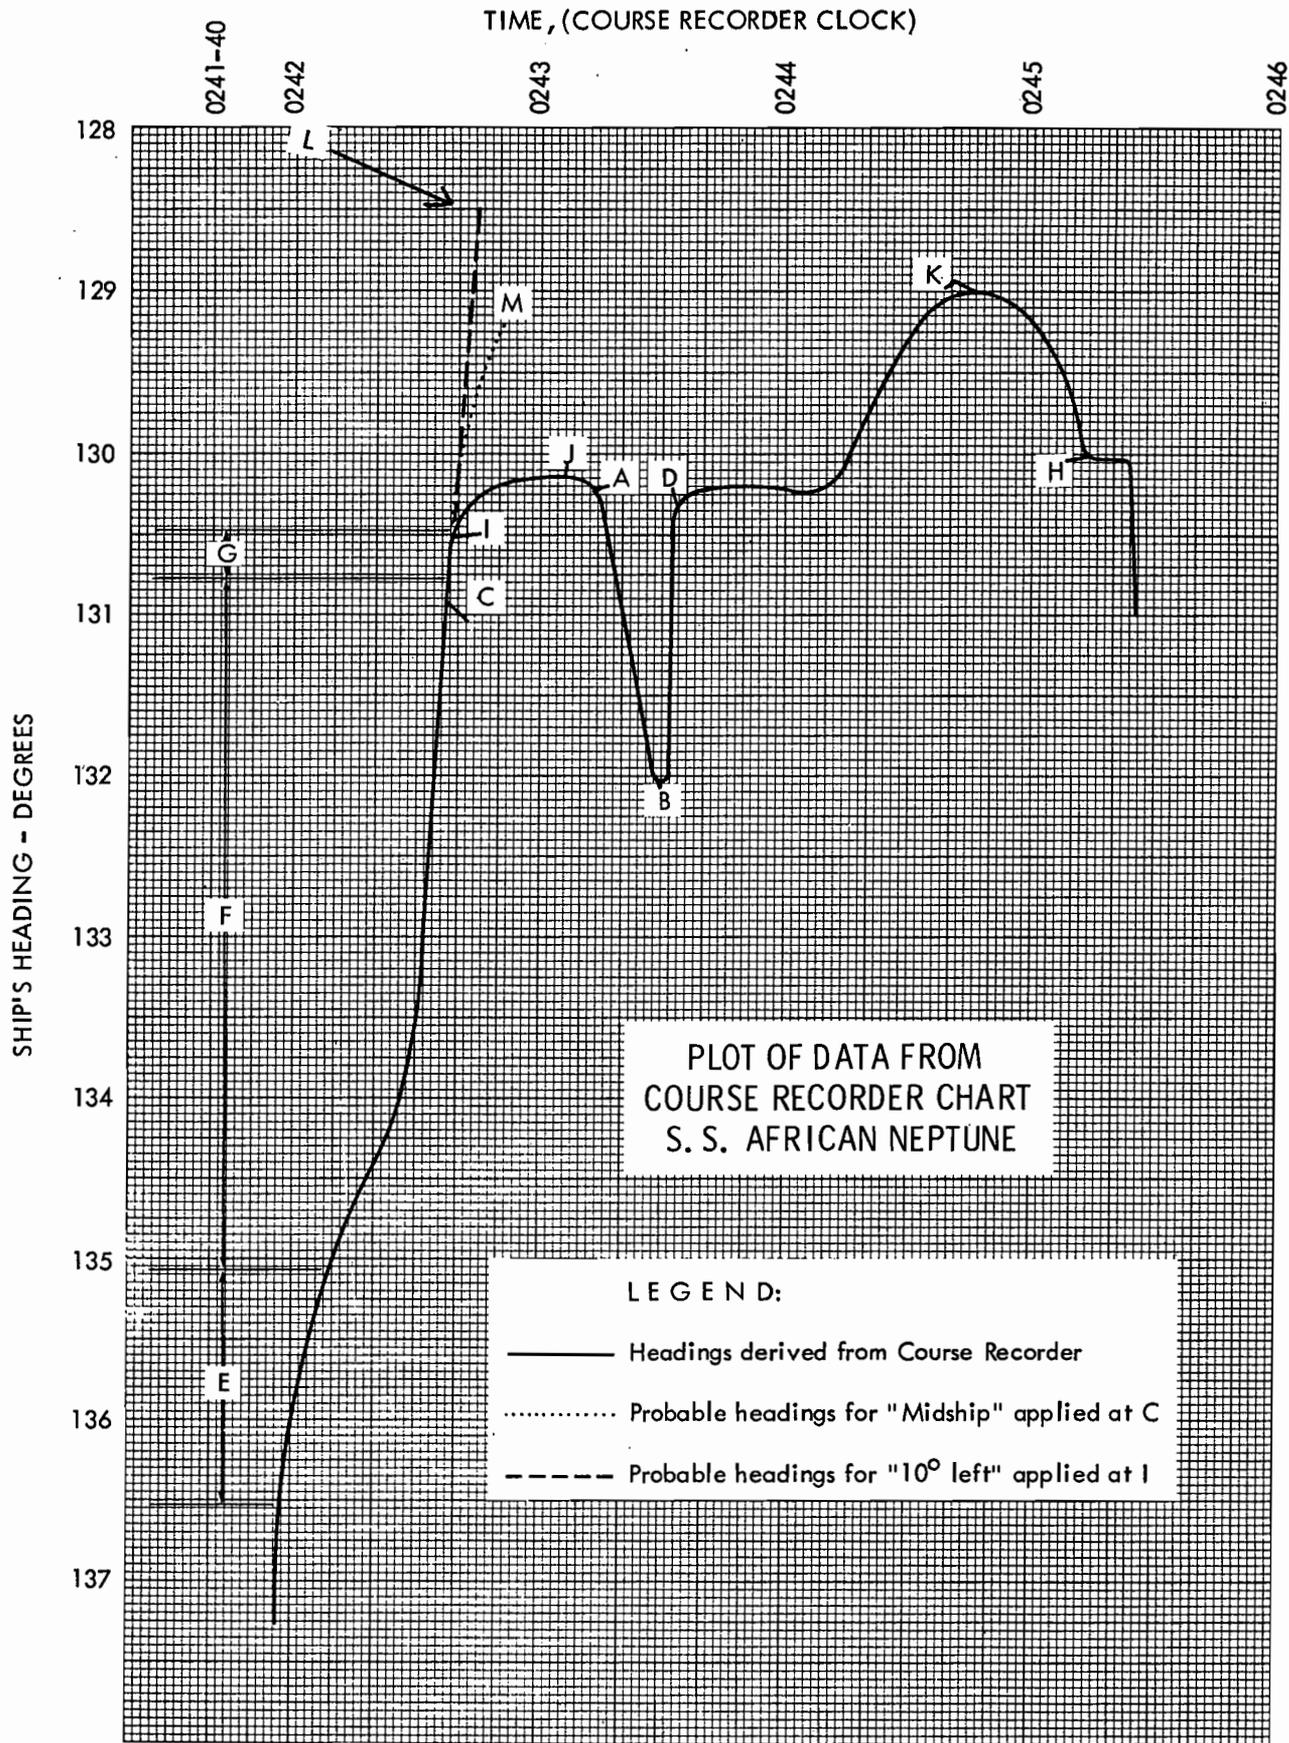
Figure 1 is a chart showing the heading of the AFRICAN NEPTUNE during the 3 minutes immediately before the collision. The data in Figure 1 were obtained by reading the headings on the ship's course recorder chart with a precision x-y reader. Because the thickness of the line on the ship's chart was significant in relation to the time scale, all readings were taken to the center of the line; heading was read to the closest 0.25° . The chart clock period, 0242 to 0245 $\frac{1}{2}$, corresponds approximately to 0245 to 0248 on the wheelhouse and engineroom clocks. Although the exact time difference between the chart clock and wheelhouse clock cannot be determined, the sequence and duration of events affecting the ship's heading can be interpreted from the chart.

The pilot on the AFRICAN NEPTUNE testified that before he gave the last order for "left 20° ," he had ordered "left 10° " and the ship had been swinging left satisfactorily. The sharply curved arc at point A in Figure 1 shows where the ship commenced swinging right in response to the helmsman's reverse application of the "left 20° " order. The arc at point B shows where the ship's heading reversed after the error was discovered and after full left rudder was applied. Because the rudder forces are changing throughout the period of rudder travel and because the ship's inertia precludes instantaneous changes in the ship's heading, it is difficult to locate precisely where the incorrect rudder application began in response to the "left 20° " order. However, the sharp curvature at A shows that the angular acceleration and, therefore, the right rudder forces were high at that time. The pilot stated that when he looked at the rudder angle indicator, it read 20° right. Thus, at about point A, the rudder probably had reached 20° right and the pilot discovered the error.

Point C identifies the end of the ship's last period of steady turn to the left before the collision. This steady turn to the left was produced by some left rudder application, probably 10° . The time interval between points C and A is about 34 seconds. Since it takes the rudder slightly less than 10 seconds to go from 10° left to 20° right, the

incorrect 20° right rudder application did not commence at point C. As further proof of this, the ship's response to a significant rudder reversal would have been more nearly like that represented from A to B to D, although not so peaked, and not gradual as shown from C to A. Therefore, the helmsman could not have gone directly from a correct left 10°, which was the prior order, to the incorrect right 20°.

The pilot recalled that prior to the last "left 10°" order, he gave several sequences of "left 10°" and, "midships" orders. Region E probably represents the result of one of the "midship" orders and region F probably represents one of the "left 10°" orders. Region G could also have resulted from another "midships" order. A subsequent "left 10°" order would have increased the ship's swing to the left again, as shown approximately by line L. If, however, the rudder had been kept amidship when the "left 10°" order was given, the ship's swing to the left would have decreased slowly, as shown approximately by line M. Instead, the ship's swing to the left decelerated rapidly and then essentially stopped before reaching point J. It therefore follows that some right rudder was applied in response to the last "left 10°" order, which probably was given at point I.

The flattening of the curve from I to A indicates, however, that this erroneously applied right rudder was not maintained. During this period, the ship continued to approach the bridge with what the pilot thought was 10° left rudder. At about point J, the pilot recognized the need to increase the ship's turning rate to the left and ordered "left 20°". Therefore, the time from the first failure to respond correctly to a left rudder order (point I) until the pilot recognized the need for a correction (point J) was about 27 seconds. A correct response to the final "left 20°" order probably would still have permitted a successful transit through the bridge opening. At the time of the "left 20°" order, the pilot was calling for nearly maximum settings on his controls (rudder and speed), and any significant increase in the ship's position error would have exceeded the ship's control capabilities. The significant increase in error did occur when the helmsman turned right in response to the "left 20°" order and the pilot failed to discover the error for about 6 seconds. The magnitude of the helmsman's error was magnified by the accompanying increase in propeller speed, which increased the forces on the wrongly positioned rudder. Even when the corrective left full rudder was applied, 22 more seconds (point A to point D) elapsed before the ship's right swing was reversed and the ship regained the heading at which the error was originally discovered. Based on this analysis of Figure 1, it must be concluded that the helmsman turned the rudder in the wrong direction twice, first at point I when left 10° was ordered and then at about point J when left 20° was ordered.

Figure 1. If the turning error had been detected and corrected immediately as the third mate indicated, the peaked arc from points A to B would have occurred much closer to point I, and there would not have been the two separate indications of right rudder applications at points I and A. If the pilot and the master had been immediately made aware of this error, they would have anticipated the slowing of the ship's swing and could have compensated sooner by correcting the rudder. They furthermore would then have undoubtedly intensified the monitoring of the helmsman.

At point H in Figure 1, the ship's right swing was interrupted abruptly. The engineer's bell log shows that a "stop" order was received at 2148½, which was probably immediately after the ship struck the bridge. The most reasonable correlation with the time scale of the course recorder confirms that the "stop" order was received a few seconds after the time indicated by point H. The sharp curvature at point H therefore indicates the collision.

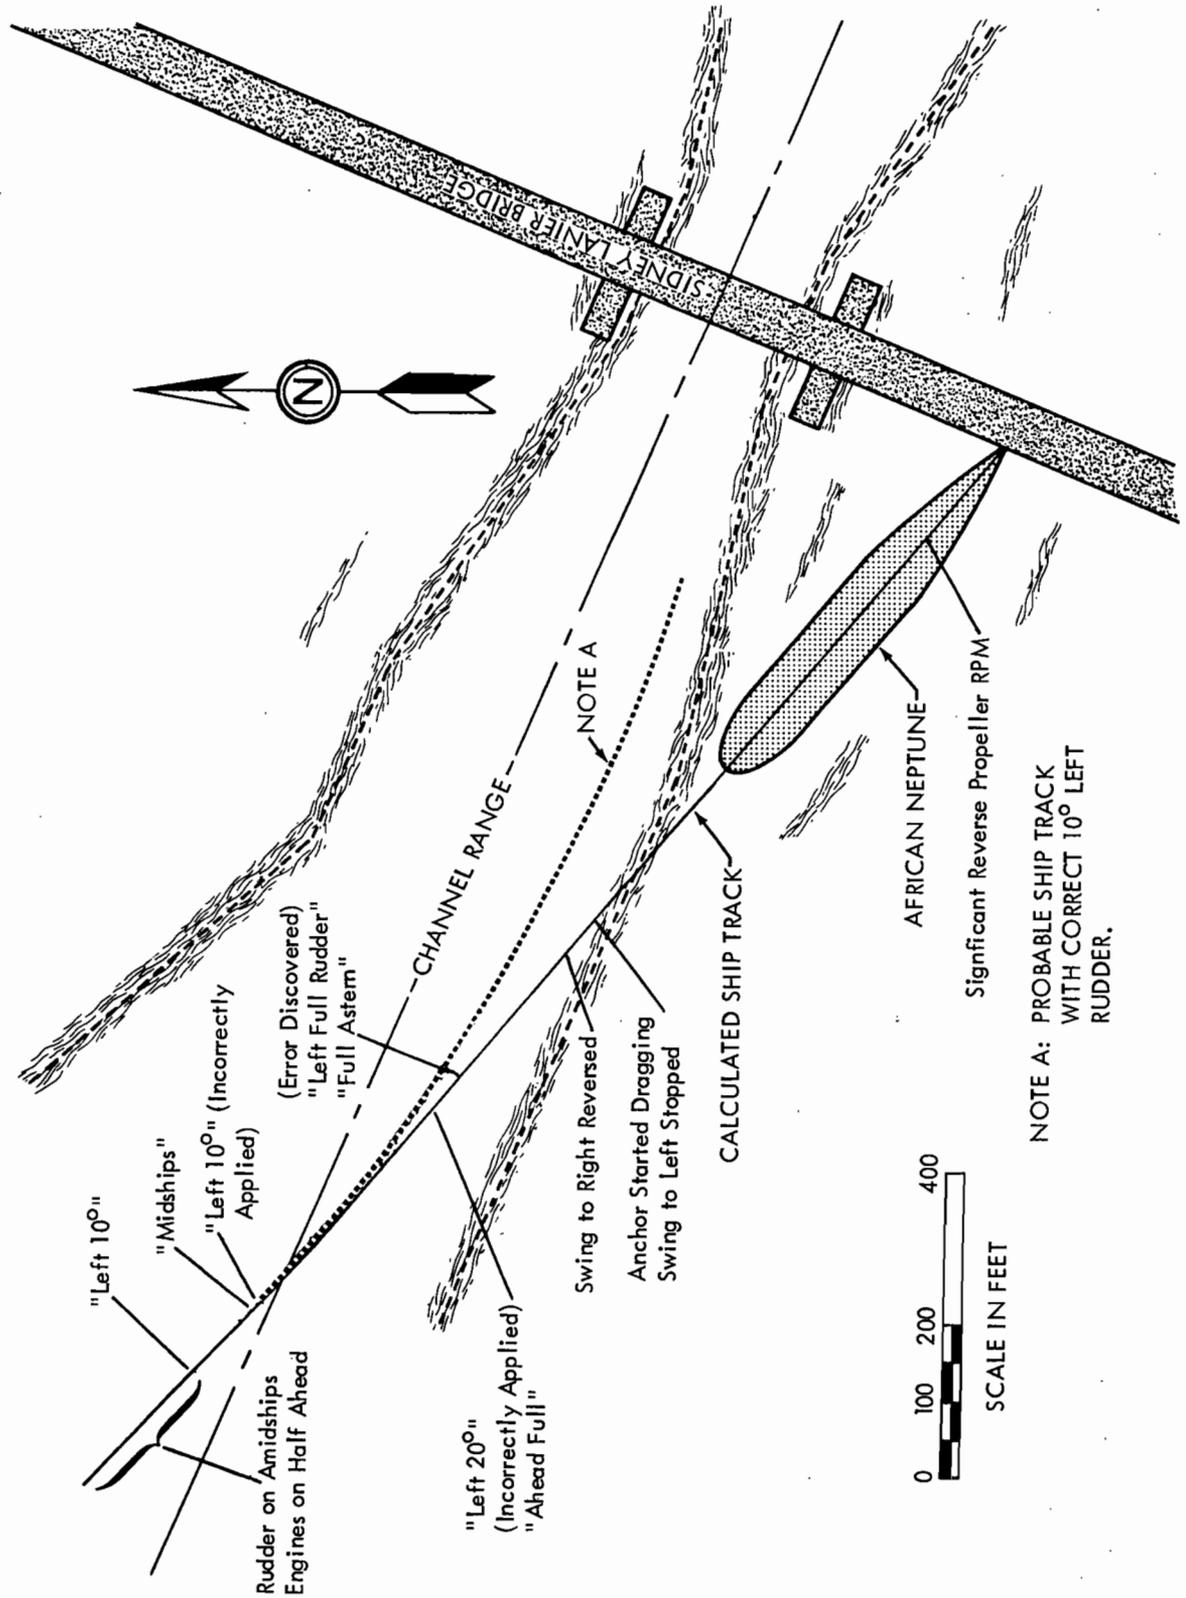
From the location of the point of impact with the bridge, the course recorder data can be combined with data on ship speed to produce the ship's track. Figure 2 has been compiled on the basis of estimated speeds of the vessel during the 3 minutes before the collision, with the assumption that at 0242 by the chart record, the ship was traveling at 7 knots. The effect of wind and current are considered negligible. The solid trackline indicates the path followed by the ship's bow. The events labeled along the solid line are spaced to show the position of the ship's bow. The cross-hatched line indicates the position the bow would have followed if the last "left 10°" order had been properly executed and the ship's swing would have been as indicated by segment L in Figure 1. This crosshatched curve also assumes the pilot would have made no further adjustments, which is unlikely.

When the steering error was discovered, the ship was on a heading of 130° and the section of the bridge directly ahead of the ship was about 900 feet away. The drawbridge was 850 feet away, aligned on a channel line of 112°. At an assumed speed of 7 knots, any maneuver to align the ship with the bridge opening would have had to have been accomplished in about 72 seconds. It took about 18 seconds to reverse the ship's swing from right to left. With full left rudder, the ship probably could have had enough time to reach a heading of 112°. However, because the ship's path was now to the right of the channel line, the ship still would not have been lined up with the bridge opening. It is highly probable that any attempt to reach the bridge opening with a hard left turn would have resulted in the ship's striking the tower which supported the southern end of the lift span. (See Figure 2.)

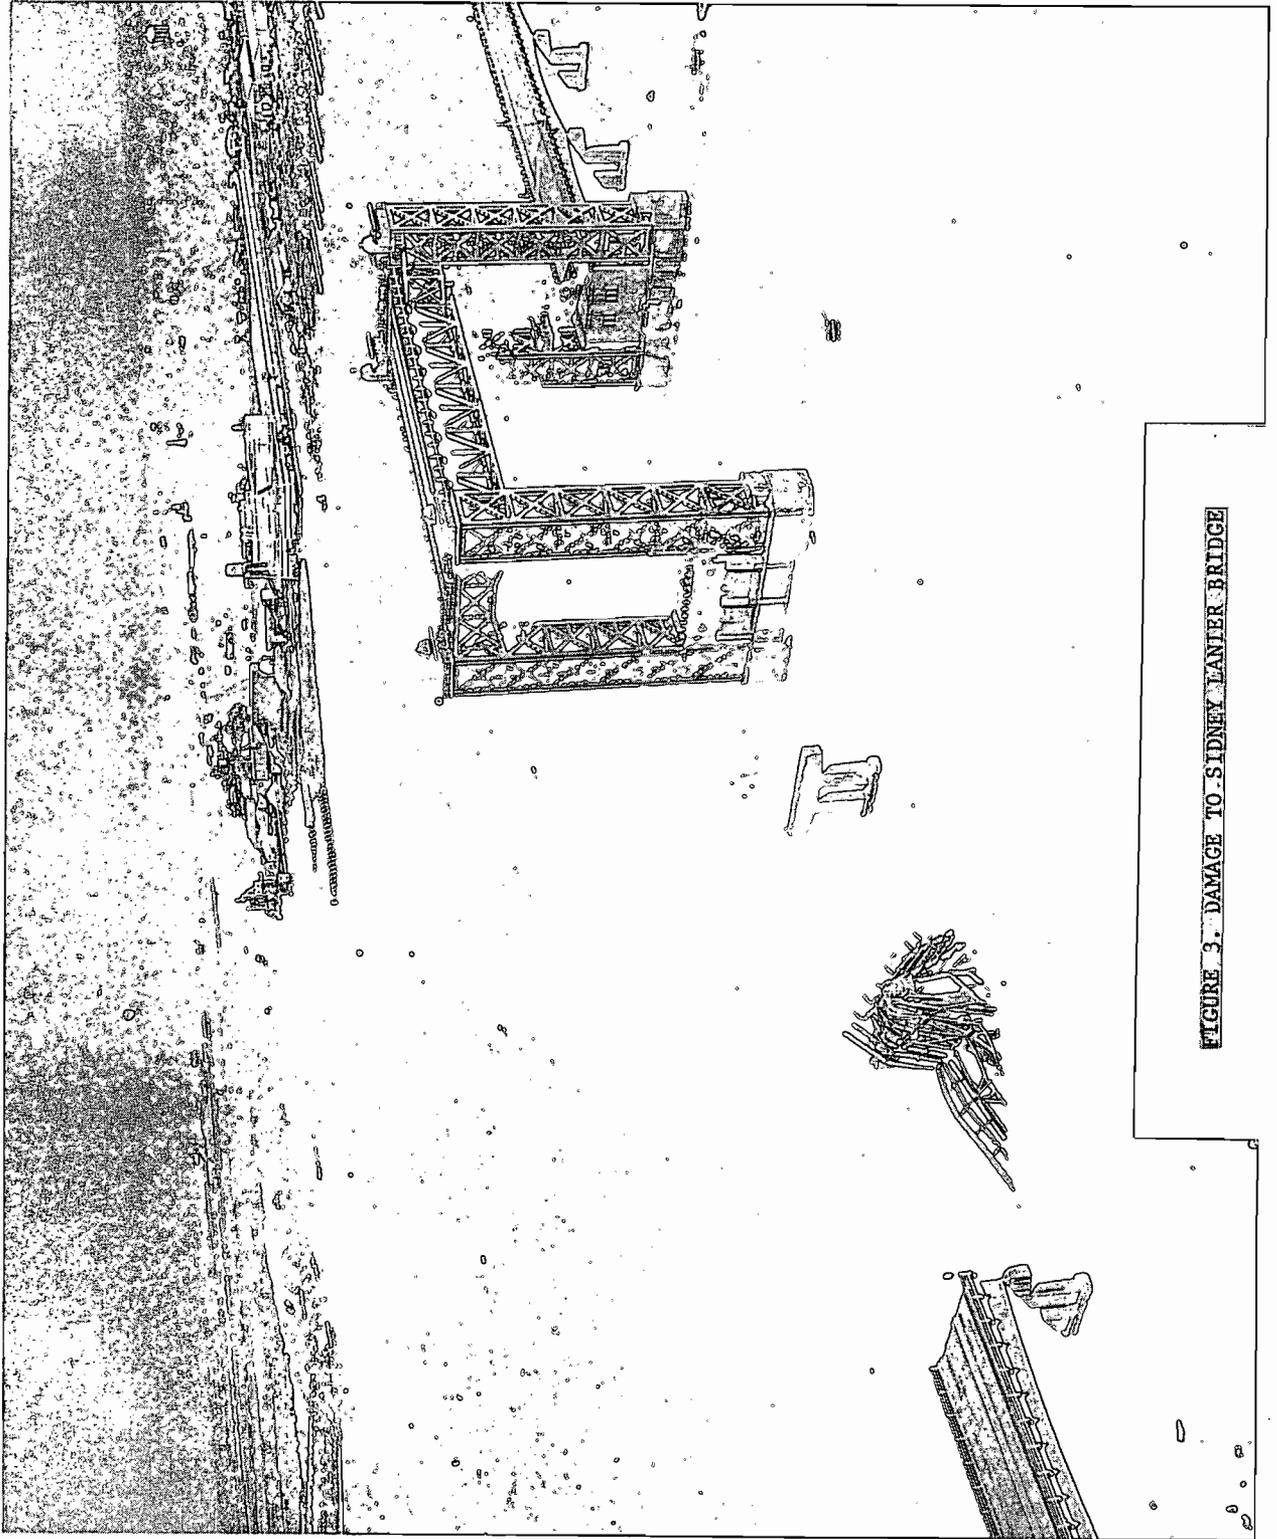
FIGURE 3. DAMAGE TO SIDNEY LANIER BRIDGE

23. At about 2149, the top of the AFRICAN NEPTUNE's forward foc'sle head bulwarks passed under the walkway on the upstream side of the Sidney Lanier Bridge and struck the bridge's steel structural member. The point of impact was slightly south of midway between two bridge piers about 250 feet south of the southernmost lift span tower. Three sections of the bridge collapsed and the vessel sustained minor damage to the bow.

29. Twenty-four (24) persons had been occupants of vehicles stopped on the collapsed portions of the Sidney Lanier Bridge. At least three of these ran to safety on the undamaged portion of the bridge. As the sections collapsed some of the structural steel bent across the concrete piers. Several persons were able to cling to this damaged structure, others fell into the water. Ten lost their lives. Two were rescued by the ship's lifeboat. The remaining survivors were rescued by harbor craft. There were no personal flotation devices on the highway bridge. The search operations continued into the following day but failed to locate any additional survivors. The remains of the deceased were recovered from waters of the Brunswick River during the next several days. The last body was recovered from a submerged vehicle on 12 November 1972. The port of Brunswick was closed to shipping at about 2250, 7 November 1972, and was reopened at 0936, 8 November 1972.

In addition to killing 10 people and injuring 11 others, the accident closed the bridge to traffic for 6 months. Repairs cost about \$1.3 million. In the reconstruction of the bridge, a flexible traffic-control system which fully implemented the intent of the Safety Board's recommendation was installed.
