**SS V. A. FOGG; SINKING IN THE GULF OF MEXICO
ON 1 FEBRUARY 1972 WITH LOSS OF LIFE**

**U.S. COAST GUARD
MARINE BOARD OF INVESTIGATION REPORT
AND COMMANDANT'S ACTION**

REPORT NO. USCG/NTSB - MAR-74-8

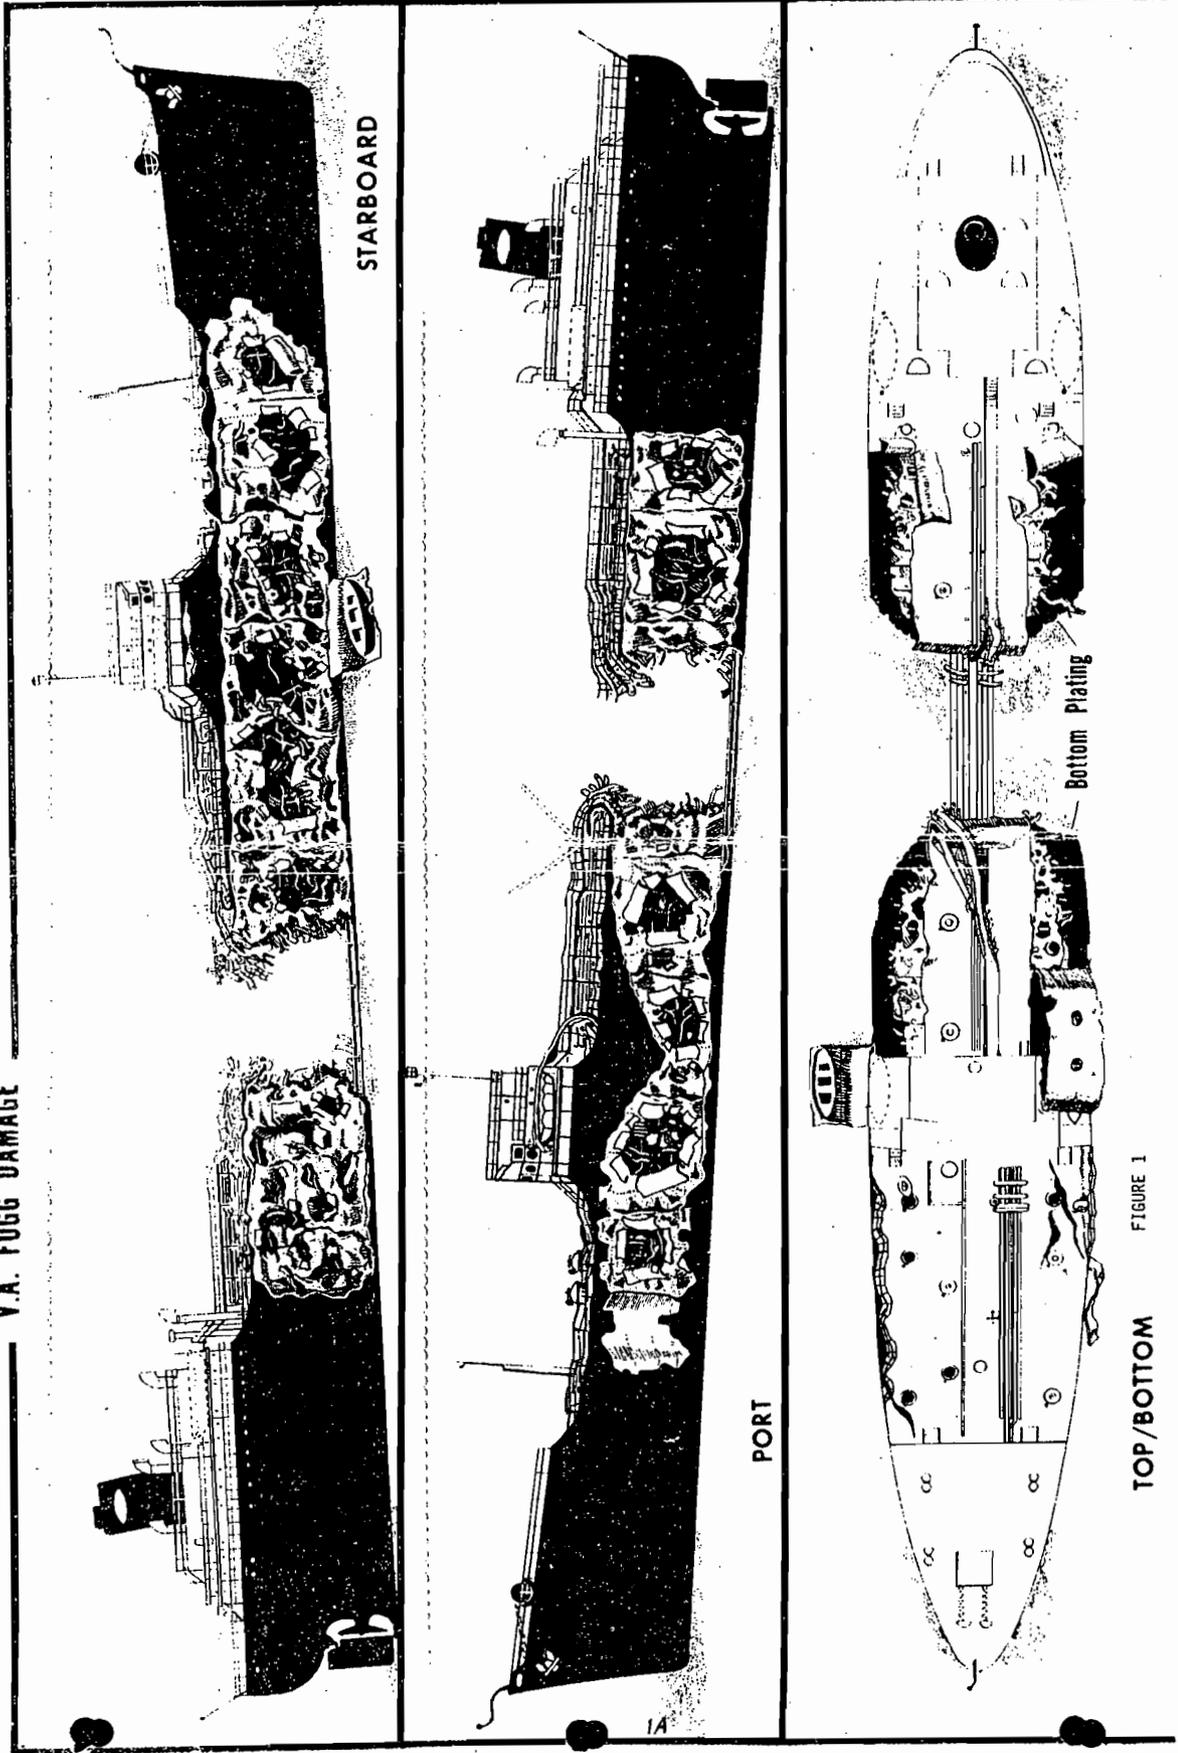
TOP/BOTTOM FIGURE 1

Only by viewing the vessel or the exhibits to this report can a true appreciation of the extent of vessel damage be gathered. To help the reader appreciate the gross damage an artist's interpretation is attached. This interpretation does not claim complete accuracy but is illustrative of the massive damage sustained by the vessel. Attached for reference purposes is a photograph of the vessel taken prior to the casualty.

V.A. FOGG DAMAGE
