MARINE ACCIDENT REPORT

**FISHING VESSEL M/V LOBSTA-1
CAPSIZING AND SINKING
IN THE ATLANTIC OCEAN
POINT JUDITH, RHODE ISLAND
SEPTEMBER 23, 1978**

NTSB-MAR-80-6

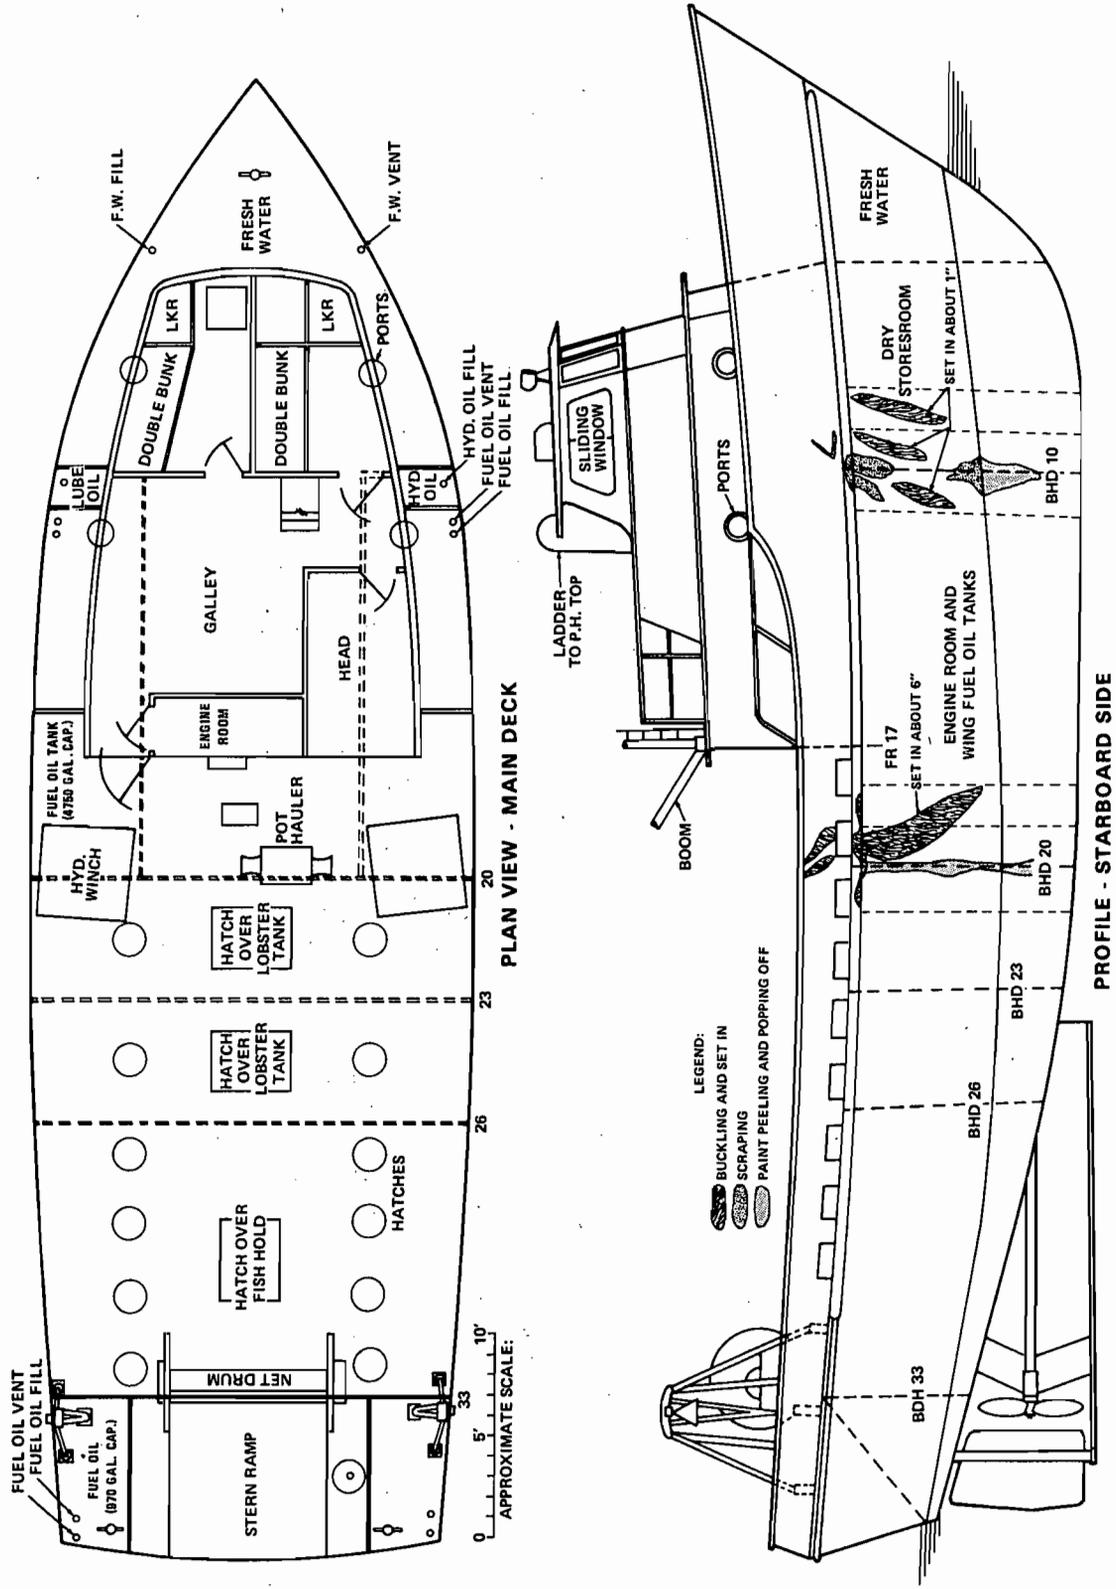
Figure 4. Trawler-LOBSTA-I.
Arrangement and Location of Damage

Because the camera angles to the hull varied, it was not always possible to estimate the amount that the side shell was deflected inward. Figure 4 indicates the approximate location of damage to the starboard side.

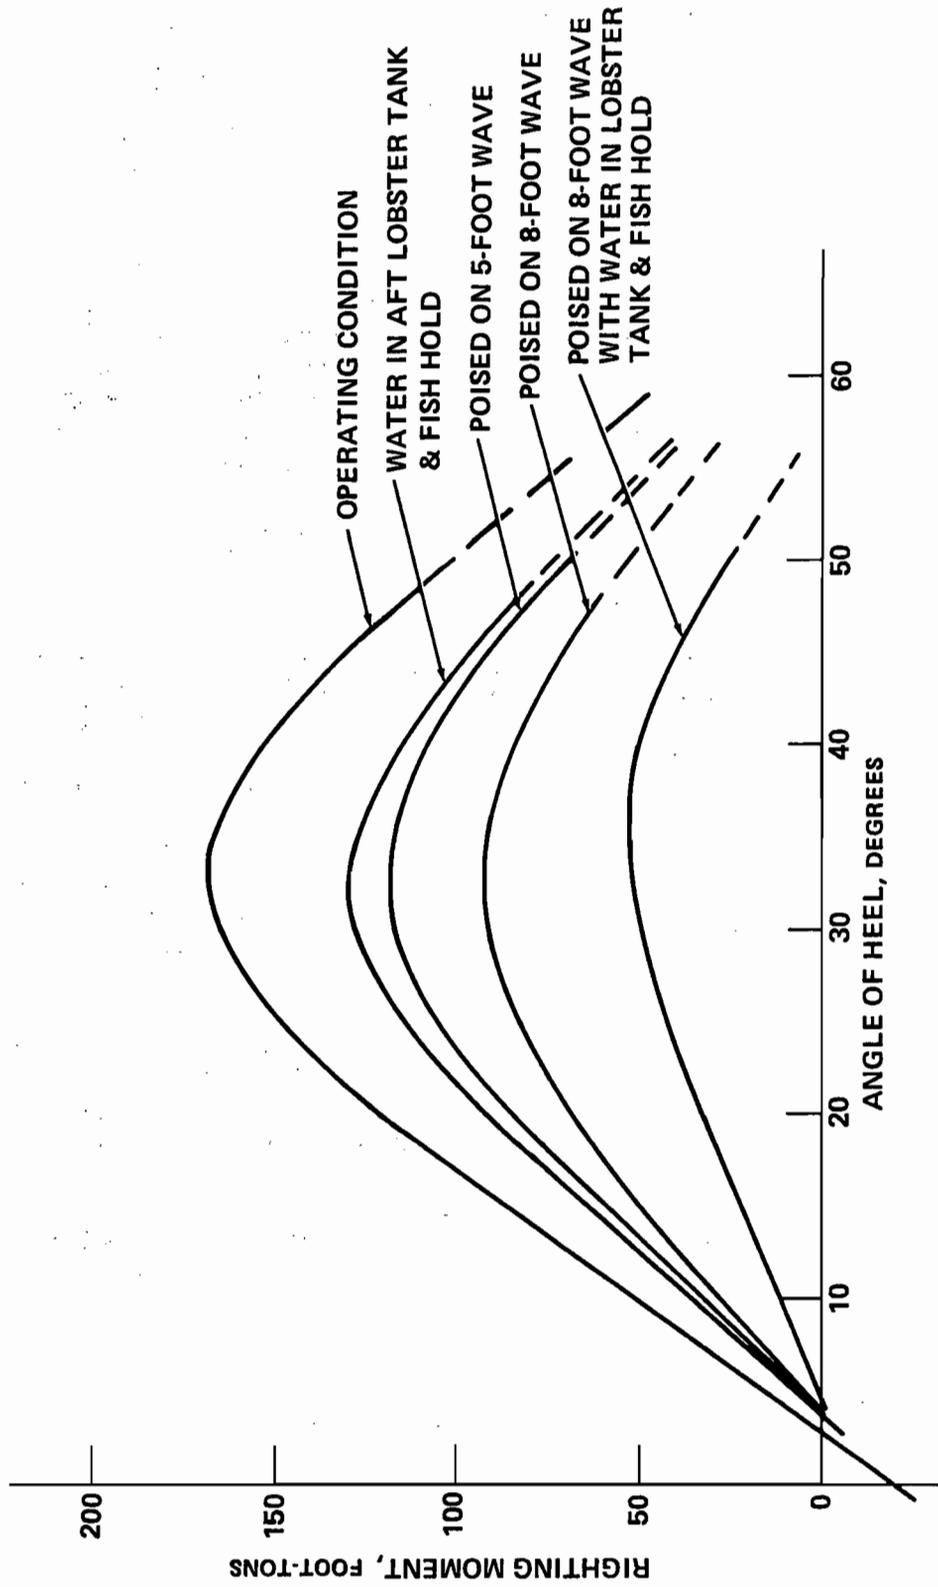
Figure 7. LOBSTA-I static stability curves.

The results of these calculations are shown in figure 7. The curves do not consider the additional righting moment developed when the pilothouse begins to immerse. The LOBSTA-I had a maximum righting moment of 165 ft-tons at an angle of heel of about 32° for the operating condition which existed on September 22, 1978. The effect of the fuel transfer for 7 hours of operation, as well as normal free surfaces, are included in this curve which shows that the vessel probably had a list of about 3°.

The effect on stability of downflooding through the overboard discharge of the after lobster tank and possible leakage through the deck hatches of the fish hold were calculated for 45 in of water in the lobster tank and 18 in of water in the fish hold. The maximum righting moment would have been reduced to 130 ft-tons primarily because of water in the lobster tank.

With the LOBSTA-I poised on the crest of an 8-ft high, 70-ft long wave, its maximum righting moment would have been reduced to 90 ft-tons; the curve for the vessel being poised on a 5-ft wave was also shown since this was in the range of reported sea conditions. The 8-ft wave approximates the steepest nonbreaking wave with a length equal to the vessel's length. Finally, the combined effect of the

water in the lobster tank and fish hold and poisoning the vessel on an 8-ft wave would have reduced the maximum righting moment to 53 ft-tons.
