NATIONAL TRANSPORTATION SAFETY BOARD

MARINE ACCIDENT REPORT

RAMMING OF THE SUNSHINE SKYWAY BRIDGE
BY THE LIBERIAN BULK CARRIER SUMMIT VENTURE
TAMPA BAY, FLORIDA
MAY 9, 1980

NTSB-MAR-81-3

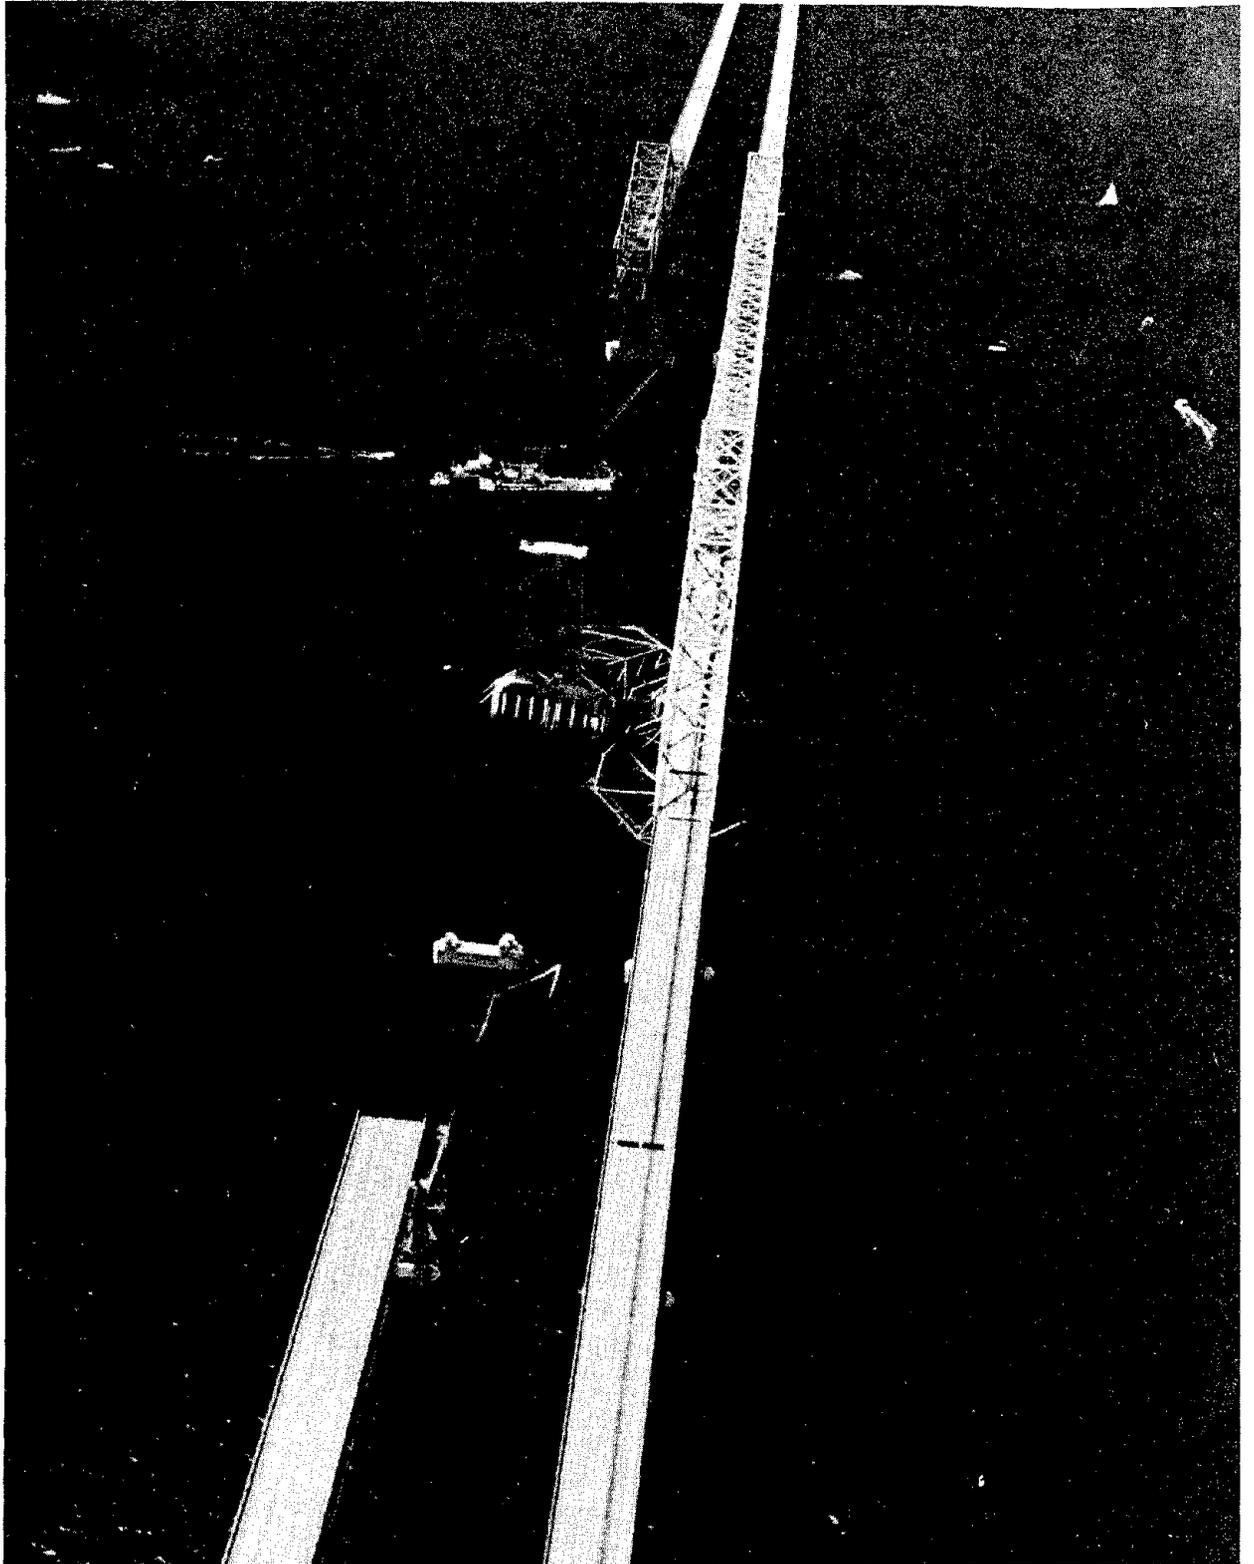
Figure 2.--Damage to the Sunshine Skyway Bridge.

The ramming caused the loss of 1,297 feet of bridge deck and superstructure, and the two columns and cap of pier 2S were also destroyed.

Pier 1S showed extensive cracking throughout, particularly in the east column, with spalling at the top of the cap. The east bearing assembly was missing, but the bottom half of the west bearing assembly was intact. Both columns of pier 2S were sheared off approximately 6 feet above the crashwall. Spalling was found on the pier footer and on the northwest corner of the crashwall. Large paint transfers were found on the northwest corner of the crashwall.

The south cantilever arm span and the suspended arm span landed in the water on their east sides. A 36-foot section of the north cantilever arm span was angled 13° downward toward the channel. There was stress damage to sway frames and gusset plates in the deck truss span between piers 3S and 4S. Both bearing assemblies of pier 3S were damaged, and there was spalling on the pier cap and on the crashwall.

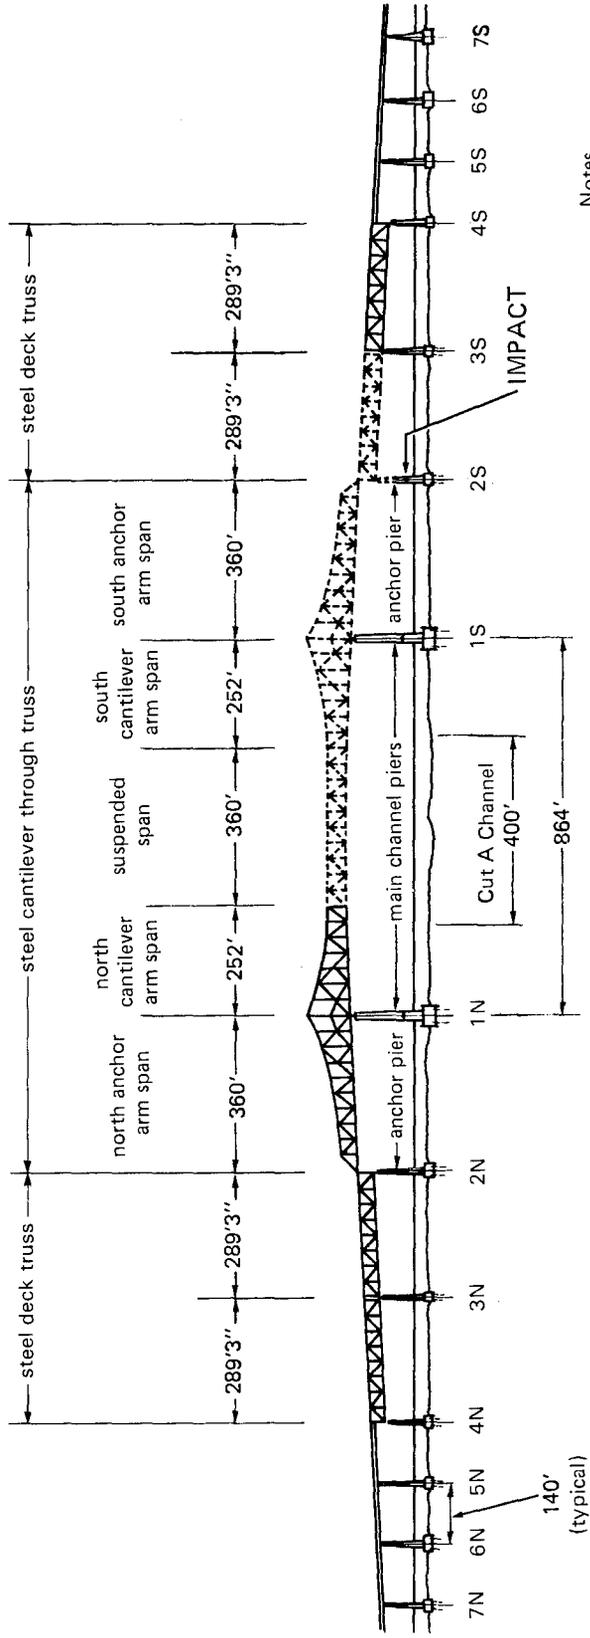
Figure 3.--Diagram of the damaged Sunshine Skyway Bridge (looking eastward).

- not to scale
- dashed lines represent fallen parts of bridge structure

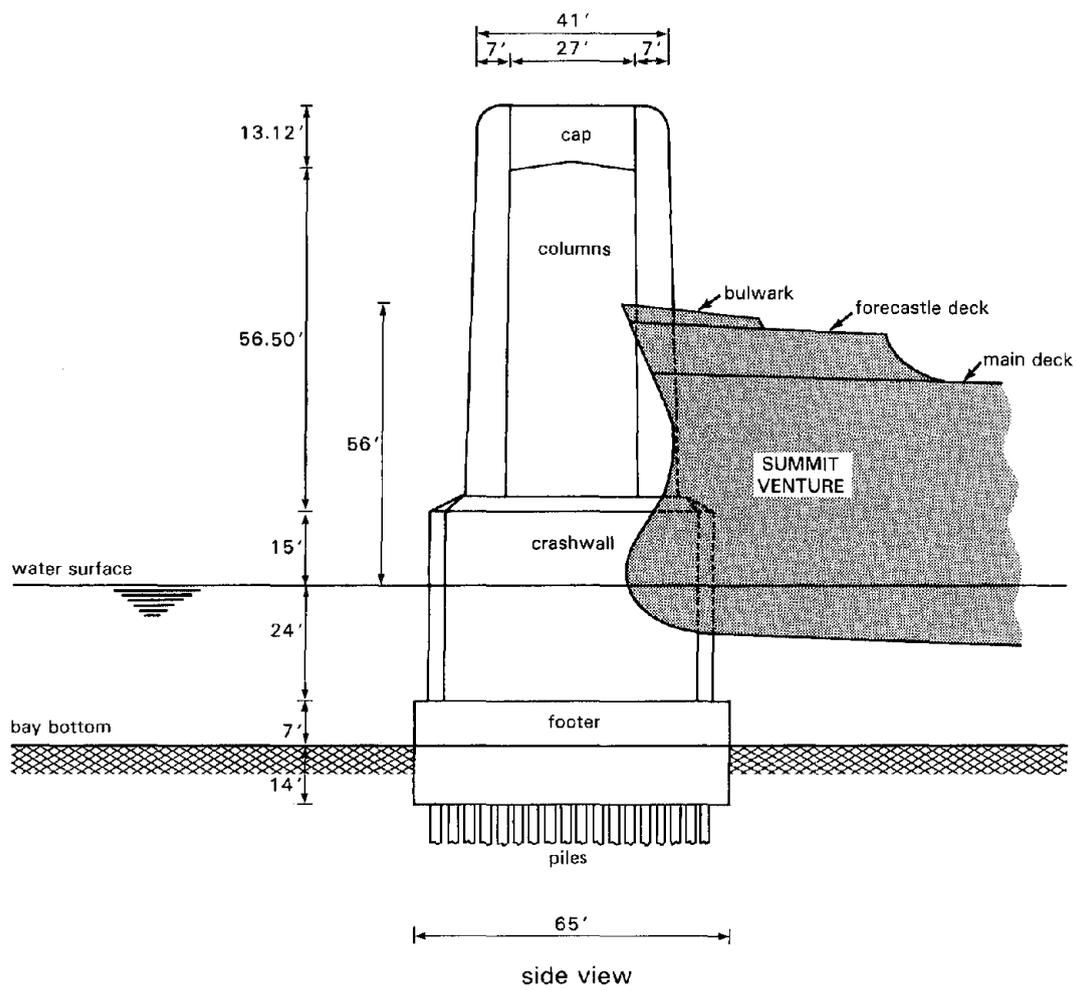
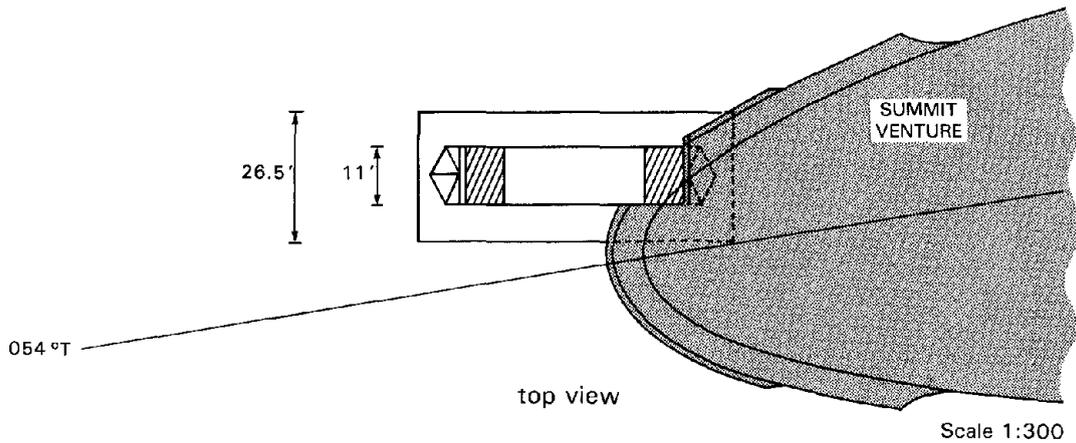
Figure 5.--Impact of the M/V SUMMIT VENTURE with pier 2S.

Safety Board investigators examined the damage to the SUMMIT VENTURE and determined that the vessel had struck pier 2S of the western span of the Sunshine Skyway Bridge about 10 feet starboard of the vessel's centerline on a heading of about 054°. (See figure 5.) The flare of the starboard bow hit the pier about 56 feet above the waterline. The vessel's stem plating, deck plating, and internal stiffeners were torn and folded in about 16 feet. (See figure 6.) A horizontal seam below the waterline in the forepeak tank shell plating was ripped from frame 212 to frame 223. The starboard shell plating was scraped heavily from frame 100 to frame 113. On the portside, there were heavy chain marks leading downward and aft from the anchor hawsepipe. The bilge keel was dished in from frame 180 to frame 188 and from frame 161 to frame 165.

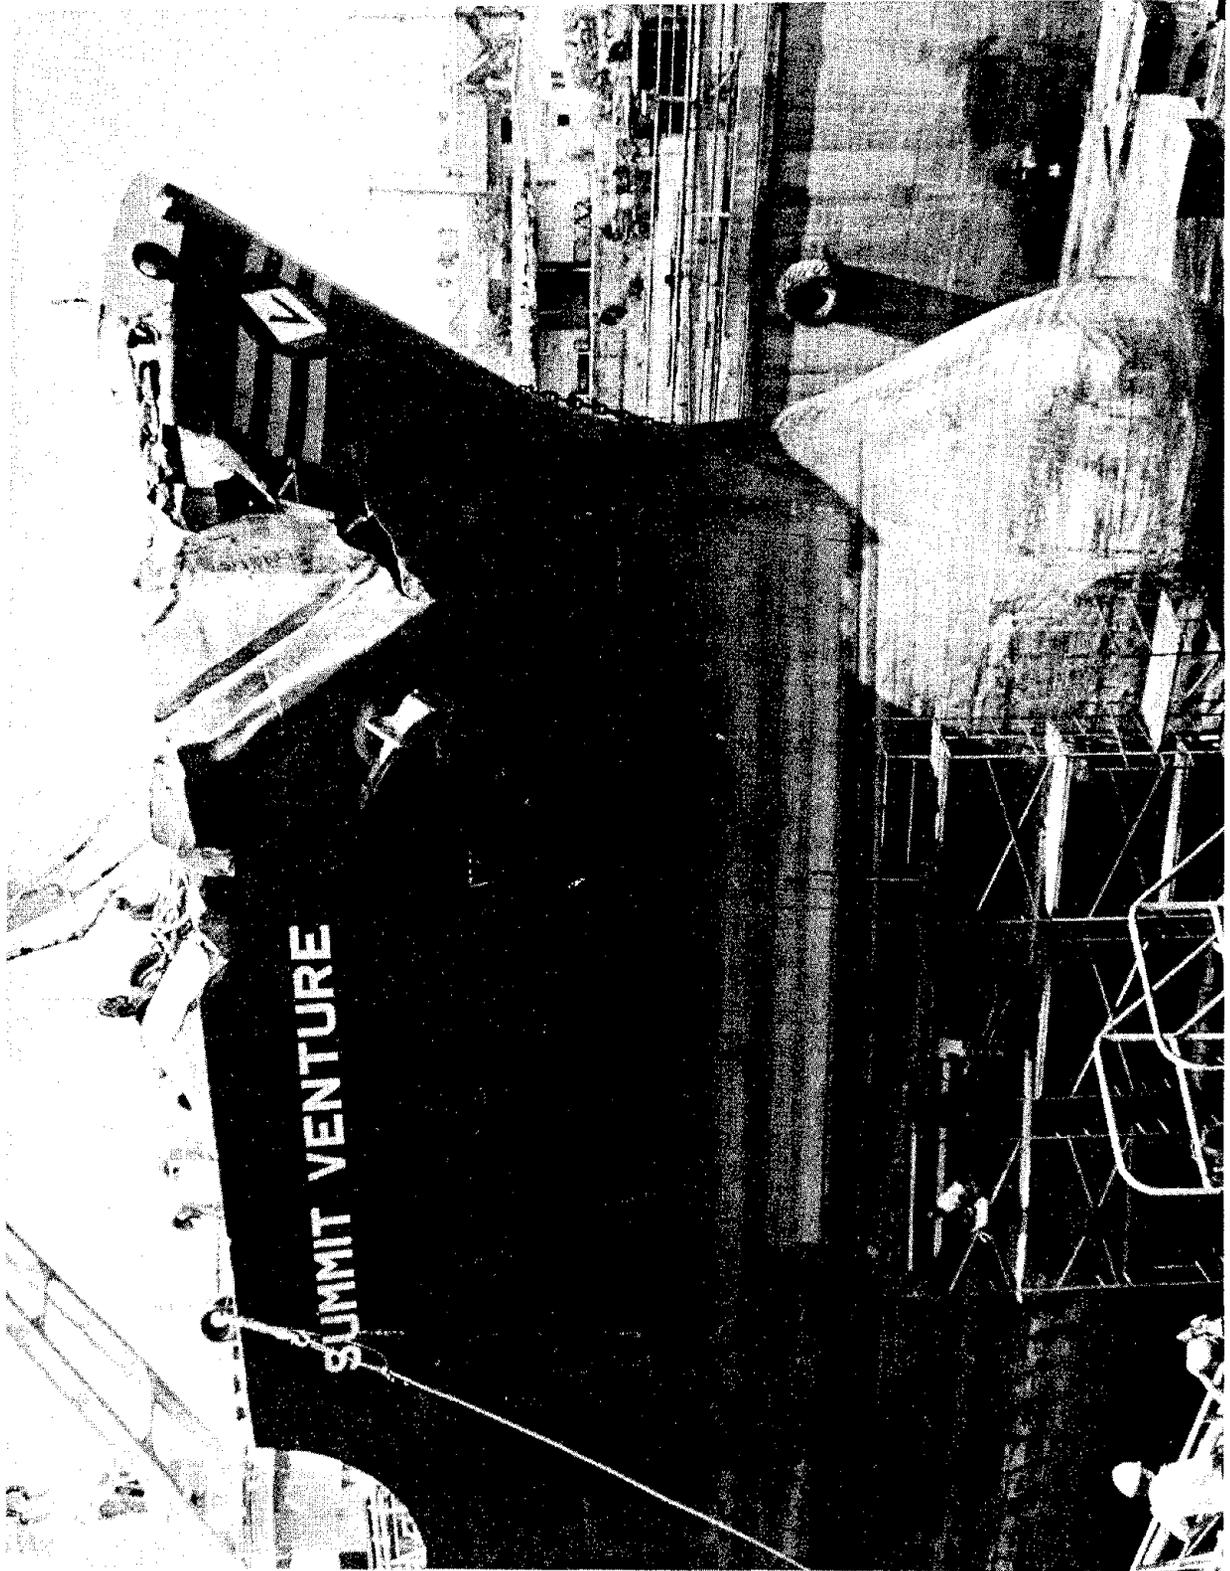
Figure 6.-- Damaged forecastle of the M/V SUMMIT VENTURE.

A 100-foot section of the highway bridge deck and roadway landed across the forecastle deck of the SUMMIT VENTURE and damaged the forward superstructure and deck equipment. Approximately 140 feet of the port anchor chain had run out before the anchor windlass was disabled; the starboard anchor remained in the stowed position.

The vessel was towed to the Tampa Shipyard drydock where temporary repairs were made before it departed for Japan. The estimated damage to the SUMMIT VENTURE was \$1 million.

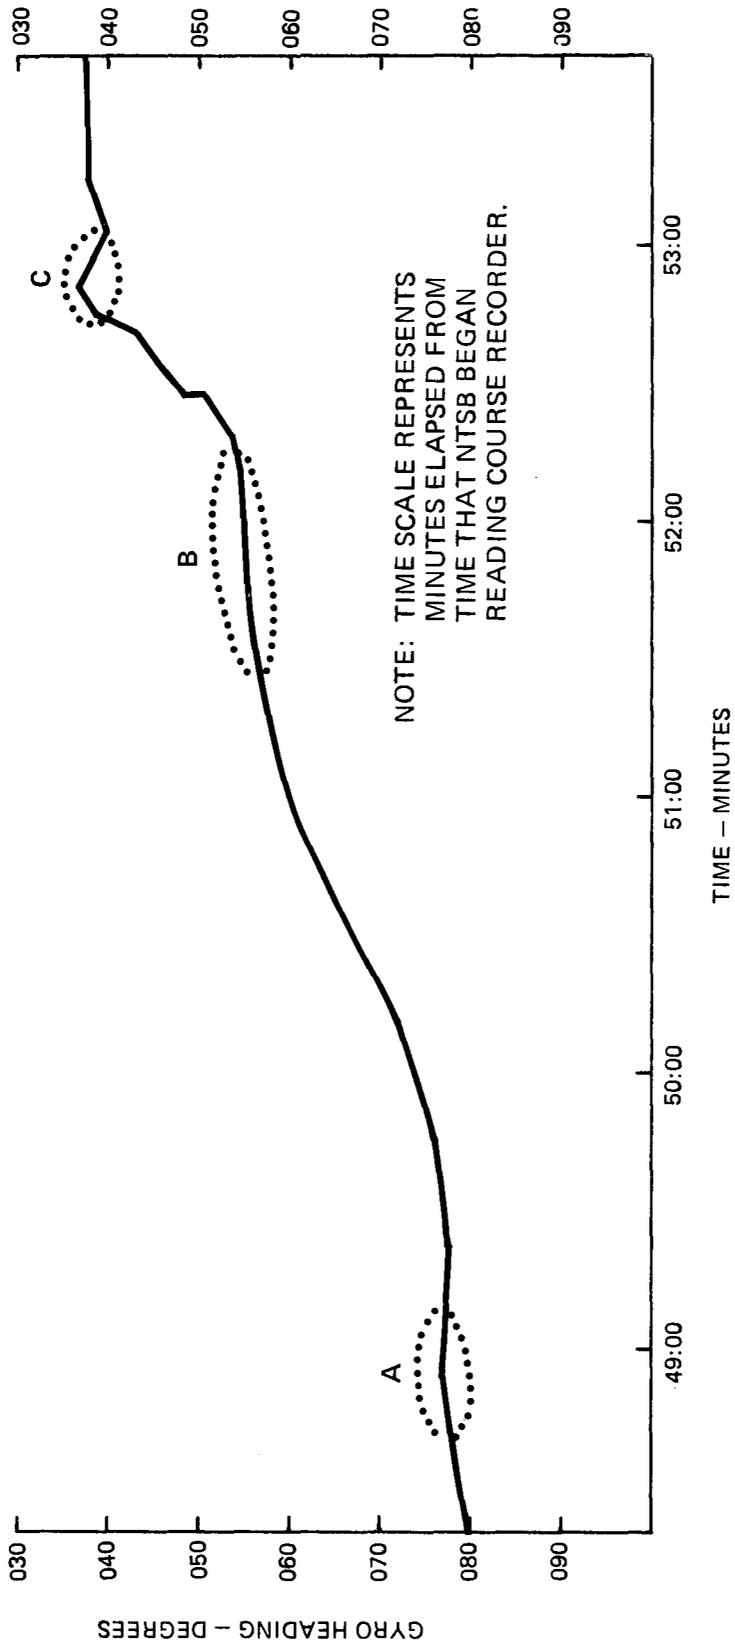
Figure 8.--Graphical representation of the SUMMIT VENTURE's course recorder trace as read by NTSB.

The SUMMIT VENTURE's course recorder graph was removed from the instrument and was forwarded to the Safety Board's laboratory in Washington, D.C. for examination and readout. The graph paper was not damaged, the course trace was clear, and there was no evidence that the course recorder had malfunctioned. The device used for the readout was an X-Y measuring machine with a moving microscope to follow the course trace and an X-Y display to show the inches of microscope movement continuously from the point where the readout was begun. The information derived from the readout of the course trace was plotted on an expanded scale. (See figure 8.)
