# **NATIONAL TRANSPORTATION SAFETY BOARD**

## **MARINE ACCIDENT REPORT**

**UNITED STATES BULK CARRIER MARINE ELECTRIC  
CAPSIZING AND SINKING  
ABOUT 30 NAUTICAL MILES  
EAST OF CHINCOTEAGUE, VIRGINIA  
FEBRUARY 12, 1983**

NTSB/MAR-84/01

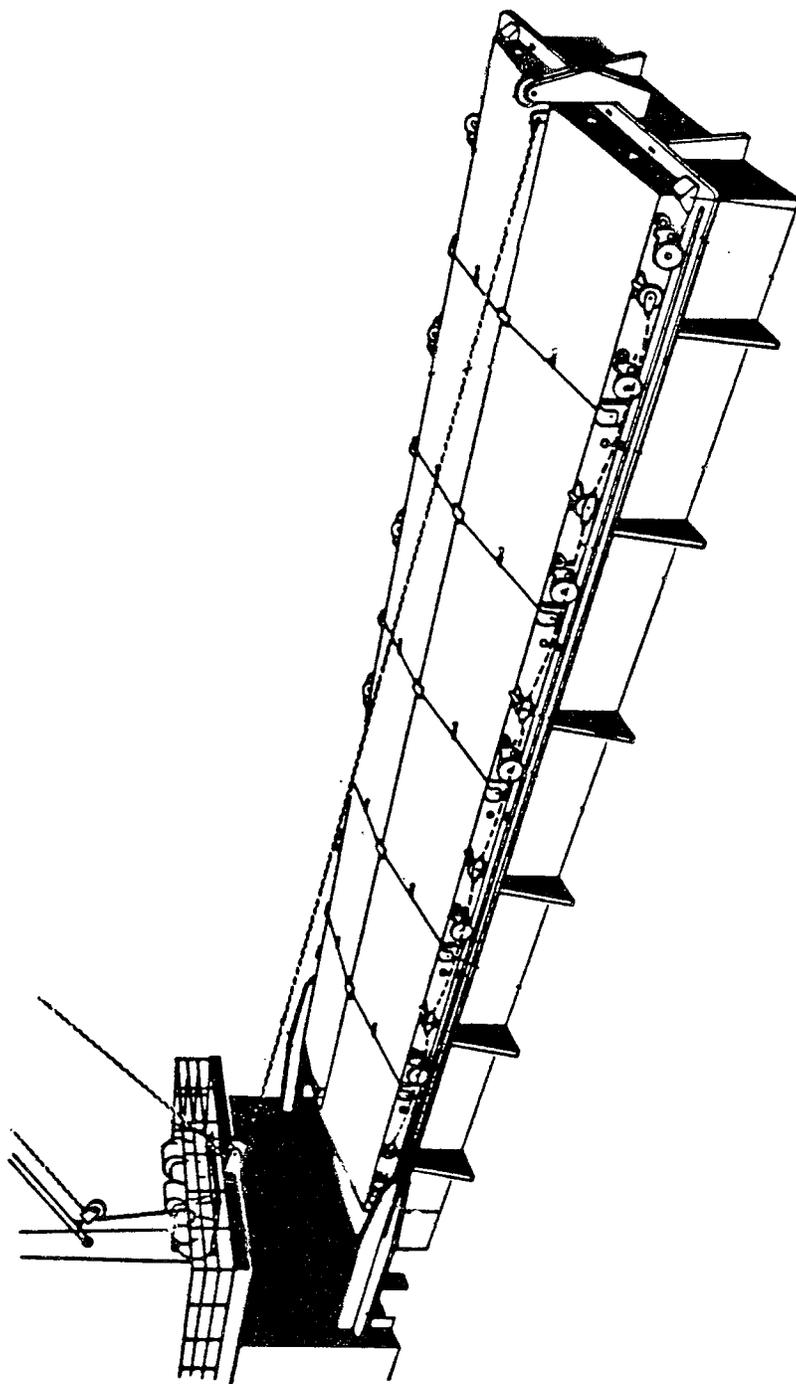
Figure 4.—Typical six-panel hatchcover.

OBSERVATIONS: During a visit to the vessel in March of 1981, I noticed that panels on No. 3 hold were in poor condition, i.e., being distorted and having wasted area on the main beams. They have deteriorated badly in the interim. At present the coamings have holes in the wheel tracks, and are so wasted that there is no strength left to support the [weight] of the panels without further distortion. The coaming compression bar is badly scaled and wasted such that it should be renewed. The falling tracks are likewise weakened, wasted and damaged. The rising tracks have slopes of uneven angles and are distorted; in addition, they are weakened so as to flex and distort easily. The panels themselves are in an even more serious state of decay. The top plates are weak, wasted, buckled and holed in many places. The cross joint wedges are all [missing], which is a serious omission and although the wedges are onboard, the state of the panels is such that extensive welding on them could lead to further rapid deterioration. There are heavy deposits around and on the panels where hatch tape is used. The rubber gasket channels are of an incorrect size (required during past repairs) and do not fit correctly to the adjacent panels. The distortions in the panels are such that fore and aft bowing precludes the side rubber from seating on the compression bar. To compound this problem the side skirts bend inboard and foul the compression bar and transverse sag causes problems at the cross joints and on the coaming back. The panels on the remaining hatches appear to be in a similar condition. A judgment as to the seaworthiness and cargo protection capabilities of these panels must be examined in conjunction with the ship's Classification Society to fully determine their exact state with an eye to the duration of further use, if any.

The crew is presently in the process of chipping, scaling, and painting the hatch covers. In this process, the top plating of the covers becomes holed in many cases, especially along the welding of the frame beams, where new beams were welded onto existing plating. Such wasted and holed areas are being temporarily repaired with epoxy cement.

The panels should be removed, grit blasted and inspected. Those that are salvable should be repaired; those that are not, should be renewed. The coamings should be grit blasted so that wasted and weakened areas can be identified and renewed.

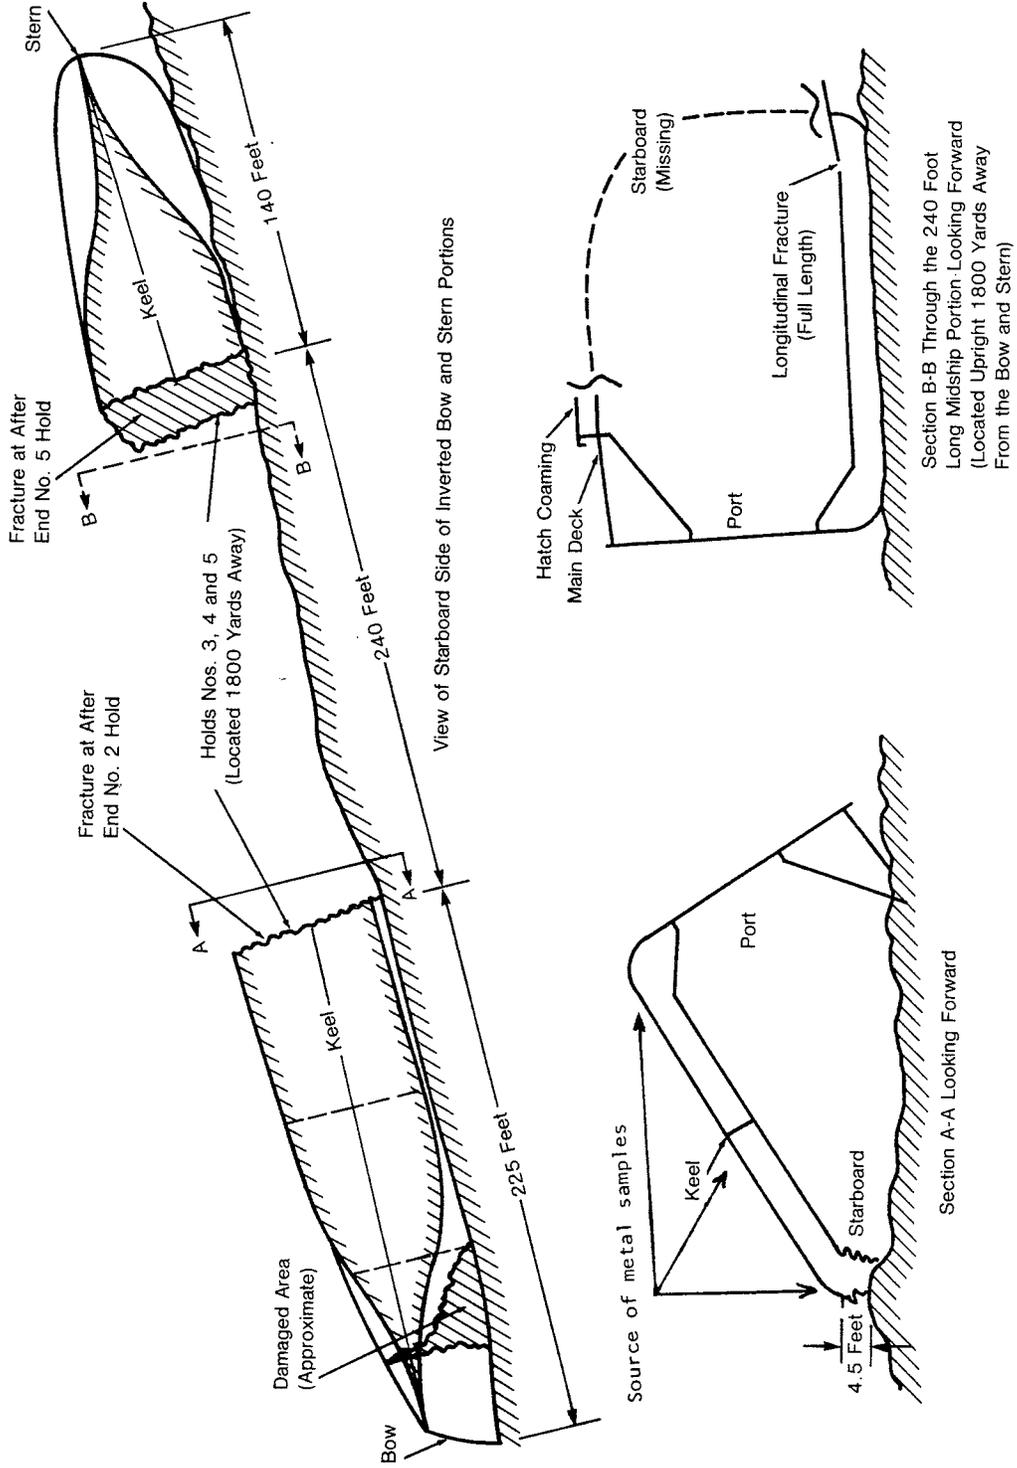
Figure 5.--MARINE ELECTRIC wreckage on ocean floor.

From February 21 to 24, 1983, divers contracted by MTL conducted an underwater diving survey of the wreck of the MARINE ELECTRIC. A qualified USCG diver was onboard the diving platform to observe the diving operations. Adverse weather conditions and limited visibility prevented the divers from conducting a complete survey of the wreck. However, divers found the wreck was in two pieces and that the forward section was inverted and listing 15° to its starboard side so that the port rail was 2 to 3 feet off the ocean bottom. A 12- to 14-foot depression was found in the sand under the forward section at the bow. A diver, who swam under the hull to the dry cargo hatch, reported that: the main deck hatch cover was not in place, two dogs were intact, two dogs had sheared off, and there was no trace of the hatch cover. The diver also located the puncture made in the No. 1 upper port wing tank on February 2, 1983, and determined by inserting a length of rod into the hole that the cement box was not in place. The port anchor was housed in the hawse pipe. The bulkwark plate on the bow was torn back about 8 feet.

About 38 feet aft of the bow, divers found a crack in the bottom of the hull at the forward end of the deep tanks. The open crack ran from the turn of the bilge on the port side, across the flat side of the bottom, and up into the starboard side. Across the 12-foot flat side of the bottom of the hull, the opening was about 1 foot wide with the shell plating bent inward for about 1 foot fore and aft of the opening. One diver said that the forward edge of the opening in the flat side of the bottom of the hull had broken in the heat-affected zone adjacent to a transverse weld (which was later corroborated by photographs) and that he could see bent stiffeners inside the opening. The opening continued through the turn of the bilge and ended about 2 feet up the port side. On the starboard side, the opening was about 2 feet wide with ragged edges and continued upward for about 6 feet before opening into a larger hole. The diver was unable to determine the dimensions of the large hole.

During phase 2, conducted between May 24 and May 29, a camera equipped remotely-operated, unmanned underwater vehicle was used to make a videotape of the wreck. Divers were also employed to take still photographs and to examine the wreck. The videotape showed that the starboard anchor was missing and that there was a large hole measuring about 40 feet long and 40 feet high on the starboard bow. The hole extended from just forward of the collision bulkhead into the forepeak tank and from the keel to the main deck. The videotape also showed: several sharp punctures in the starboard shell plating aft and above the level of the starboard hawsepipe; a crack in the stem at the 21-foot draft mark and below this level that the stem was bent about 10° to starboard; large cracks in the shell plating on the port side near the 21-foot draft mark; and some smaller fractures near the keel. The port anchor was in place with the devil's claw engaged. The starboard devil's claw was hanging down into the sand, and an unknown length of chain was found hanging down from the starboard riding chock. The shell plating at the No. 1 hold was intact and there were no signs of grounding damage on the bow section. A fairly clean fracture was found around the entire girth of the vessel near the after end of No. 2 hold; however, the starboard side plating could not be observed because only 4.5 feet of starboard side plating above the bilge keel was visible. (See figure 5.) A videotape was made of the entire fracture in the No. 2 hold. No shell plating remained between the aft end of the No. 2 cargo hold and the aft end of the No. 5 cargo hold; however, there was debris. Two sections were thought to still be attached by the starboard main deck plating buried in the sand since a metal detector indicated metal buried in the sand between the two sections. A jagged and irregular break was found at the after end of the No. 5 cargo hold. The break extended into both the aft pumproom and the No. 5 cargo hold with part of the aft No. 5 cargo hold bulkhead remaining. The stern shell plating was intact.

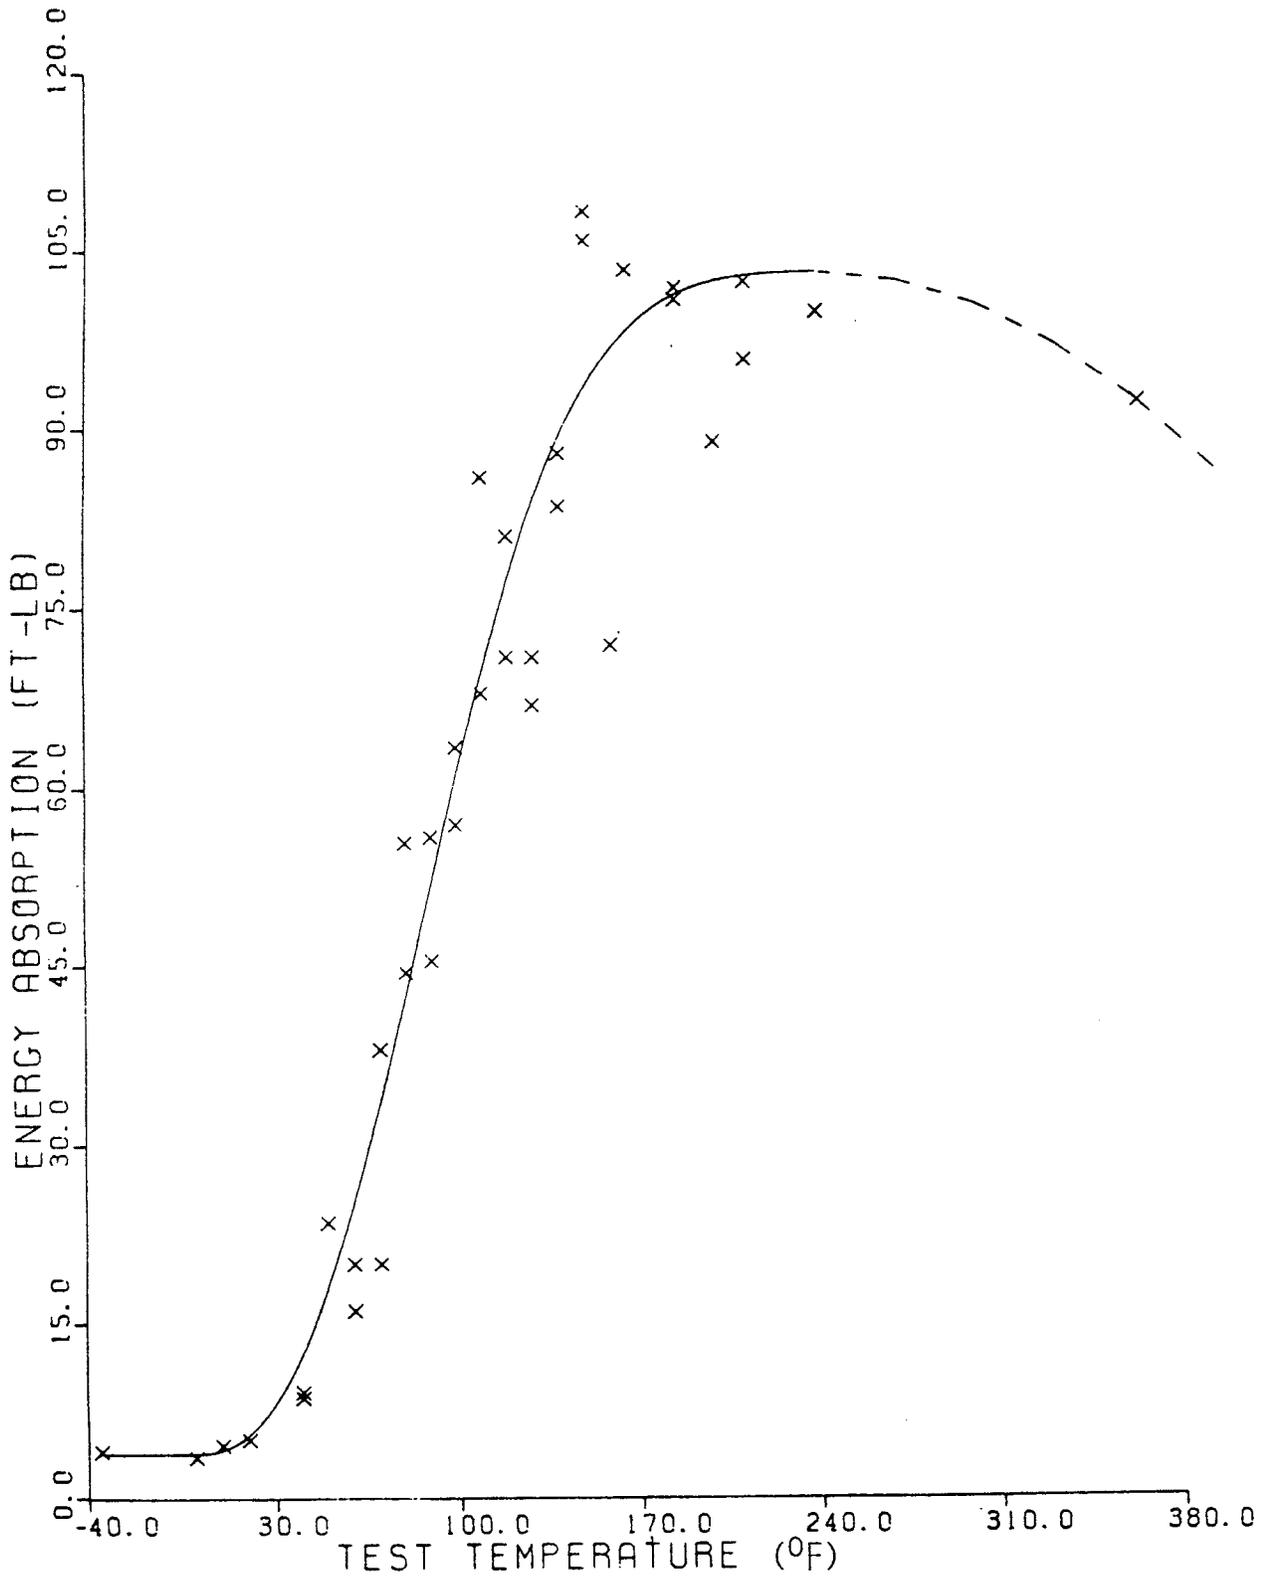
Figure 7.—Charp V-notch transition curve.

steel. The 1983 ABS rules require Charpy V-notch testing, with an average minimum energy absorption of 20 foot-pounds at 32° F. Charpy V-notch tests performed by the National Bureau of Standards revealed that the shell plating had an energy absorption of less than 10 foot-pounds at 32° F. This low value by itself does not necessarily indicate that the steel plate used in the construction of the cargo midbody in 1961 was unsafe. In fact, the deformation in the shell plating in the fractured area at the after end of No. 2 cargo hold indicates that brittle failure was not the cause of the separation of the area in question.

The fracture-toughness crack-tip opening displacement test conducted by EMTECH indicated that the critical crack size <sup>19/</sup> of the metal tested was 2.5 inches for dynamic loading and 40 inches for slow loading at a temperature of +40° F with a nominal stress level of 20,000 psi.
