**NATIONAL
TRANSPORTATION
SAFETY
BOARD**

MARINE ACCIDENT REPORT

**FIRE ABOARD
THE BAHAMIAN PASSENGER VESSEL
M/V SCANDINAVIAN SEA
CAPE CANAVERAL, FLORIDA
MARCH 9, 1984**

NTSB/MAR-85/03

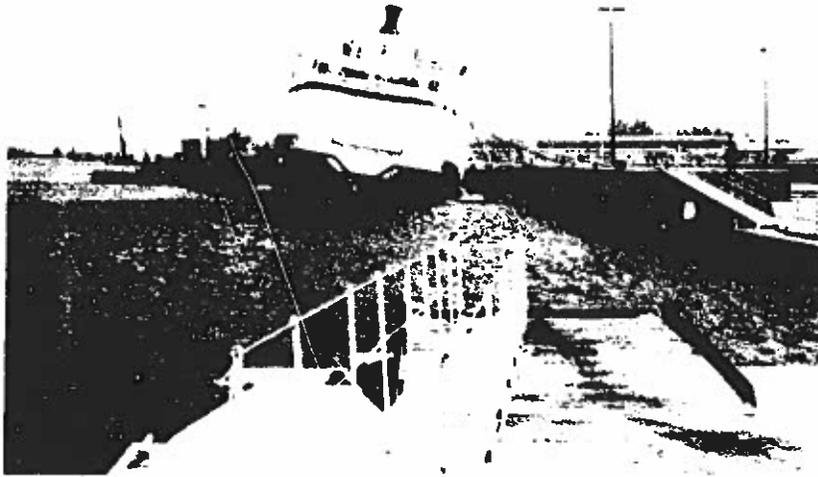
Figure 4.--SCANDINAVIAN SEA, listing to starboard.

March 11.--At 0102, the Gulf Strike Team arrived at the terminal and made preparations to enter the vessel to survey the situation and choose locations for pumping out the water. Additional pumps were placed in designated areas. By 1000, the list was reduced to about 6°, and a full scale assault was made on the fire which had progressed into the upper deck and lounge deck although still contained in the forward vertical fire zone. Firefighting personnel attacked the fire on their assigned decks with 2 1/2-inch hoses with 1 1/2-inch hoses as backup. The STEADFAST's damage control assistant closely monitored the amount of water introduced into the vessel and based on the pumping capacity of the portable pumps and the eductors, limited the amount used. As the list increased, selected hose teams were pulled back until the pumps reduced the list. It was later determined that the list had at one time reached a maximum of 10.8° to starboard.

The results indicated a small loss of righting arm 14/ at the maximum reported heel angle. More significantly, however, was the projected loss of righting arm of the vessel if the water had been applied to the fire for an additional hour at the reported rate of 5,000 gallons per minute with no dewatering. The calculations indicated that the ability of the vessel to right itself after an external heeling force has been applied would have been reduced over 50 percent from the condition of the vessel upon arrival at the terminal.

The study also determined that the longitudinal spread of entrapped water in circumstances similar to those found aboard the SCANDINAVIAN SEA can add to the loss of righting forces. This is especially true in the upper decks where there is little or no watertight subdivision to prevent water from spreading fore and aft along the low side of a vessel with a list. The study indicated that the vessel was in no danger of capsizing but pointed out that immersion of the portlights could have caused flooding if one or more of them had failed.

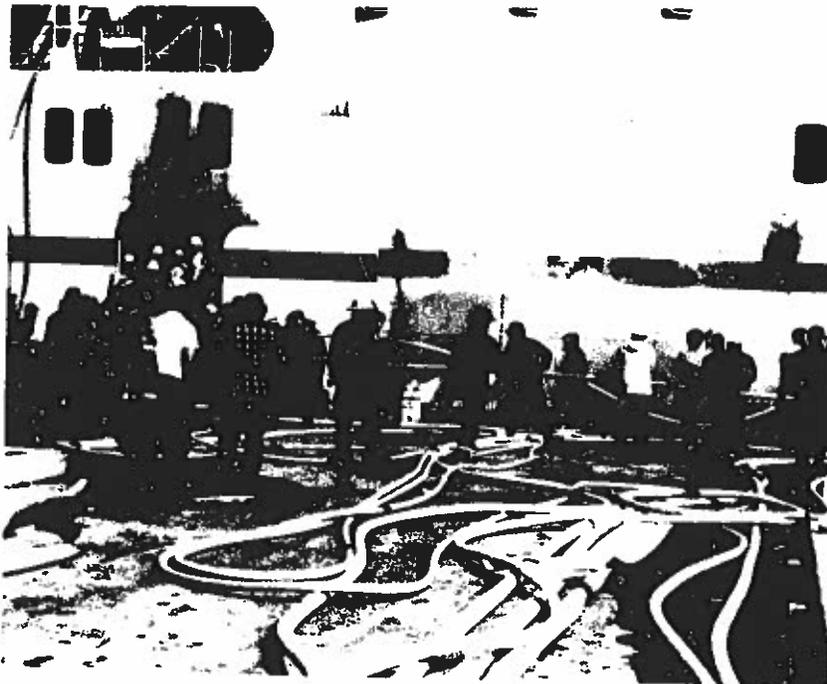
At 1155, because of the potential danger posed by the forward fuel oil tanks, a meeting was held with the local fire department personnel, the vessel's master, and USCG officials. The attendees at the meeting decided to close the watertight door on "A" deck in the forward end of the vessel and put a layer of water over the forward fuel oil tanks. The forward storerooms and the anchor chain locker also were flooded to increase the vessel's forward draft to 22 feet in order to place the top of forward fuel oil tanks below the outside surface of the water. The SCANDINAVIAN SEA then developed a starboard list which stabilized at about 3°. One of the vessel's engineers broke several toilet bowls close to the deck on the starboard side to allow the water on the deck to drain into the forward sewage tanks. Drainage into the sewage system limited the water accumulation. The sewage pump was secured, however, when flooding of the deck over the fuel oil tanks commenced and the vessel's list increased significantly. By 1415, the list had increased to about 8°, and the firefighting efforts were suspended. (See figure 4.) Eductors 6/ were brought in to pump out the areas where water had collected on the starboard side of some of the lower decks. After conferring with the ship's officers, the STEADFAST's damage control assistant, the DILIGENCE's engineering officer, and the COTP established limits for the amount of list that the SCANDINAVIAN SEA would be allowed to assume. If the list exceeded 8°, the firefighting hose streams would be reduced by half; if the list exceeded 10 1/2°, then all persons would be evacuated from the vessel; when the list returned to 6°, full firefighting efforts would be resumed. Firefighting personnel moved firetrucks and other associated equipment away from the berthed vessel. (See figure 5.)

Figure 5.--Hoses from pumper trucks stretched on the pier.

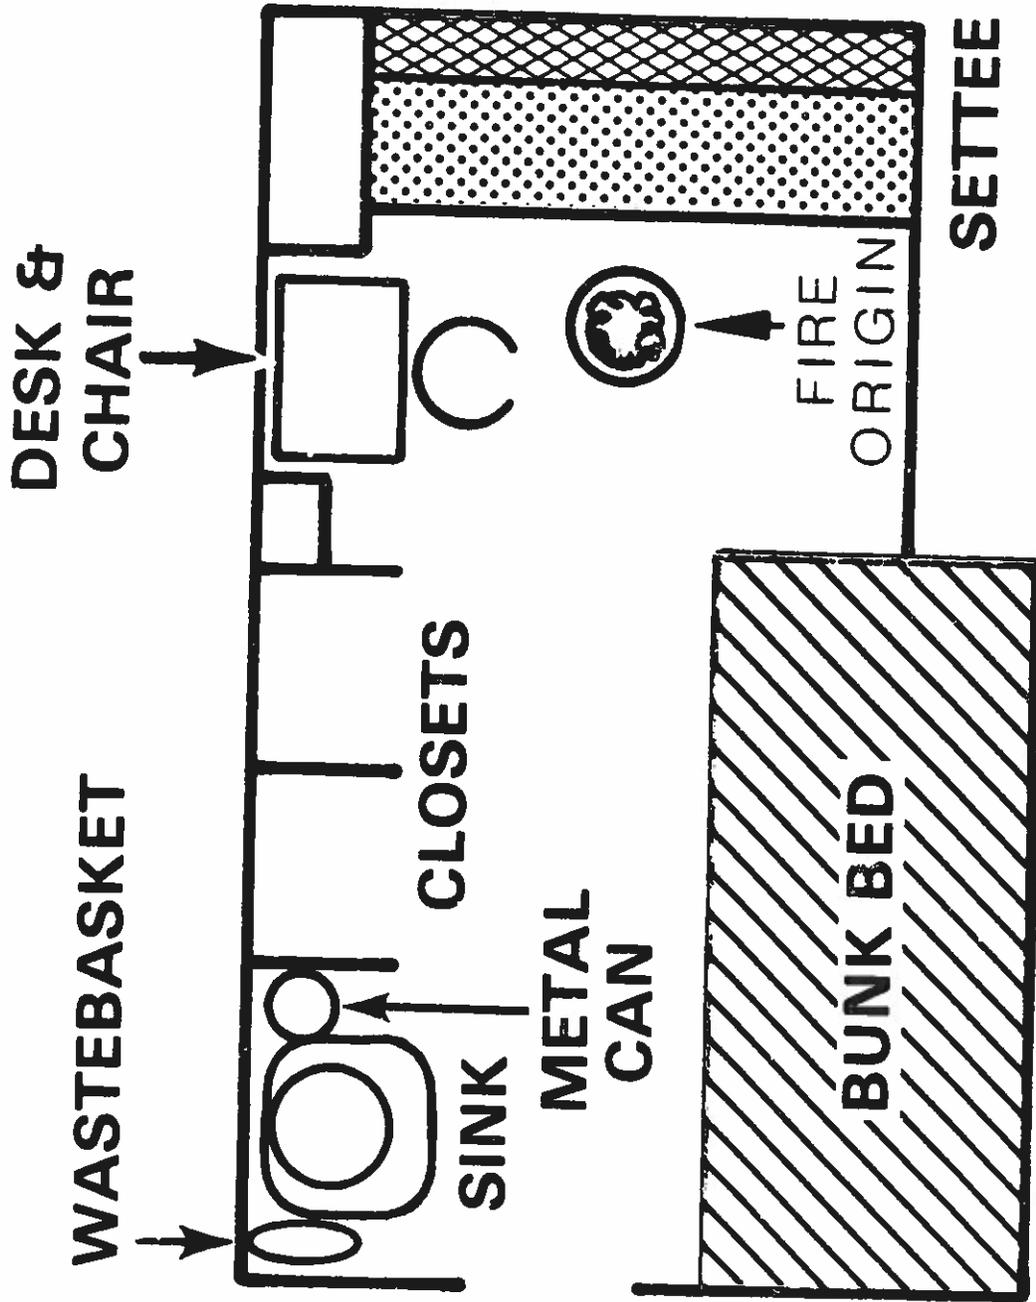
Figure 6.--Diagram of room 414.

The SCANDINAVIAN SEA was severely damaged by fire, smoke, and water as well as by overhauling activity once the flames were extinguished. The forward main vertical zone was most affected by the fire. In room 414, fire investigators found a 3-foot-diameter circular burned pattern near the settee (see figure 6) which had burned through the carpet to the vinyl asbestos floor tile beneath it. The "A" deck accommodations forward of frame 165, including the bulkhead and overhead panels, piping, ventilation ducts, and electrical wiring, were severely damaged. (See figures 7 and 8.) Of the 13 rooms on the "A" deck area forward of frame 165, 10 rooms including lockers, restrooms, and showers where doors had been left open were gutted. The doors in the other three rooms were closed and the rooms only showed evidence of smoke and some heat damage. The insulation on the electric wire cables in the overhead spaces above the passageway was completely burned.

- o It is difficult to burn carpeting completely through without some other fire fueling product. It is most uncommon for carpeting to burn in a circular pattern (in this case, about 3 feet in diameter) in the absence of a flammable liquid;

- o The burn pattern in the corner above the wastebasket indicates the fire burned upward from within the wastebasket;
- o The construction of the vessel was mainly asbestos and steel, materials that resist fire spread. The combustibles were mainly cabin furnishings, clothing and personal effects, the formica like covering over the asbestos wall panels, and the carpeting. The carpet in room 414, similar to the carpet used throughout the vessel, was a fire resistant type that would not burn without the aid of an accelerant or other fuel; and

The 3-foot-diameter burn pattern found in the carpeting indicates that a fire was set or fed with an accelerant. The heat of a fire rises so that the radiative flux to the surface, as in this case to the carpet, is low and generally insufficient to ignite and burn a product, such as carpeting without some other heat sources. This would be

particularly true of carpeting over a heat conductive, non-combustible floor material, such as steel. In this instance, the carpeting was laid over vinyl tile which was laid over steel deck material, so that heat would have carried away rapidly. While carpeting can be burned and frequently is in home fires where the floor is wooden or in fires of intense heat with high fuel loading and sufficient oxygen, these factors were not present. Carpeting also will burn if thermoplastics melt and drip or run onto the floor covering. In this particular fire, it was possible the circular pattern found in front and under the settee could have been caused by the melting of the cushions (polyurethane) of the settee. To determine the probability of such an occurrence, the Safety Board examined settees in other rooms to determine the construction materials used in the settee. It was determined that the settee was constructed of a wood frame, a foam rubber (probably butadiene) seat, and a polyurethane back. Polyurethane was the only material in the construction that had the potential to melt and pool. However, it could not have pooled and created the circular pattern found in the investigation. The burn pattern was too far forward in the room. Since the back cushion of the settee was polyurethane, any polyurethane that had melted would have dripped on the carpet along the back wall of the room resulting in a linear burn pattern and not the circular pattern found some distance from the wall.

The burn pattern in the corner under the sink of room 414 indicated that combustible material in the wastebasket burned upward, i.e., there is a typical "V" pattern. The fact that the towel which had an odor of alcohol was not completely consumed, suggests that ashes and debris from the walls or ceiling of the room fell into the wastebasket and limited the availability of oxygen to continue the combustion process.

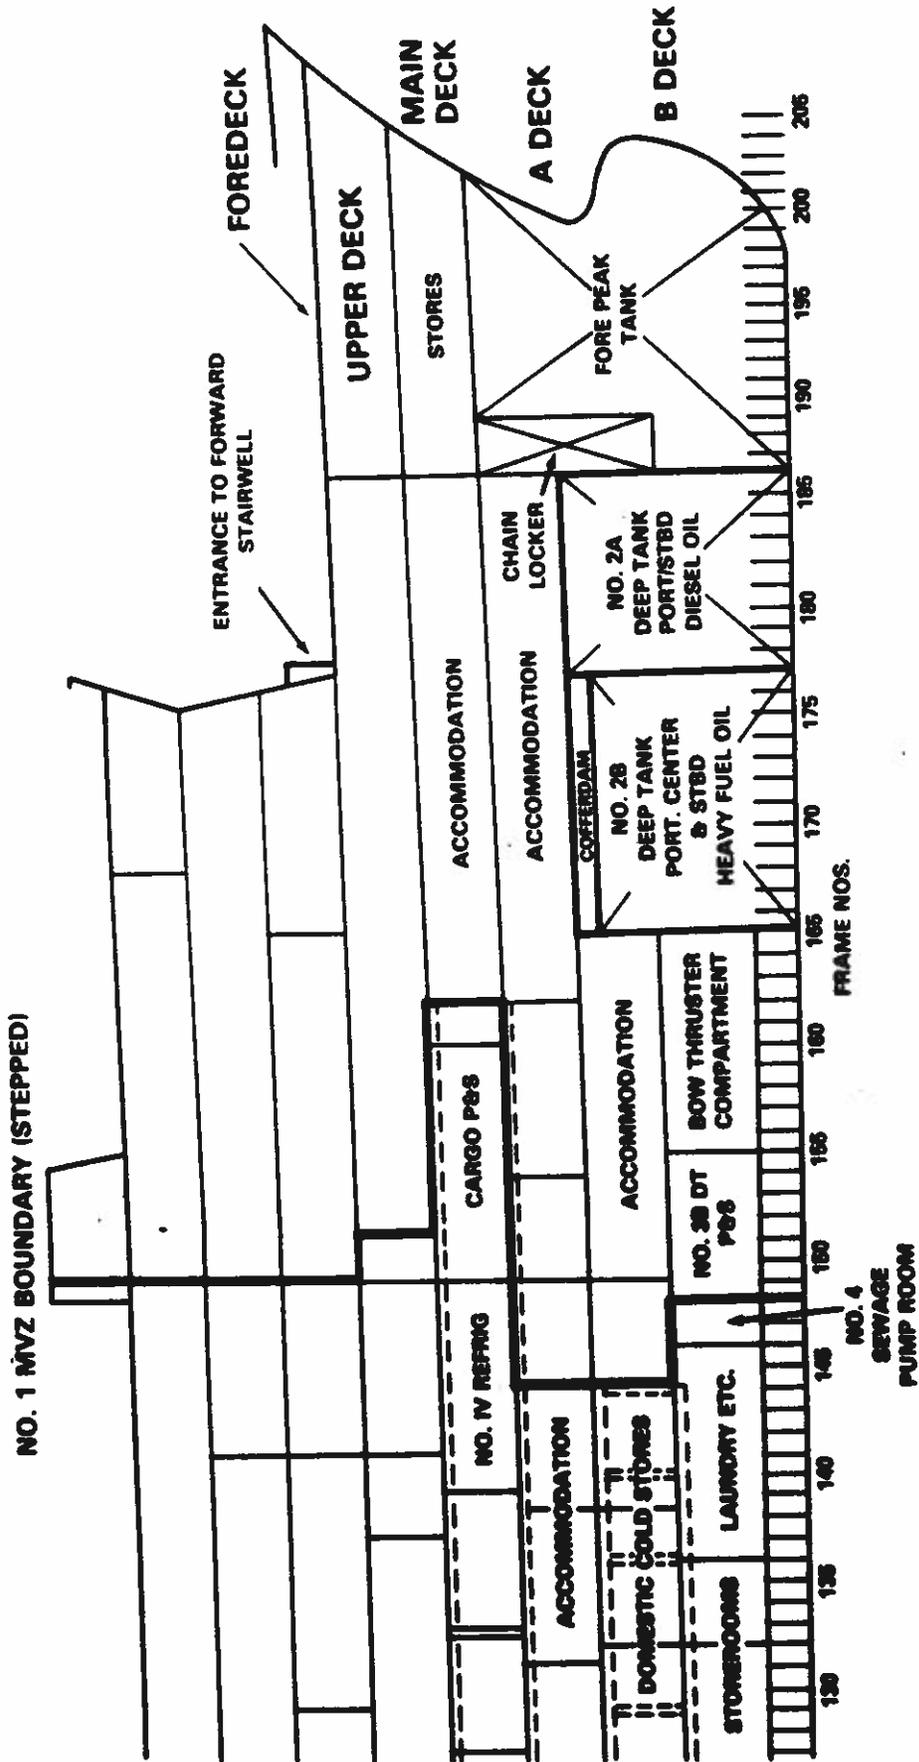
The bulkheads at the aft end of the forward vertical fire zone were the primary fire boundaries. The fire doors in the boundary that were closed fully contained the fire and prevented the spread of flames to other parts of the vessel. In one instance, a temperature of 1250° F was measured on the after surface of the fire door in the stair column on the main deck at frame 153.

Figure 11.--Location of forward fuel oil tanks and forward main vertical zone boundary.

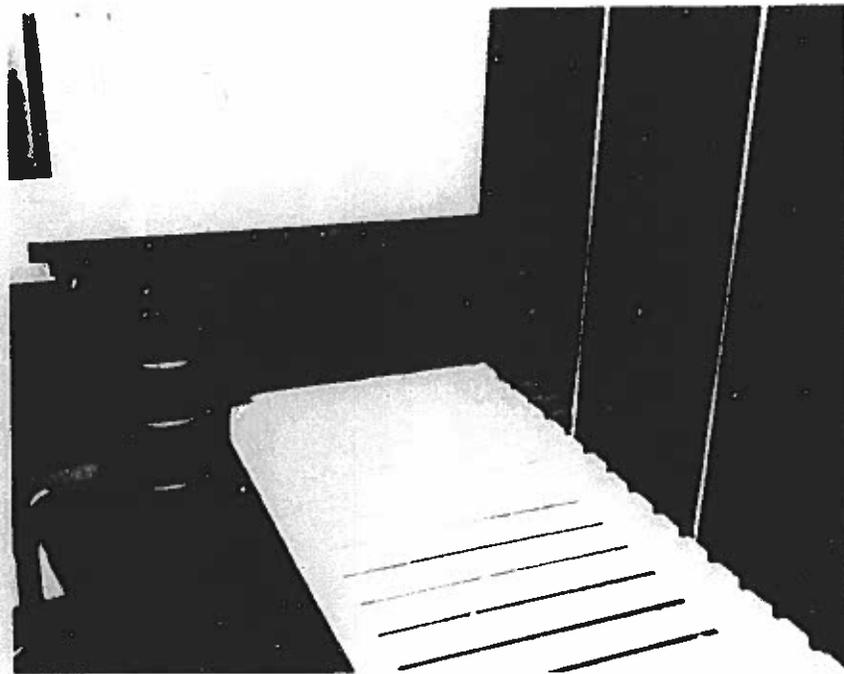
Figure 12.--Typical bed with wood mattress support.
