MARINE ACCIDENT REPORT

**FIRE ABOARD THE
BAHAMIAN PASSENGER SHIP
M/V SCANDINAVIAN SUN
PORT OF MIAMI
MIAMI, FLORIDA
AUGUST 20, 1984**

NTSB/MAR-85/08

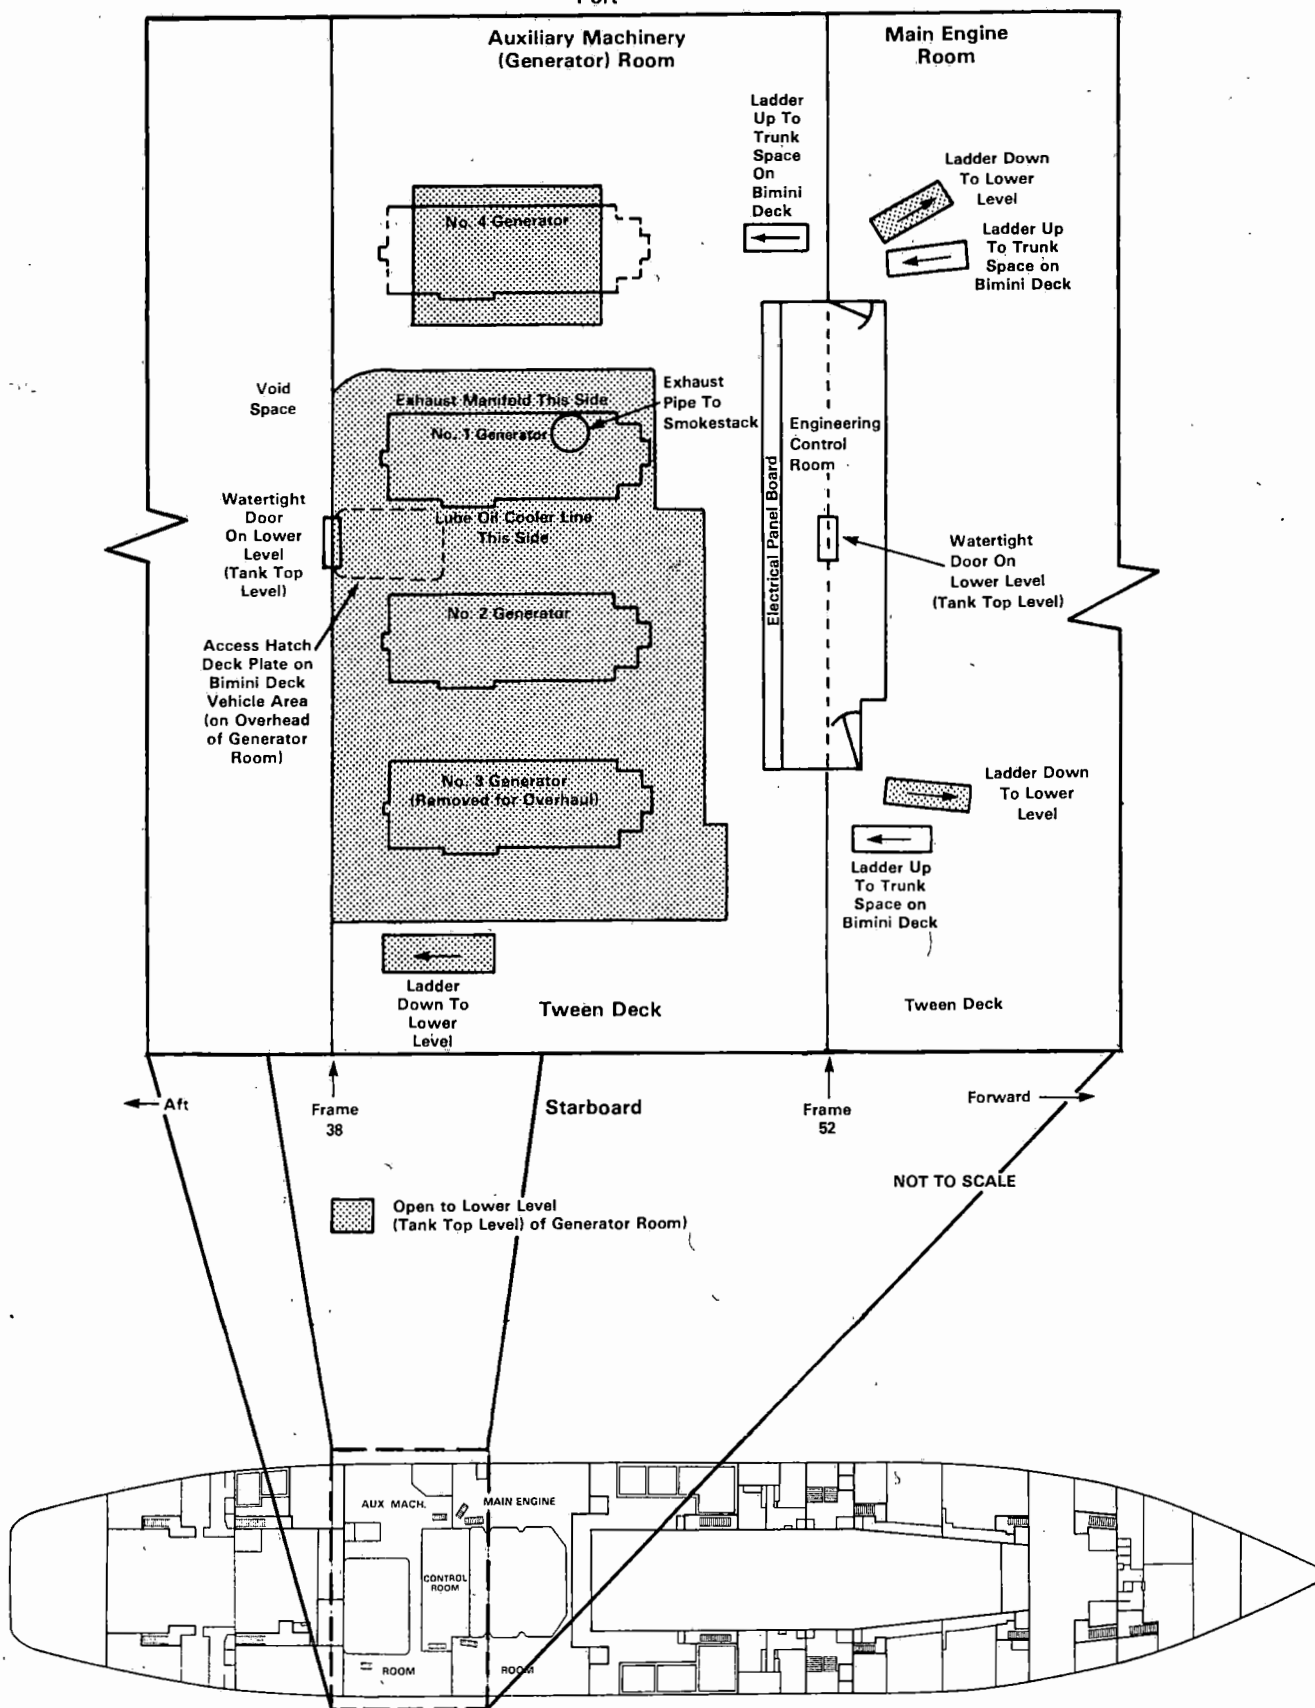
Figure 2.--Plan view of generator room.

The fire damage in the generator room was minor. The vestibule, aft of the port trunk space, and the crew passageway aft of the vestibule sustained extensive damage. Fire damage in the stair tower on the Bimini and Andros Deck levels was extensive. On the Nassau Deck, the after portion of the stairtower was burned severely and the damage in the forward portion was limited mainly to smoke and heat damage. Burning carpeting

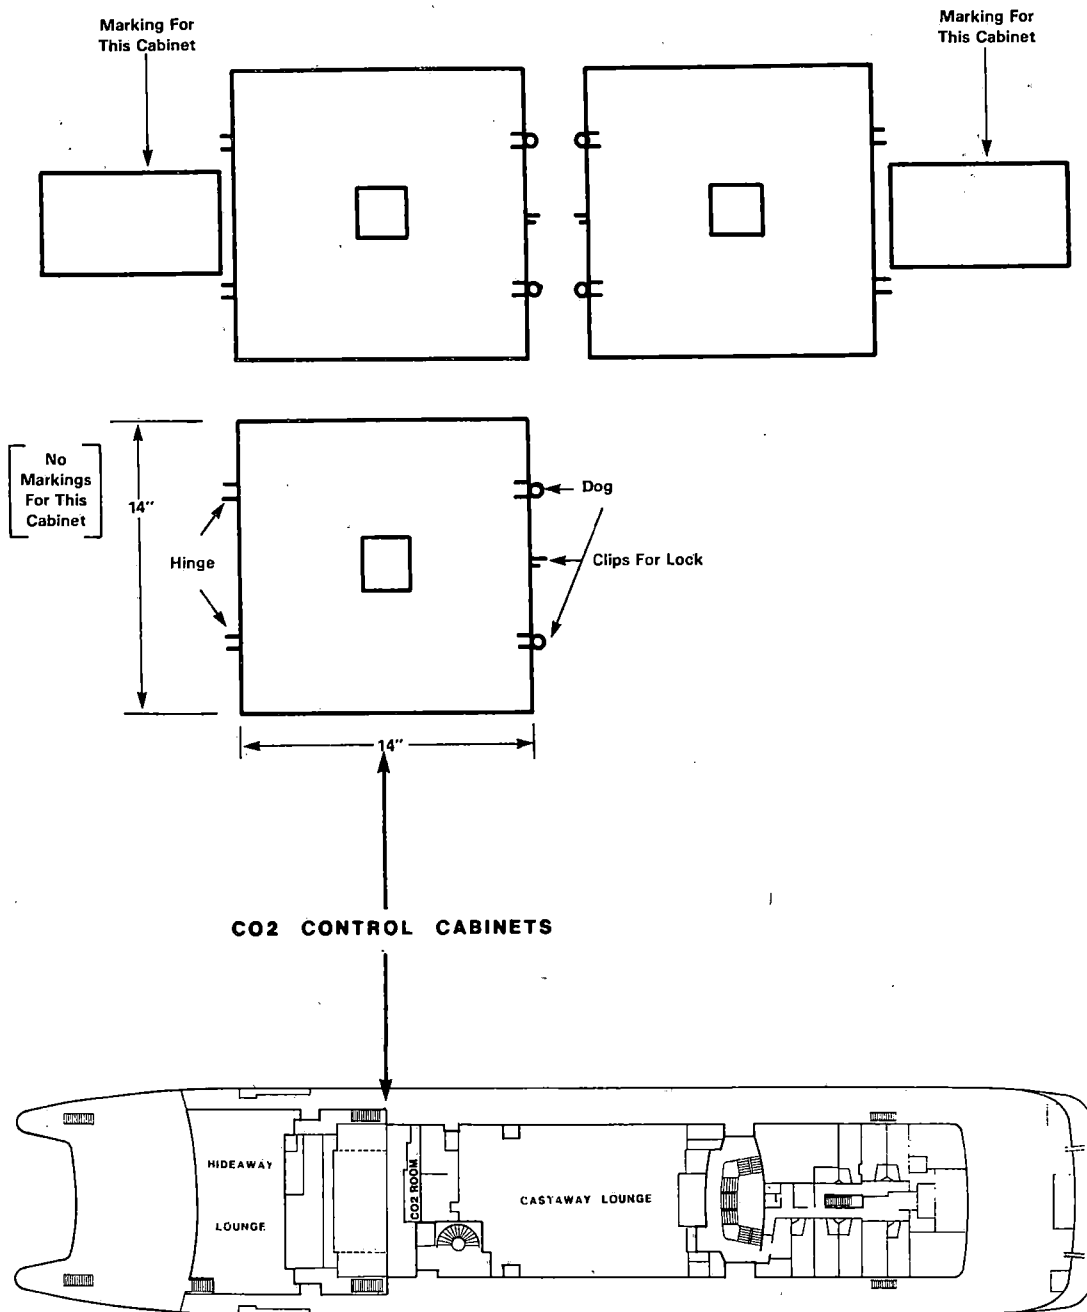
Figure 6.--Carbon dioxide cabinets.

The only control cabinets for CO₂ release for the main engine room/generator room, the stabilizer room, and the separator room are on the port side of the Exuma Deck on the outside bulkhead on the stair tower. Unlocking and opening the CO₂ cabinet door automatically caused the ventilation to shut down and an alarm to be sounded in the space served by the CO₂ system. On the night of the accident, only two of the three cabinets were labeled: the upper left cabinet was marked "separator room" and the upper right cabinet was marked "engineroom." The lower left cabinet was unmarked. SOLAS regulations require that CO₂ controls be labeled clearly. The cabinet marked "engineroom" contained a single CO₂ control for both the engine room and the generator room. The lower left cabinet contained the CO₂ control for the starboard stabilizer room. This control was activated by the chief engineer after discussion with the engineers assembled at the cabinets as to which control provided CO₂ to the generator room. It was not learned until 5 days after the fire that four cylinders of CO₂ were released into the stabilizer room instead of the generator room. Therefore, the fixed CO₂ system contributed nothing to extinguishing the generator room fire. After the fire, the cabinets were properly labeled.

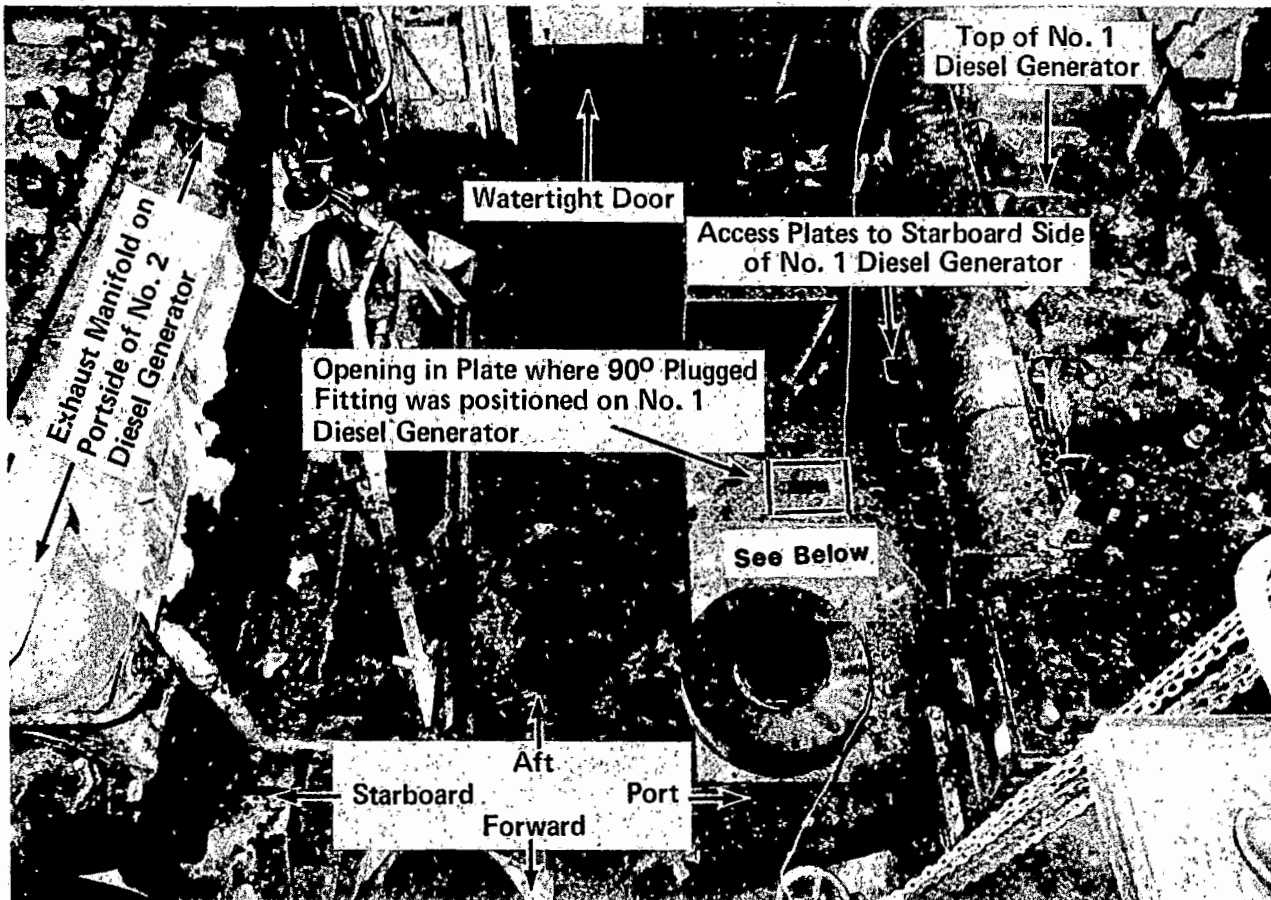
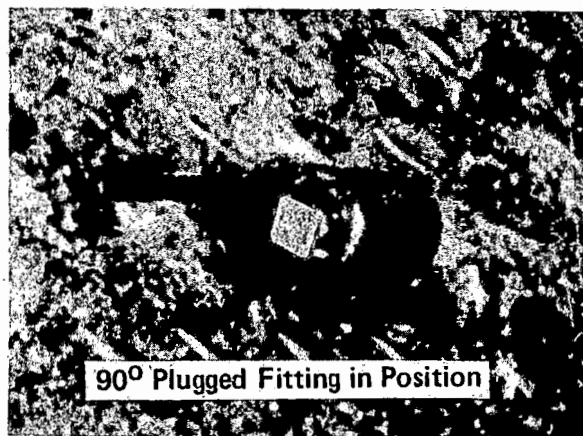
Figure 7.-- No. 1 diesel engine generator (looking down and aft from the tween deck level).

Overhaul of the No. 1 Diesel Generator.--At 0001 on August 19, 1984, while the vessel was moored at the Port of Miami, the engineers on watch started to overhaul the No. 4 cylinder of the No. 1 diesel generator. The repair required removal of the cylinder head and an access plate located on the starboard side of the engine. A platform on the forward starboard side of the engine in the area of the five forward cylinders (the engine has 8 cylinders) provided a flat surface 2 1/2 feet wide by 4 1/2 feet long and 2 feet above the deck to gain access to the top of the engine. The platform was positioned over a 3-inch lubricating oil line and the lubricating oil cooler. A threaded 1/2-inch pipe fitting in the lubricating oil line which was plugged protruded about 1 to 2 inches through a 2-by 6-inch rectangular opening near the center of this platform, by the No. 4 cylinder access plate. (See figure 7.) During an interview with the second engineer, he stated that the pipe fitting was not removed. The repair of the No. 4 cylinder was completed by 1230, August 19, 1984, and the diesel generator was placed in operation at 1630 and was run continuously until the accident. A postaccident examination of the No. 1 diesel generator revealed that the pipe fitting was not in place in the generator's lubricating oil line; it was found on the engine access platform.

The pipe fitting protruding above the surface of the access platform on the starboard side of the No. 1 diesel generator hampered the engineering personnel working on the starboard side of the engine. Even though the second engineer stated that the pipe fitting was not removed while repairs were being made to the cylinder, it seems quite likely that the fitting was removed to facilitate access to the cylinder while it was being overhauled and that the fitting probably was only hand tightened when it was replaced. The fitting probably vibrated loose while the generator was operating from 1630, August 19 until it rotated free of the threaded opening about 30 hours later at 2300 on August 20. After the accident, the fitting was replaced with a plug and wired to prevent it from rotating loose.

When the fitting rotated loose, lubricating oil which was under about 70 pounds pressure, sprayed vertically above the engine and probably atomized as it discharged under pressure. Droplets of oil probably fell back down on to the hot engine manifold. Atomized oil also was carried by the strong supply air ventilation draft toward the overhead escape trunk which led to the trunk space at the bottom of the port smokestack casing on the Bimini Deck. The most probable source of ignition of the lubricating oil was the hot exhaust manifold on the No. 1 diesel engine. While the manifold generally was well insulated, there were some exposed hot metal surfaces where minimum temperature exceeded the autoignition temperature of the lubrication oil.

The engine lost about 37 gallons of lubricating oil in the approximate 1 minute it took the engineer on watch to shut down the No. 1 diesel generator to stop the spraying oil. After the oil was ignited by the manifold, the flame spread along the path of the atomized oil and ignited other combustibles. The strong supply ventilation entering the generator room provided the ready supply of oxygen needed to produce intense burning of the lubricating oil and a medium for the rapid movement of the heat and flames out of the compartment. Although the fire in the generator room was hot, it did not burn very long especially at the generator level on the lower level of the generator room. The fire in this space was concentrated on the forward bulkhead around the electrical cabinets on the tween deck. The lubricating oil was the initial combustible, and the melamine veneer on the bulkheads in the stair tower and vestibule appears to be the major fuel contributing to the spread of the fire.

1. A plugged pipe fitting in the lubricating oil line from the No. 1 diesel generator which had not been tightened adequately vibrated loose, allowed oil to spray onto the engine's hot exhaust manifold and then ignite.
