MARINE ACCIDENT REPORT

ENGINE ROOM FLOODING OF THE
U.S. TANKSHIP PRINCE WILLIAM SOUND
NEAR PUERTO VALLARTA, MEXICO
MAY 9, 1986

NTSB/MAR-87/07

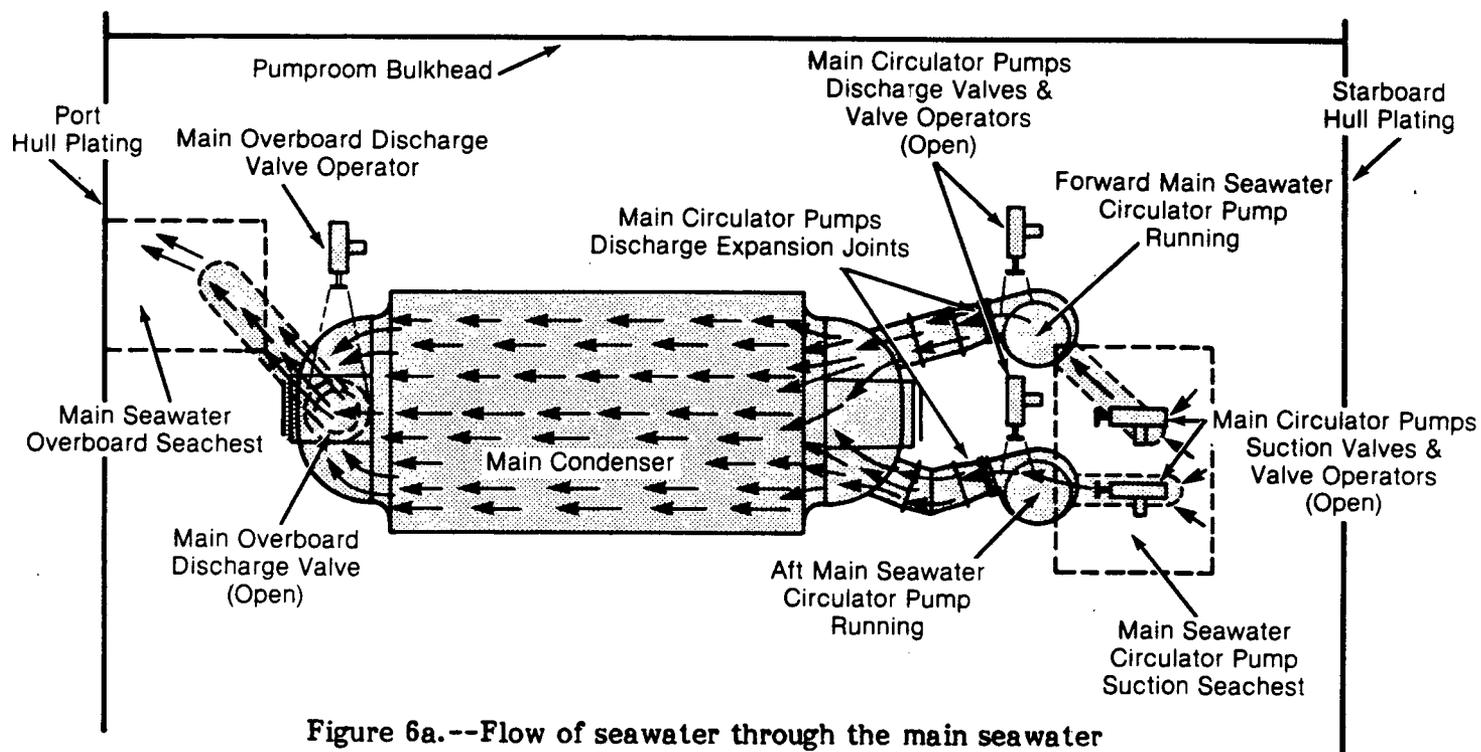
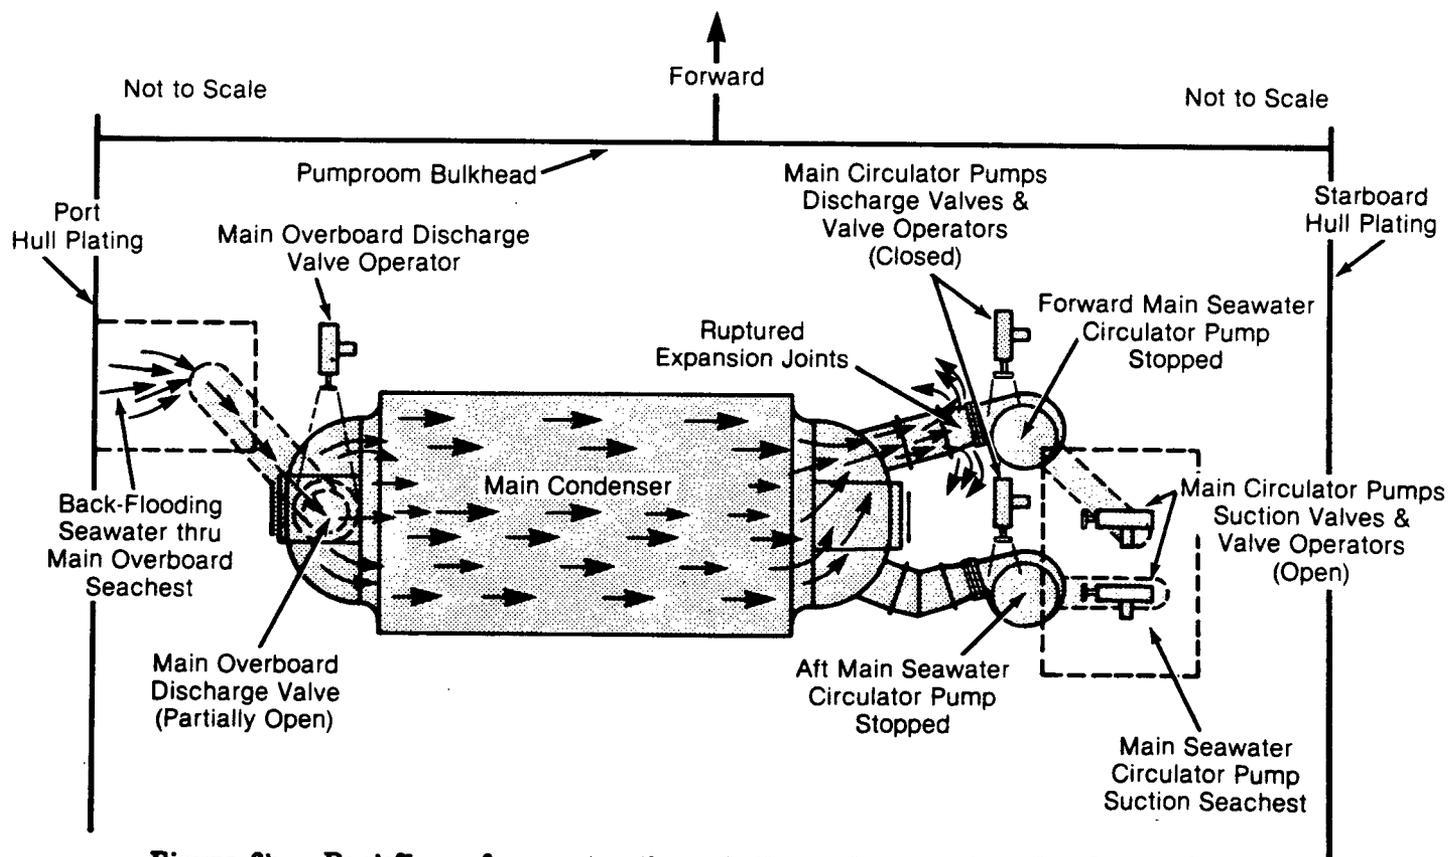
Figure 6.--Plan view of the main seawater circulating system.

Figure 6a.--Flow of seawater through the main seawater circulator system before the accident.

Figure 6b.--Backflow of seawater through the main seawater circulator after the main circulator pumps discharge valves were closed and the main seawater overboard discharge valve was partially open.
