NATIONAL TRANSPORTATION SAFETY BOARD

MARINE ACCIDENT REPORT

**FIRE ON BOARD THE BAHAMIAN PASSENGER SHIP
THE SCANDINAVIAN STAR
IN THE GULF OF MEXICO
MARCH 15, 1988**

NTSB/MAR-89/04

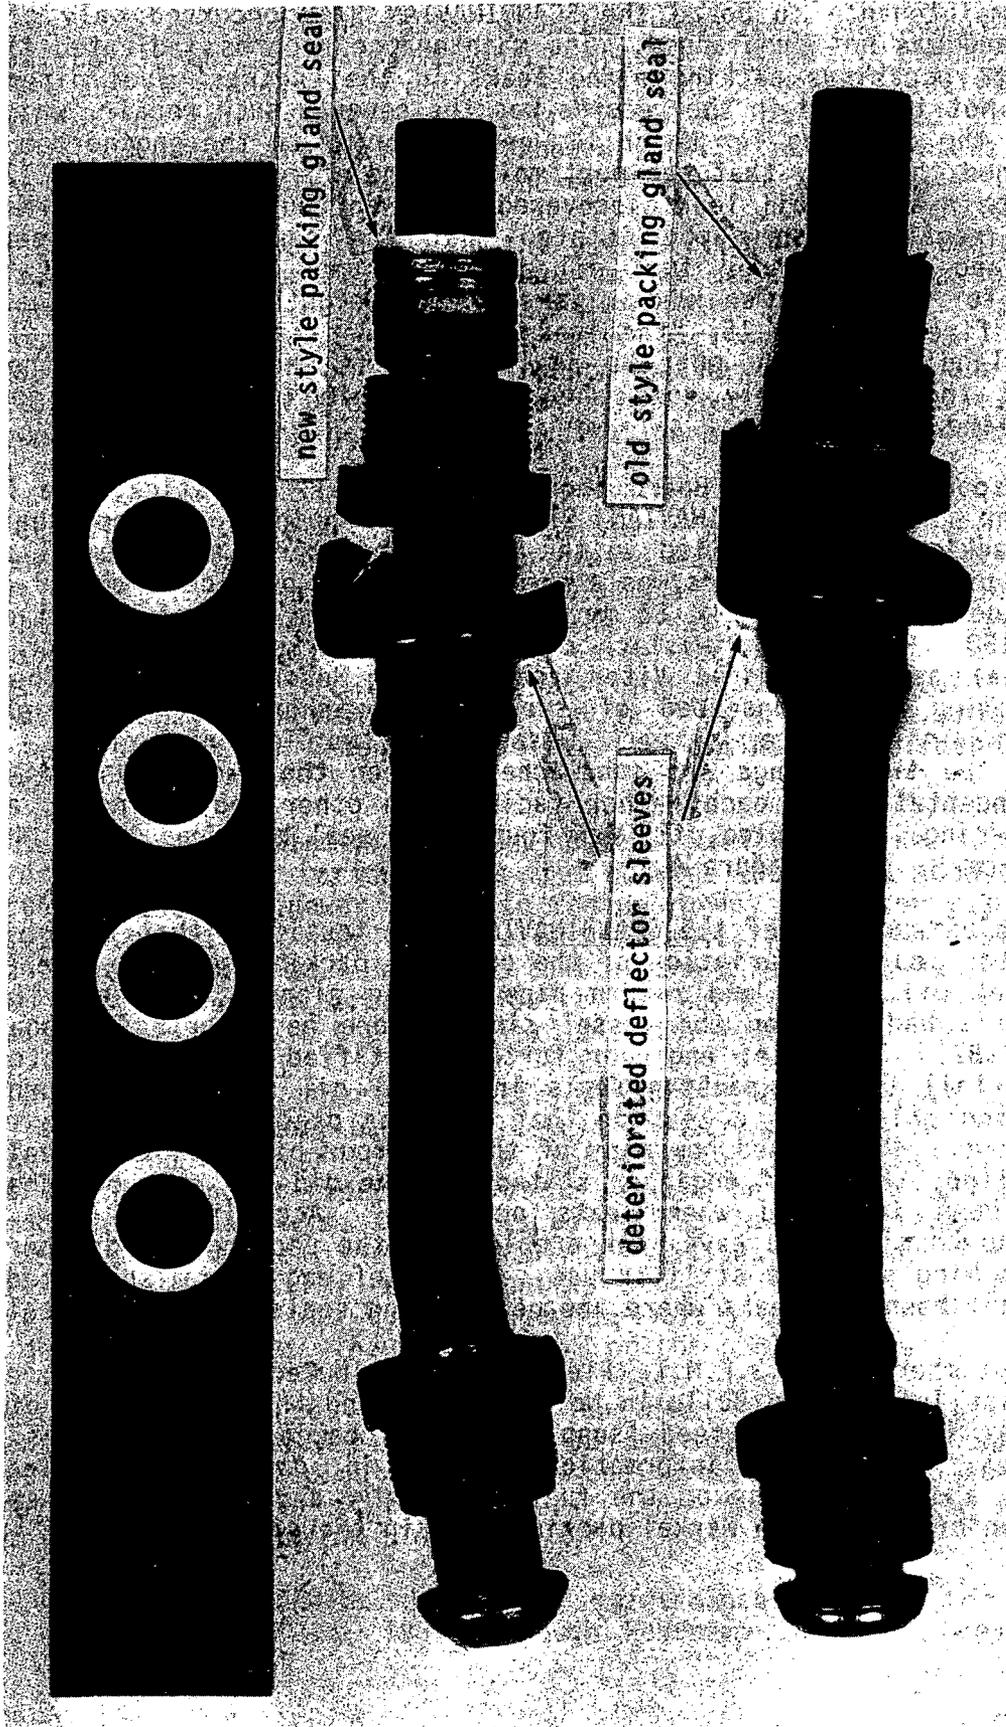
Figure 4.--Packing gland seals and deflector sleeves on engine injector pump fuel oil supply and return pipes.

The chief engineer of the SCANDINAVIAN STAR testified that the ship had purchased the improved variation of the original packing seal for the engine mounted fuel oil supply and return pipe packing glands. He said the new packing seals had been on the vessel since before he reported on board in March of 1987. The chief engineer further testified that he directed the crew to install the new packing seals in a fuel oil supply or return pipe packing gland only after a leak in that pipe was discovered and the engine was shut down. When asked how many of the new four piece packing seals had been installed, the chief engineer stated that he did not know but that new ones had been installed when leaks occurred. According to the chief engineer, he continued to have leak problems on the packing glands where the original packing seal was still in use. The chief engineer also stated that there had not been any leaks where the new packing seals had been installed.

In September 1975, S.E.M.T. Pielstick distributed to Pielstick engine users Service Information Bulletin No. 29 concerning the overhauling of fuel oil cylinder injector pump feed [supply] and discharge [return] pipes. The eight pages of service information cover, in detail, the cleaning, inspection, and maintenance of the fuel oil supply and return pipes and the installation of the Martin Merckel packing seal in the packing glands.

S.E.M.T. Pielstick also stated that the deflector sleeve installed over the fuel oil pipelines packing gland nut will prevent pressurized fuel oil, leaking through the packing seal in the gland, from spraying onto hot engine parts. The remains of a deflector sleeve was found on the fuel oil supply pipeline to the No. 7 cylinder injector pump. About 25 deflector sleeves, on both the port and starboard main engines, were missing entirely or only a small portion of the sleeve remained. Postaccident inspection of the sleeves indicated that the sleeves had deteriorated from age and not as a result of damage from the fire. (See figure 4.) A fuel oil deflector sleeve should be installed on each of the fuel oil supply and return pipeline packing glands, for a total of 64 sleeves. Prior to the accident, Pielstick had no record of any order for this part from SCANDINAVIAN STAR or SeaEscape. The staff and chief engineer testified that they did not know the purpose of the deflector sleeves.

Packing Gland--The starboard main diesel engine fuel oil supply pipe to the No. 7 cylinder was removed from the vessel and sent to the Safety Board's laboratory in Washington. The packing found in the fuel oil supply pipe packing gland was one piece, made of a rubber-like material and measured, 25 mm OD, 18 mm ID, and 12 mm H.

The fire aboard the SCANDINAVIAN STAR started about 2325 on March 15, 1988, when fuel oil leaking from the packing gland of the fuel oil supply pipe to the No. 7 cylinder fuel oil injector pump on the inboard side of the starboard main engine developed into a large spray that contacted the hot exhaust manifold of the starboard main engine and ignited. The engineering watch crewmen could have taken a number of immediate actions after the fire had started that would have controlled or contained the fire and, consequently, lessened the severity of the accident.

Leaks, similar to the one which occurred at the packing gland in the fuel oil supply pipe to the No. 7 cylinder fuel oil injector pump, had occurred before on the SCANDINAVIAN STAR. According to the engineroom log book, engine maintenance records, and testimony of the watch motorman, fuel oil leaks at the packing glands were a recurrent problem and the leaks were at times severe enough to require stopping the engine to make repairs at sea. In fact, on March 14, 1988, one day before the accident, while the vessel was en route from Tampa/St. Petersburg to Cozumel, the port engine was stopped to repair a packing gland fuel oil leak to the No. 6 cylinder on the port engine.

The investigation revealed further that in 1975 the engine manufacturer had designed a new packing seal for the packing glands in the fuel oil supply and return pipes and that the ship had recently purchased a number of the new packing seals. According to the chief engineer, who testified that there was no planned maintenance program on board the SCANDINAVIAN STAR, he would install the new seals only after a fuel oil leak was discovered. He made no attempt to replace or schedule the replacement of all the old packing seals even though he knew that leaks continued to occur at those locations where the old seals were still in place and that he experienced no new leaks at those locations where the new seals had been installed.

The post-fire survey of the engineroom revealed the remnants of a deflector sleeve on the packing gland of the fuel oil supply pipe to the No. 7 cylinder injector pump. The survey revealed further that of the 64 deflector sleeves that should have been installed on both main engines about 40 percent were either missing entirely or only had small portions remaining. Furthermore, examination of these sleeves revealed that they had deteriorated from age and not as a result of fire damage. Although the designed purpose of the deflector sleeve is to divert a fuel leak in the packing gland away from hot engine ignition sources, the staff and chief engineer testified that they did not know the purpose of the deflector sleeve. The Safety Board concludes that engineering department personnel were not sufficiently knowledgeable of the engineroom machinery and its function to carry out their responsibility to maintain the vessel in a safe condition. Had the engineering staff known the purpose of the deflector sleeves and taken action to replace those missing or deteriorated, the accident may not have occurred.

The foregoing indicates that the SCANDINAVIAN STAR lacked any type of preplanned maintenance program since the obvious and prudent course of action would have been to replace all of the old packing seals with the new style which were in stock aboard the ship. The Safety Board believes that had all the old packing seals been replaced, as would be accomplished in a preventive maintenance program, the fuel oil leak at the packing gland may not have occurred.
