PB92-916401
NTSB/MAR-92/01

MARINE ACCIDENT REPORT

GROUNDING OF THE
U.S. TANK SHIP STAR CONNECTICUT
PACIFIC OCEAN, NEAR BARBERS POINT, HAWAII
NOVEMBER 6, 1990

ADOPTED: JANUARY 7, 1992

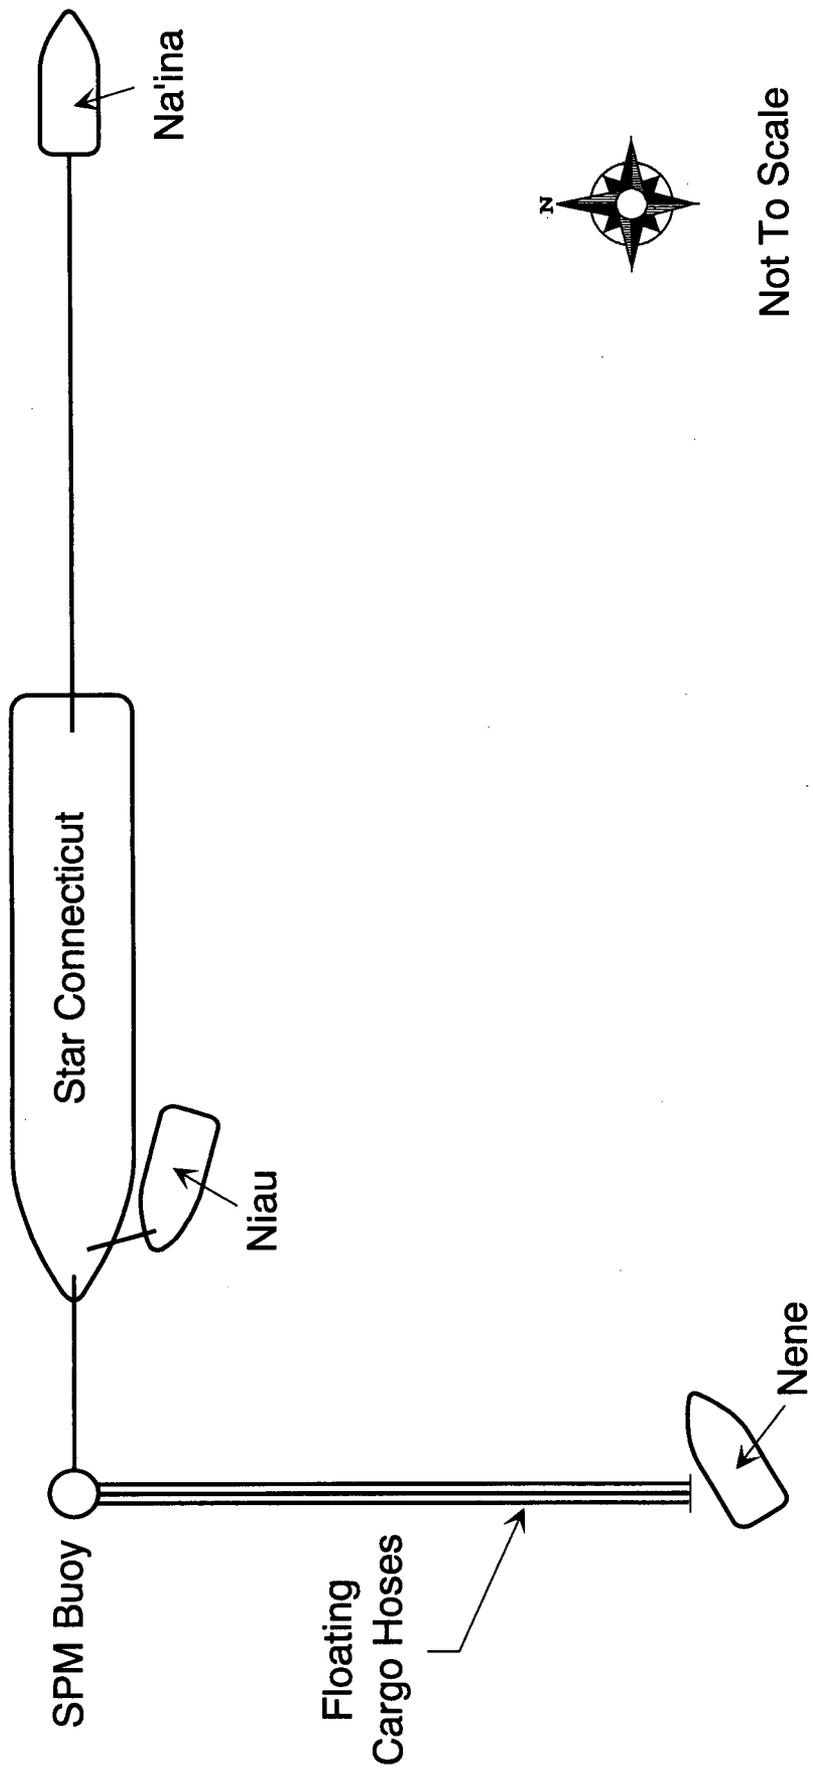
Figure 3.--Arrangement of vessels prior to unmooring.

At 1757, the junior third mate completed routine tests of the ship's navigation, communication, and control equipment. He found all equipment to be in good operating condition. Between 1849 and 1853, he tested the main engine satisfactorily in the astern direction. About 1856, the tug NIAU arrived alongside the STAR CONNECTICUT and within a few minutes, was made fast by one mooring line to the tanker's port bow. (See figure 3.)

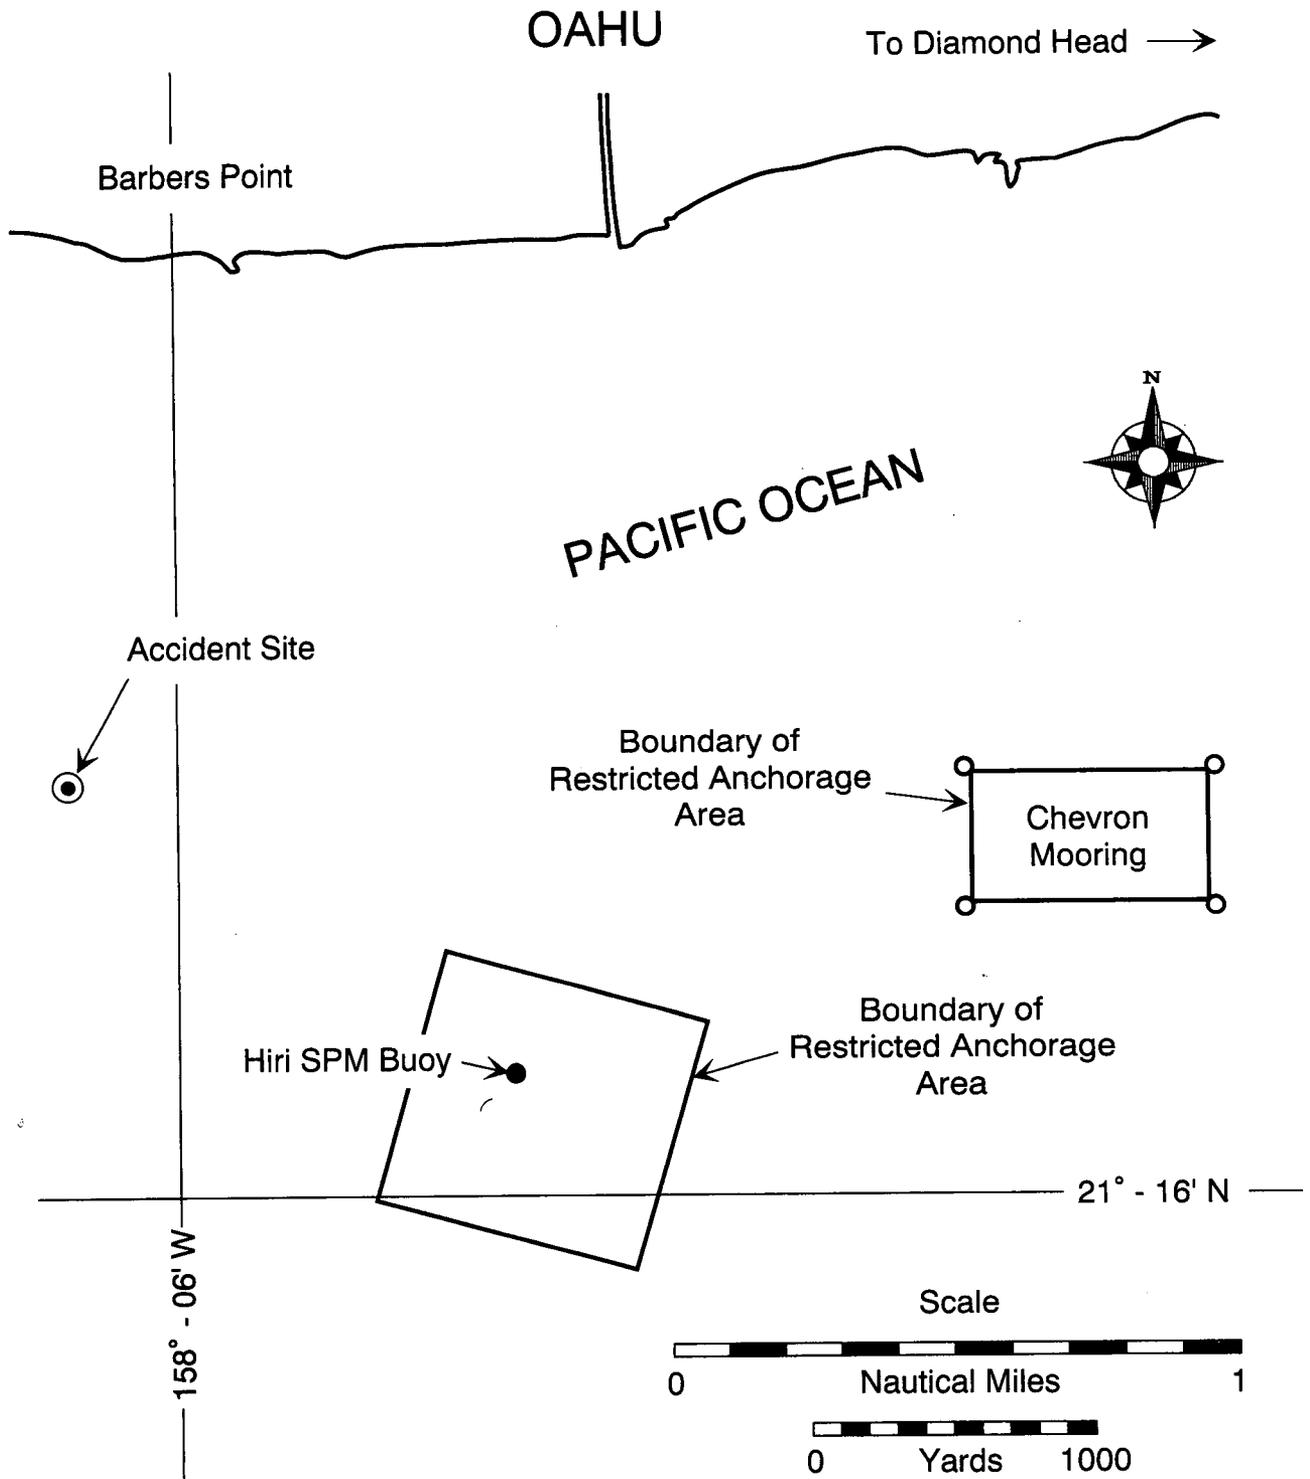
Figure 4.--Chart of area showing accident site.

vessel's grounding. The STAR CONNECTICUT's deepest draft was 36.4 feet. Within about 1,500 yards inshore of the spm the water depth shoaled to less than 36 feet. Despite his knowledge that ocean currents were unpredictable, the master maneuvered the vessel into a constricted area inshore of the buoy. Given the master's experience, the Safety Board believes that he should have recognized that he was placing his vessel at increased risk of grounding even if navigation fixes were plotted frequently. If the vessel suffered a propulsion or steering failure, or some other serious breakdown while maneuvering inshore of the buoy, the master would have little time and space within which he could react in order to prevent grounding. Moreover, his course inshore of the spm buoy took the tank ship over submerged pipelines which might interfere with the ability of the ship to drop its anchors in an emergency. In the Safety Board's opinion, the master's decision to pass inshore of the spm buoy was a poor one, exacerbated by his decision to disembark personnel before he had completed the intended maneuver and placed his vessel in safe water.

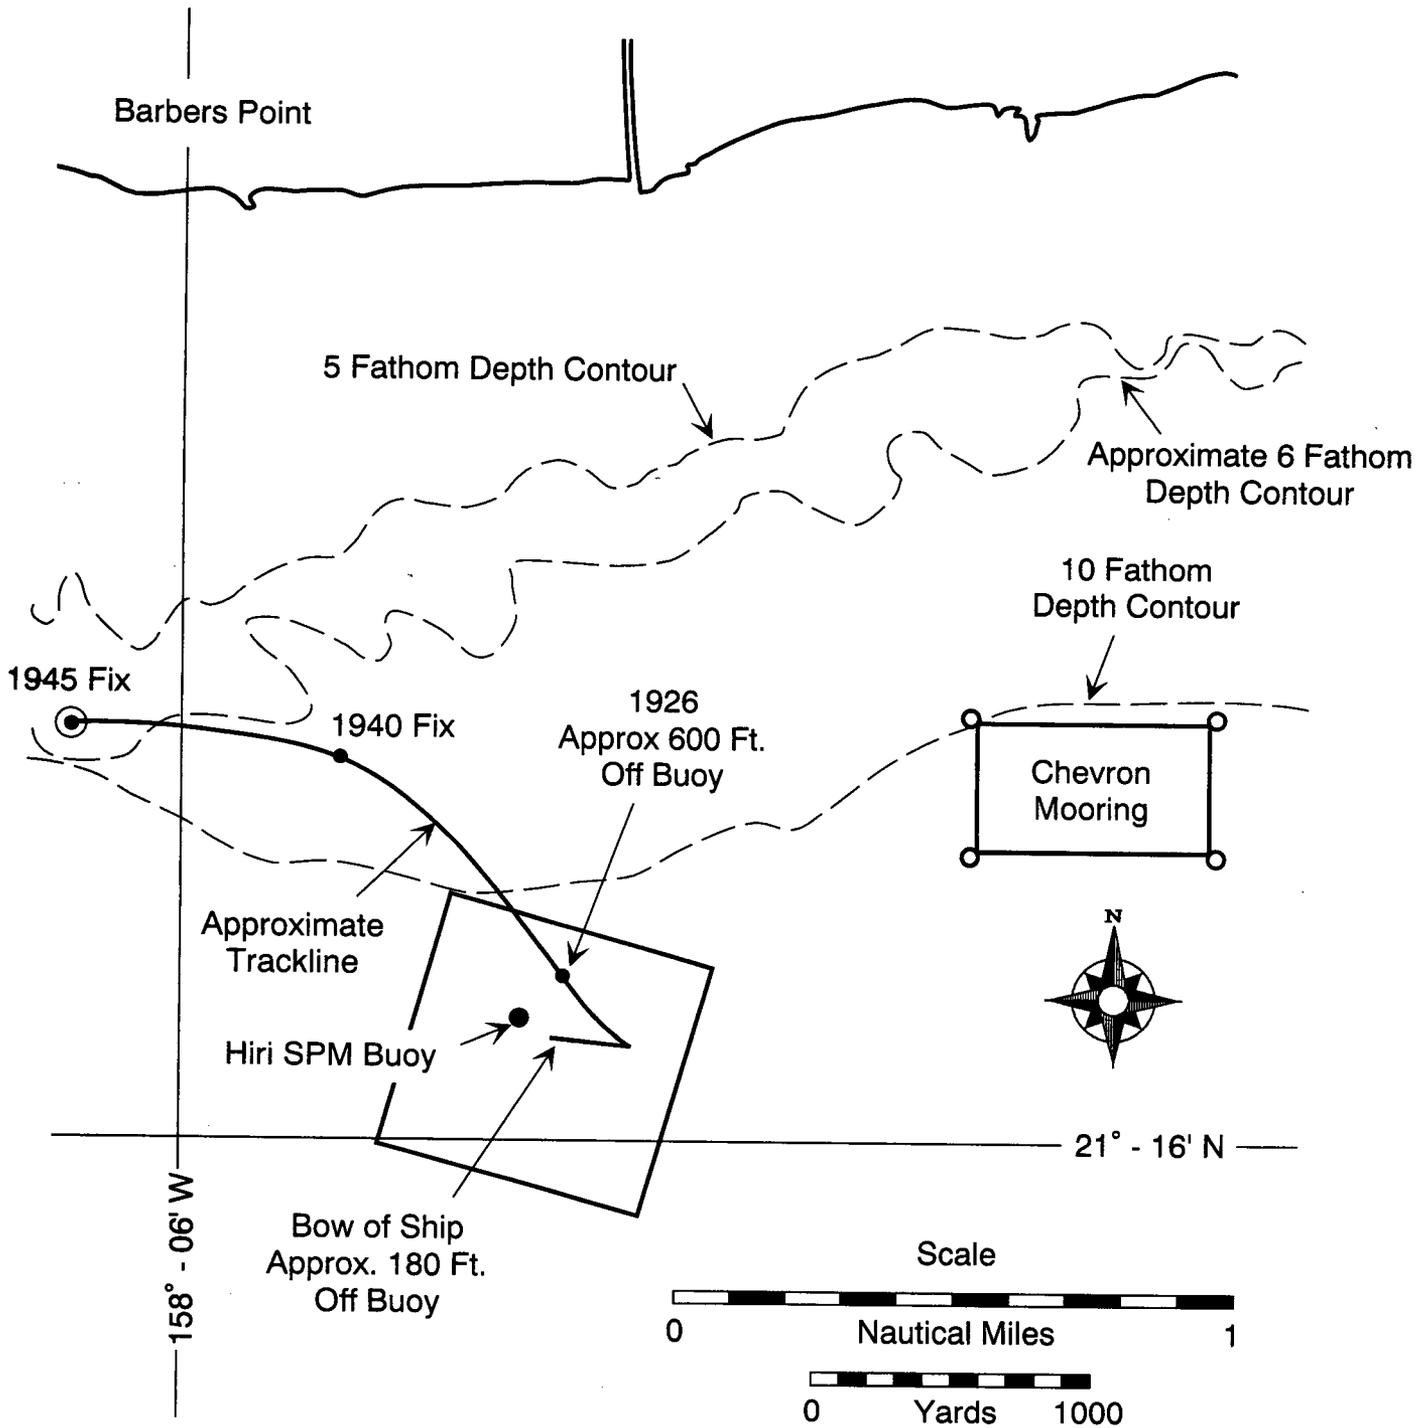
Figure 6.--Chart of area showing approximate trackline of STAR CONNECTICUT departing the HIRI SPM buoy.

Beginning at 1912.6, the senior mooring master issued a series of astern engine orders to back the ship clear of the spm buoy. The STAR CONNECTICUT had a single right-hand-turning propeller. When the engine was operated astern, the ship would back to port, which would cause the bow to swing to starboard. The data from the course recorder showed that about 1916, the ship's head started swinging rapidly to starboard. At 1918, when the senior mooring master transferred the conn to the master, the master attempted to check the swing by ordering hard left rudder and half ahead with the engine. At 1922, the master ordered the engine to slow ahead, but kept the rudder hard left. Despite the execution of these orders, the ship continued to swing to the right until it reached a heading of 337° at 1925. Even with the application of hard left rudder for 9 minutes, the ship swung through a 45° arc to the right. Thus, the ship was under a substantial turning moment after the master assumed the conn.
