NATIONAL TRANSPORTATION SAFETY BOARD

MARINE ACCIDENT REPORT

**EXPLOSION AND FIRE
ON THE U.S. TANK SHIP SURF CITY
PERSIAN GULF
FEBRUARY 22, 1990**

Abstract: On February 22, 1990, the reflagged 760-foot-long U.S. tank ship SURF CITY, loaded with naphtha and automotive diesel oil, exploded and burned in the Persian Gulf. The fire burned for 2 weeks and 196,985 barrels of the 606,215 barrels of cargo were lost. The damage loss resulting from this accident was \$31.53 million. The safety issues discussed in this report are the ballast tank entry procedures; extension of the inert gas system to include the ballast tanks; ballast system integrity; repeated stress related fatigue fracturing in cargo/ballast tanks; location of fire foam monitor; and retrofit or replacement of primary lifesaving equipment. The Safety Board made recommendations addressing these issues to the U.S. Coast Guard, the International Chamber of Shipping, the International Association of Classification Societies, the Gleneagle Management Company, Inc., and through the U.S. Coast Guard to the International Maritime Organization.

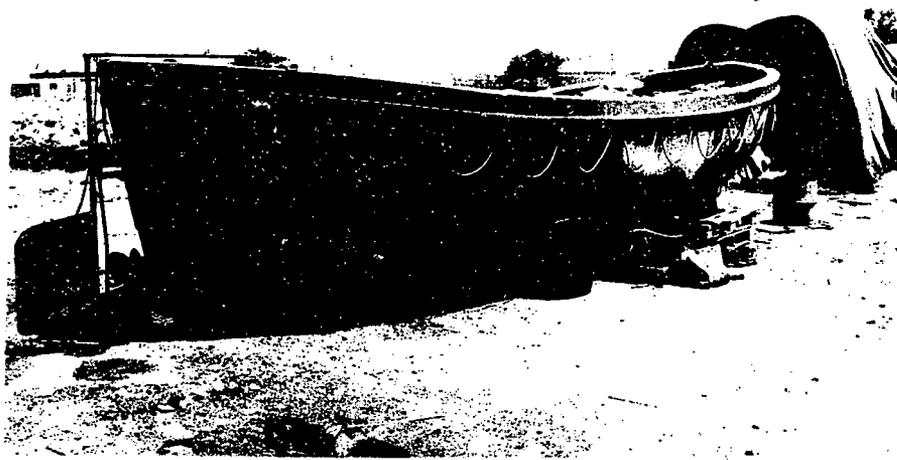
The blaze on the SURF CITY consumed the starboard lifeboat. On May 2, 1990, Safety Board and Coast Guard investigators inspected the port lifeboat at the Gulf Agency Company Terminal, Dubai, U.A.E. They found that a "gripe" or steel cable used to secure the lifeboat in its stowed position was tightly wound around the propeller drive shaft. (See figure 10.)

**Figure 10.--SURF CITY's port lifeboat
with gripe wrapped around propeller shaft.**

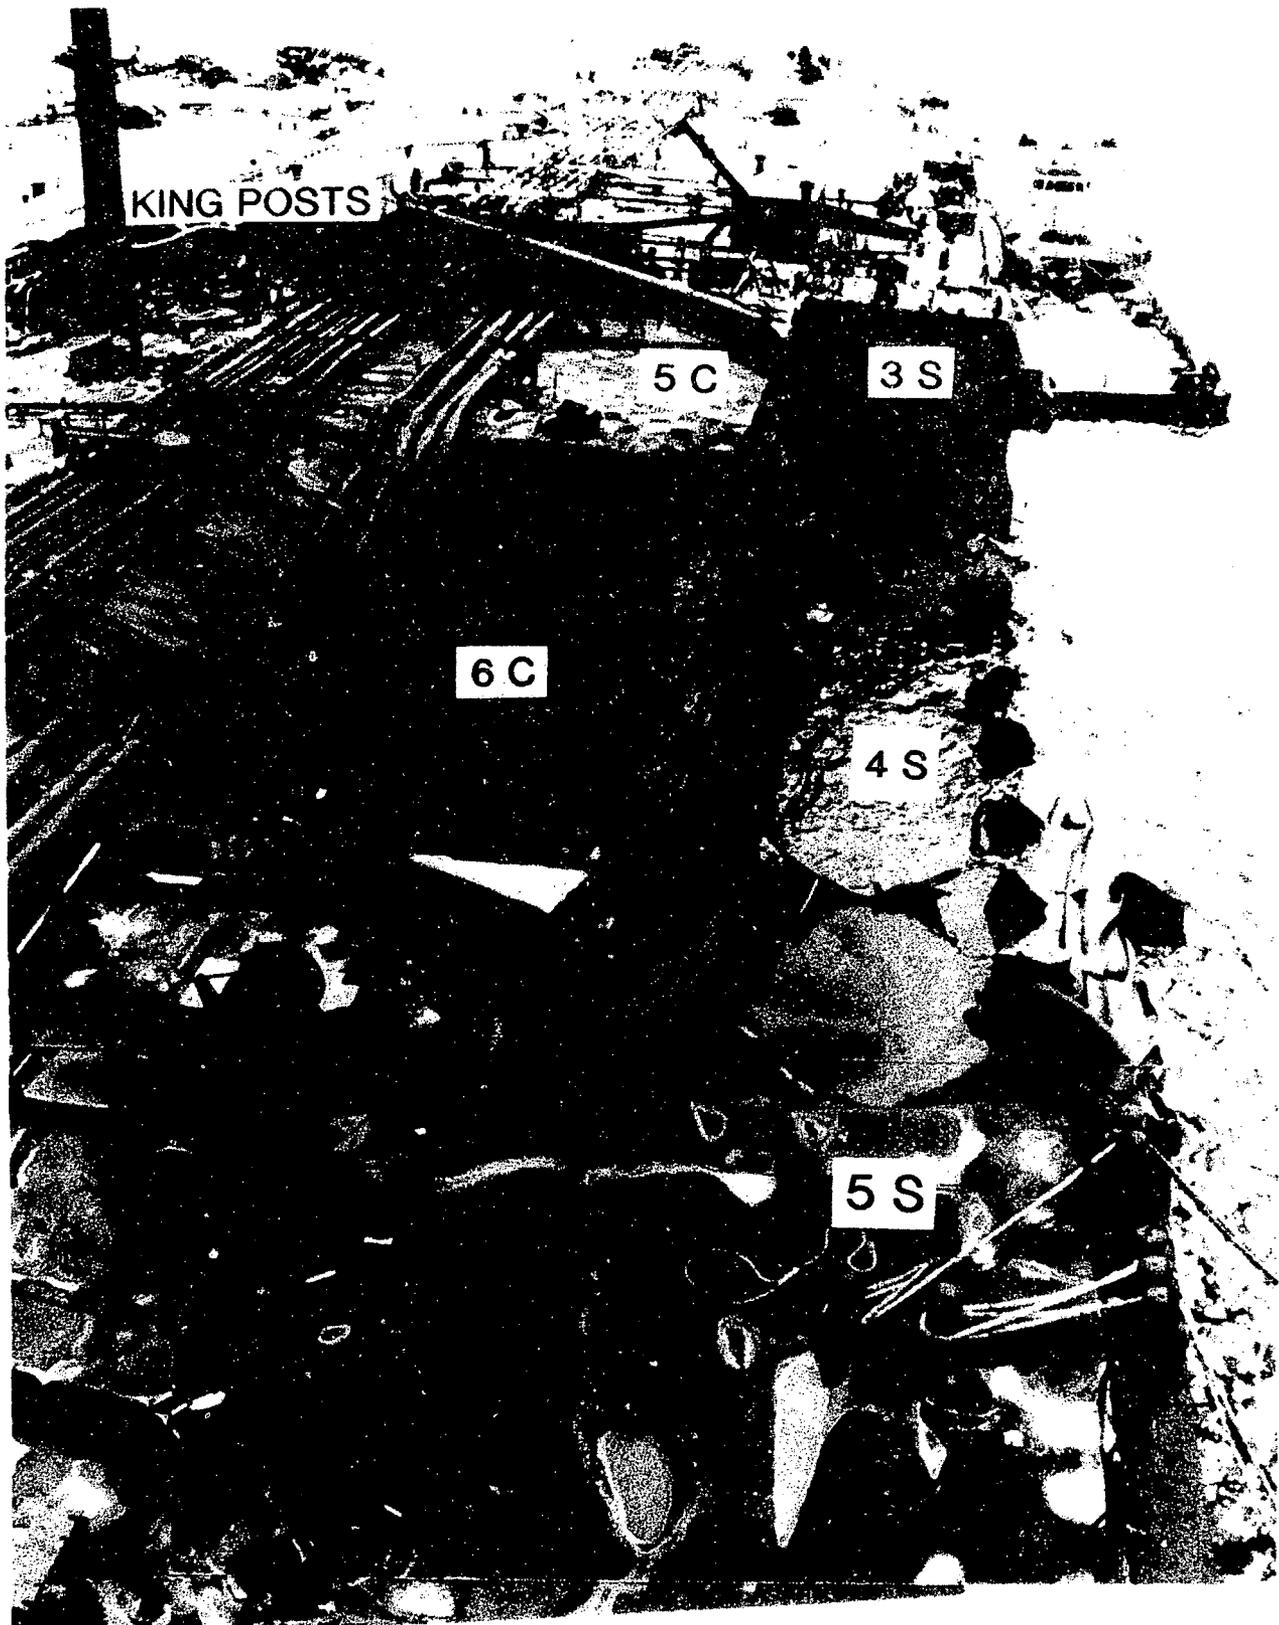
The examination showed that fire and intense heat had completely gutted the navigation bridge and wheelhouse. Most of the windows were missing, all equipment was incinerated, and the bridge deck plating and bulwarks were warped. Fire also consumed all combustible contents in the accommodation house compartments located port to starboard in the forward area of D, C, and B decks and

Figure 11.--Looking forward on the starboard side into the damaged tanks.

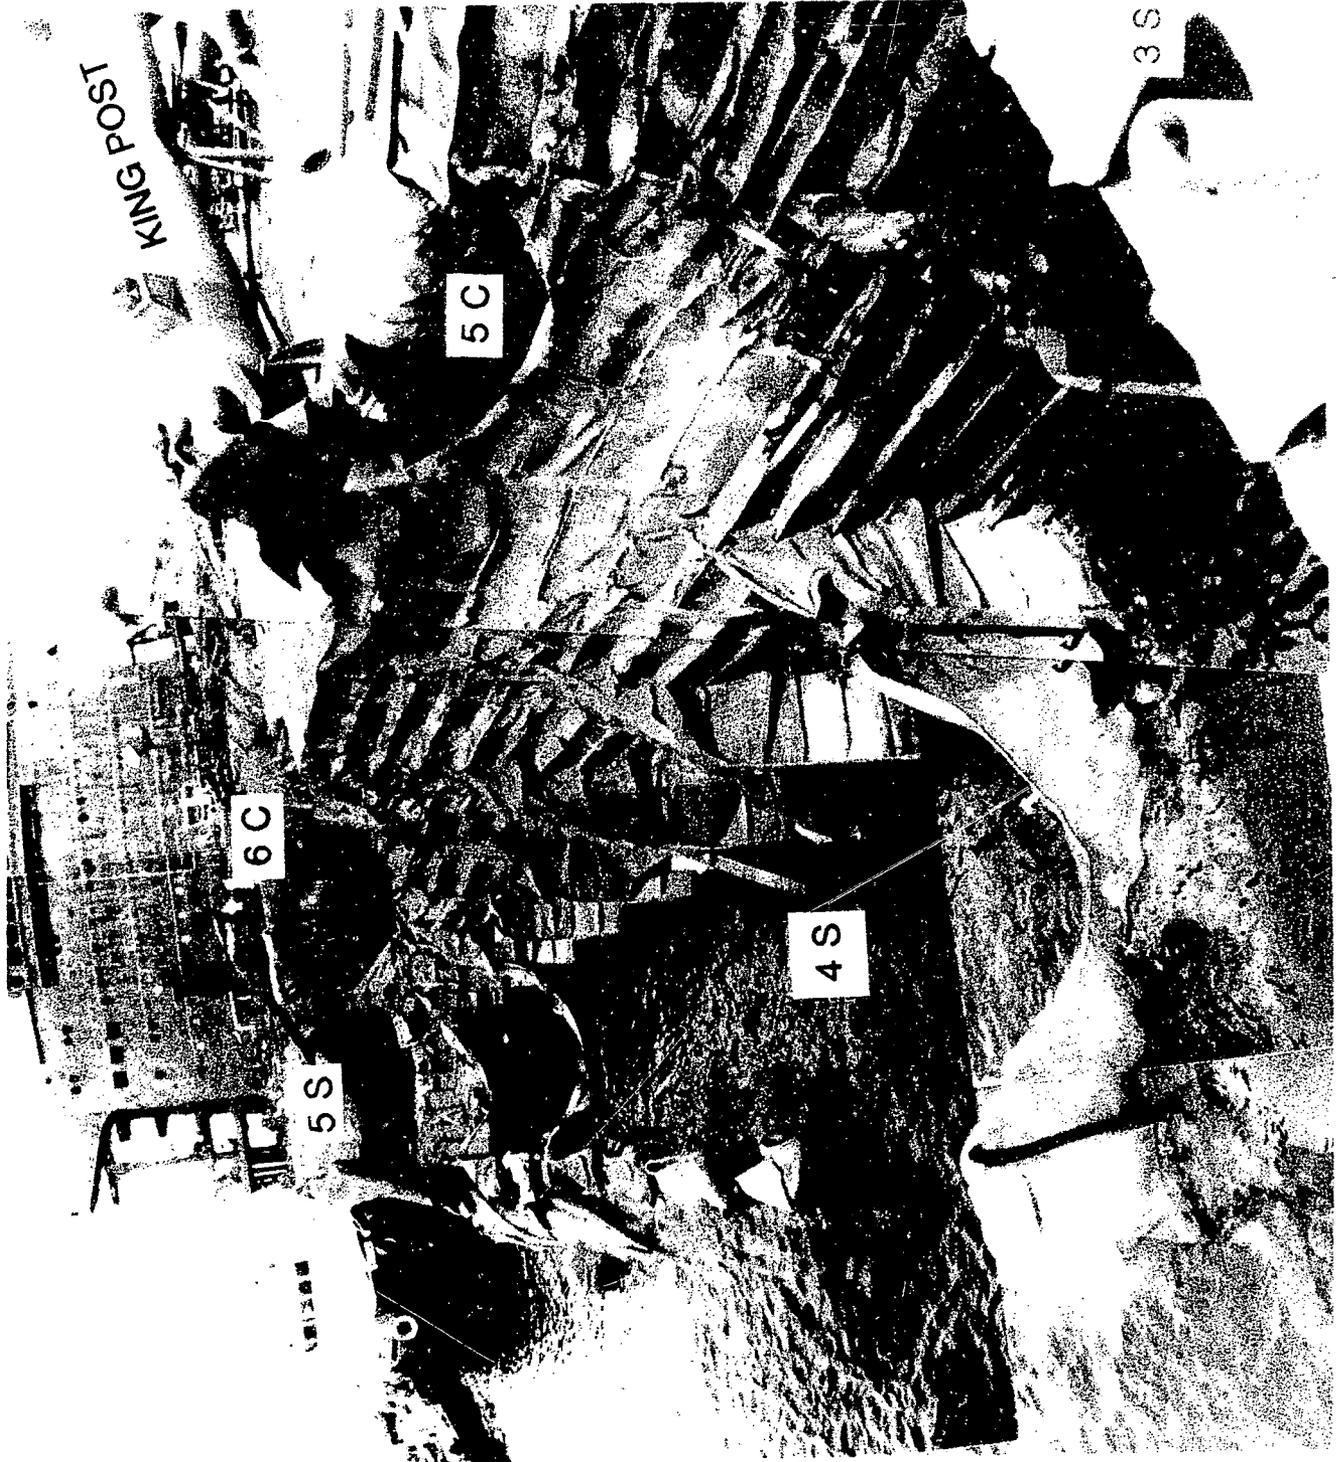
Figure 12.--Looking aft on the starboard side into the damaged tanks.
