National Transportation Safety Board Marine Accident Report  
Collision of the U.S. Towboat Fremont and Tow with the  
St. Vincent and the Grenadines-Registered Containership  
Juraj Dalmatinac, Houston Ship Channel, December 21, 1992

PB93-916402  
NTSB/MAR-93/02

## **MARINE ACCIDENT REPORT**

**COLLISION OF THE U.S. TOWBOAT FREMONT AND TOW WITH  
THE ST. VINCENT AND THE GRENADINES-REGISTERED  
CONTAINERSHIP JURAJ DALMATINAC  
HOUSTON SHIP CHANNEL  
DECEMBER 21, 1992**

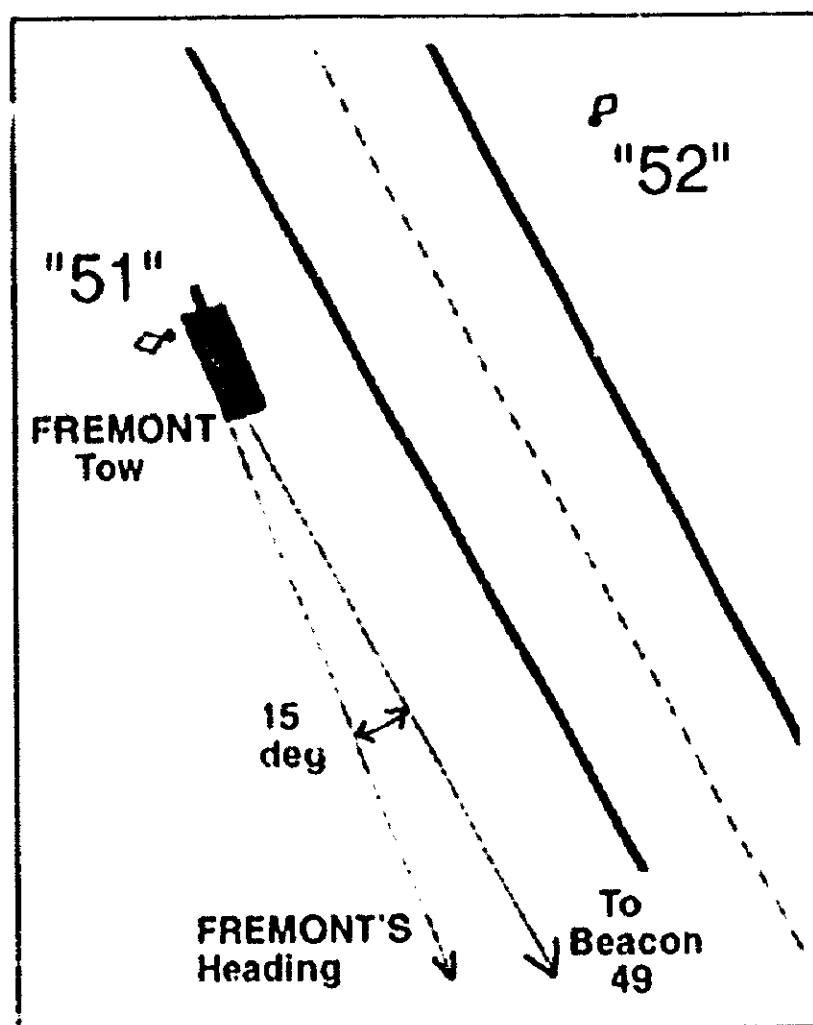
The operator testified that he shined a spotlight several times toward buoy 52 but could not see it in the dense fog. He therefore established the heading of his tow by shining the spot light on buoy 51 and referring to radar, which was on the 2-mile scale. He estimated that the tow was 15° to the right of buoy 49. In this position, the stern of the tow was on the channel side of buoy 51 and the head of the tow was outside the green buoy line (see figure 3).

Figure 3. The position of the FREMONT at buoy 51 as described by the tow operator.

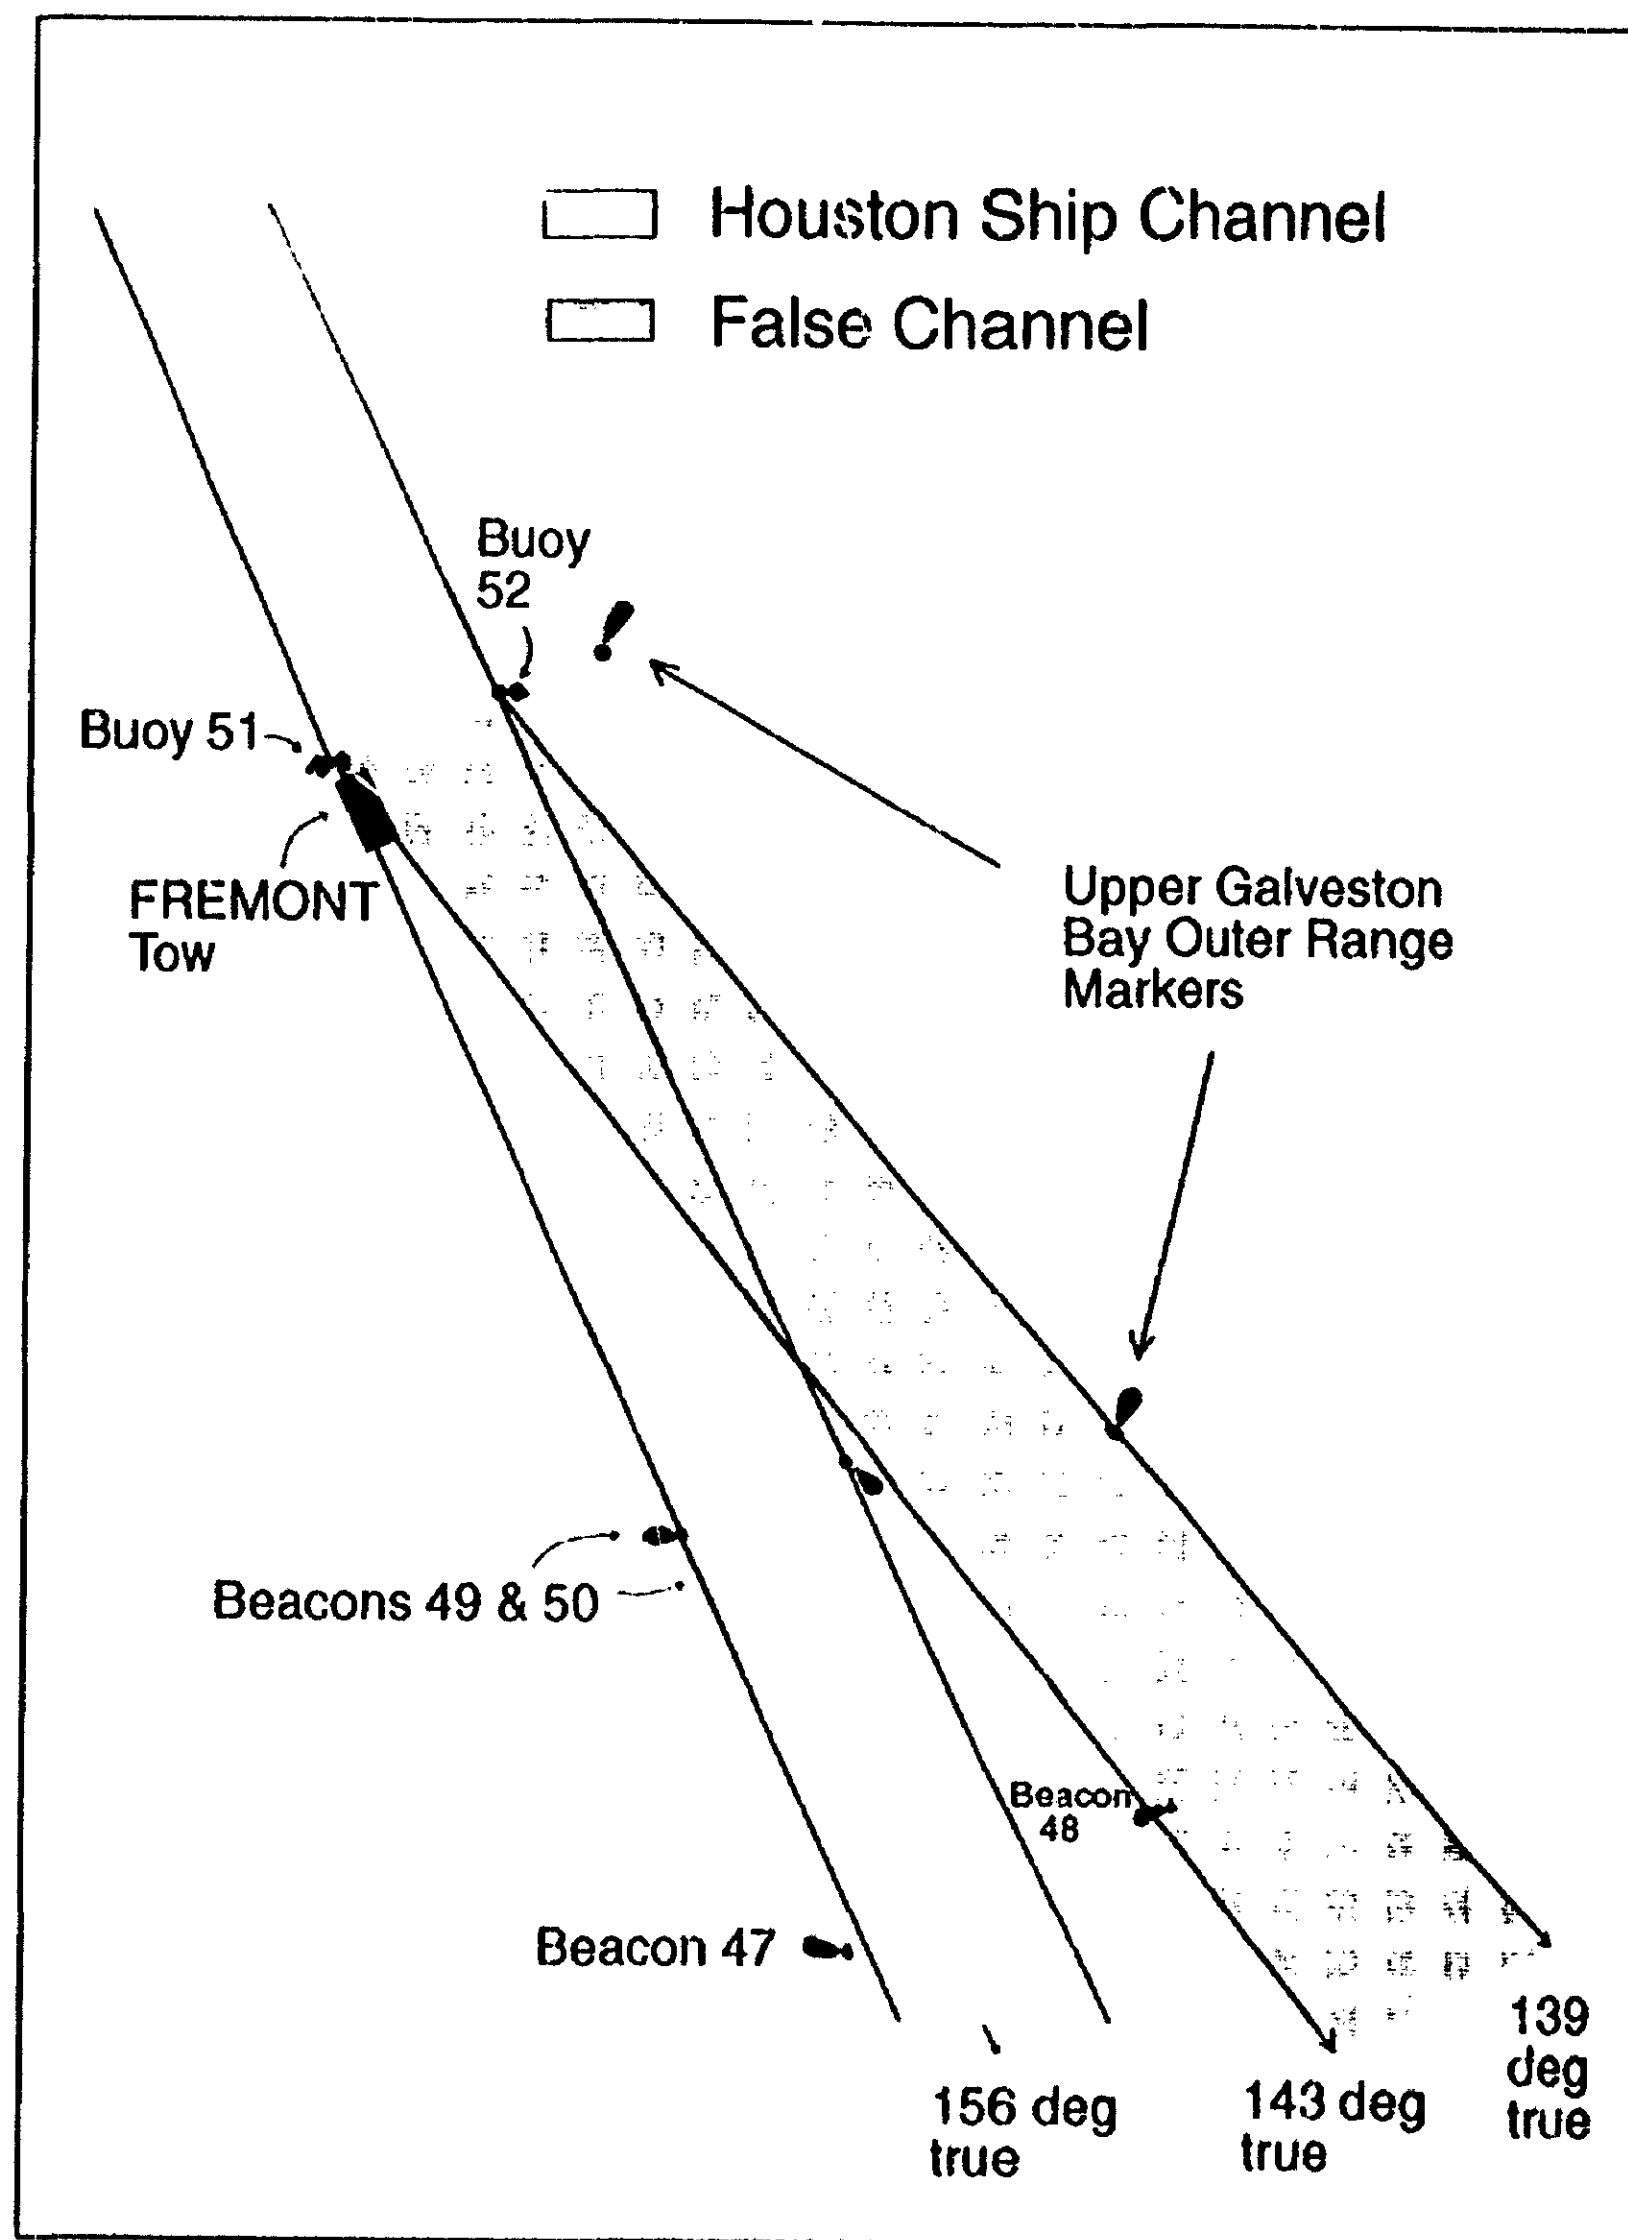
Figure 6. How navigation aids form "false channel" with respect to HSC.

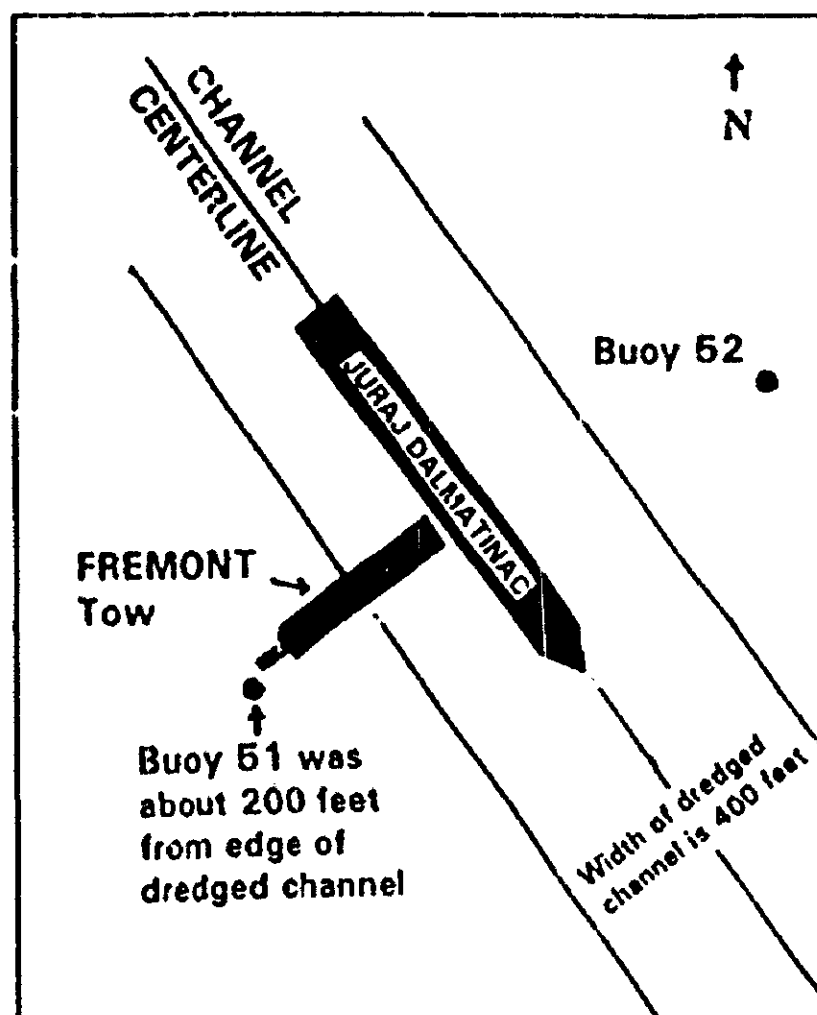
Figure 7. Above shows worst-case scenario in which the tow is perpendicular to channel.
