NATIONAL TRANSPORTATION SAFETY BOARD

MARINE ACCIDENT REPORT

GROUNDING OF U.S. PASSENGER VESSEL
M/V YORKTOWN CLIPPER
IN GLACIER BAY, ALASKA
AUGUST 18, 1993

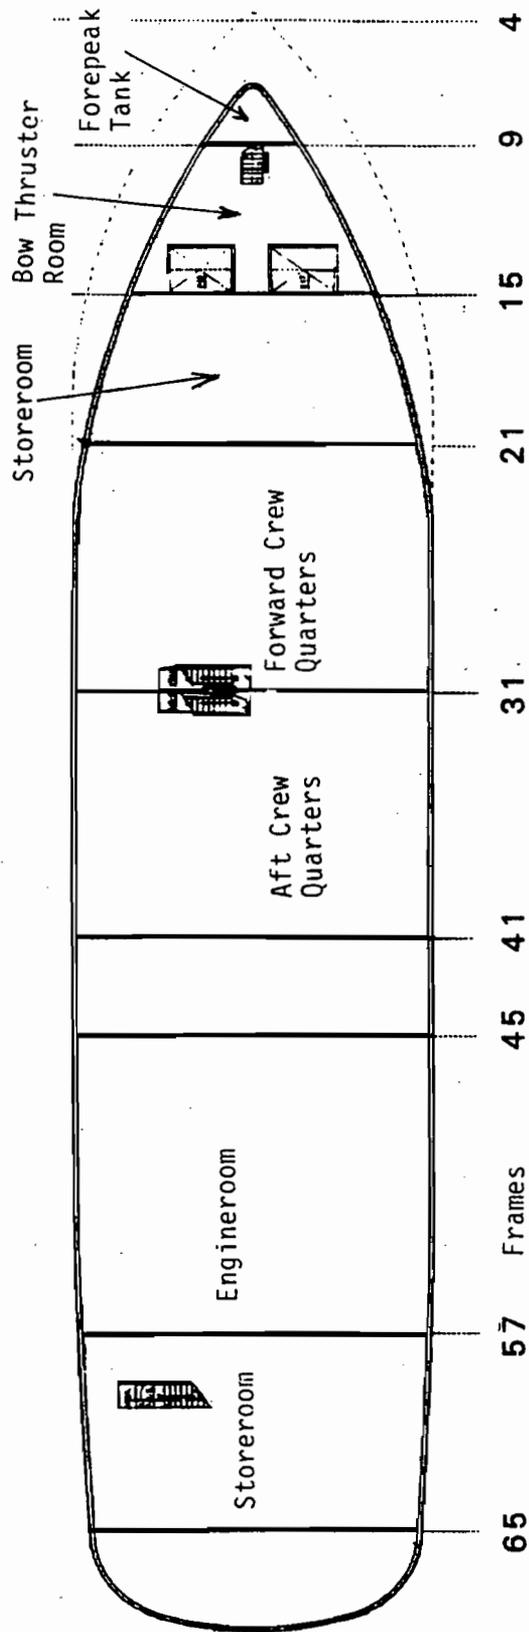
Figure 4. -- Watertight bulkheads on the hold deck.

He called the master by portable radio, gave him a status report, and asked him to close the remaining sliding watertight doors in the bulkheads at frames 21, 31, and 45. (The master could close the doors by remote control from the bridge.) The chief engineer then proceeded to examine the forward crew quarters (frames 21 to 31). Below this compartment were a port and starboard fuel oil tank, a port and starboard void, and an 8-foot-wide centerline duct. He removed the manhole cover over the duct and immediately saw the bottom was covered with diesel fuel oil, indicating that at least one of the fuel tanks had been breached. He crawled aft into the duct, where he saw sea water bubbling in, but he could not see any breach in the hull. He said that he tried to stuff rags into the openings through which the water was flooding and then crawled out and secured the manhole cover in place. He checked the compartments further aft but did not find any other flooding.

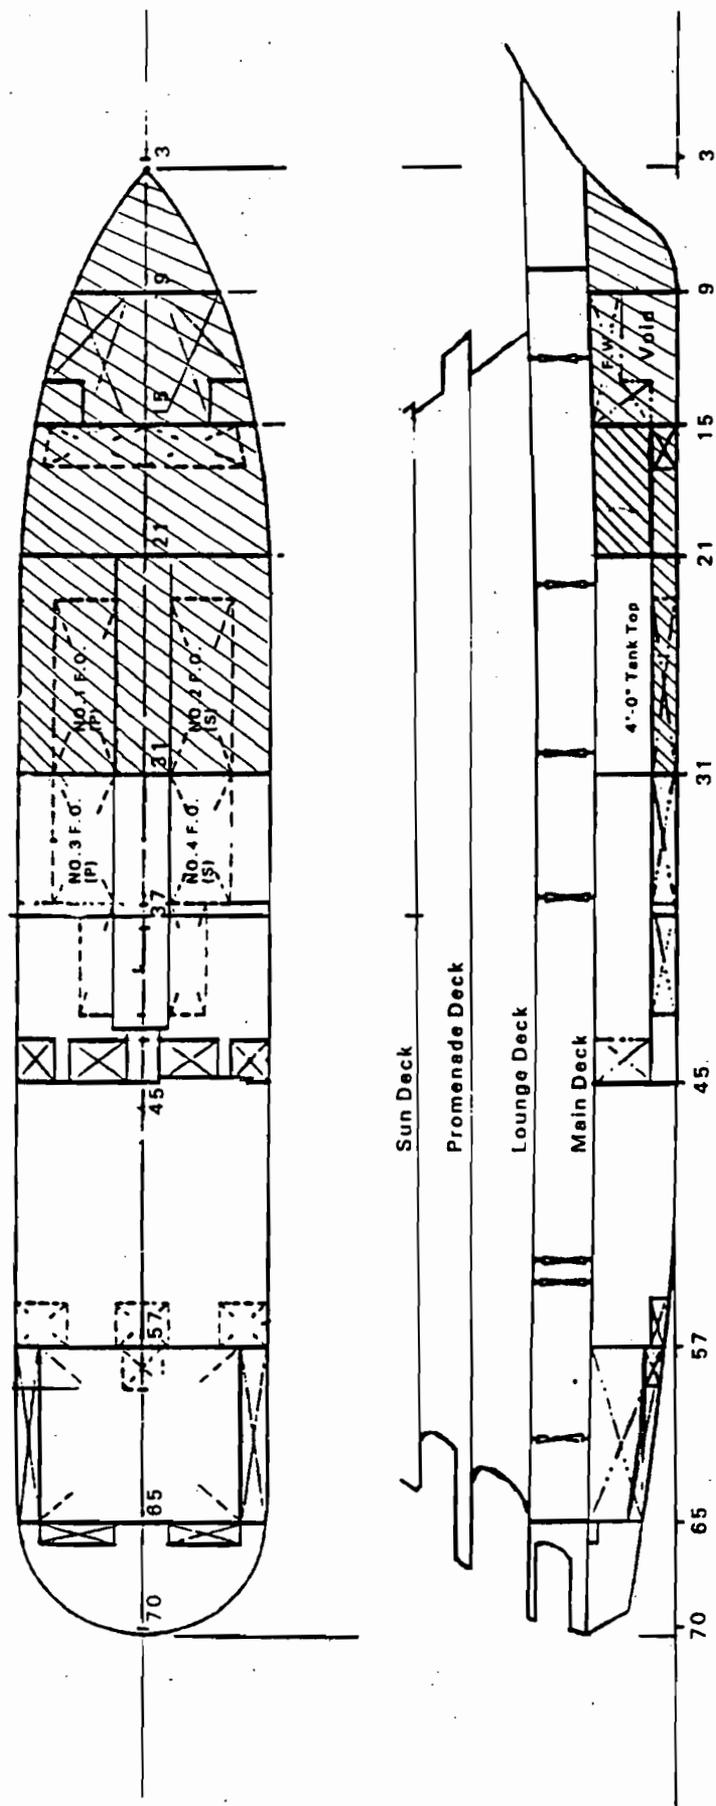
Figure 5.--Flooded spaces.

Water leaking through the single center-bolt manhole cover over the port void, which the engineer tried to tighten, caused the storeroom to flood. This flooding caused the bow to sink more and increased the risk that the bow thruster room would overflow and sink the vessel. Fuel oil leaking through the single center-bolt manhole cover over the duct in the forward crew quarters caused oil damage to the crew quarters and led to dewatering complications. The Safety

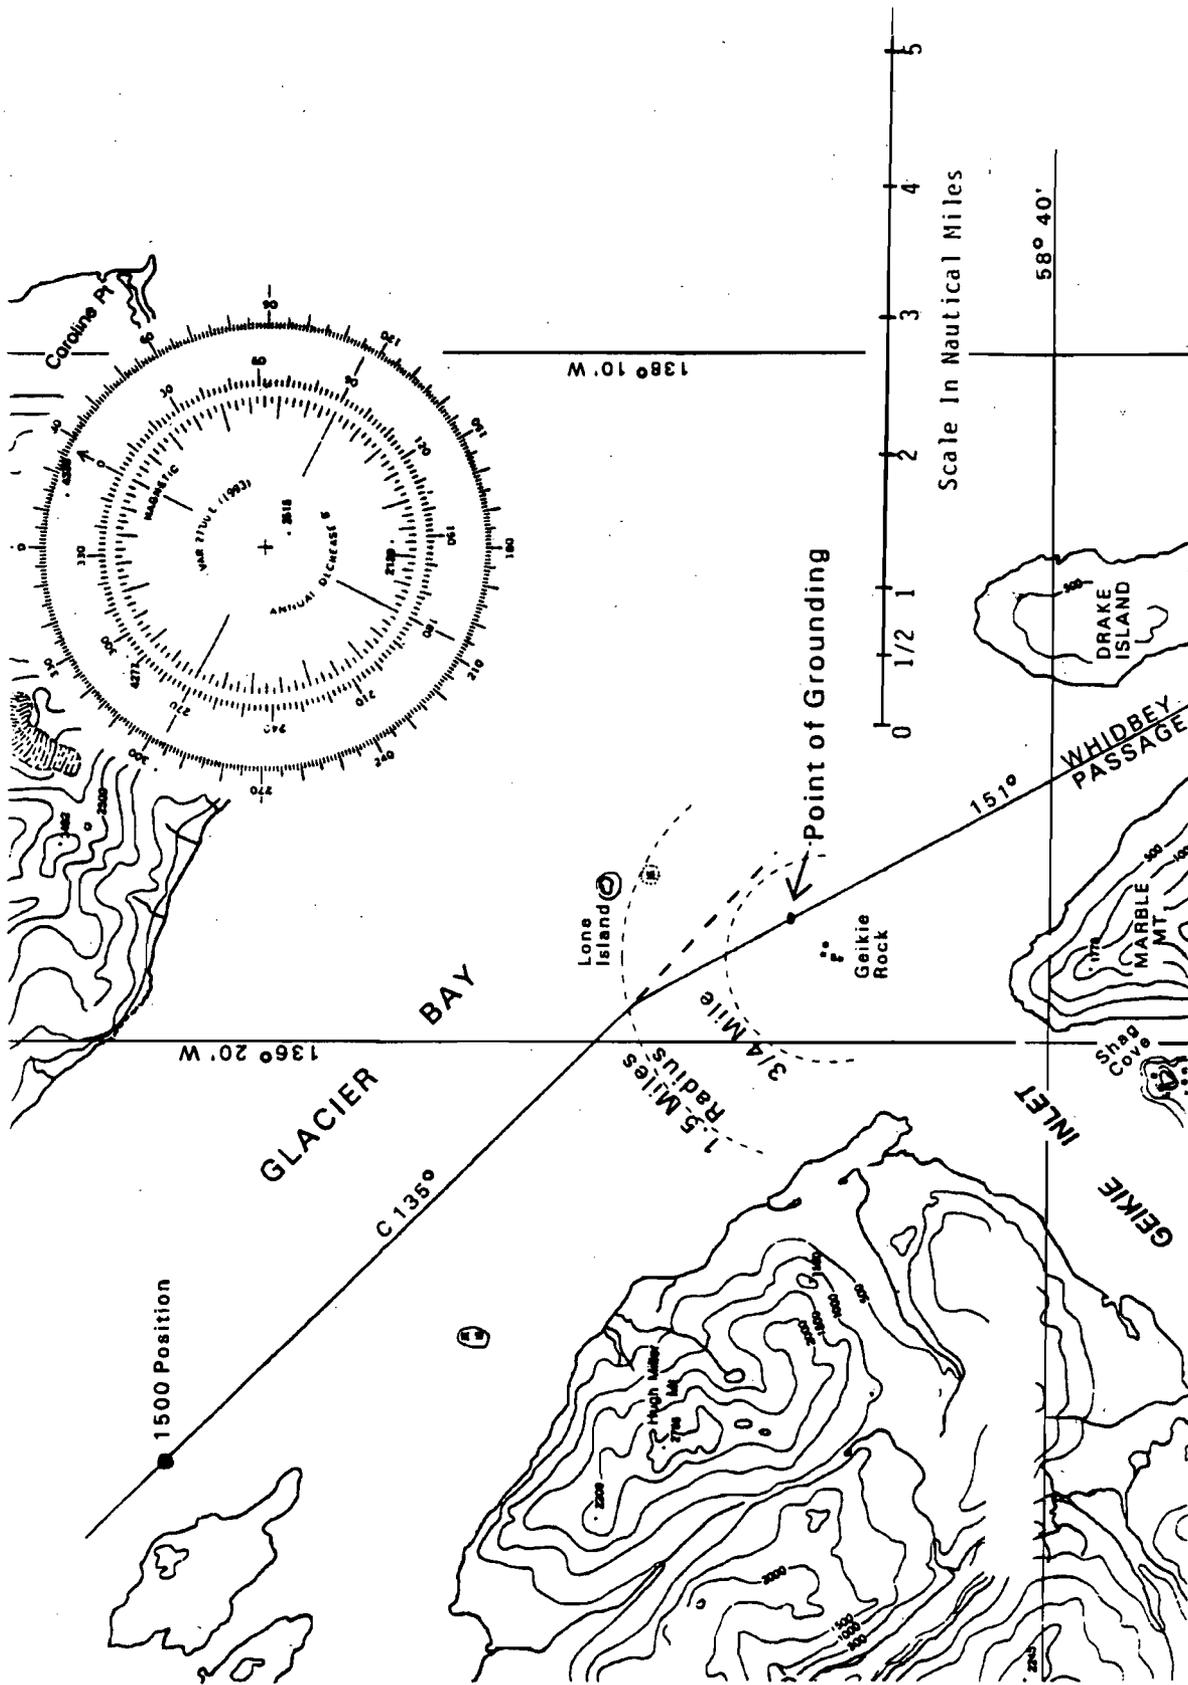
Figure 7.--Probable track line.

accident.) The track line of the YORKTOWN CLIPPER was also extended from its position as logged at 1500 on its reported course of 135°. The 135° course line and the 151° bearing line from the grounding site intersected at a distance of 1 1/2 miles from Geikie Rock (see figure 7).

between Geikie Rock and Lone Island. In fact, the track line passes outside the 3/4-mile boundary the second officer had set for himself for beginning a turn to the left. Therefore, the inner marker he had placed on the radar would not have intersected Geikie Rock had he remained on course 135°. Had he plotted his intended course from the 1500 position, he might have seen that a turn to the left was not required and that, consequently, he would not have to use the inner marker as a cue to turn. Under such circumstances, a turn to the right directly from course 135° would have been proper. That would have left only the outer marker as the effective cue, and when it touched Geikie Rock, he probably turned to the right prematurely instead of waiting until the marker touched Drake Island.
