**MARINE ACCIDENT REPORT**

**FIRE ON BOARD THE U.S. FISH PROCESSING VESSEL  
ALASKA SPIRIT, SEWARD, ALASKA, MAY 27, 1995**

**Adopted: June 11, 1996  
Notation 6594A**

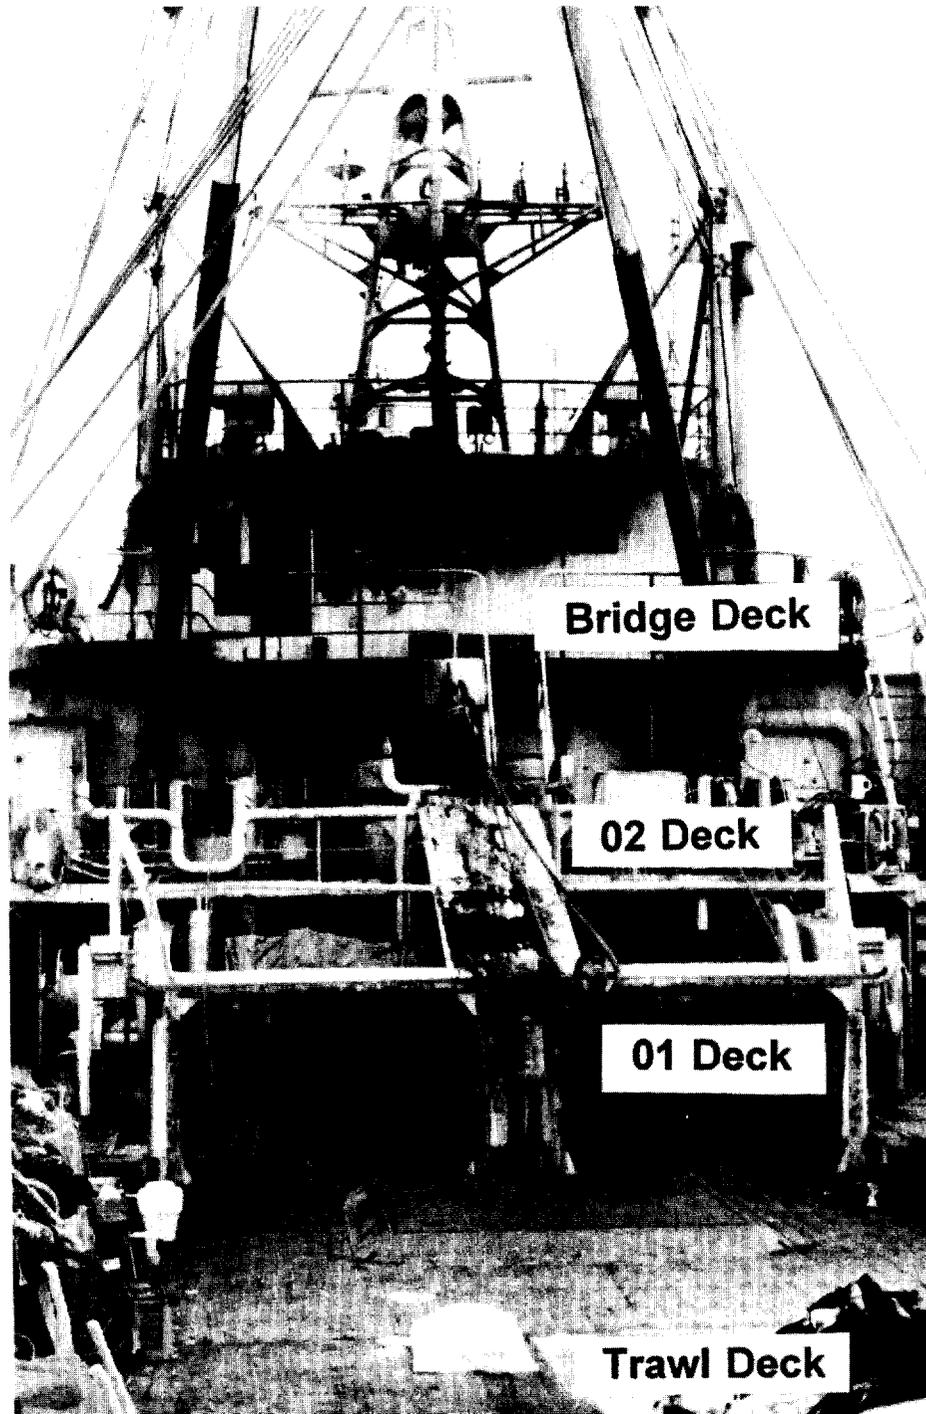
Figure 6 — View of the deckhouse from the trawl deck, looking forward  
*(courtesy NFPA, Quincy, Massachusetts)*

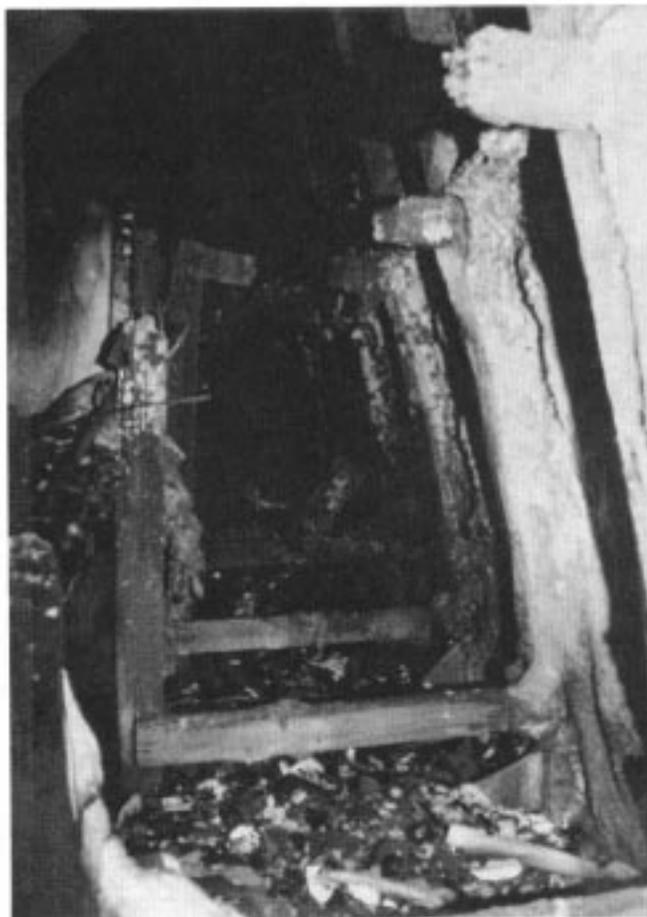
*Hull Structure and Construction* -- To provide thermal insulation in the accommodation spaces, the steel hull on the accommodation decks was covered with about 2 inches of sprayed-on rigid polyurethane (RPU) foam before the

wood overhead and bulkhead finishes were installed. The steel bulkheads in the assistant fish master's room (originally a radio room) were covered with plywood paneling. (see figure 7 ). The overhead and the bulkheads had been finished on the interior with 1- by 3-inch wood strips (furring strips) fastened to the steel hull framing. The furring strips were covered by ¼-inch plywood paneling. The exposed paneling surface appeared to have a vinyl veneer.

Figure 7 — Forward bulkhead of 02 deck. Shows construction details of wood framing over polyurethane foam insulation (courtesy NFPA, Quincy, Massachusetts)

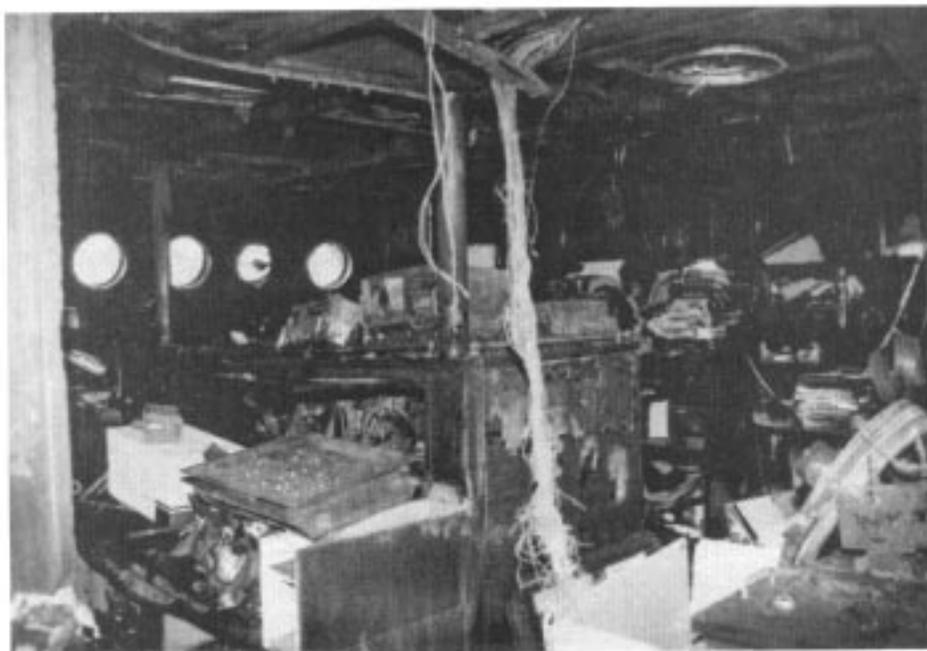
The hull and steel deck plating in the area of the wheelhouse and 02 deck were buckled and distorted, and showed discoloration consistent with intense heat. Masts and associated rigging in the area of the fire sustained heat damage.

Figure 8 — Fire-damaged wheelhouse, revealing overhead construction  
*(courtesy NFPA, Quincy, Massachusetts)*

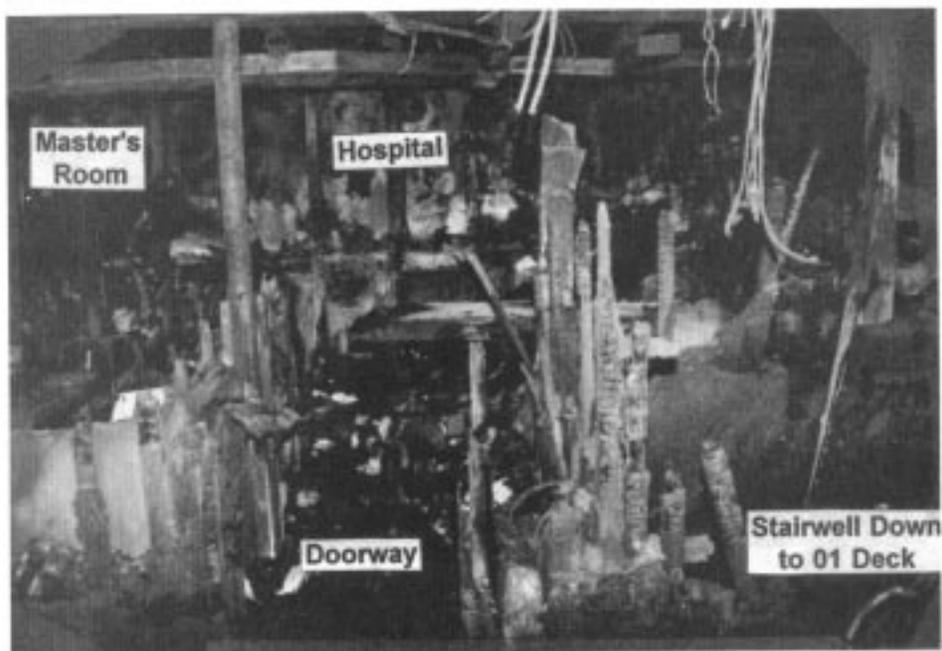
The rooms on the port, forward center, and forward starboard sides of the 02 deck were gutted (see figure 9). The RPU foam insulation and woodwork in the 02 deck were burned and, in most areas, completely destroyed. The fish master's room in the starboard corridor aft was significantly burned, but not as

extensively as rooms on the port side. The crew shower/toilet on the starboard side sustained only heat and smoke damage. The fire damage in the starboard side corridor decreased from forward to the aft doorway exit.

Figure 9 — 02 deck fire damage, looking into master's room  
*(courtesy NFPA, Quincy, Massachusetts)*

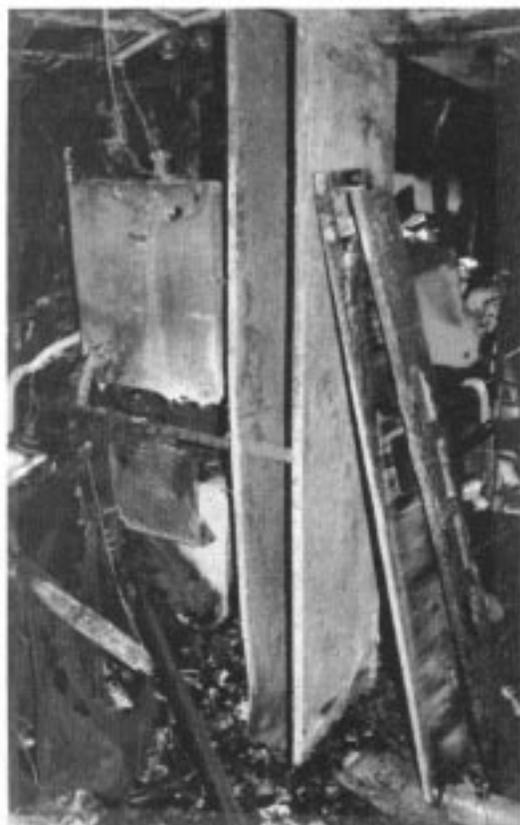
In the wheelhouse, the chase went from the deck to the overhead. The chase was constructed of sheet metal on three sides, and the fourth side was covered with plywood. The remains of this plywood were found leaning against the chase, and the screws for fastening the plywood to the chase were still in place on the chase (see figure 10). The metal interior of the chase had RPU residue on its surface. No wires were found in it.

Figure 10 — Chase in wheelhouse  
*(courtesy NFPA, Quincy, Massachusetts)*

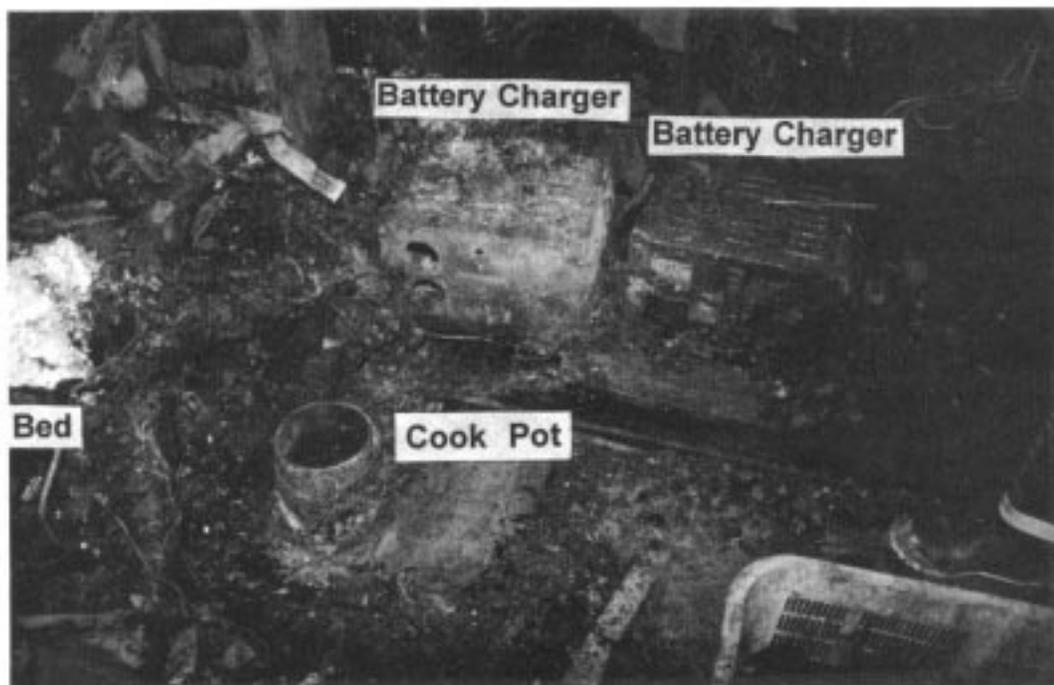
The left (when facing aft) charger stood next to another wooden box, the corner of which was burned through. The shelf supporting the chargers was burned through under the left half of the left charger. A round concentric metal object was found sitting on the carpet forward of the left battery charger. Investigators removed the chargers and the cylindrical object—which was tentatively identified as a cook pot that had been used by the assistant fish master—for further examination (see figure 11).

Figure 11 — Fire pattern around cook pot  
(courtesy NFPA, Quincy, Massachusetts)

The burn patterns in the support shelf and the box next to it were more clearly visible after the chargers were removed. A metal reinforcement strip was found under the wooden shelf, and solidified molten aluminum was found under this shelf, directly below a round opening in the bottom frame of the left charger. The wires to and from the chargers were examined before the chargers were removed. No evidence of electrical arcing<sup>20</sup> was noted.

The cook pot was found next to the built-in bunk bed. A darkened burn pattern around it trailed over to the corner of the left battery charger. A power cord extended from the bottom of the cook pot forward to the center of the forward bulkhead. The insulation on the exposed cord and plug had been destroyed. Because of the damage to the room, investigators could not determine whether the plug had been connected to an electrical receptacle.
