MARINE ACCIDENT/INCIDENT SUMMARY REPORT

**CAPSIZING OF QUESTAR MOTORBOAT AND
DROWNING OF OPERATOR SOUTH OF SHELTER
ISLAND NEAR JUNEAU, ALASKA
AUGUST 21,1994**

Accident Number: DCA-95-MM-032

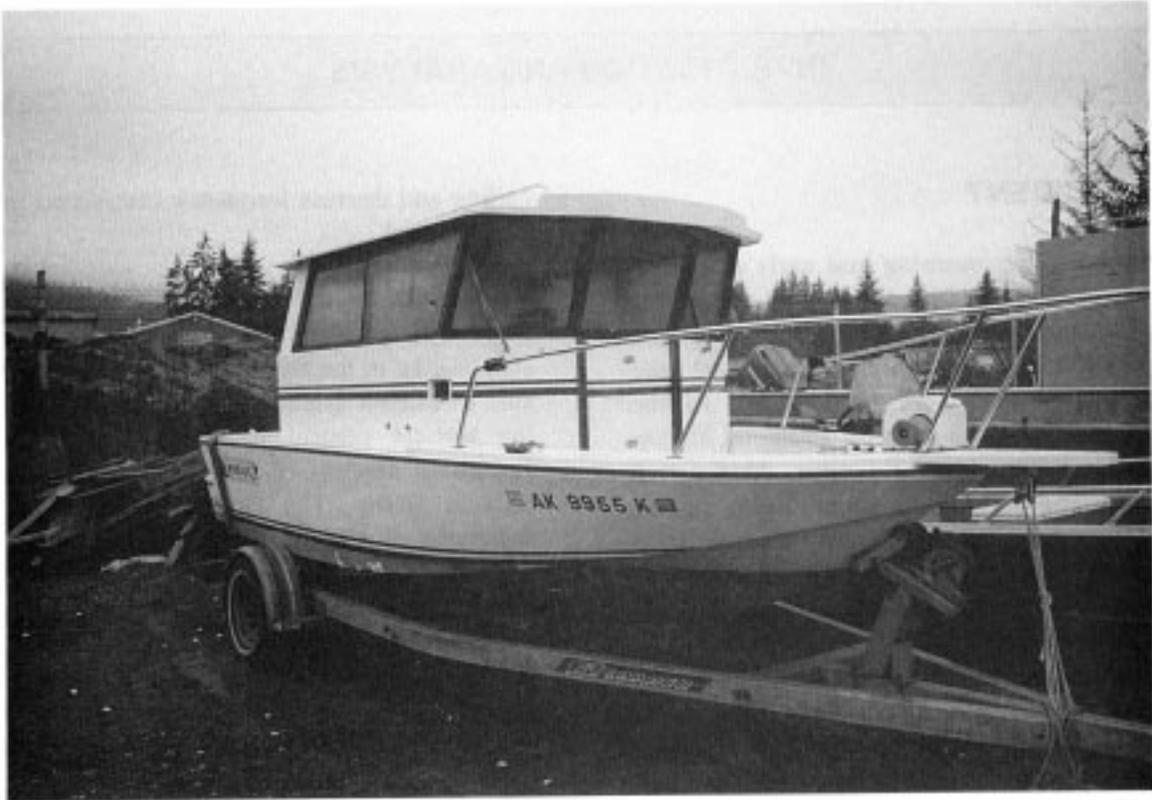
Figure 1 -- Profile of 18-foot Questar, starboard bow

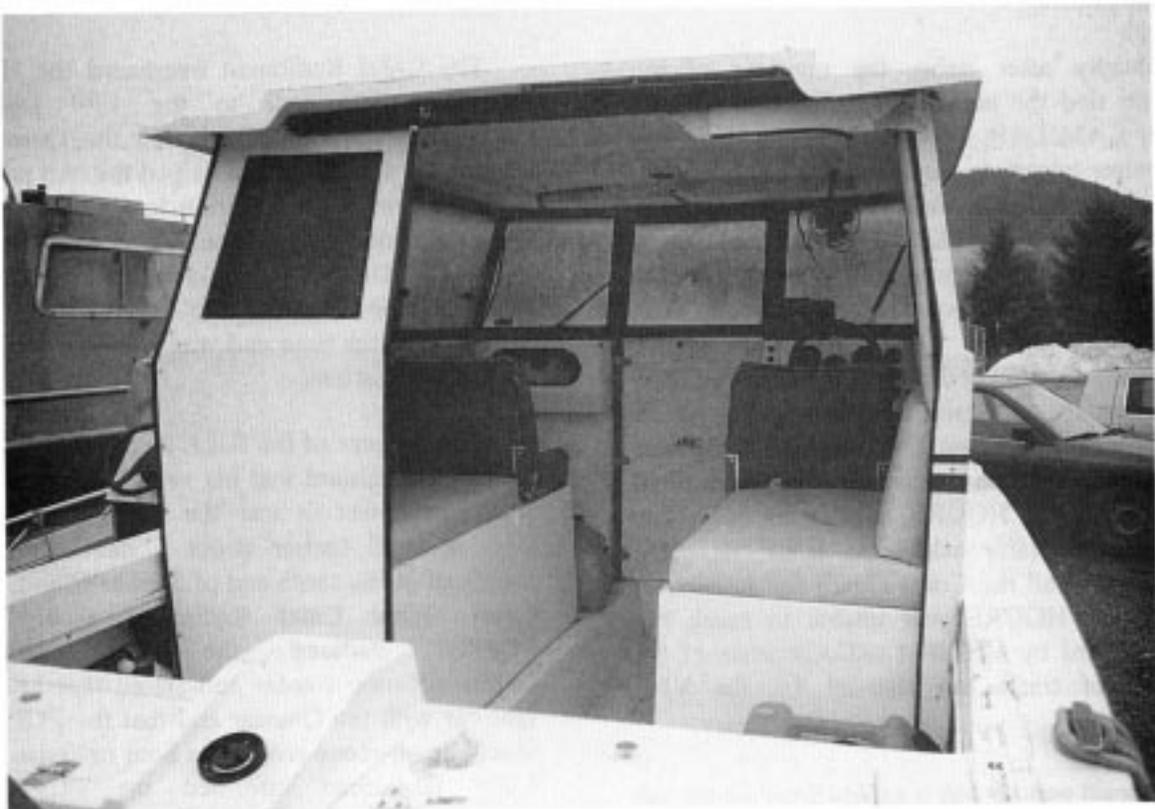
Figure 2 -- Questar cabin from stern, starboard. After cabin bulkhead partially missing.

In addition, the operator failed to ascertain the condition of the Questar, what the original problem was, and what other problems the crew were experiencing with the vessel while waiting for assistance. The Questar had initially taken on water after unloading fish next to the KAMILAR, and the operator had been unable to start either engine. After the Questar was towed back to the KAMILAR by the IDLE HOURS, the motorboat continued to take waves over the side, requiring the operator and passenger to run the bilge pump and bail out water. The Questar's open fore and aft decks had minimal drainage, and the vessel had a low freeboard in relation to the waves it was encountering. Moreover, the Questar's high wind profile in relation to her shallow draft made her susceptible to wind loading. Had the PUPPET's operator examined the Questar more closely and talked to her crew, he may have determined that the vessel's seaworthiness in the prevailing sea conditions was questionable.
