Issued January 25, 2022

MIR-22/02

Grounding and Sinking of Fishing Vessel *Tenacious*

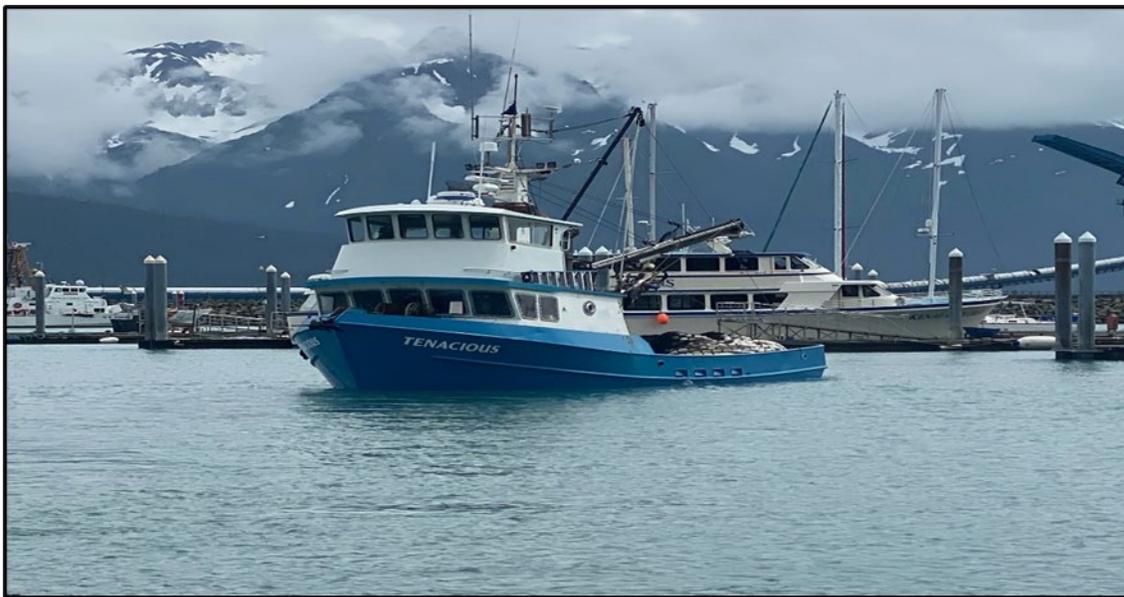
Figure 1. *Tenacious* under way before the casualty. (Source: Zimmerman Fisheries LLC)

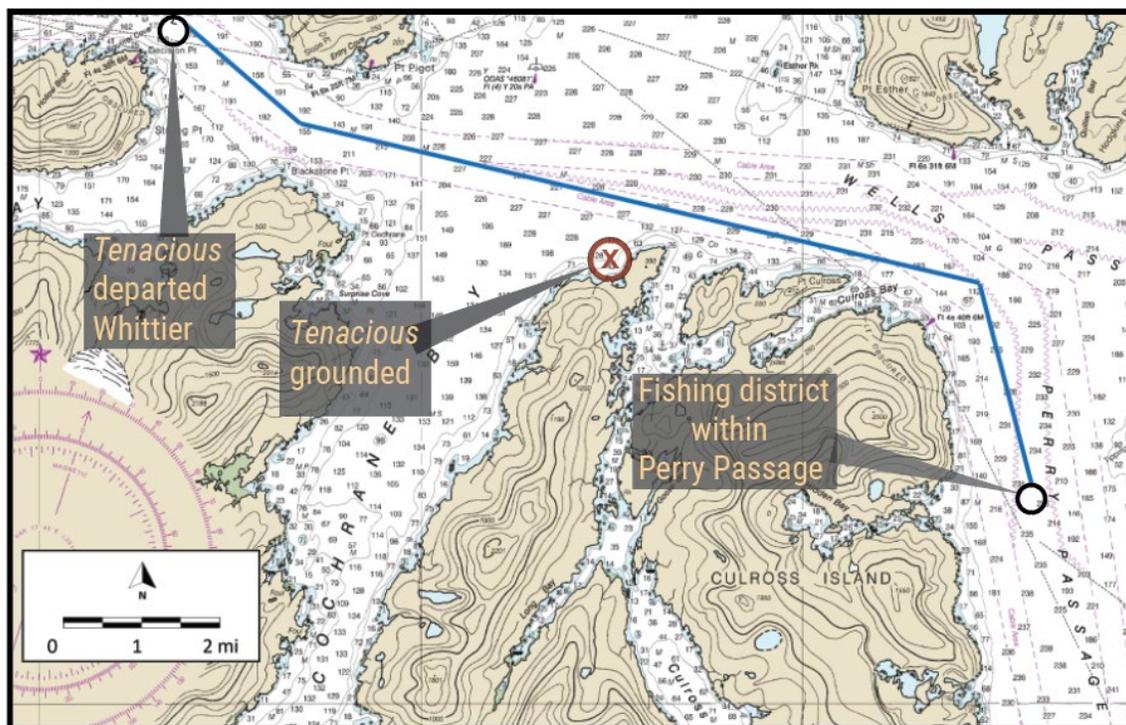
The captain took the wheelhouse watch after departure while the crew slept. While motoring across the mouth of Cochrane Bay on autopilot, the *Tenacious* struck rocks on an unnamed point of the mainland, west of Point Culross, part of the Chugach National Forest, on the opposite side of the passage. The captain later told investigators he fell asleep. According to the captain, in that area shallow water with rocks extended “offshore a little bit.” The captain and crew awoke upon contact. The captain attempted to back off the rocks, and the vessel started going in circles. The captain then went to the engine room to investigate and found the space flooding through penetrations in the forward bulkhead. He began to line up the bilge pump to pump out the engine room but was forced to leave when water started flooding from behind a live electrical panel.

Figure 3. Extract of National Oceanic and Atmospheric Administration (NOAA) chart 16705 (annotated by NTSB). An estimation of the intended route is shown in blue, and the grounding location marked by a red X. Soundings are in fathoms.

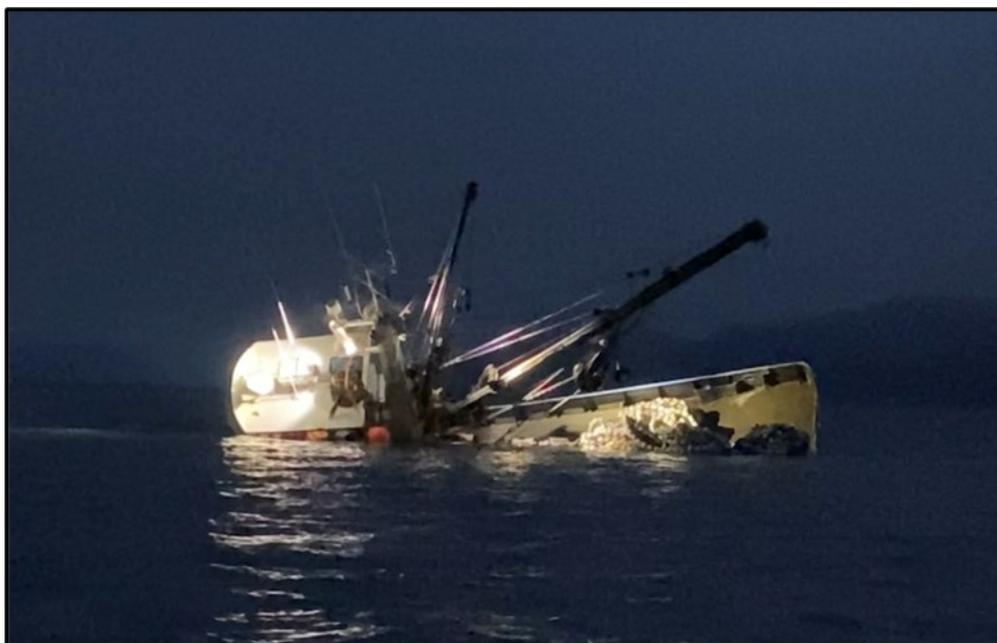
Figure 4. *Tenacious*, sinking by the bow, about 0345 on July 24. (Source: Lucas Brockman)

The vessel was holed below the waterline in the bunkroom. Water entered the engine room via penetrations in the non-watertight bulkhead between the bunkroom and engine room. With one of its two fish holds already full of water, much of the hull volume was flooded, and the vessel sank—as its reserve buoyancy was overcome.

Maintaining watertight integrity of a vessel is a fundamental principal of safe operations on water. Within the hull, watertight bulkheads are designed to prevent progressive flooding when portions of the hull are compromised in a collision or other contact. Had the bulkhead between the bunkroom and the engine room been watertight, it would have contained the flooding to the bunkroom.
