Issued February 18, 2022

MIR-22/05

# Engine Room Fire aboard Towing Vessel *Miss Dorothy*

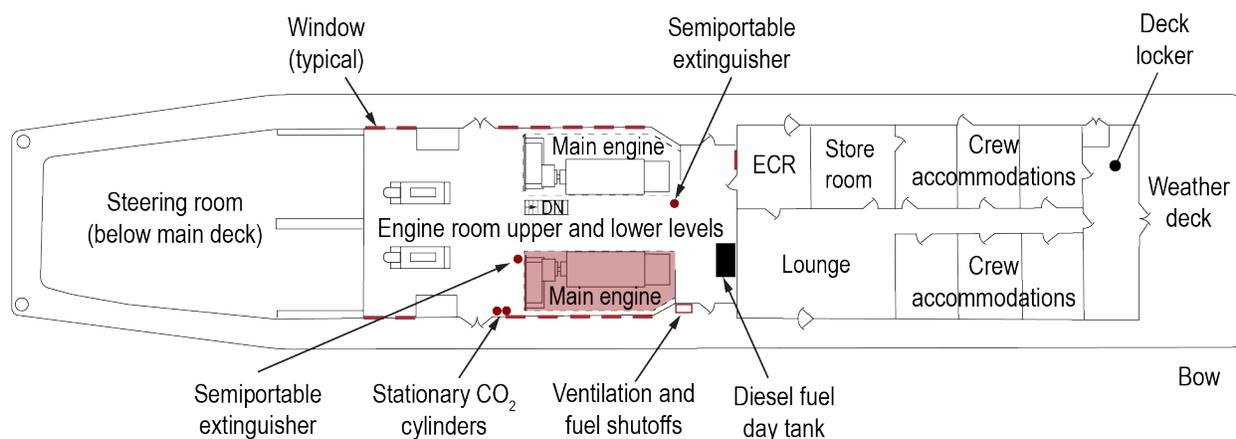
**Figure 3.** *Miss Dorothy* main deck layout. The area where the fire was discovered is highlighted in red.

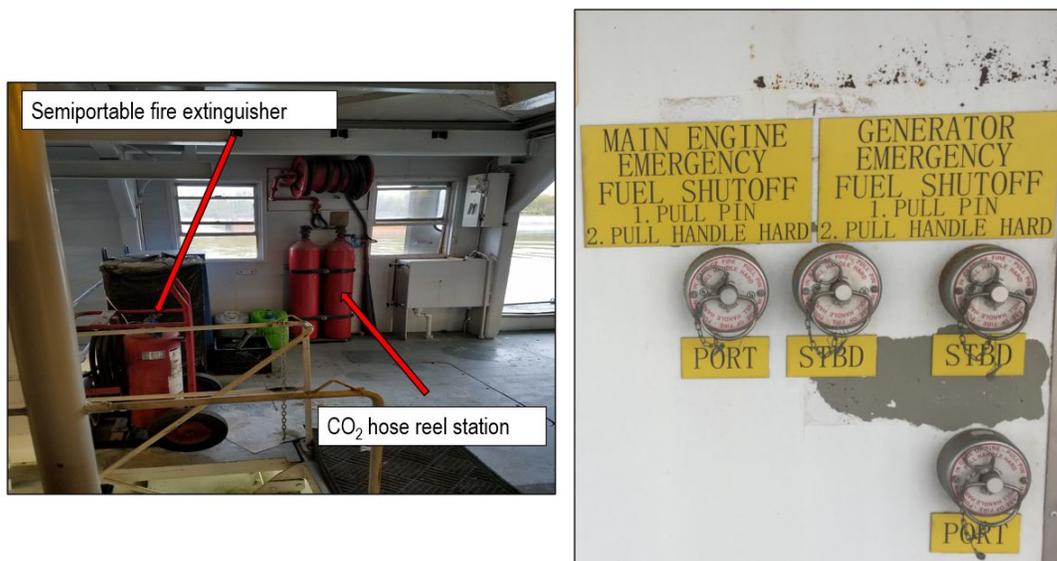
The chief engineer stated that he was able to pull the shutoff for the starboard main engine, but, due to the fire, the cable handles for the port main engine and the online generator were too hot for him to pull. He believed that the starboard main engine stopped several moments after he pulled the wire. (During a postcasualty examination, investigators discovered that all four fuel oil shutoff valves were open, and the metal cables connected to the valves had been severed during the fire.)

**Figure 4.** Engine room fire-extinguishing equipment (*left*). Emergency fuel oil shutoff pull station (*right*). (Source: WRBM)

pull the shutoff for the starboard main engine. However, after the fire, investigators discovered that the emergency fuel shutoff valves located on the fuel oil day tank remained open and that the wires leading to the remote activation pull station were severed and partly consumed by fire. Because these valves remained open, fuel oil would have remained available to the engines so long as the integrity of the fuel supply system was maintained and the engine-driven fuel pumps remained operational. If the engine continued to operate after the fire was well-established, the brazed joint on the starboard main engine 0.5-inch fuel return line would have de-brazed, causing fuel to leak from the joint while the engine was running, which likely contributed considerably to the severity of the fire. Additionally, throughout the fire, up until the point when the electrical system ceased to operate due to failure of the onboard electric generator or electrical circuitry, the automatic electric fuel oil transfer pump would have continued to fill the 500-gallon diesel fuel day tank when the low-level switch was activated. This perpetual supply of fuel would have contributed to the size and duration of the fire.

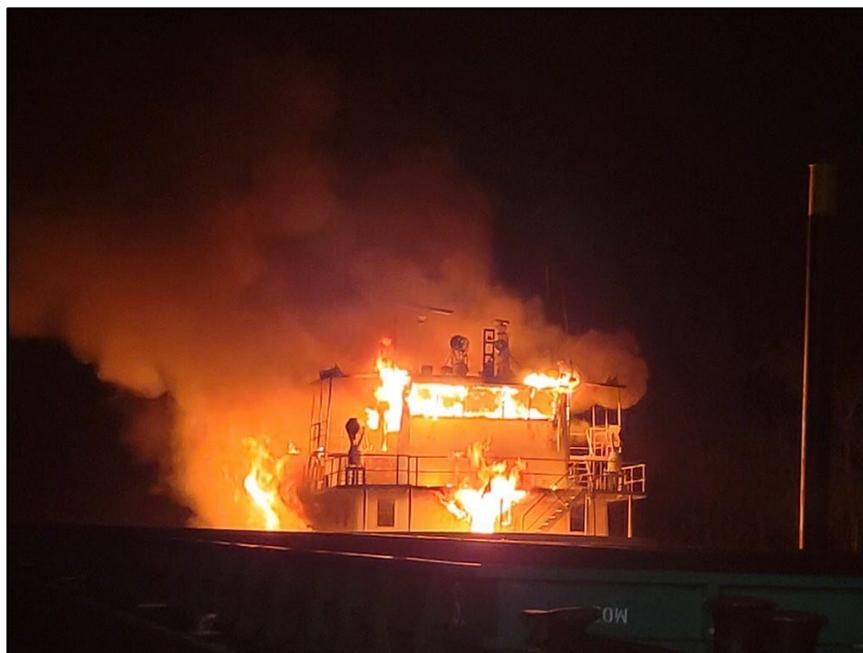
**Figure 5.** *Miss Dorothy*'s wheelhouse and superstructure consumed in flames following the crew's evacuation to the tow's barges. (Source: WRBM)

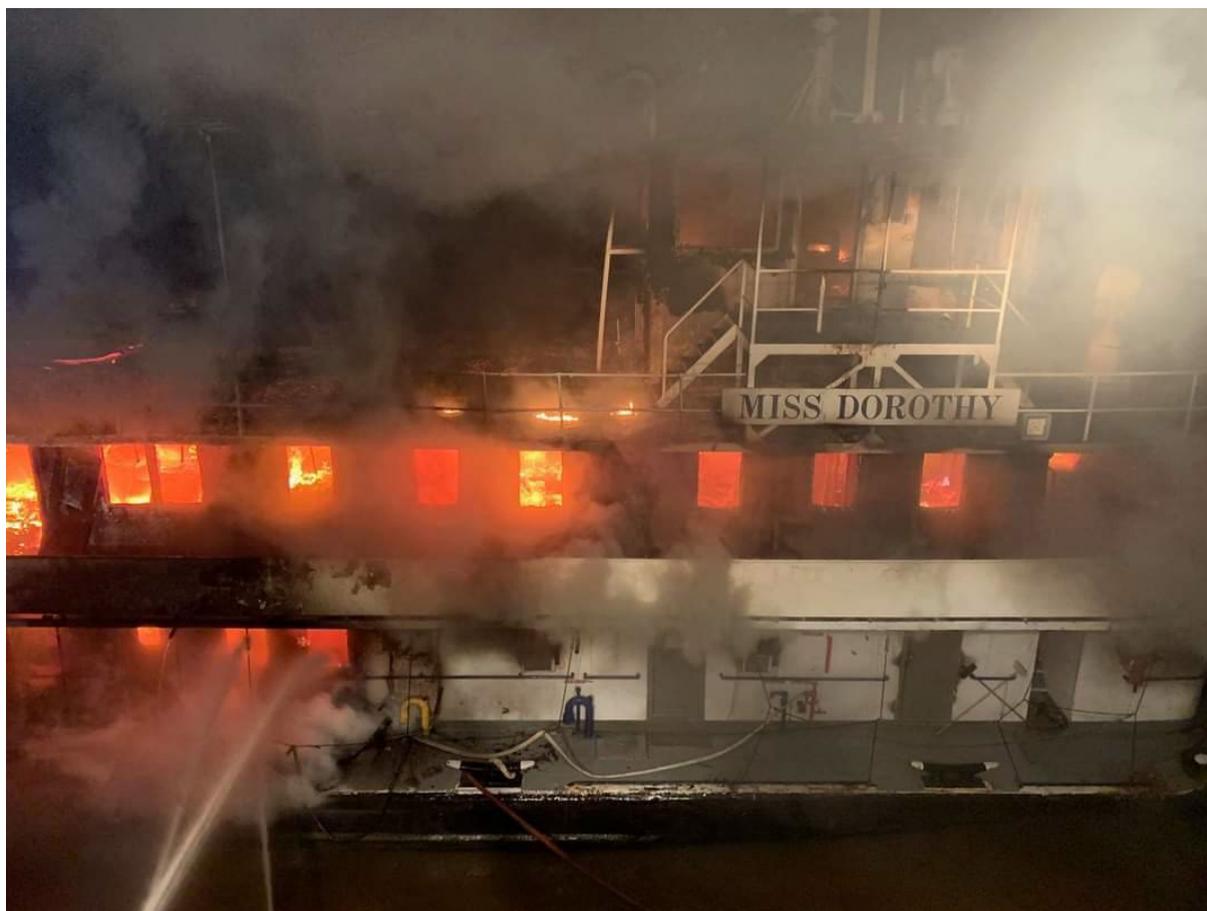
**Figure 6.** Starboard side of the *Miss Dorothy* during firefighting efforts from the Good Samaritan towing vessel *Christopher Wilson*. (Source: WRBM)

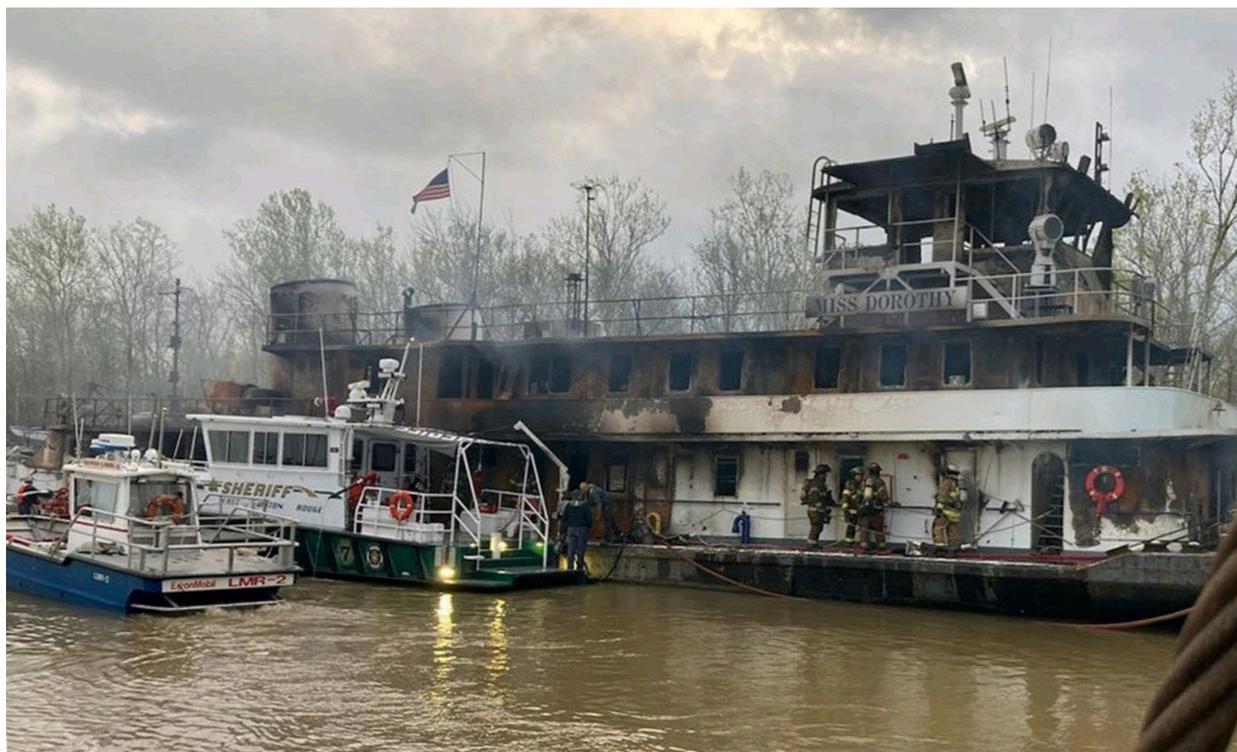
**Figure 7.** East Baton Rouge Sheriff's Office and ExxonMobil fire boats alongside the burned-out *Miss Dorothy* after the fire had been extinguished. (Source: WRBM)

The fire destroyed much of the vessel, including the engine room, storerooms, accommodation spaces, and the wheelhouse. A postcasualty examination of the *Miss Dorothy* showed that the level of severity of fire damage was highest on the forward end of the starboard main engine. Heat damage in this area was also more severe, and the aluminum valve covers and the aluminum engine governor control housing were all

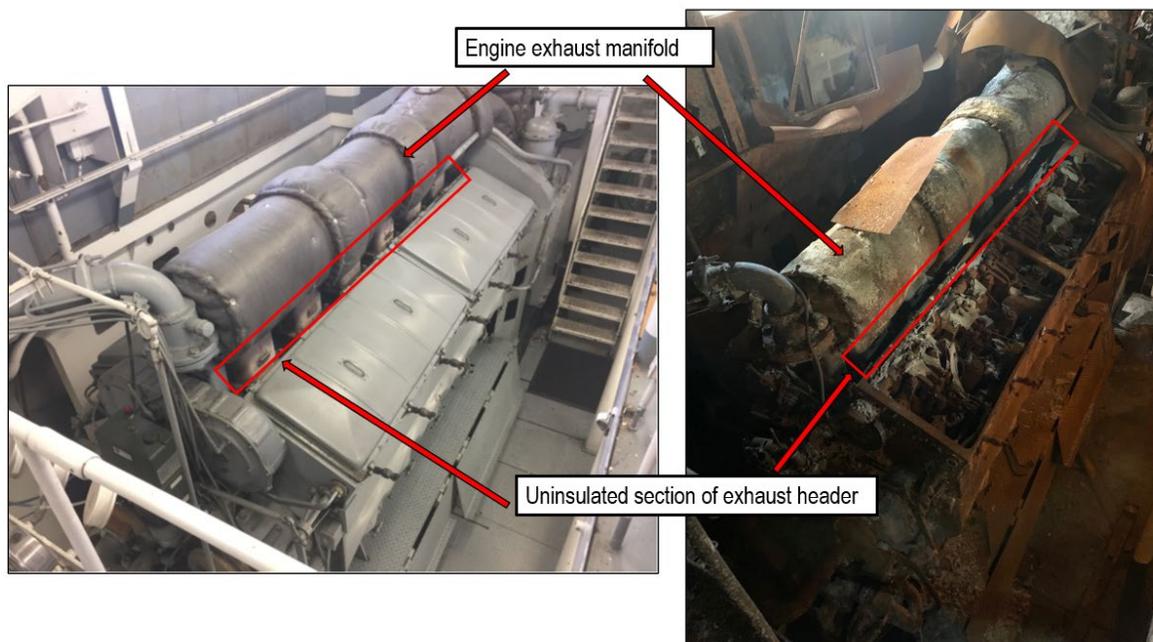
During the postcasualty examination of the vessel, investigators discovered that the 0.5-inch fuel oil return line from the left bank of the starboard main engine, located on the forward end of the engine, had become displaced from its connection flange. The starboard engine exhaust manifold was lagged with insulation, but the section of exhaust header between the engine block and the horizontal portions of the exhaust manifold were not shrouded, insulated, or lagged. This section of exhaust header for the forward inboard cylinder of the starboard engine was about 36 inches from the fuel oil pump end of the starboard main engine and the fuel oil return line that was discovered to be disconnected. WRBM management stated that the engine exhaust surfaces could reach "north of 600°F" when the engine was operating loaded (similar to the night of the fire) and that the fuel pressure in the return line varied between 15 and 30 pounds per square inch gauge.

Section 143.220 (b) of Title 46 *Code of Federal Regulations* Subchapter M for existing towing vessels such as the *Miss Dorothy* states that "piping and machinery components that exceed 220 °C (428°F), including fittings, flanges, valves, exhaust manifolds, and turbochargers, must be insulated. Measures must be in place to prevent flammable or combustible liquid piping leaks from coming into contact with these components."

**Figure 8.** Starboard main engine before (*left*) and after (*right*) the fire, with the uninsulated section of exhaust header indicated. (Source: WRBM)

The fuel used in the engine at the time of the fire was ultra-low sulfur diesel, a highly combustible liquid with a standard flashpoint of 140°F and an average autoignition temperature of 428°F.<sup>4</sup> To prevent combustible liquids, such as diesel fuel, from contacting piping and machinery components that exceed temperatures of 428°F, regulations require that such components be insulated. However, after the fire, investigators found that the exhaust header leading from the individual cylinder heads to the exhaust manifold—which were subject to temperatures greater than 428°F (often higher than 600°F)—near the suspected origin of the fire were uninsulated. Therefore, it is likely that the uninsulated exhaust header acted as an ignition point for the atomized or spraying diesel fuel.

The National Transportation Safety Board determines that the probable cause of the engine room fire aboard the towing vessel *Miss Dorothy* was the ignition of spraying diesel fuel from a main engine's fuel system onto an uninsulated section of the engine's

Engine rooms contain multiple fuel sources, making the spaces especially vulnerable to rapidly spreading fires. Regulations for towing vessels state that “piping and machinery components that exceed 220 °C (428°F), including fittings, flanges, valves, exhaust manifolds, and turbochargers, must be insulated.” Uninsulated engine exhaust surfaces can provide an ignition source for flammable liquids that can easily develop into fires that are difficult to contain. Towing vessel owners and operators, Coast Guard marine inspectors, and third-party organization (TPO) towing vessel examiners should be aware of these dangers and fire risks and should regularly and thoroughly inspect equipment to ensure that measures are in place to prevent flammable liquids from coming into contact with hot surfaces.

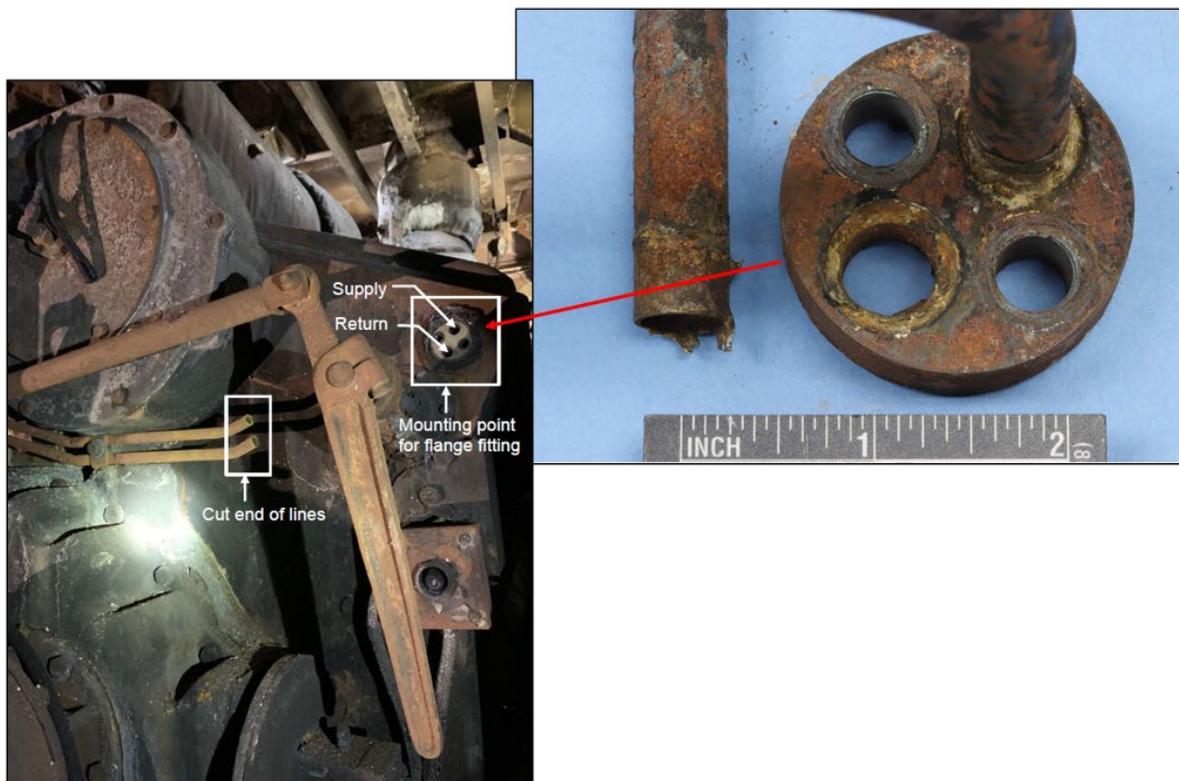
Materials engineers from the National Transportation Safety Board examined the fuel oil supply and return lines from the left banks of both the starboard and port main engines. The lines for the starboard main engine were pressure-tested for leaks; none were found. The fuel pipes and flanges were examined for other notable features (such as cracks, crevices, or dents), but none were found. In addition, the chemical composition of the starboard main engine flange, fuel pipes, and brazing metal was examined using a scanning electron microscope equipped with an energy-dispersive X-ray spectrometer. The flange material was consistent with a low-carbon steel. The fuel lines were made of a double-wall construction, and the material was consistent with mild or low-carbon steel. The brazing compound used to secure the supply and return fuel lines to the flange was determined to have a composition very similar to a commercially available silver alloy brazing material, which had a brazing range between 1,205°F and 1,400°F. The brazing material on the displaced starboard main engine return line was “denuded of braze metal on its top side, and the braze material had accumulated on underside.” The supply line on the starboard main engine showed signs of extrusion but did not become displaced similarly to the return line.

**Figure 9.** Starboard main engine after the fire with section of fuel oil supply and return lines removed (*left*). Laboratory image of flange and de-brazed and separated fuel oil return line (*right*).

A forensic fire investigator concluded that the rapid growth and spread of the fire was indicative of a fuel oil fire. In the area of the starboard main engine, investigators found a 0.5-inch fuel return line that had a de-brazed joint that had separated; however, a laboratory examination of the line showed no signs of loss of integrity, fatigue, or material failure, other than the de-brazed joint. Due to the chemical composition of the brazed joint, temperatures exceeding 1,200°F would have been required to de-braze it and only would have been present in a well-established fire. Therefore, the return line likely separated as a result of the fire, and it is probable that the source of fuel oil did not originate from the examined section of the return fuel line nor the brazed joint. Instead, the fuel likely came from another undetermined pressurized source (near the forward end of the starboard main engine) capable of spraying or atomizing the fuel, such as a faulty flange connection, gauge line, pressure gauge, or pump seal.
