Issued March 16, 2022

MIR-22/07

Contact of Tanker *Riverside* with Moda Ingleside Energy Center No. 4 Loading Dock

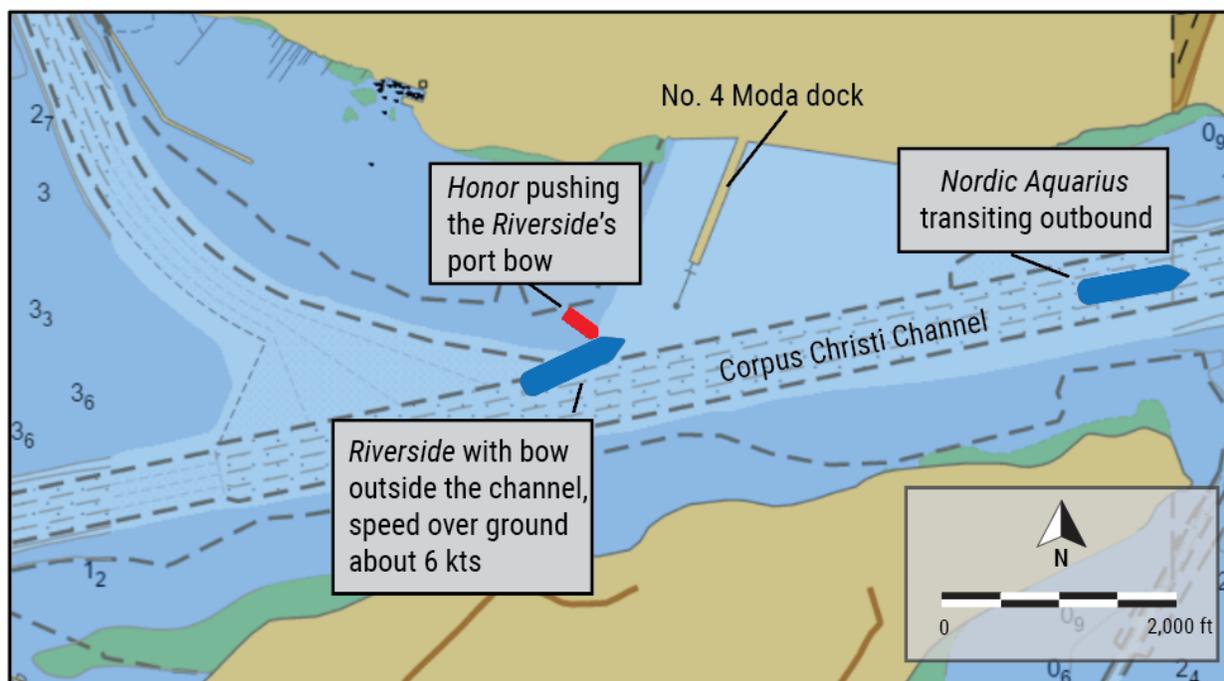
Figure 4. Approximation of *Riverside* at 1300, just before the contact with the no. 4 Moda dock dolphin and catwalk, with the tug *Honor* pushing its port bow; the *Nordic Aquarius* has departed the no. 4 Moda dock and is transiting outbound. (Background source: NOAA)

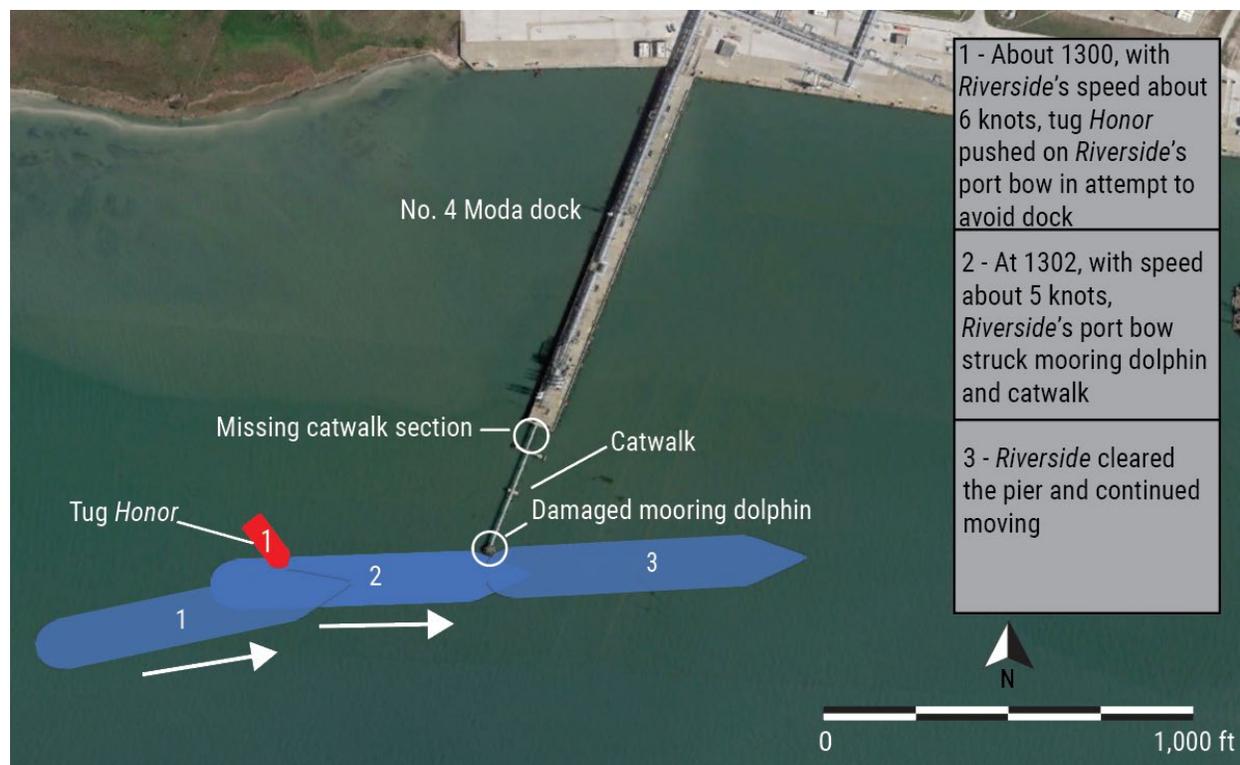
Figure 5. Final events surrounding the *Riverside*'s contact with the no. 4 Moda dock. (Background source: Google Earth)

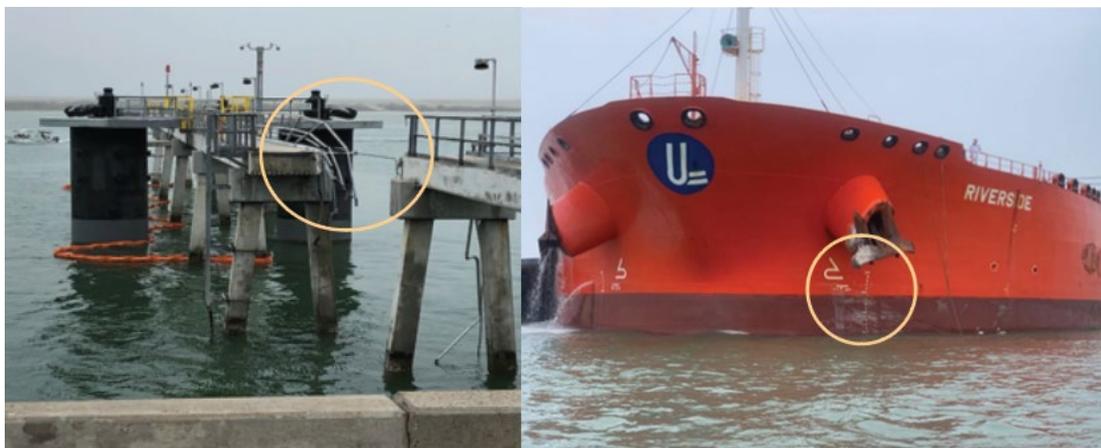
A damage survey determined that the no. 4 Moda dock and mooring dolphin sustained significant damage; a portion of the no. 4 Moda dock's catwalk between the mooring dolphins was missing. According to the classification society report on the damage to the *Riverside*, dated March 16, 2021, the vessel sustained several bent internal frames and hull indents to the fore void space, forepeak tank, and the no. 1 port water ballast double bottom side tank. Additionally, the port anchor shank was bent 20°, and there was scraping damage to the hull.

Figure 6. Damage to the no. 4 Moda dock catwalk (left) and the *Riverside* (right), circled. (Source: US Coast Guard)

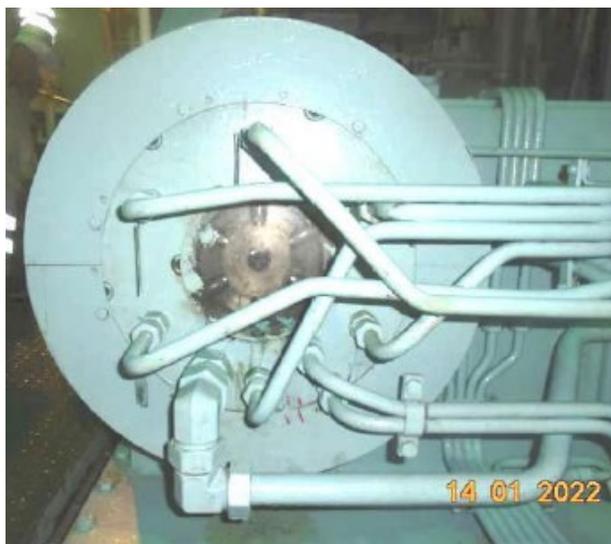
The main engine used a 435-psi (30-bar) pneumatic system for starting in both the ahead and astern directions. It also used a 100-psi (7-bar) control air system to maintain its operation. During a main engine starting air system evaluation, technician 1 determined that the piston slide valve on the no. 6 starting air actuator within the starting air distributor was sticking, which prevented the 7-bar pneumatic signal (pilot air) from opening the no. 6 cylinder air valve. When the actuator and housing were removed, the technician found hardened grease and dirt within the actuator, which he concluded prevented the actuator from moving properly.

Figure 7. The main engine's starting air distributor containing the no. 6 starting air actuator valve. (Source: Thome Ship Management)

Technicians identified that the cause of the main engine start failures was the inability of the no. 6 actuator to initiate piston rotation due to hardened grease and dirt, preventing proper movement. Following the casualty, technicians discovered other problems within several main engine systems, including the fuel pumps, the control air drying system and start air system, and numerous pneumatic air control valves.

The technicians told investigators that the engine start system failed because the vessel's engineers did not clear moisture from the start air system by draining the air tanks on a routine basis. The chief engineer's written standing orders required daily draining during machinery space rounds. However, based on the technicians' assessments, it appears this routine maintenance was not regularly performed. Over time (and before the vessel arrived in Corpus Christi), this allowed hardened grease to build up in the actuator.

moisture accumulation within the start air tanks and piping system due to insufficient draining of the system on a routine schedule. After the actuator was cleaned, the technicians tested the engine and started it in both in the ahead and the astern modes from the bridge, the engine control room, and locally at the main engine with no further issues.

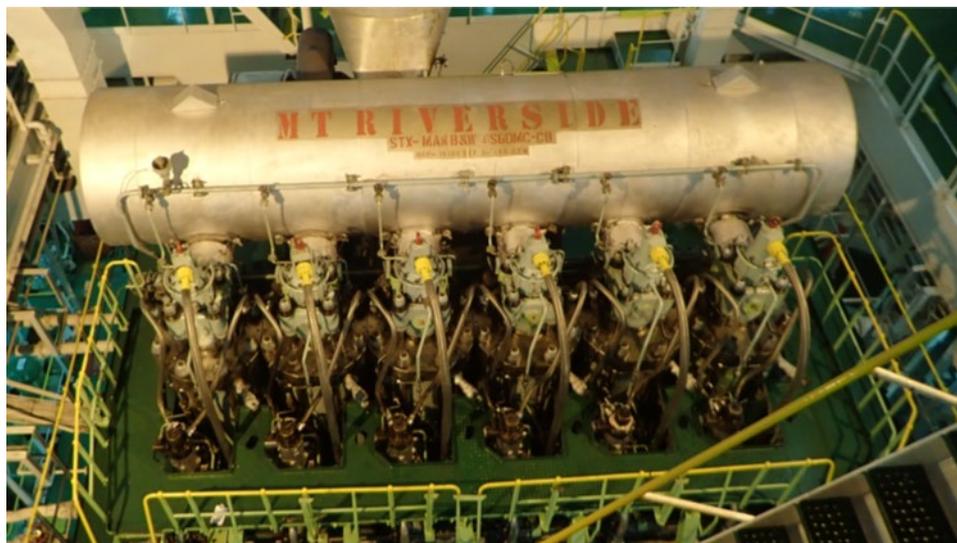
During the evaluation of all systems related to the main engine, technician 2 identified minor issues with the fuel system pumps, which showed signs of wear and would eventually need to be replaced. Additionally, the technicians found leaking air control valves that required maintenance while the technicians were on board to return them to their proper operational status. Although these deficiencies needed to be addressed, the technicians did not indicate that they contributed to the main engine's failure to reliably start.

Figure 8. The top of the *Riverside* main engine. (Source: Coast Guard)
