Issued March 17, 2022

MIR-22/08

Contact of *Kevin Michael* Tow with Melvin Price Locks and Dam Guide Wall

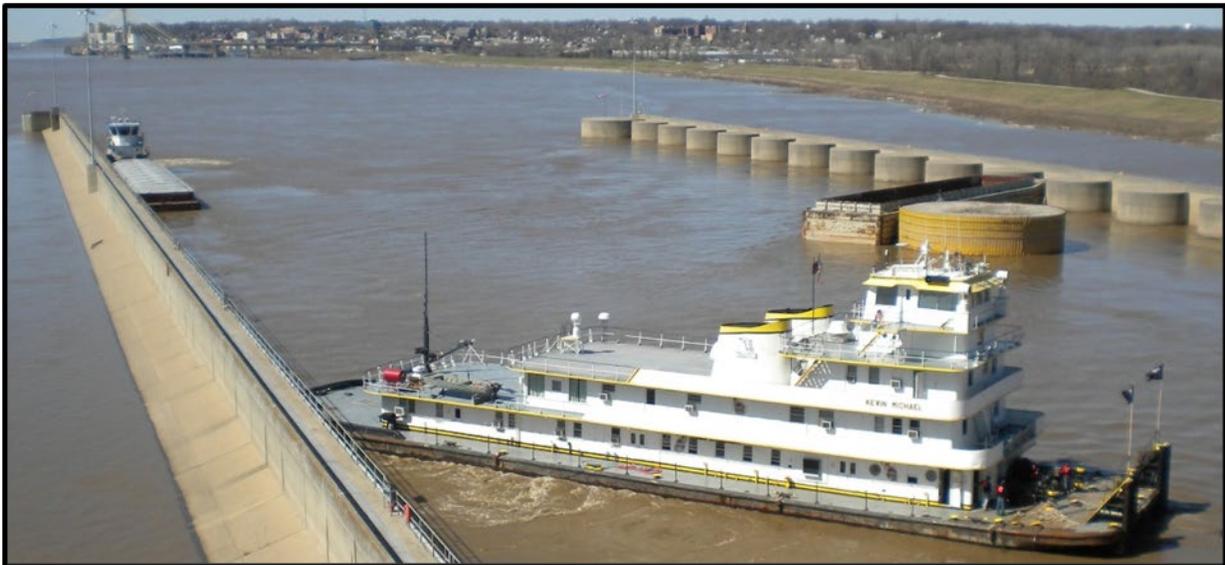
Figure 1. *Kevin Michael* under way at the Melvin Price Locks and Dam after the casualty. (Source: US Coast Guard)

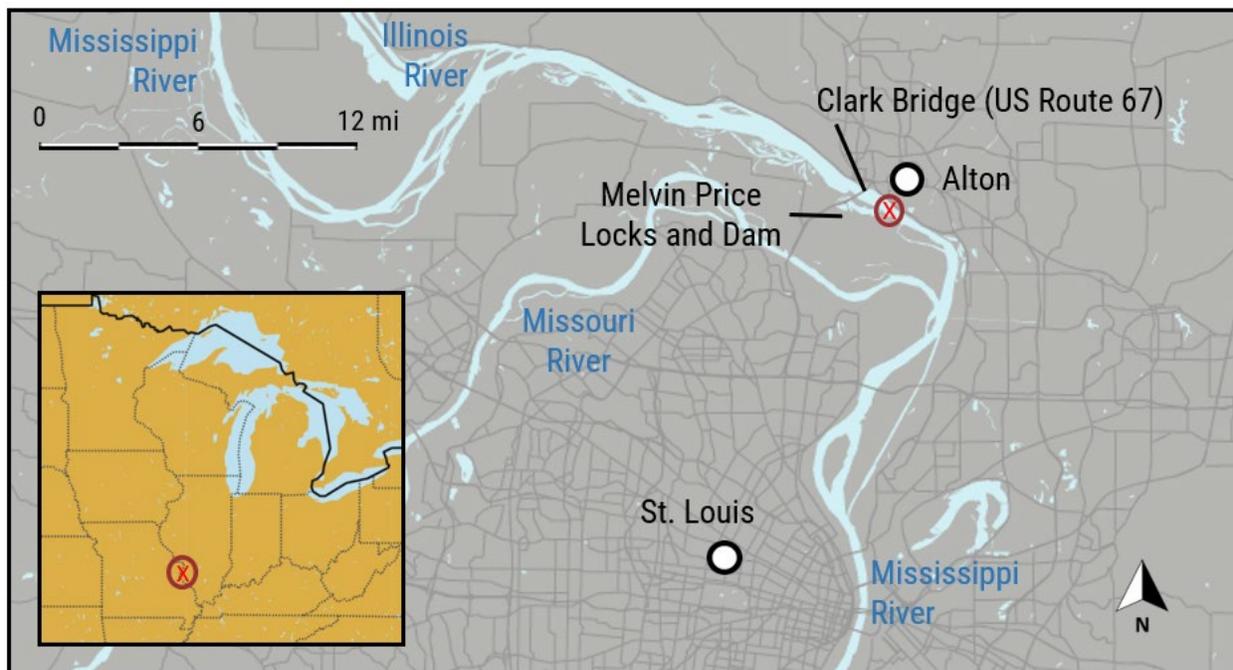
Figure 2. Area where the *Kevin Michael* tow contacted the Melvin Price Locks and Dam guide wall, as indicated by the red X. (Background source: Google Maps)

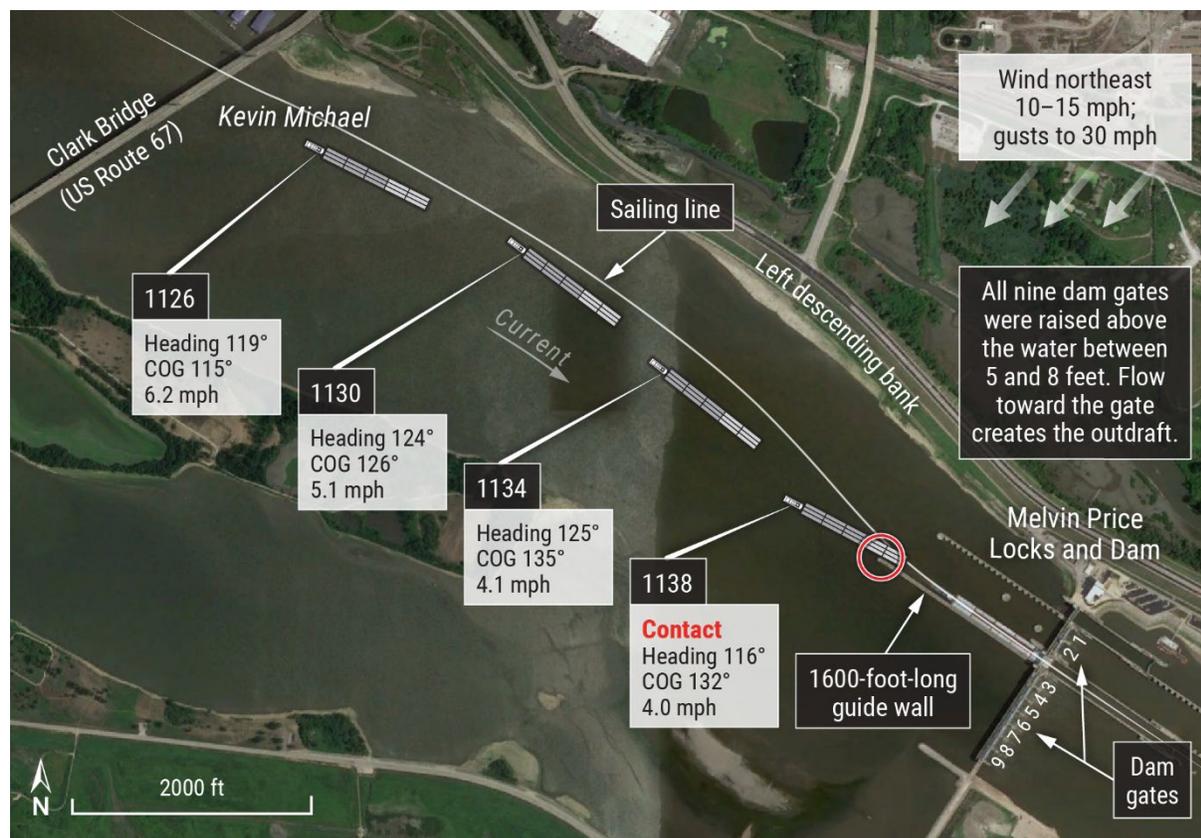
Figure 4. Annotated electronic chart system track history of the *Kevin Michael* tow over the last 12 minutes leading up to the casualty. (Background source: Google Earth)

over ground, was near zero. At 1130, the tow was about 300 feet to the right of the sailing line, aligned with the auxiliary lock chamber upstream guide wall (the sailing line on inland navigational charts is the preferred or recommended route within the reaches of a navigable channel). The upstream guide walls were separated by 400 feet.

Between 1130 and the time of the contact 8 minutes later, the lateral slide indicator showed the bow and stern moving to starboard (toward the center of the river) with a few short movements to port. The pilot told investigators that when the head of the tow was about 1,000 feet from the bull nose of the main lock chamber guide wall (between 1135 and 1136 based on ECS data), he became concerned with the approach into the lock chamber because the outdraft "really got strong," and the wind was pushing the tow sideways across the river more than he anticipated. The pilot radioed his concern to the two crewmembers at the head of the tow who were providing him with distances to the guide wall.

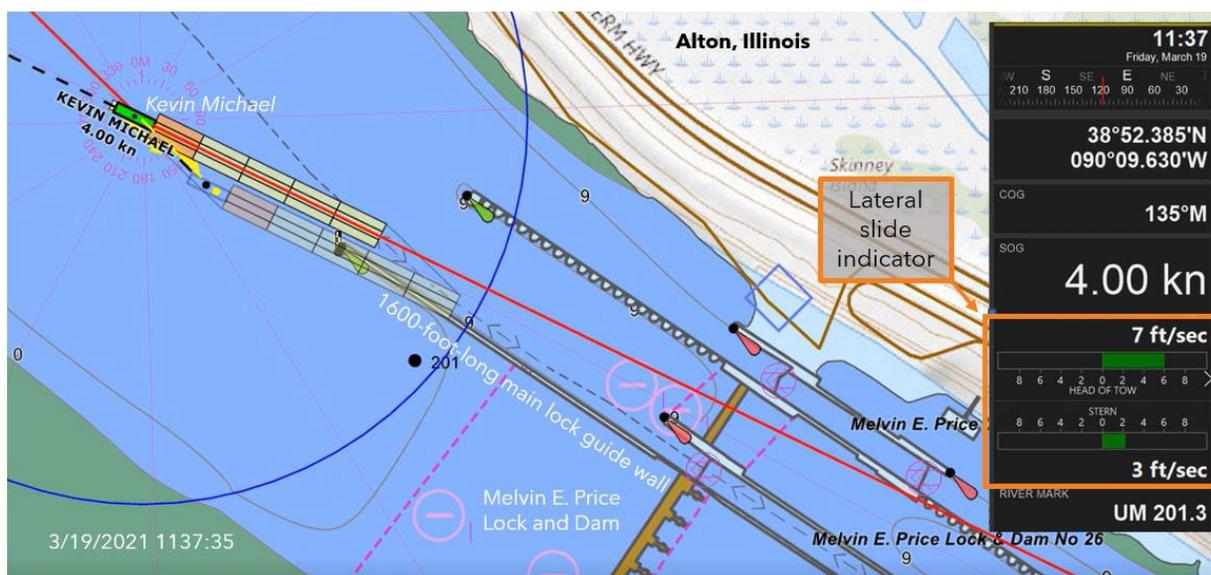
Figure 5. Screenshot of the *Kevin Michael* ECS at 1137 with the bow and stern sliding laterally to the right at 6.1 and 2.1 feet per second (rounded to 7 and 3 feet per second in lateral slide indicator).

At 1138, the empty outboard barge in the second row on the starboard side string contacted the guide wall bull nose, causing the tow to break apart. At the time of the contact, the tow's speed over ground was 4 mph, its heading was 116°, and its course over ground was 132°. In the minute before the contact, the lateral slide indicator showed speeds as high as 6.1 feet per second (4.1 mph) at the bow and 2.1 feet per second (1.4 mph) at the stern.

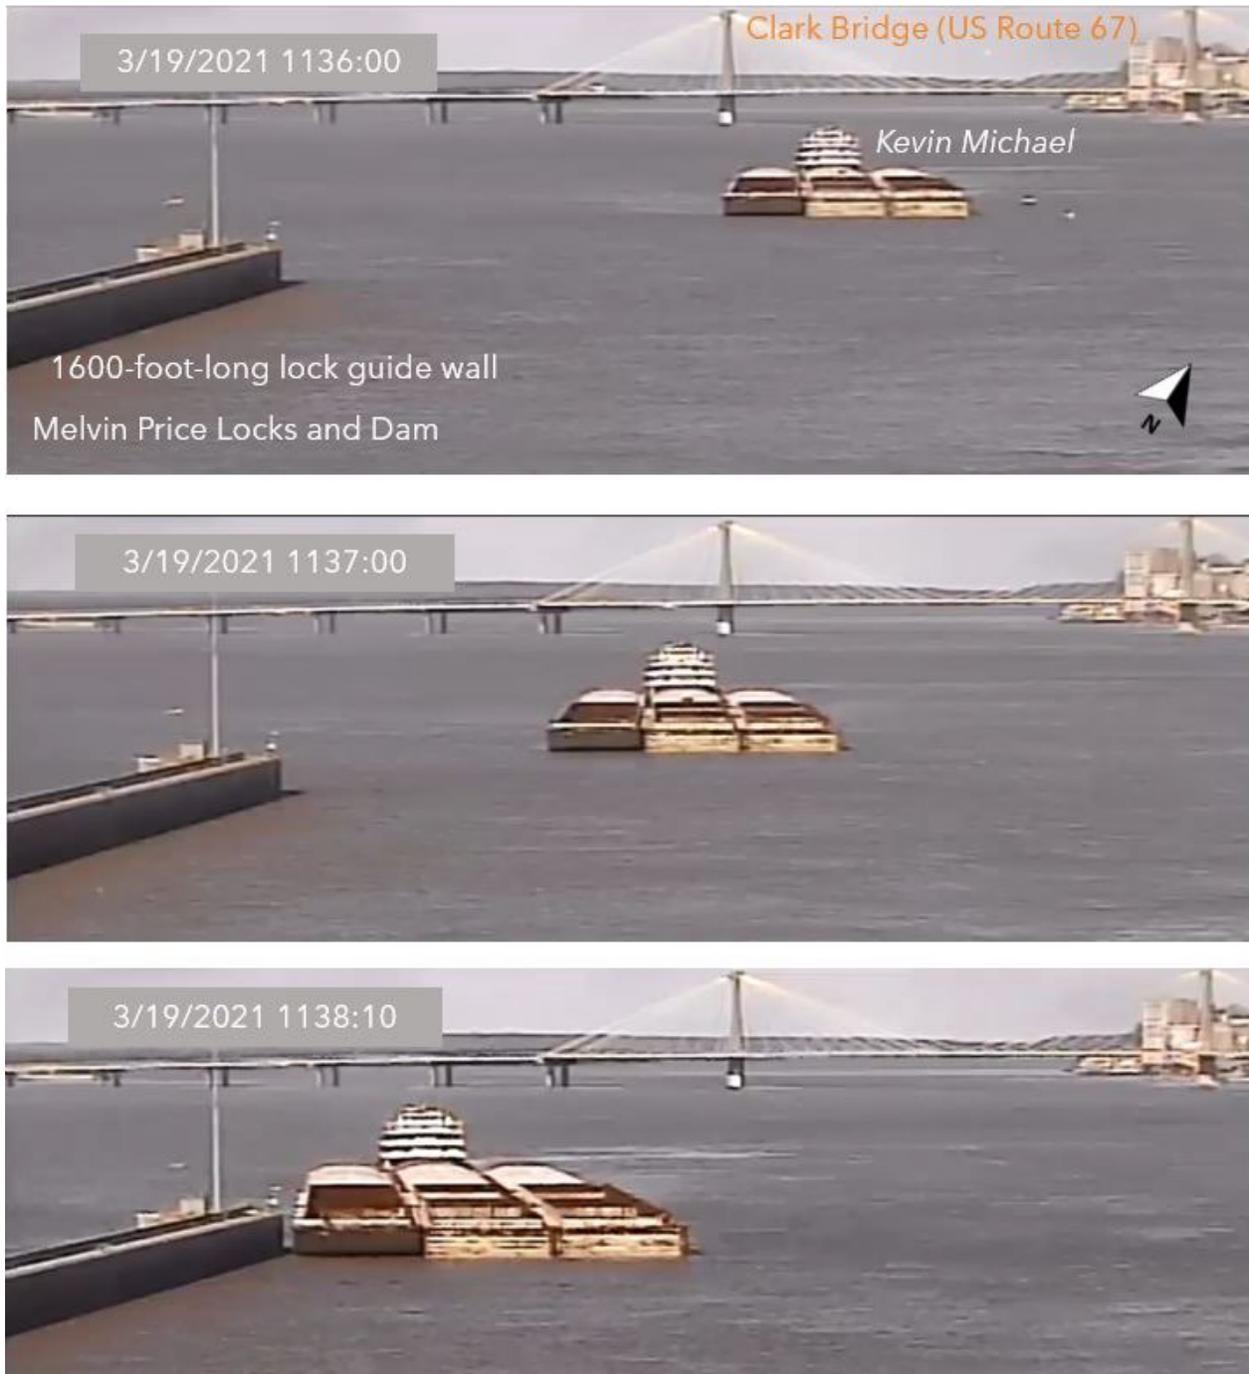
Figure 6. Screenshots of the *Kevin Michael* tow, starting 2 minutes before the contact. (Source: US Army Corps of Engineers)

Eight barges drifted into the forebay area north of gates 1 and 2, with one barge entering the open main lock chamber. Seven barges drifted into gates 3-9. Following the barge breakaway, the lock was closed to traffic. Nearby towing vessels rounded up the barges. The lock reopened the next day, March 20, at 1950. The lock closure delayed seven southbound and three northbound tows.

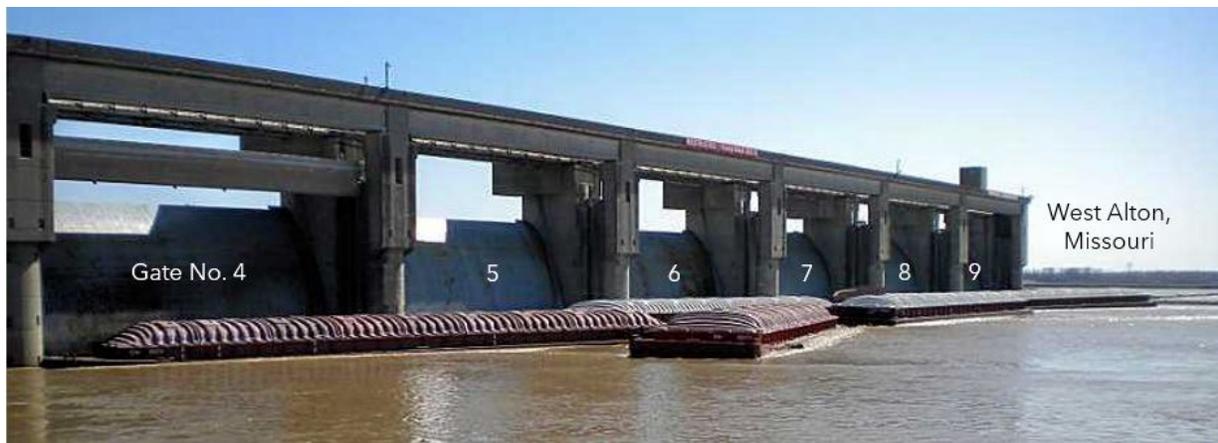
Figure 7. Barges upstream of the Melvin Price Locks and Dam west of the guide wall following the casualty. (Source: Coast Guard)

The *Kevin Michael* was not damaged. Six barges incurred damage to the sides and bottom, coaming, covers, and mooring fittings. The west guide wall was scraped, but an inspection determined it to be structurally sound, and it did not require repairs. Gates 4 and 5 incurred minor damage. The bottom of the raised gate 5 was perforated, and the plate and supporting ribs were deformed.
