Issued March 31, 2022

MIR-22/11

Grounding of Tanker *Bow Tribute* and Subsequent Contact with River Intake Fender Systems

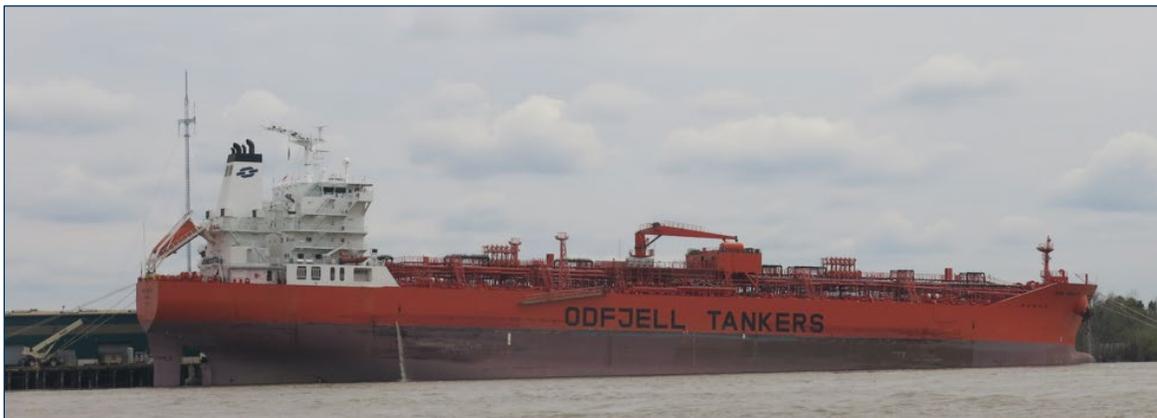
Figure 1. *Bow Tribute* moored alongside a dock after the casualty.

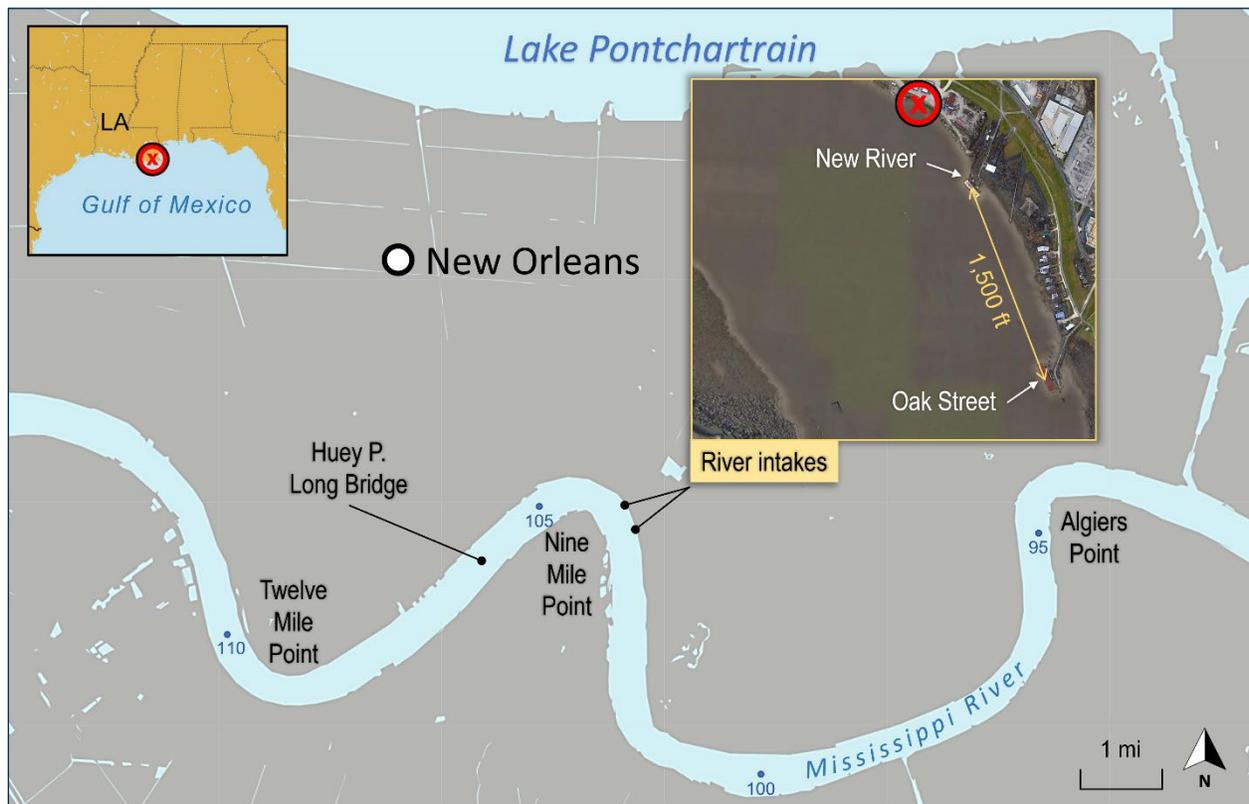
Figure 2. Area where the *Bow Tribute* grounded as indicated by a red X, and then struck the New River and Oak Street river intake fender systems. (Background source: Google Maps)

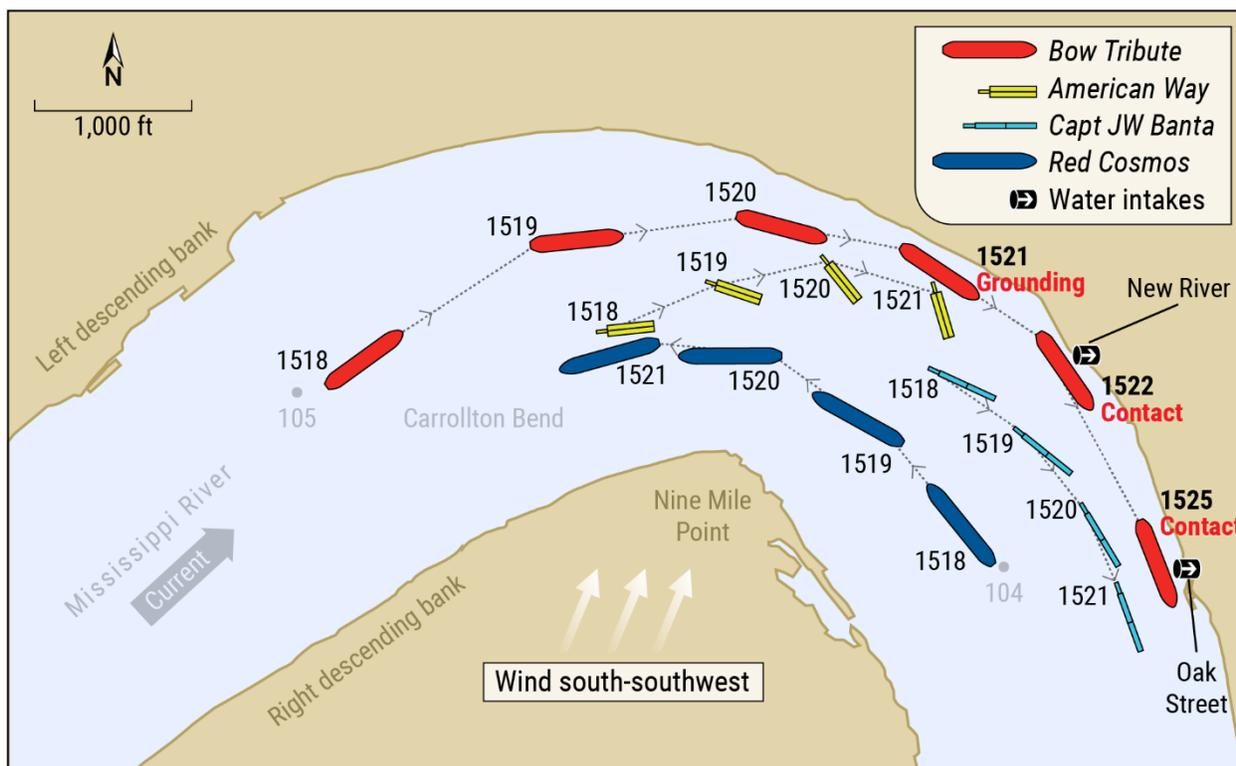
Figure 3. Positions of the *Bow Tribute*, *American Way*, *Capt JW Banta*, and *Red Cosmos* (approximate scale) in the Carrollton Bend in the minutes leading up to the casualty, based on automatic identification system data. The *Bow Tribute*'s subsequent contact at the two river intakes is also identified.

At 1519, the tanker and towing vessel were traveling about 0.15 miles apart: the *Bow Tribute* at 15.1 knots was astern of the *American Way* at 7.8 knots. Noticing the *American Way* was “widening out and sliding” into the bend (moving sideways toward the left descending bank), the NOBRA pilot on the *Bow Tribute* hailed the pilot on the *American Way*, asking, “You’re gonna make it, huh?” He received no response. Seconds later, the NOBRA pilot again hailed the *American Way*; this time the towing vessel’s pilot acknowledged the radio call. “I’m the one overtaking you,” said the *Bow Tribute*’s pilot. “You gonna be alright?” The pilot of the *American Way* replied that he was “trying to get up.”

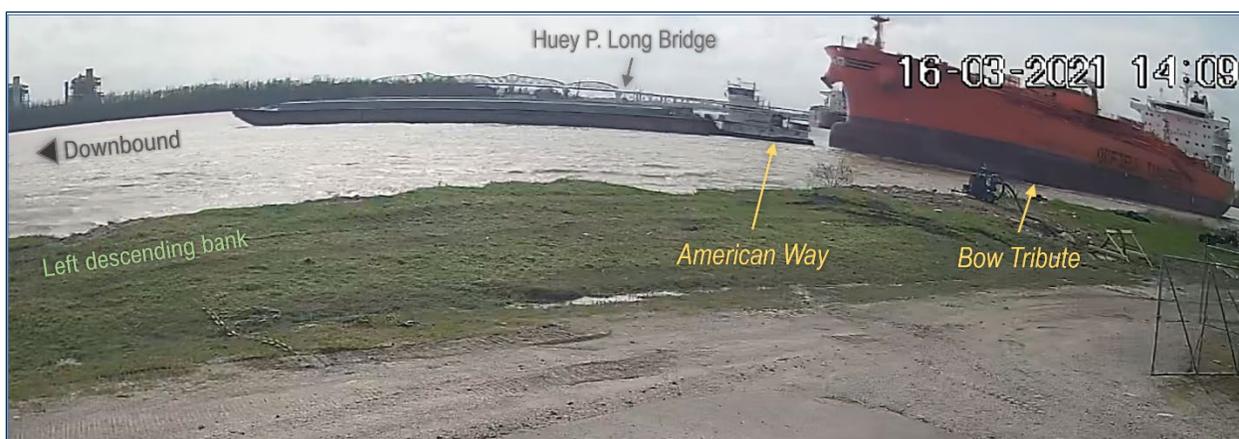
Figure 4. CCTV footage looking upriver at 1521 shows the *Bow Tribute* near the left descending bank with the *American Way* by the tanker’s starboard bow. (Timestamp is 1 hour 11 minutes behind the actual time.) (Source: Crosby Dredging)

As the NOBRA pilot ordered the engine to full astern, the master of the *Bow Tribute* arrived on the bridge and recalled seeing the *Bow Tribute* was so close to the bank that there was only one direction to turn, to starboard, but the *American Way* was close on the starboard side and therefore in the way. At 1521:45, the sound of vibrations could be heard on the bridge from the ship's voyage data recorder, and on closed-circuit TV (CCTV) cameras located on the left descending bank, the stern of the *Bow Tribute* could be seen momentarily interacting with the bank (grounding) and its stern rising out of the water while the vessel was traveling about 10.3 knots. The tanker continued along the left descending bank with about 21 knots of wind on its starboard side. The NOBRA pilot on the *Bow Tribute*, not wanting to collide with the *American Way*, told investigators that he kept the vessel near the shoreline because he could no longer see the *American Way* under the *Bow Tribute*'s starboard bow.

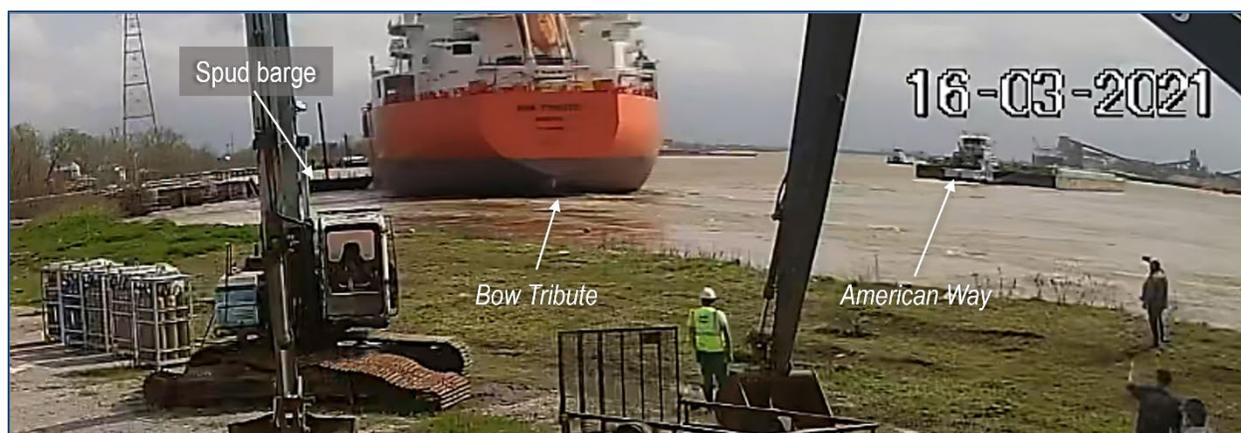
Seconds later, at 1522:26, the port side of the *Bow Tribute* struck a spud barge moored at mile 104.1 for the New River water intake system owned by the Sewerage and Water Board of New Orleans. The barge was part of a fender system to protect the river intake pipes. After being struck, the barge broke free from its spuds and moorings and drifted downriver. The NOBRA pilot on the tanker issued a series of rudder orders to port and starboard and, at 1522:38, ordered the starboard anchor let go, seeing the *American Way* was not at risk of being below the *Bow Tribute*'s starboard anchor. The second officer relayed the order to the bosun on the bow, who let go the starboard anchor without delay.

Figure 5. CCTV footage looking downriver at 1522:26 shows the *Bow Tribute* when it struck the spud barge protecting the New River water intake pipes. (Source: Crosby Dredging)

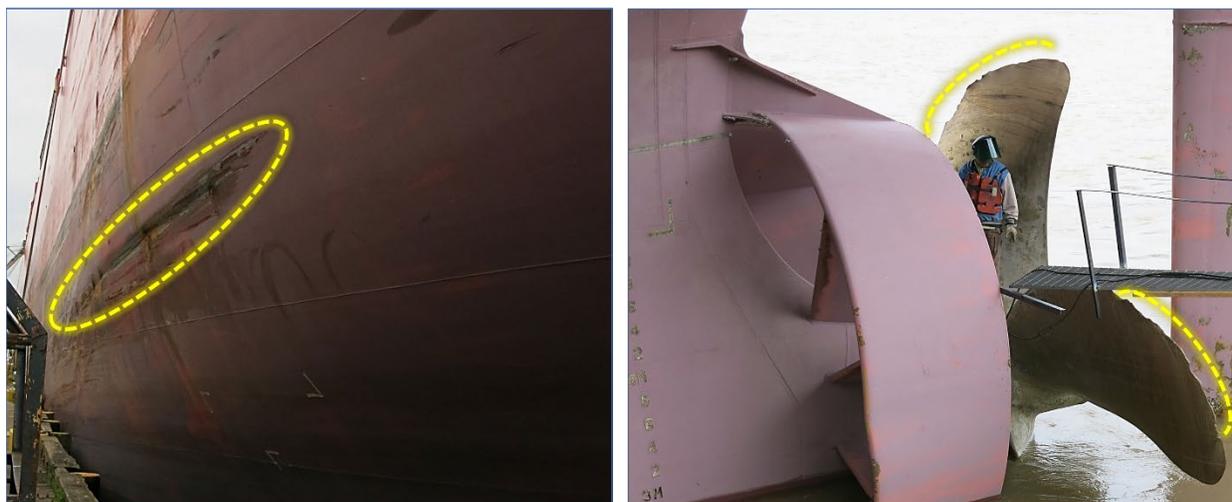
Neither the *American Way* nor its barges sustained any damage. On the *Bow Tribute*, all four of the propeller's blades were found with indentations, bends, and loss of material on their edges, as well as there was damage to the stern tube shaft seals. There was also damage to the portside hull shell plating: below the waterline near the aftmost cargo tanks and machinery spaces and above the waterline outboard of the machinery spaces (where there were scrapes and an indentation). The portside accommodation ladder was also damaged.

Figure 6. Postcasualty damage to the *Bow Tribute*'s portside aft hull (*left*) and propeller (*right*), as indicated by yellow dashed lines.

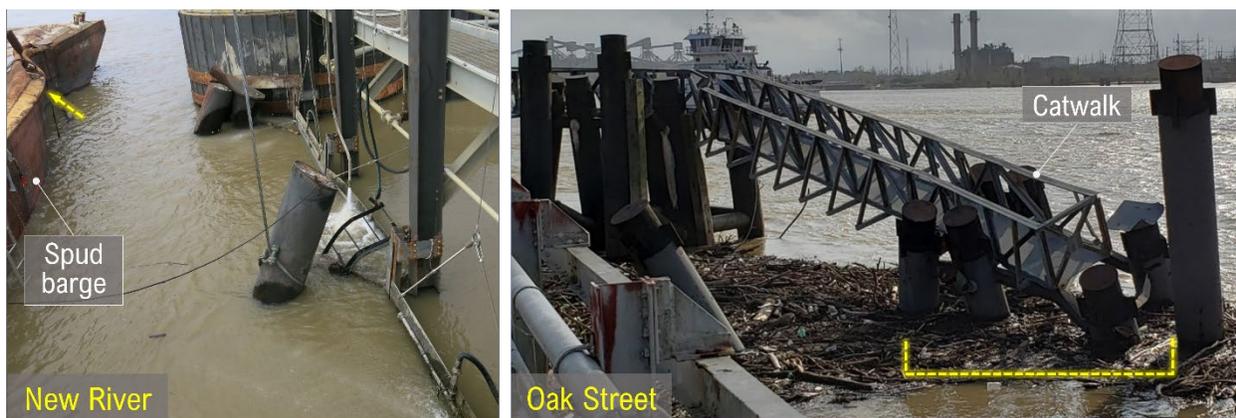
The fender systems for both river intakes sustained damage, but there was no damage to their pipes; the intake systems continued functioning without interruption. As a result of the protection barge being pushed into the fender system at the New River water intake, the dolphin piles, cells, and intake screen incurred damage. Also, the protection barge that broke free (but was later recovered by a nearby tugboat and returned to its original location) sustained compression damages and a crack in the hull. The Oak Street water intake fender system had a catwalk destroyed, and there was damage to its dolphin piles. Both river intake fender systems had been damaged during a previous casualty 5 years prior (on February 2, 2016) when struck by the tanker *Nordbay*; overall, they had not been repaired or replaced prior to the contact by the *Bow Tribute*.⁶

Figure 7. Damage to the river intake fender systems: (left) arrow shows damage to the spud barge at New River; (right) bracket identifies the damaged catwalk and dolphin piles at Oak Street downriver. (Source: Coast Guard [right photo])
