Flooding and Sinking of Towing Vessel

Proassist III

On December 24, 2020, about 1742 local time, the towing vessel *Proassist III* was transiting the Caribbean Sea, 3 miles off the coast, near Puerto Yabucoa, Puerto Rico, when its stern compartments began flooding.¹ The three crewmembers aboard attempted to pump out the water but were unsuccessful and subsequently abandoned the vessel. They were rescued by a responding Good Samaritan vessel, and the *Proassist III* later sank about 0.25 miles from shore. No injuries were reported. An oil sheen was visible after the vessel sank. The vessel was later recovered but was considered a constructive total loss valued at \$968,000.

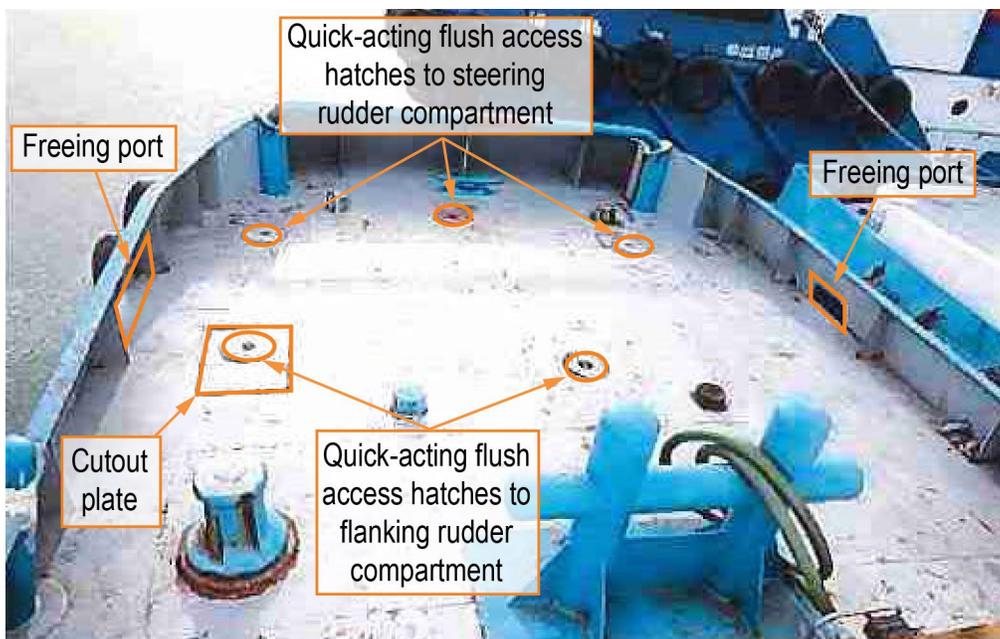
About 1640, when the vessel neared the Punta Tuna Lighthouse, the second deckhand said he noticed that the stern "was riding a little low." The deckhand/engineer said that he and the second deckhand removed the quick-acting flush access hatch for the flanking rudder compartment near the centerline of the vessel to see if the vessel was taking on water. (There were additional quick-acting flush access hatches on the starboard and port sides of the deck; the starboard-side hatch was encompassed by a rectangular cutout of the deck plate measuring about 27 inches wide by 40 inches long, which the captain believed was welded in place.) They stated that they saw about 3 feet of water in the compartment. The deckhand/engineer said he then checked for water in the vessel's other compartments, including the steering rudder compartment and engine room, and found none.

Figure 4. Main deck at the stern of the *Proassist III*. (Background source: Coast Guard)

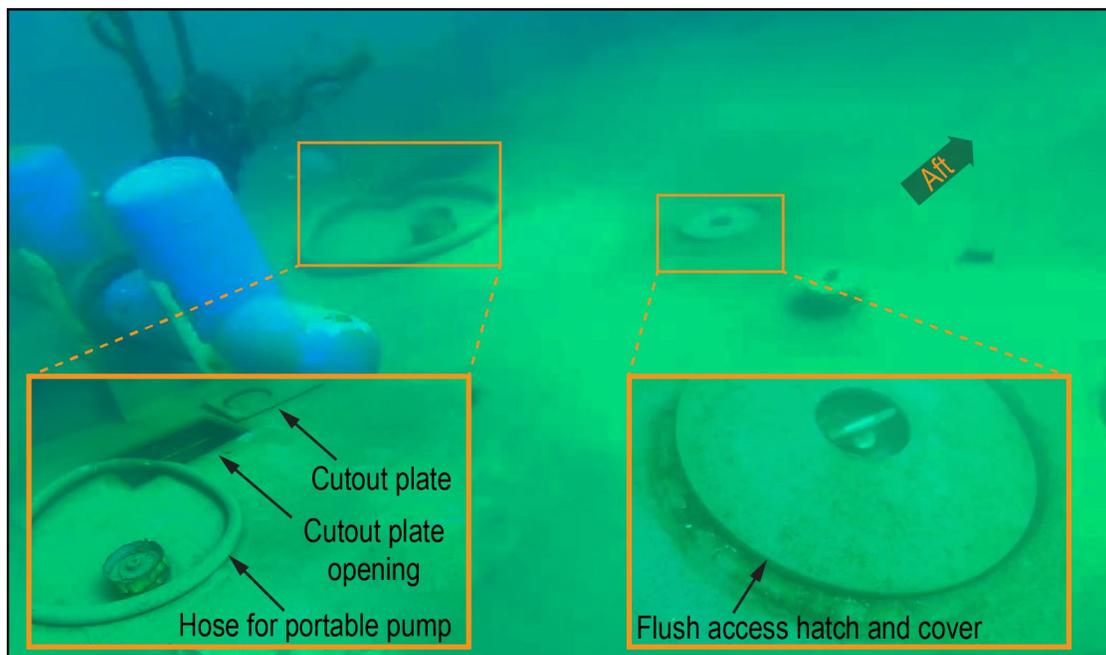
After the sinking, divers hired by the owner examined the vessel under water. After the examination, the NTSB reviewed the video, which showed the starboard-side rectangular cutout plate to the flanking rudder compartment laying on the deck next to its opening. The quick-acting flush access hatch opening that the plate encompassed was missing its cover (see figure 5). A portable pump hose, which the deckhands said had been used to pump water from the compartment out through the center flush hatch opening, could be seen extending into the compartment through the cutout plate opening. The cutout plate did not appear to have securing device or bolts to keep it in place, nor a gasket or gasket material, and the edges of the plate and the plate frame appeared wasted (corroded). Additionally, the center quick-acting flush hatch cover to the flanking rudder compartment was found unseated.

Figure 5. Starboard-side cutout plate with missing quick-acting flush access hatch cover (*left*) and unseated center quick-acting flush access hatch cover (*right*) to flanking rudder compartment. (Background source: Jorge Oller Reyes)

The underwater survey showed that the starboard deck cutout plate that encompassed the quick-acting flush access hatch to the flanking rudder compartment was displaced. The portable pump discharge hose was found with a loop on deck and both ends leading down through the cutout plate opening, indicating that the pumping the crew described was likely occurring through the cutout plate. With the cutout plate open, any water on deck would have drained into the flanking rudder compartment. Further, since the cutout plate (a flat steel plate inset resting on a framed lip) had no apparent gasket or means to be secured, water on deck would have drained through its seams even if it had been in place.

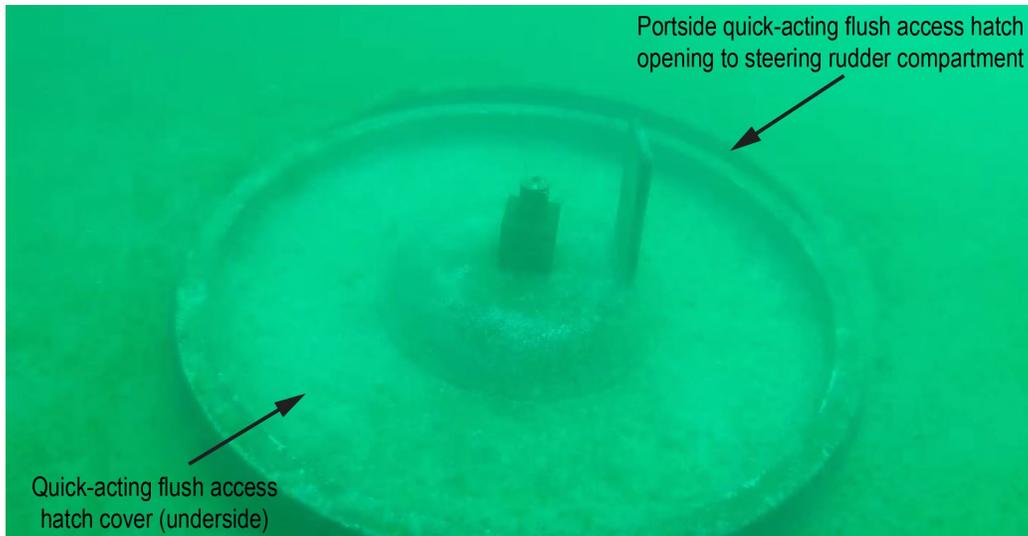
Video of the two quick-acting flush access hatches for the steering rudder compartment showed that the portside hatch cover was upside down and laying so that it covered more than half of the opening (see figure 6). A gasket was missing, and the underside of the cover was absent any dogs or mechanism to secure it in place.

Figure 6. Upside down portside quick-acting flush access hatch cover and opening to the steering rudder compartment. (Background source: Jorge Oller Reyes)

access hatches providing access to the flanking and steering rudder compartments, nor the cutout plate that encompassed the starboard flush access hatch to the flanking rudder compartment, had bolts or a securing mechanism (dogs) to keep them in place. Further, the covers and hatch were missing gasket material and had corroded frames; therefore, water on deck would have seeped through the hatch seals into the compartments below. However, the rate of flooding through the unsecured hatch seals also would not have approached the calculated 304 gpm.

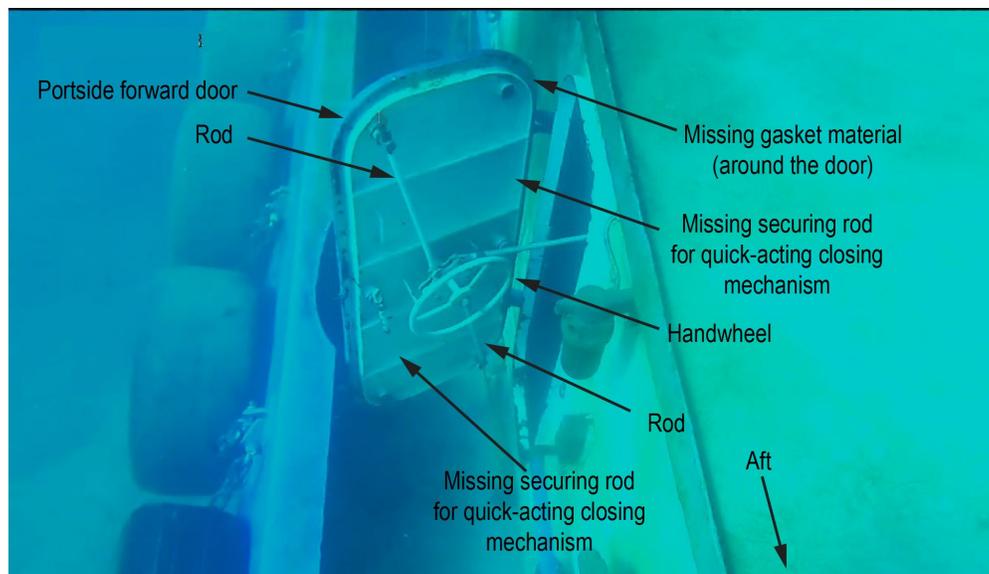
The aft weathertight door on the port side and the only door on the starboard side of the house (which was also weathertight) were shown open in the video (see figure 7). Portions of the quick-acting closure devices used to secure the corners of the open doors appeared to be missing, as well as gasket material used to keep water from seeping into the interior of the vessel when each door was closed on its frame. In addition, the starboard-side door was missing a lower rod, and the two top rods appeared to not be connected to the top of the door and still connected to the hand wheel. The unsecured rods appeared to have swung downward and stretched across the sides of the door, preventing the door from being closed.

Figure 7. Portside forward quick-closing weathertight door on the main deck. (Background source: Jorge Oller Reyes)

As the vessel progressively flooded, its freeboard would have decreased, resulting in more water on deck and higher flood rates through unsecured or open aft deck hatches. Eventually, water would have reached the deckhouse, where it would have also begun downflooding through the weathertight doors on the port and starboard sides, which were found open during the postcasualty underwater survey (even if the doors had been closed, they would not have been sealed tightly, since they were missing gaskets or in disrepair).

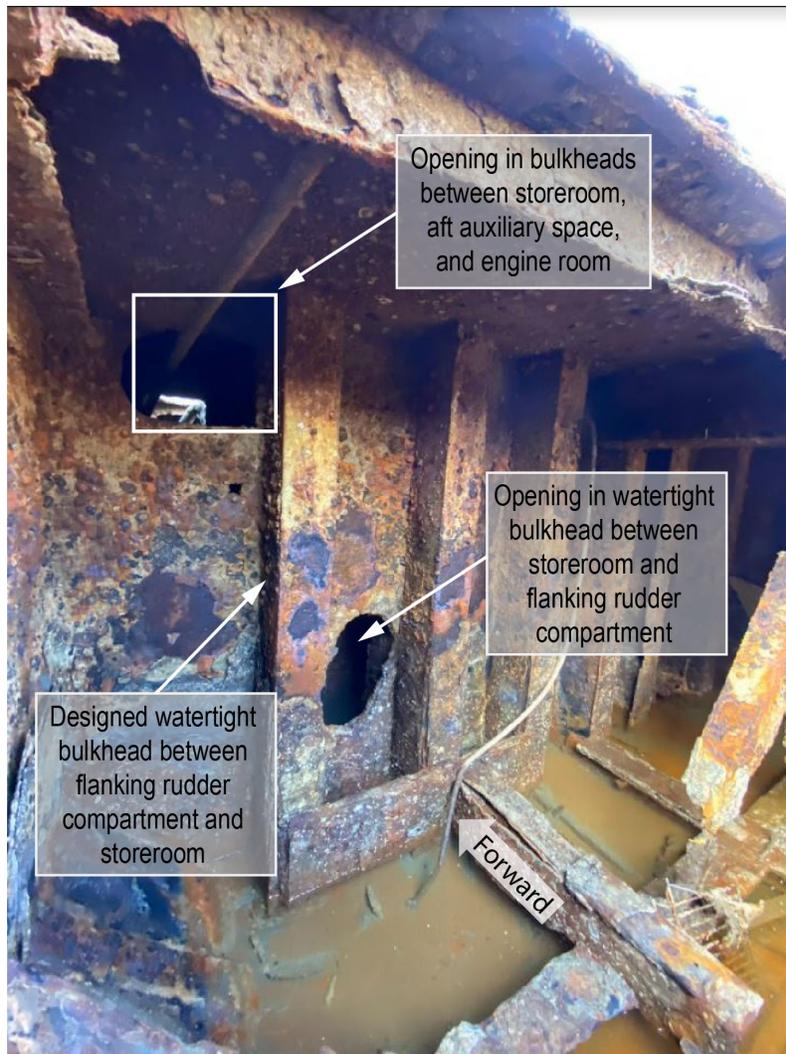
The *Proassist III* was refloated and brought shoreside to Puerto Yabucoa on September 27, 2021. During an examination of the recovered vessel on November 17, 2021, investigators found several openings in designed watertight bulkheads: there were openings for a pipe running through the bulkheads separating the engine room, auxiliary machinery space, storeroom, and flanking rudder compartments; there were openings in the watertight bulkhead between the storeroom and the flanking compartments; and the section of the watertight bulkhead between the flanking and steering rudder

compartments, similar to the bulkhead shown in figure 8, was missing. During the examination, investigators determined the distance from the stern of the vessel to the bulkhead between the storeroom and flanking rudder compartments was 27.5 feet, and from the deck to the bottom of the vessel in the flanking rudder compartment and the steering rudder compartment measured 7 feet 7 inches and 5 feet 1 inch deep, respectively. The owner told investigators he planned to scrap the vessel.

Figure 8. Flanking rudder compartment after recovery. Openings in bulkhead shown also typical of other bulkheads below the main deck separating compartments. (Source: Coast Guard)

About 30-40 minutes after the crew discovered the water and attempted pumping it off, the flanking rudder and steering rudder compartments were completely filled, and the deckhands abandoned their dewatering efforts. Even before the compartments were completely filled, ongoing progressive flooding would have occurred through the openings (found during the postcasualty examination) in the bulkheads separating the engine room, auxiliary machinery space, storeroom, and flanking rudder compartments, including cutouts for a pipe to run through those spaces.
