Fire aboard Fishing Vessel *Nobska*

On April 30, 2021, about 1810 local time, a fire erupted aboard the fishing vessel *Nobska* while the five-member crew was ground fishing in Georges Bank, about 80 miles east of Cape Cod, Massachusetts.¹ The fire started in the engine room and quickly engulfed the vessel. When attempts to extinguish the fire proved unsuccessful, the crew prepared to abandon ship and activated the vessel's emergency position indicating radio beacon (EPIRB). A US Coast Guard helicopter rescued the crew from the stern of the fishing vessel. Neither injury nor pollution was reported. The *Nobska*, valued at an estimated \$2.4 million, was declared a total constructive loss.

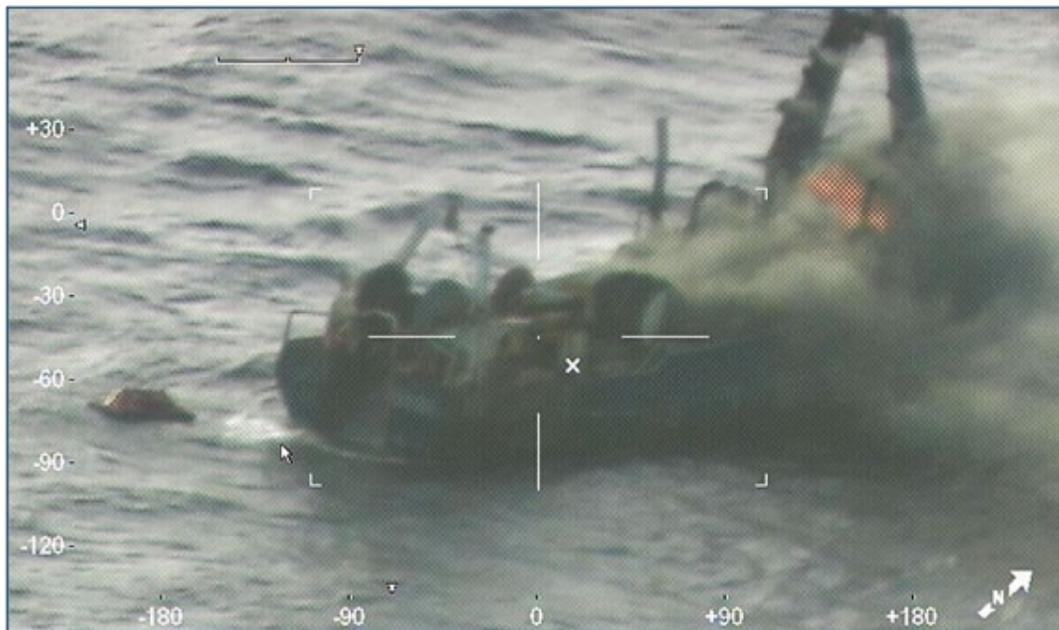
aircraft confirmed that the five crewmembers were on the stern of the vessel and that the *Nobska* was engulfed in flames with smoke billowing from the vessel's bow to about midships. Crewmembers, directed by the rescue swimmer from the helicopter, entered the water and were hoisted to safety. The helicopter then departed the scene at 1908.

Figure 3. Photo taken from the Coast Guard HC-144 aircraft at 1827 shows the bow of the *Nobska* on fire before the rescue. The deployed liferaft appears on the left. (Source: US Coast Guard)

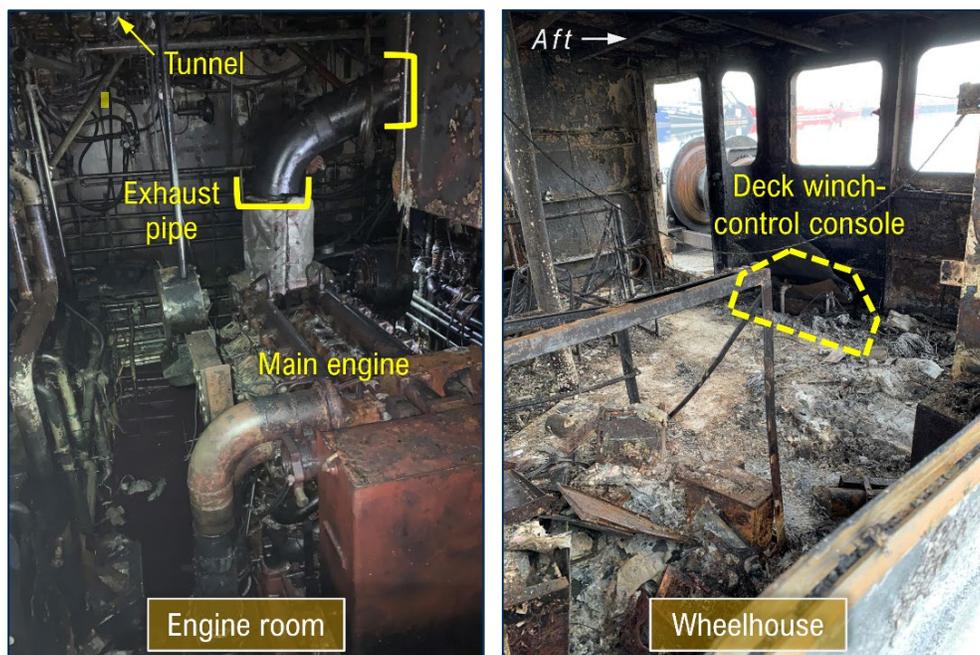
About 1700, as the crew was on deck preparing to retrieve the net, the captain was in the wheelhouse at the deck winch-control console. As the captain was assisting in retrieving the net, he saw black smoke emanating from under the console. The captain stepped out of the wheelhouse to alert the crew of the fire. Within moments, the entire wheelhouse area was engulfed in flames, which quickly spread to the entire forward section of the vessel. The crew, now on the aft main deck, used two more handheld B-2 extinguishers and deployed a grenade-type fire extinguisher through a portside hatch leading to the engine room, but their attempts to extinguish the fire were unsuccessful. The four remaining fire extinguishers on board could not be reached due to the fire.

After the fire extinguished itself about 2 days later, the *Nobska* was towed to New Bedford on May 4. The next morning, investigators examined the vessel and found an extensive amount of fire damage within the vessel and throughout the engine room. All combustible materials in the forward part of the vessel were incinerated, leaving only the steel decking and structure. In addition, there were several overhead frames in the engine room that had warped and separated from deck plating above.

During the examination, it was noted that the fire damage to the main diesel engine, diesel engine generator, and hydraulic system diesel engine was limited to the melting of plastic parts. Damaged hydraulic hoses were found on the bulkhead aft of the main diesel engine and within the tunnel located in the overhead of the engine room 2 feet away from the main diesel engine. Due to the extent of the fire, it could not be determined if the damage to the hydraulic hoses occurred before or during the fire that engulfed the vessel, nor could the location of where the second fire initiated be

Figure 4. Post-fire damage of the engine room, where the crew removed the lagging from the exhaust pipe, as indicated by the yellow brackets (*left*), and of the wheelhouse, where the captain observed black smoke emanating from under the deck winch-control console (*right*).

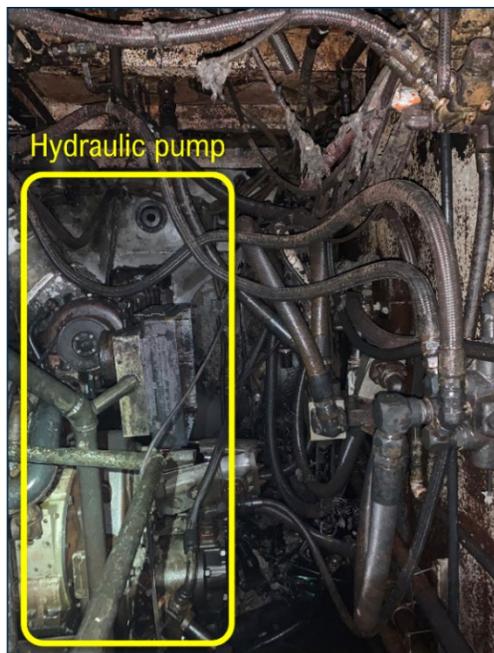
Three pumps attached to the hydraulic diesel engine supplied hydraulic pressure up to 2,500 pounds per square inch (psi) to operate the port and starboard deck winches and net drum used to deploy and haul in the nets. The engine, pumps, and hoses were in the aft part of the engine room. Two of the three hydraulic pumps drove the two deck winches; the third hydraulic pump drove the net drum, boom, and hoisting cargo winch.

Figure 5. Post-fire hydraulic pump and hoses inside the engine room.

The heat from the first fire, which would have entered the vertical pipe/hose tunnel, may have caused heat damage to the other hoses inside the tunnel. Also, the removal of the damaged hydraulic line and the installation of the replacement hydraulic hose could have inadvertently caused damage to the hose being installed or to the other hydraulic hoses bundled together within the tunnel. The damage to the hoses from either the first fire or the replacement of the hydraulic hose may not have been apparent to the crew, but it would have weakened their structural integrity, thereby increasing the likelihood of their failure, which could have caused hydraulic fluid to spray within the engine room.

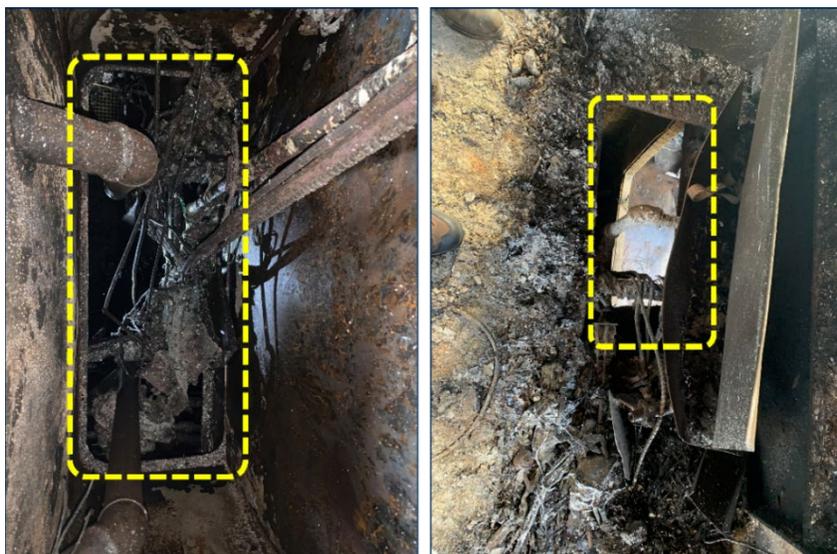
A 1-by-2-foot rectangle-shaped pipe/hose tunnel extended vertically from the overhead of the engine room up two decks to the deck winch-control console in the wheelhouse. Within this tunnel, there were fifteen 0.25-inch-diameter hydraulic hoses connecting to the console that were bundled tightly together. There were no pipe/cable fire stops or other methods to prevent the passage of smoke, heat, and fire from the

engine room into the tunnel.³ As an uninspected fishing vessel, the construction of the pipe/hose tunnel on the *Nobska* was not subject to any fire-protection regulations, as required for the construction of many Coast Guard-inspected vessels. For example, on inspected passenger vessels, regulations stipulate the length of time structural fire protection attached to bulkheads, decks, and

Figure 6. Damaged pipe/hose tunnel, as identified by yellow rectangles, looking up from the engine room (*left*) and down onto the deck winch-control console location (*right*).

The fire started within the engine room and spread quickly up two decks to the wheelhouse, where it ignited combustible materials and spread further. The deck between the engine room and the accommodation space on the *Nobska* was made of steel but had no fire insulation to slow or prevent the passage of heat. Consequently, the pipe/hose tunnel running between these two spaces acted like a chimney, funneling the heat, smoke, and flames up to the wheelhouse.

As an uninspected commercial fishing vessel, the construction of the tunnel on the *Nobska* was not subject to any structural fire-protection regulations, as required for the construction of Coast Guard-inspected vessels. Had the tunnel opening on the *Nobska* been sealed, including pipe/cable-type fire stops, and its surrounding structure insulated with fire-retardant materials, the fire would not have been able to rapidly spread, and damage may have been limited/contained to the engine room.

The pipe/hose tunnel on board the *Nobska*, which extended from the engine room up two decks to the wheelhouse, did not have any insulation, pipe/cable fire stops, or other barriers to prevent the passage of smoke, heat, and fire—known as structural fire protection. This type of unprotected vertical tunnel has the potential to provide a pathway for a fire to spread quickly outside of the space of origination. Vessel owners and operators should identify such openings between decks and ensure they are structurally fire protected to prevent the spread of a fire.

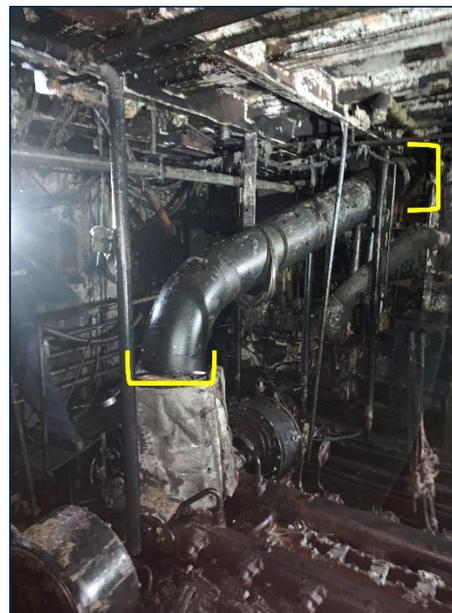
Figure 7. Missing main engine exhaust pipe lagging, as identified by yellow brackets.

console to engulfing the wheelhouse moments later indicates that the source of the fuel for the fire was abundant and volatile. Once the lagging was removed from the main engine exhaust, there was no insulation providing protection in the event flammable liquids, such as hydraulic fluid or diesel fuel oil, contacted the hot exhaust pipe's surface. Since the hydraulic fluid used in the system was located within the engine room and had a flash point of about 420°F, the second fire likely was the result of another hydraulic hose leak. When the fluid left the hydraulic hose under pressure, the fluid atomized before it contacted a hot surface, most likely the exposed main engine exhaust pipe, and flashed into a fire.

engine room that allowed hydraulic fluid to spray onto a hot surface, likely the exposed main engine exhaust pipe. Contributing to the failure of the hydraulic hose was possible heat damage from a fire that occurred earlier in the day.
