Issued April 28, 2022

MIR-22/14

Grounding and Sinking of Fishing Vessel *Sage Catherine Lane*

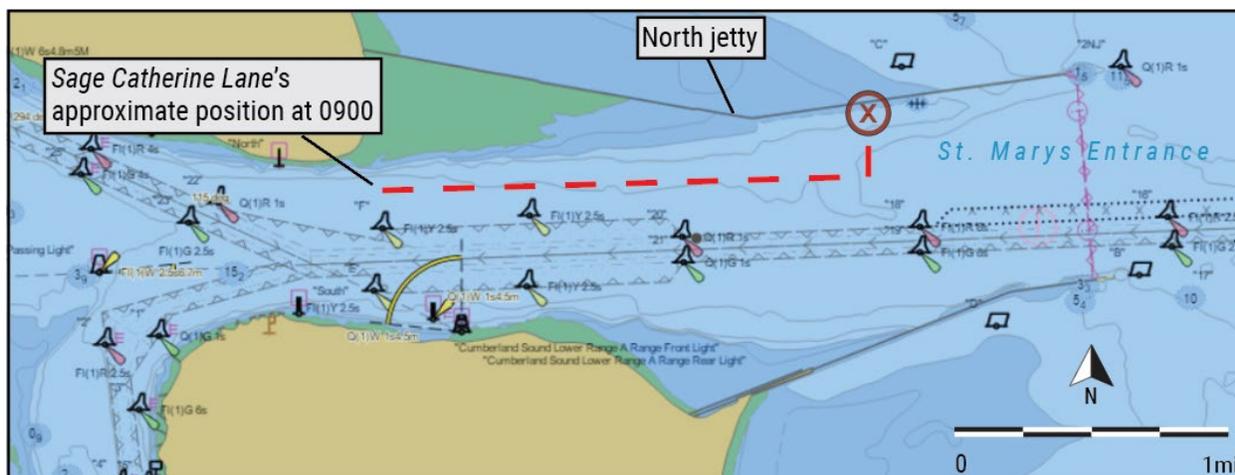
On June 9, 2021, at 0800, the crew of the *Sage Catherine Lane* left the anchorage in Cumberland Sound and began transiting outbound on the St. Marys River to engage in shrimping offshore. About 0900, the captain maneuvered the vessel outside of the navigation channel and continued on an easterly course between the red buoys and the northern jetty, due to high traffic within the channel. As the vessel transited parallel to the channel outbound, crewmember 1 went to the bow to secure the anchor, and crewmember 2 went to his room. The captain, who was alone in the wheelhouse, set the vessel's autopilot to maintain the vessel's heading out of the inlet to open water as the vessel started passing the jetty. The vessel was transiting at a speed of 9 knots. He answered a cell phone call and then proceeded down to his bunk room. About 0915, while the captain was still on the cell phone and in his room, he felt the vessel turn abruptly to port. The captain returned to the wheelhouse to investigate, and as he arrived, he saw that the vessel was heading toward the northern jetty. The captain attempted to turn away from the jetty, and he put the vessel's engine in reverse, but the *Sage Catherine Lane* struck the jetty and grounded before his actions could sufficiently stop or turn the vessel.

Figure 3. Chart with red dotted line showing the estimated path of the *Sage Catherine Lane* and the casualty location on the north jetty of the St. Marys Entrance, as indicated by a red X. (Background source: National Oceanic and Atmospheric Administration)

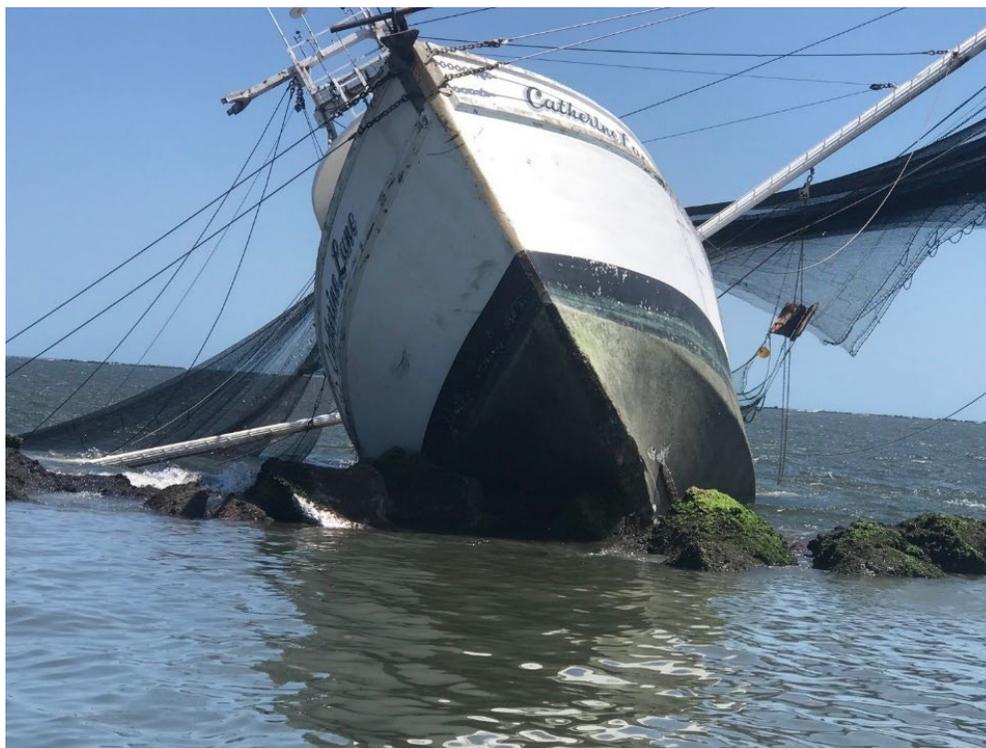
Figure 4. *Sage Catherine Lane* aground on the St. Marys Entrance north jetty. (Source: Coast Guard)

After the vessel grounded, crewmember 1 checked the engine room and other below-deck spaces and did not find any flooding. The captain tried to back the vessel off the jetty. At first, the vessel started to move astern, but then it began to rock back and forth before heeling to starboard. The captain stopped the engine; the two

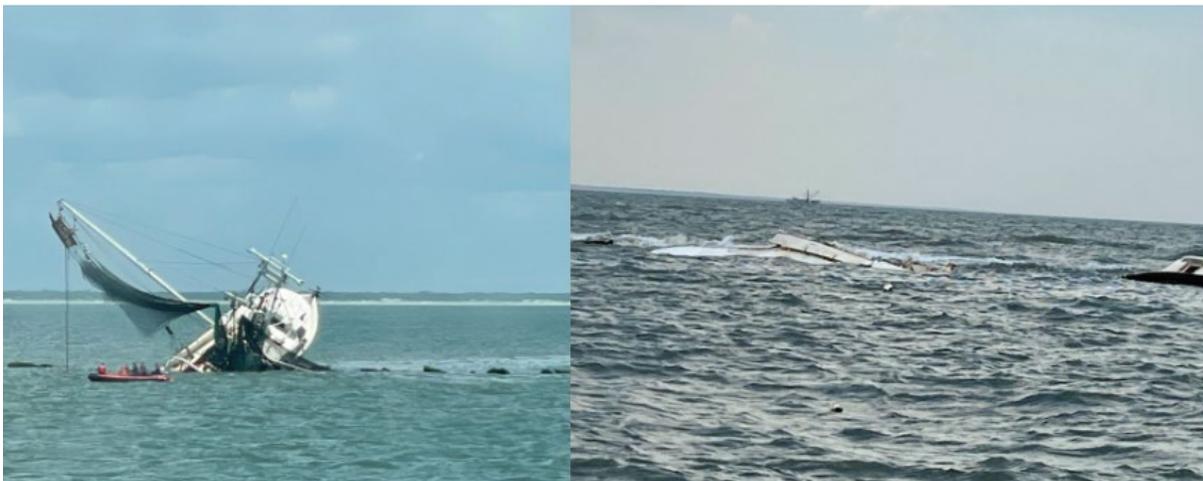
crewmembers checked the engine room again and found that it was starting to flood. The captain and crew donned life jackets and abandoned the vessel, and the crew of a Good Samaritan vessel, who witnessed the incident, rescued them from the water. Crewmember 2 sustained a minor laceration to his right hand while abandoning the vessel but did not seek additional medical care. The vessel remained on the jetty for 2 days, and then it broke apart and sank following a thunderstorm on the third day.

Figure 5. *Sage Catherine Lane* following the grounding on the jetty (left), and after being broken apart on the jetty 3 days later (right). (Source: Coast Guard)
