Issued May 10, 2022

MIR-22/15

Engine Room Fire aboard Containership *President Eisenhower*

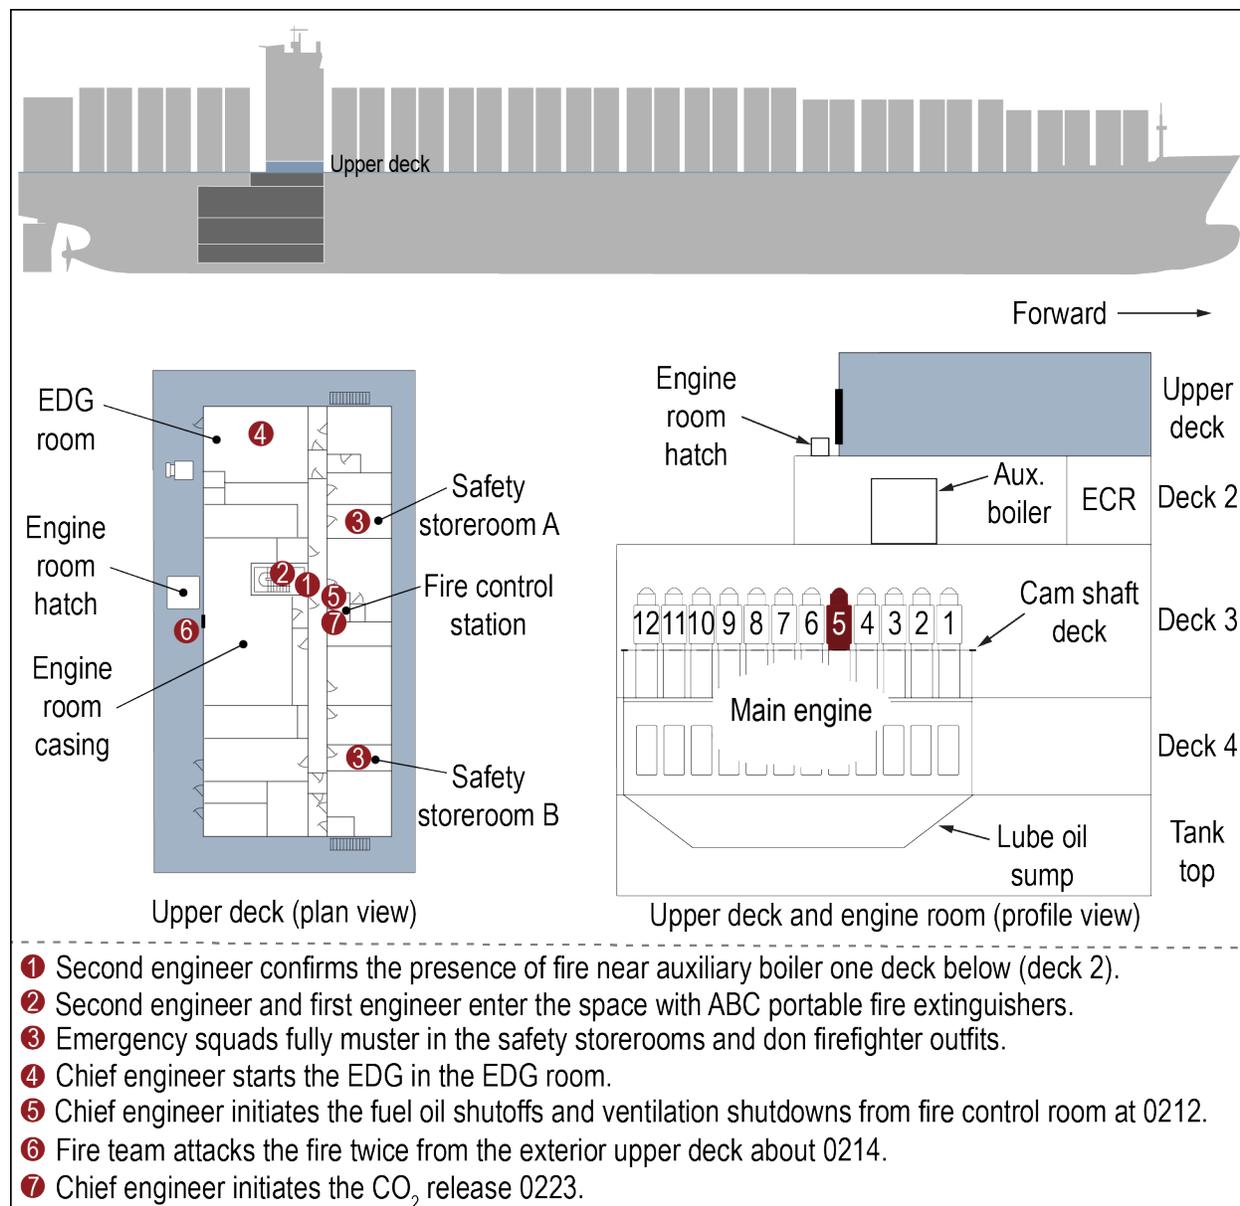
Figure 3. Profile view of the *President Eisenhower* (top). Plan view of the upper deck showing the sequence of events during the fire (left). Profile of the upper deck and engine room decks with the origin of fire highlighted (right).

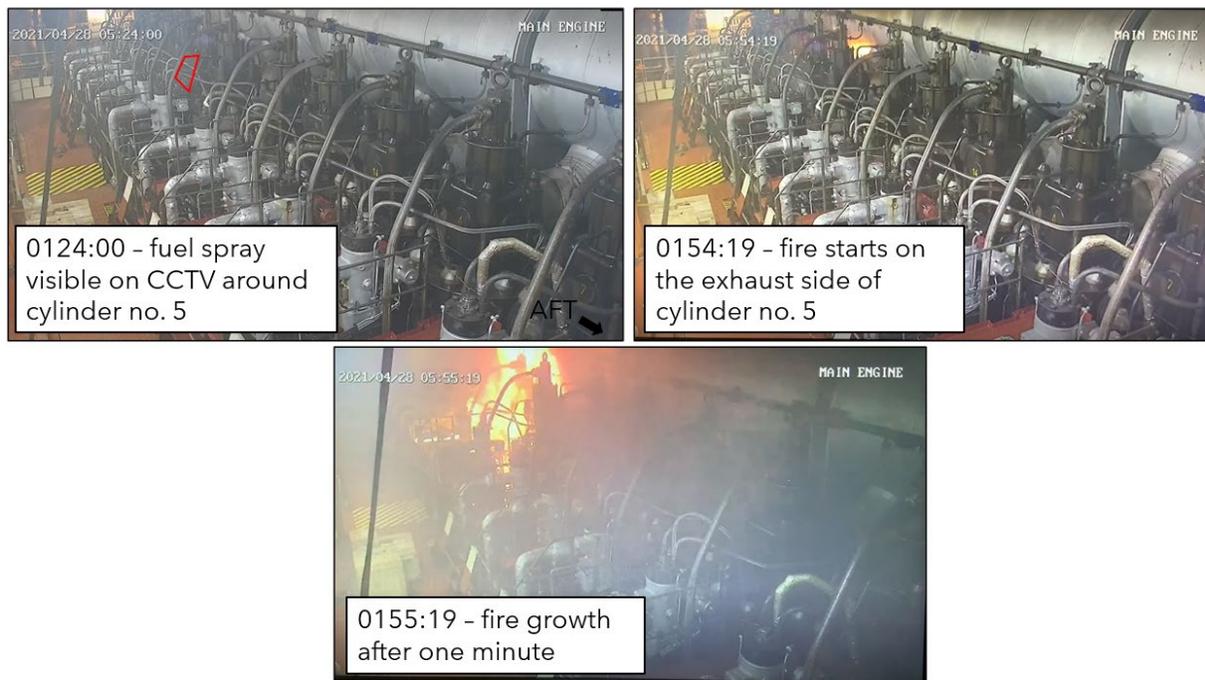
After the casualty, investigators reviewed the vessel’s recorded CCTV footage of the main engine and the auxiliary boiler. The footage showed that at 0124:00, 30 minutes before the fire started, ultra-low sulfur diesel oil (fuel being consumed by the main engine at the time of the fire) spray was observed around the no. 5 cylinder. The spray varied in intensity but remained visible up to its ignition at 0154:19, at which point the fire increased in intensity very quickly.

Within 1 minute, cardboard and wooden boxes containing spare parts that were being stored next to the auxiliary boiler, directly above the no. 5 cylinder, also caught on fire. Five minutes after the fire started, the main engine video was no longer visible due to thick smoke in the engine room. The auxiliary boiler video showed fire continuing to consume the boxes and adjacent combustible materials for about 15 minutes, until it too was obstructed by thick smoke.

Figure 4. CCTV screen captures of the main engine showing fuel spray in the area around the no. 5 cylinder about 30 minutes (*clockwise*) before the fire, the moment the fire started, and the progression (time stamps are 4 hours ahead). (Background source: APL)

CCTV footage showed that about 0124, while the containership *President Eisenhower* was under way at night, ultra-low sulfur diesel fuel began spraying in the area around the main engine’s no. 5 cylinder, about 30 minutes before the fire started. The engine room was unattended at the time, and the leaking fuel went unnoticed. Although not installed aboard the *President Eisenhower*, CCTV video analytic technology exists that can be integrated into an existing system. This technology was approved by the vessel’s classification society as an acceptable method to identify fuel mist in real time and alert the crew of the dangerous situation. Had this technology been in use aboard the *President Eisenhower*, because of the length of time fuel was spraying before ignition (30 minutes), there is a chance the fire could have been avoided.

Rapid oil leak-detection systems are a valuable tool that can be used to prevent fire in machinery spaces. Video analytic technology is designed to use standard CCTV video to detect fuel mist and spray in real time and alert the crew before any ignition and fire. This technology is supported by class societies as an acceptable method for identifying leaks and can be integrated with existing CCTV systems. Had this technology been in use aboard the *President Eisenhower*, the spraying fuel oil may have been detected well before the fire developed.

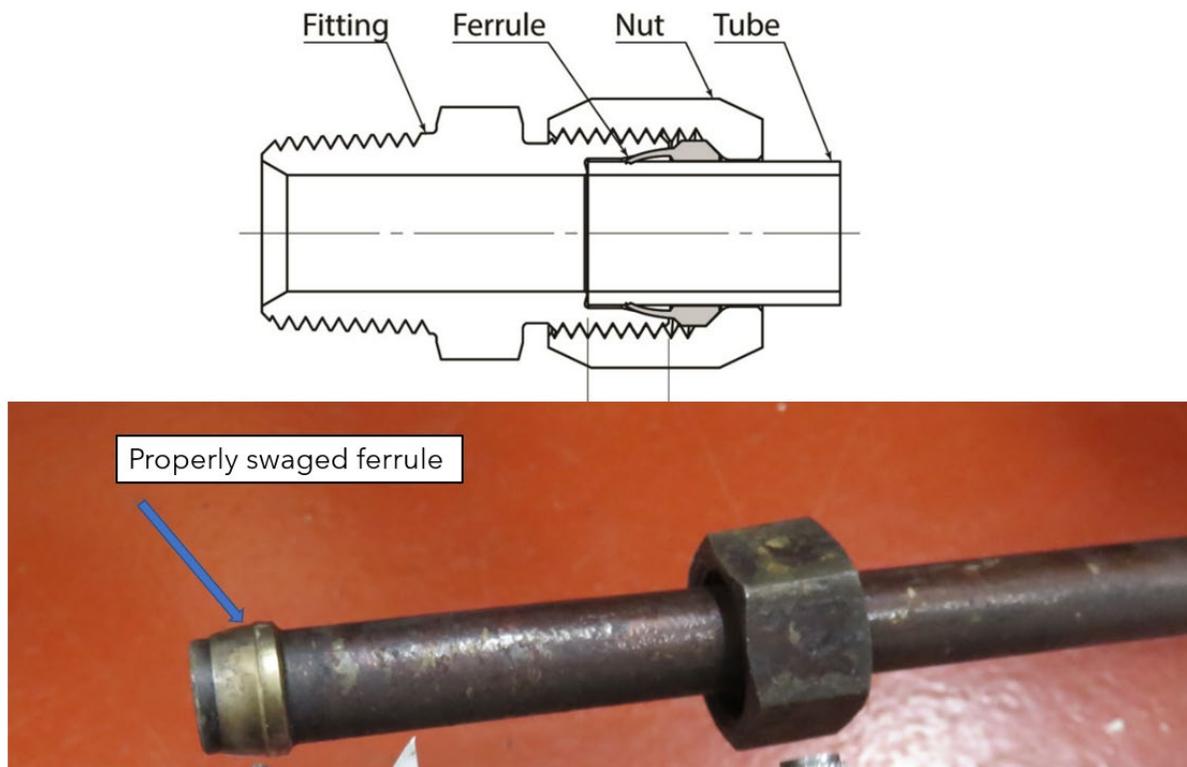
Typical for compression fittings, a ferrule needs to be permanently clamped, or “swaged,” onto the new tubing to facilitate sealing. The second engineer completed this swaging process while he installed the new section of tubing at the engine. He stated that he had never had to replace a section where a new ferrule needed to be swaged onto the steel tubing. He also said that during the installation, the new section of tubing did not line up easily to its securing brackets and that he had to temporarily remove some brackets to facilitate better alignment. Methods to verify whether a ferrule had been properly swaged included loosening the compression fitting nut and visually inspecting the ferrule, and pressure testing the associated system (because the fuel pipe was not OEM, there was no manufacturer procedure for replacing the return line). Following the installation, the second engineer and first engineer used the main engine fuel pump to pressure-test the associated system to about 116 pounds per square inch (the normal operating pressure) for about an hour. Both engineers inspected the tubing and fittings for leaks during this period, and none were identified. No one other than the second engineer checked the tightness of the compression fittings or condition of the swaged ferrules.

Figure 5. Cross-sectional diagram of typical compression fitting and body (*top*). Properly swaged ferrule on the *President Eisenhower's* old section of fuel oil return tubing (*bottom*). (Top source: Worldwide Fittings)

The postcasualty examination of the disconnected fuel oil return tubing and failed compression fitting revealed that the compression fitting's sealing ferrule was not sufficiently swaged to the steel tubing. A representative from the engine manufacturer determined that this was likely due to incorrect tightening of the compression fitting, or the ferrule was mounted incorrectly—in essence, the pipe was not fully inserted through the ferrule at tightening. The second engineer, who had never completed an installation in which a new compression fitting ferrule needed to be installed onto steel tubing, acknowledged having difficulties while completing the installation. After the installation, he pressure-tested the system for about an hour, during which no leaks were identified. He could have also loosened the compression fitting nut and visually inspected the ferrule to verify it had been successfully swaged to the tubing after tightening the compression nut. Had he done so, he likely would have identified that the ferrule had been improperly swaged.

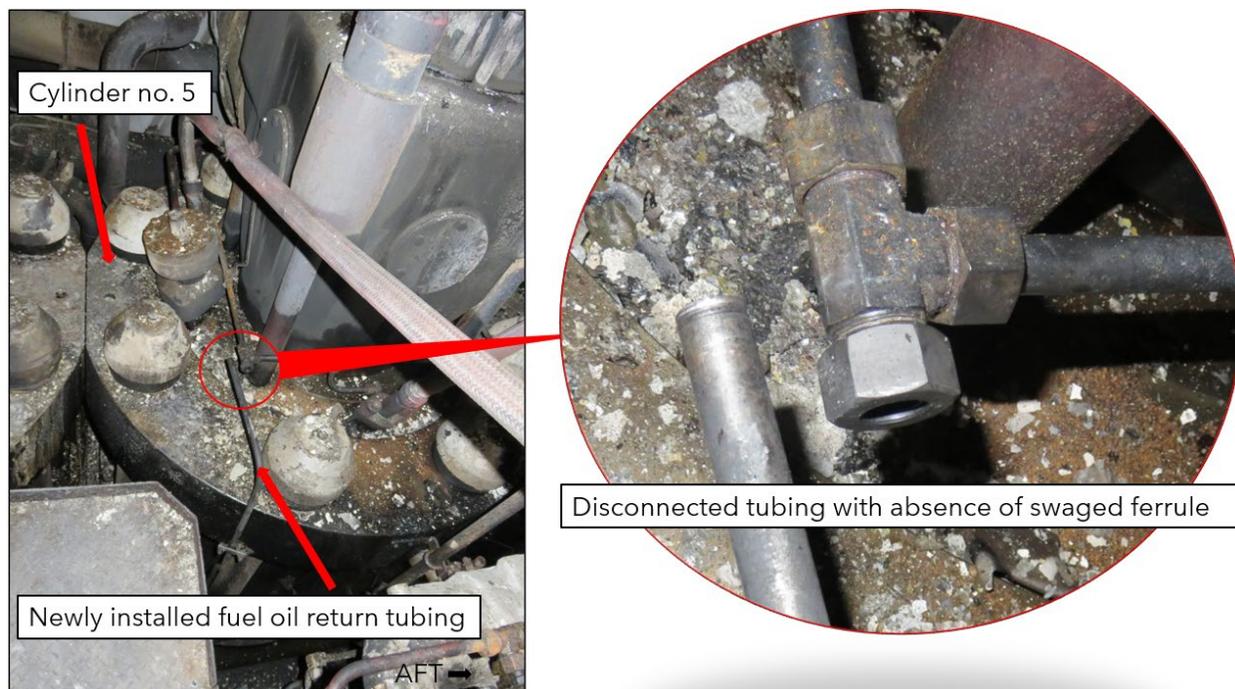
A postcasualty examination of the vessel showed the newly installed fuel oil return tubing for the no. 5 cylinder had completely disconnected from the body of the compression fitting closest to the cylinder cover. The compression nut for the fitting was able to be loosened by hand, and the ferrule was not swaged onto the tubing. In addition, an engine exhaust compensator flange for the no. 5 cylinder, which was about 48 inches away from the separated tubing, was not insulated or shielded by sheet metal. Main engine data indicated that at similar engine loads as when the fire started, exhaust gas temperatures reached about 600°F.

Figure 6. Cylinder no. 5 and the disconnected, newly installed fuel oil return tubing.

A postcasualty examination of the vessel showed that a compression fitting on the end of a newly installed section of fuel return tubing had disconnected, causing the fuel oil to spray (the return system pressure was 116 pounds per square inch). For 30 minutes, the fuel continued to spray, and eventually, it ignited off a hot surface and started a fire. Ultra-low sulfur diesel fuel is a highly combustible liquid with a standard flashpoint of 140°F and an average autoignition temperature of 428°F.⁹ To prevent combustible liquids, such as diesel fuel, from contacting surfaces that exceed

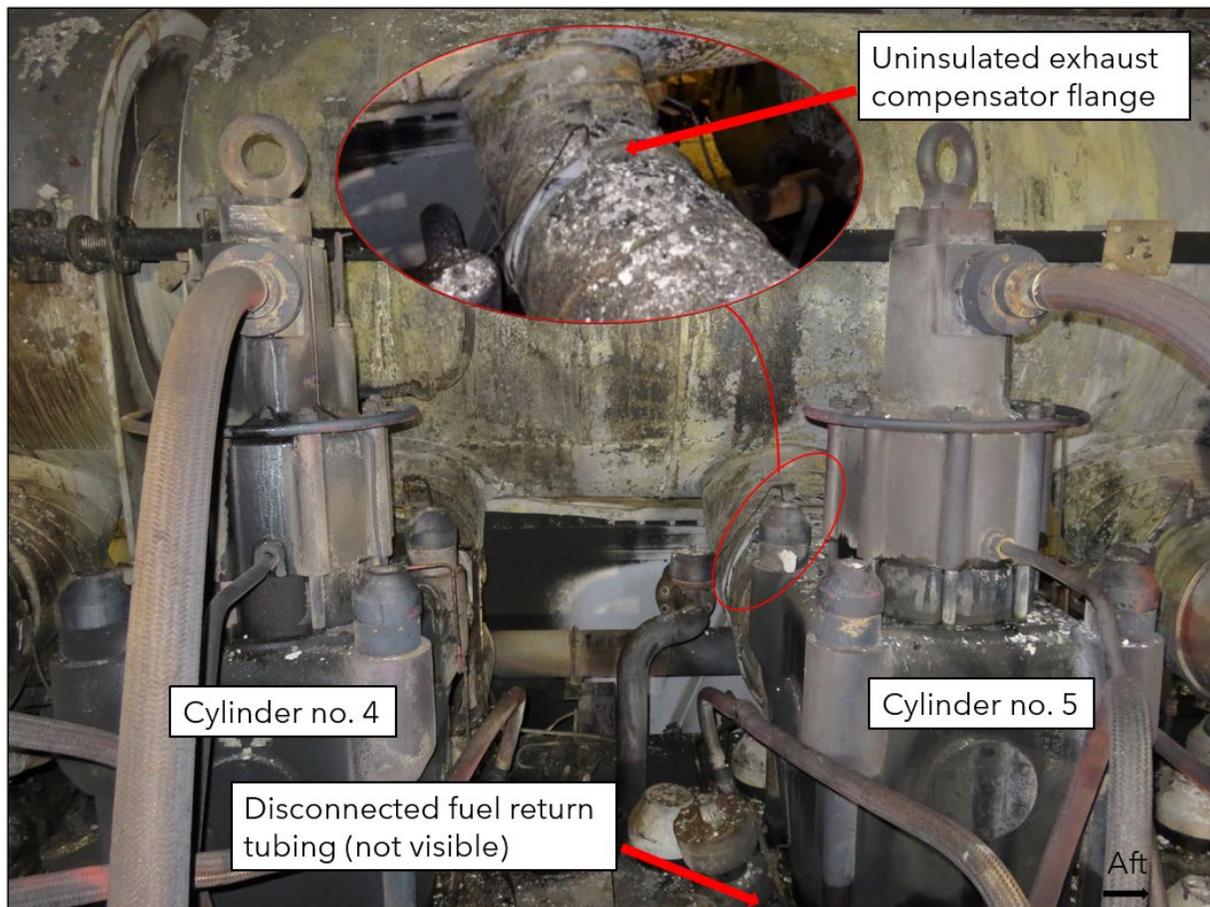
After the fire, the engine manufacturer determined that the fire had started when fuel oil from the disconnected return tubing on the no. 5 cylinder sprayed fuel oil onto the exposed surface of a flange for the exhaust valve compensator (expanding/flexible bellows-type exhaust piece between the cylinder and engine exhaust manifold). The service report completed by the manufacturer also indicated that the “insulation for the exhaust compensator flanges for all cylinder units was found insufficient and sheet metal not covering the flanges.” The report concluded that “all surfaces with a temperature above 220°C [have] to be properly insulated” and the reason for the disconnected fuel return tubing on cylinder no. 5 was “likely due to incorrect assembly in way of insufficient tightening” of the compression fitting, or the “ferrule was not mounted correctly, i.e., the pipe was not fully inserted through the steel ferrule at tightening.”

Figure 7. Main engine cylinder no. 5 uninsulated exhaust compensator flange in relation to the disconnected fuel return tubing.

temperatures of 428°F, SOLAS regulations require that such components be properly insulated, and the Coast Guard issued a Marine Safety Alert in 2017 to mariners recommending that they regularly check heat sources to verify compliance. However, after the fire, investigators found that an exhaust valve compensator flange on the no. 5 cylinder—which was subject to internal engine exhaust temperatures greater than 428°F (often as high as 600°F)—near the disconnected fuel return tubing end was exposed and not insulated. Therefore, it is likely that the unshielded and uninsulated exhaust valve compensator flange acted as an ignition source for the spraying diesel fuel.

The National Transportation Safety Board determines that the probable cause of the engine room fire aboard the containership *President Eisenhower* was a crewmember insufficiently swaging a compression fitting ferrule during the installation of fuel oil return tubing for a main engine's cylinder, allowing an end of the tubing to disconnect and spray fuel oil onto a nearby unshielded and uninsulated cylinder exhaust component.
