MIR-22/19

Engine Room Fire aboard Bulk Carrier *Roger Blough*

Sturgeon Bay, Wisconsin

February 1, 2021

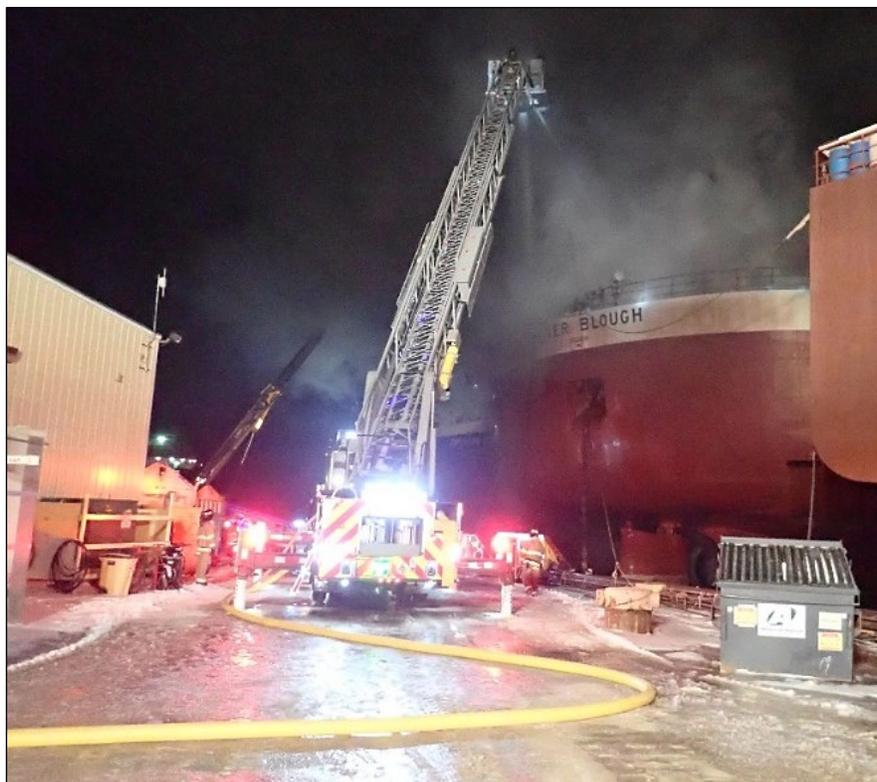
Figure 4. Stern of the *Roger Blough* during firefighting efforts. (Source: Coast Guard)

The first units from the fire department arrived at 0143 to fight the fire, which was starting to expand into the galley on the poop deck (see figure 4). Upon assessing the fire, firefighters determined it had traveled through the port and starboard conveyor belt trunks that angled up to the poop deck, to the aft cargo-unloading booms on the spar deck below, and throughout the engine room on the lower deck. The fire was extinguished later that day at 1300. It did not spread to any of the neighboring vessels.

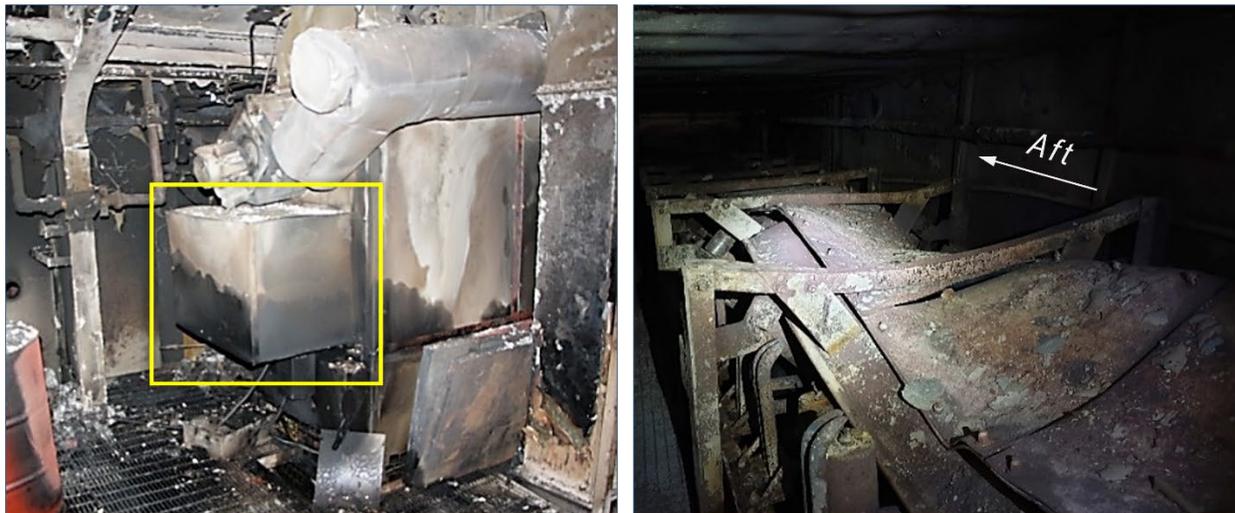
The fire investigation discovered extensive damage throughout the engine room spaces as well as to parts of the aft house, self-unloading cargo booms, and the section of the conveyor belt trunks passing through the engine room (see figure 5, right). US Coast Guard investigators noted that most of the fire damage in the engine room was centrally located on the lower deck near the furnace and on the level above leading up to the stack (operating deck).⁶ On the lower level, there was significant smoke and thermal damage in and around the furnace. Nearby metal objects did not burn but sustained thermal damage on surfaces facing the furnace. There was also extensive smoke and thermal damage above the furnace where the portside conveyor belt trunk was located. A closer examination of the furnace showed extensive thermal damage specifically at the burner enclosure, where there was noticeable discoloration of the metal structure and significant soot (see figure 5, left). When the enclosure was opened by investigators, the burner showed significant fire damage, including melting and warping of the cast aluminum framing. The soot line was primarily above the burner

assembly, which was resting on the bottom of the enclosure, while below and behind it, there were no indications of soot or heat damage.

Figure 5. Furnace with burner enclosure outlined (*left*), and fire-damaged conveyor belt within the conveyor belt trunk above the furnace (*right*). (Source: Coast Guard)

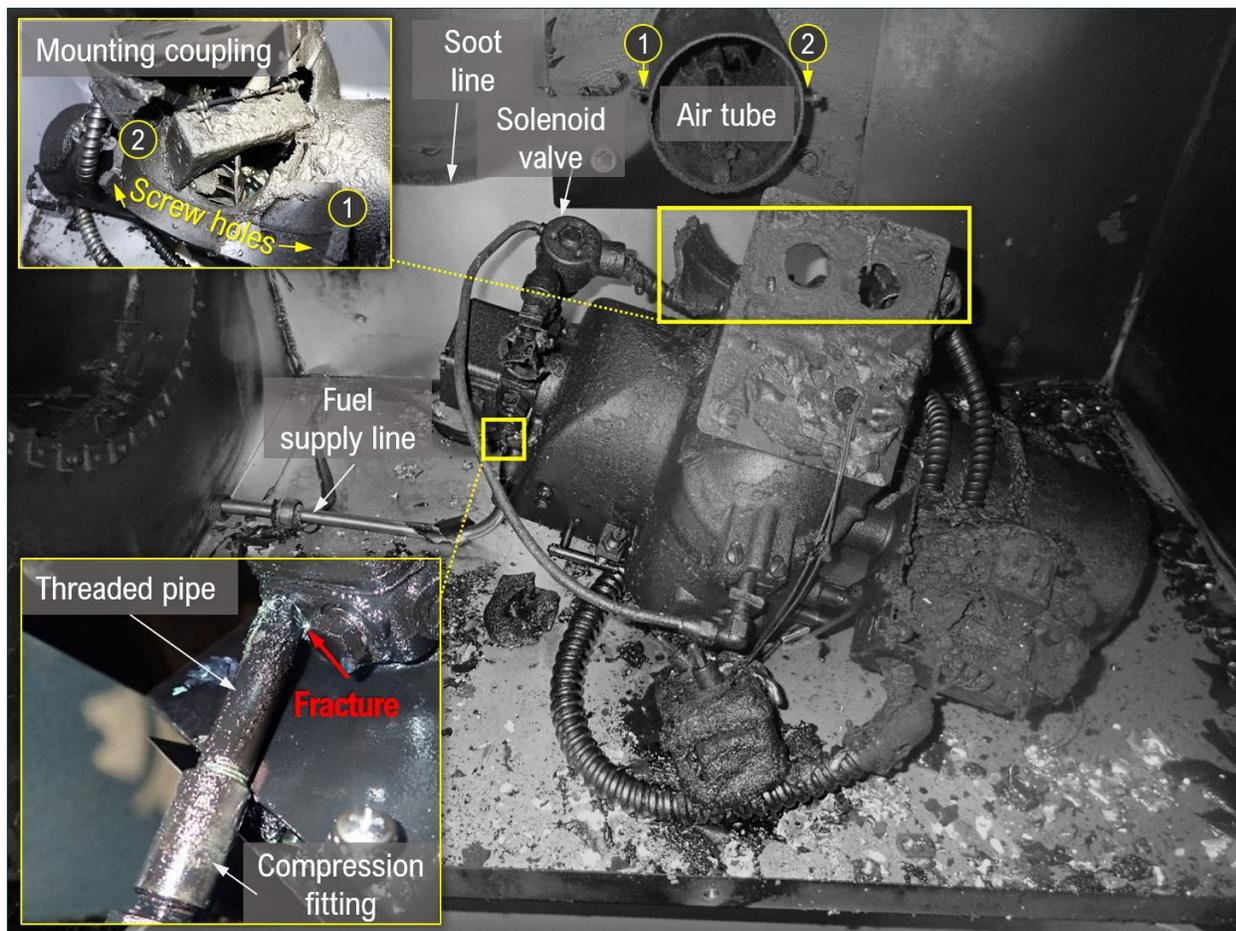
Investigators found the burner assembly detached from the air tube and resting on the bottom of the burner enclosure. The fuel supply line was connected to the burner with a compression fitting from the fuel supply line tubing to a short pipe (a few inches) located at the underside of the burner assembly that threaded into the burner body. The threaded pipe, which had bent about 10° to the right when facing the burner assembly, was fractured. The location of the fuel supply line fracture was before the burner's fuel shutoff solenoid valve (see bottom inset of figure 6). The 4,144-gallon storage tank that supplied fuel to the furnace was found empty after the fire.

Figure 6. Photo of the fire-damaged burner detached from the air tube, lying on the bottom of the enclosure, shows the fracture point where the fuel supply pipe threaded into the burner assembly (*bottom inset*) and the fractured mounting coupling (*top inset*, interior view). (Source: Coast Guard)

In addition, the burner's aluminum mounting coupling, which overlapped onto the steel air tube by a half inch, was fractured on both sides at the hole for each set screw used to secure it to the air tube (see also figure 6, top inset; nos. 1 and 2 indicate the location of the screws). The fracture separated the top part of the coupling from the bottom. The two set screws were found still threaded into the air tube. The technical service manager from the burner manufacturer, who had worked for the company for 27 years, said, "I haven't seen a failure like this before." Except for the mounting coupling, no other structures or framing supported and held the burner in place.

It is possible that the cast aluminum mounting coupling was damaged during the repeated removal and reinstallation of the burner assembly, which could occur if it were twisted or not pulled directly off the air tube, causing a strain on both set screw holes. Another possibility is that the set screw holes may have been fractured if the set screws

Furthermore, investigators found the soot line inside the burner enclosure was distinguishable above the burner assembly, which was resting on the bottom of the enclosure (see figure 6). This demarcation indicated that an uncontrolled fire occurred after the burner assembly disconnected from the air tube in the furnace and fell; had the fire erupted while the burner assembly was still connected to the air tube, the soot line would have been higher. Thus, it is likely that the coupling was the initial failure point. Therefore, the NTSB concludes that the repeated removal and reinstallation of the burner assembly during the ship's engineers' attempts to repair it without consulting the manual or the manufacturer may have damaged the mounting coupling and thereby led to its eventual failure.

Following the failure of the coupling, the burner dropped to the bottom of the enclosure. As a result, the weight of the burner assembly likely caused the vertically oriented fuel supply line and pipe connected to its underside to bend downward and fracture at the point where the pipe was threaded into the burner assembly. Because this fracture was located before the burner's internal pump and fuel shutoff solenoid valve, fuel under head pressure from the fuel oil storage tank a deck above released into the enclosure. Therefore, the NTSB concludes the furnace's burner assembly became detached from the air tube and fell when the mounting coupling fractured, which likely bent and fractured the fuel supply line to the burner, thereby allowing fuel to spray onto the operating burner and ignite within the enclosure.

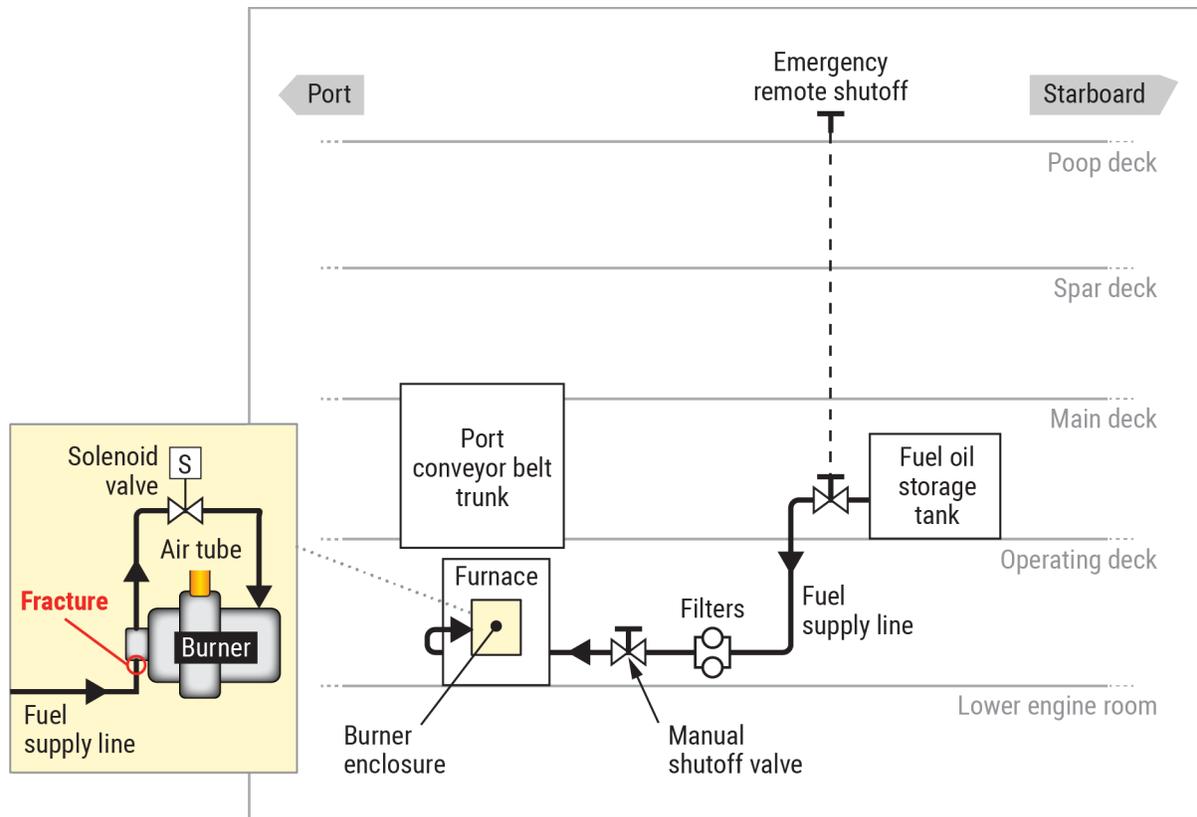
Figure 7 provides a simplified section view of the ship (looking forward). The location of the furnace relative to the portside conveyor belt trunk—which passed over the furnace—and the flow of fuel from the diesel fuel oil storage tank to the furnace are shown. The storage tank, also in the engine room, was located on the operating deck, a deck above the furnace. The fuel supply line had a manually operated shutoff valve at the tank that could be closed remotely during an emergency from the starboard side of the poop deck. Next to the furnace, about 10 inches away, another manual shutoff valve on the fuel supply line as it entered the burner enclosure could isolate the furnace from the fuel system but could only be operated locally. Lastly, a fuel shutoff solenoid valve on the burner assembly would close and stop pressurized fuel from entering the furnace’s combustion chamber in the event of a signal from the furnace’s control system.

Figure 7. Simple section view of the engine room with arrangement of the furnace's fuel supply (not to scale).

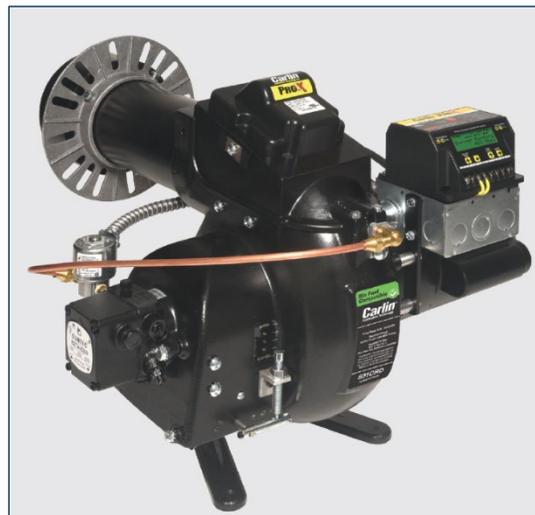
Figure 8. Burner assembly with pedestal support. (Source: Carlin Combustion Technology)

The cast aluminum burner housing was designed to be mounted on the furnace's horizontally positioned air tube or, for some installations, to be supported by a pedestal (see figure 9). In the furnace of the *Roger Blough*, it was mounted to the air tube with a coupling, an arrangement that did not require the pedestal. A technical service manager from the manufacturer, Carlin Combustion Technology, told investigators that while the burner can be mounted without the pedestal, it is common practice for installers to use the pedestal to provide support below the burner to ensure it will not move. The company that installed the furnace submitted to the vessel's owner a furnace design proposal that did not include the pedestal support for the burner.

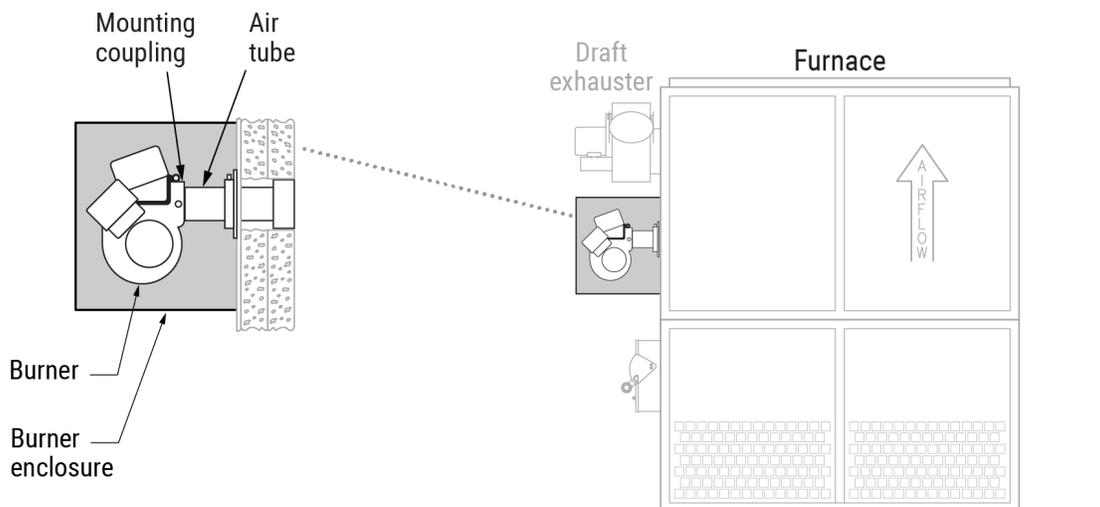
Figure 9. Diagram showing the burner assembly within the enclosure as mounted on the furnace on board the *Roger Blough*.
