Issued August 23, 2022

MIR-22/20

Fire aboard Fishing Vessel *Blue Dragon*

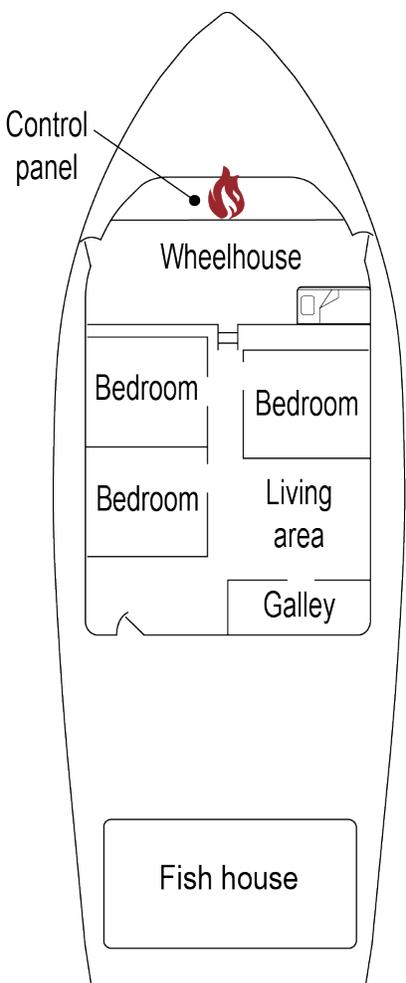
Figure 3. Main deck general layout (not to scale) with location of fire indicated by flame symbol.

The NMFS observer stated that he discovered the fire underneath of the wood control panel console; his statement was consistent with the deckhand's description that, a bit later, the fire was reaching all the way to the overhead of the forward bulkhead of the wheelhouse. Thus, the origin of the fire was likely under the wheelhouse console. Because the wheelhouse was destroyed by fire, investigators could not determine the cause of the fire. However, the captain stated that he believed the cause was electrical. After the casualty, investigators examined a similar vessel owned by the same company (*Blue Dragon II*) and found wiring that did not meet typical marine standards (improper connections, loose, disorganized, and bare wires) under the wooden wheelhouse console, as well as computer equipment and batteries. Such substandard electrical outfitting can result in an electrical fault, which can serve as a source of ignition for a fire. Given that both vessels were owned and operated by the same company and were designed with similar console equipment, the condition of the *Blue Dragon's* wiring was likely comparable to the *Blue Dragon II's*. Additionally, because there was similar electrical equipment stowed under both consoles, it is likely the fire started from an electrical source.

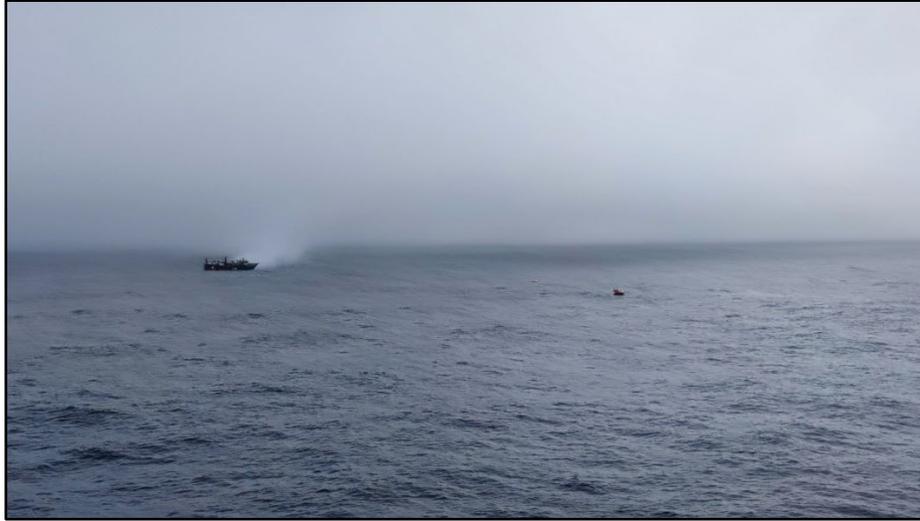
Figure 4. *Blue Dragon* smoldering with *NordRubicon*'s rescue boat in foreground. (Source: *NordRubicon*)

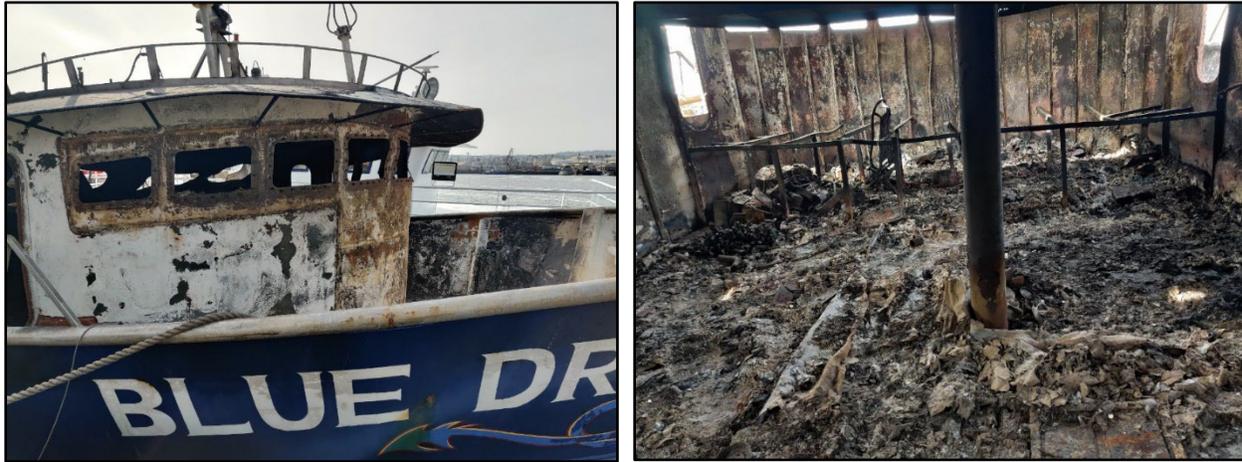
The interior of the *Blue Dragon's* superstructure was consumed by the fire, including the survival suits stored under the deck of the wheelhouse. The *Blue Dragon* was rebuilt from the main deck up and placed back in service in August 2022.

Figure 6. *Blue Dragon* wheelhouse exterior (left) and interior looking forward (right), after the fire. The framing of the false deck in right image indicates the location of what was the wheelhouse deck. (Source: Coast Guard)

The vessel's wheelhouse and accommodations consisted of combustible interior joinery construction, outfitting, and furnishings—a high fire load (availability of combustible materials in a given area). Additionally, paint cans and welding rods (also combustible materials) were found on the *Blue Dragon* in the void space beneath the wheelhouse (under the false deck). All of these materials fueled a fire that could not be contained with the limited firefighting equipment available—the water hose (wash down hose) did not reach the location of the fire, leaving only extinguishers to fight the fire.

The National Transportation Safety Board determines that the probable cause of the fire aboard the fishing vessel *Blue Dragon* was from an unknown source, likely electrical in nature, which ignited the wooden wheelhouse console. Contributing to the extent of the fire damage was the substantial use of combustible materials in the joinery, outfitting, and furnishings in the wheelhouse and accommodation spaces.

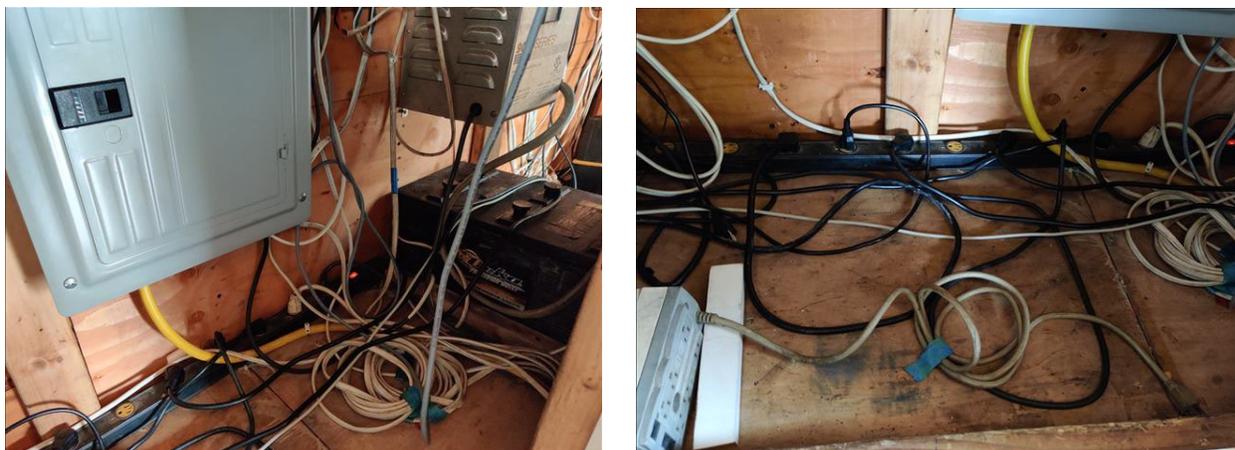
After the casualty, investigators visited both the *Blue Dragon* and *Blue Dragon II*. The *Blue Dragon's* wooden wheelhouse console had held two laptops used for navigation and a flat screen monitor used as a television. The wheelhouse deck was raised a few feet above the main deck, and beneath this “false deck” was a void space. Investigators found paint cans and welding rods under the *Blue Dragon's* false deck. According to the captain of the *Blue Dragon*, there was nothing stowed under the wheelhouse console, and he believed the cause of the fire was electrical. A deckhand told investigators that he was aware of computer equipment and possibly batteries stowed under the console. There was no smoke detector installed in the wheelhouse. The *Blue Dragon II's* wooden wheelhouse console was similar to the *Blue Dragon's* in that it was open to the void below the wheelhouse false deck. Under the *Blue Dragon II's* console, investigators found wiring that did not meet typical marine standards—there were bare wires, improper connections, and loose and disorganized wiring.

Figure 7. *Blue Dragon II* pilothouse console wiring. (Source: Coast Guard)

Substandard electrical installation and outfitting—including bare wires, unsecured wire nuts, overloaded circuits, loose wiring, and household wiring not designed for marine use—is a common cause of electrical fires. Additionally, batteries have been identified as ignition sources of fires in multiple modes of transportation. Vessel operators should ensure electrical systems are adequately designed, installed, and maintained in accordance with established marine standards to prevent fires.
