MIR-22/21

Sinking of Commercial Fishing Vessel *Emmy Rose*

Atlantic Ocean

November 23, 2020

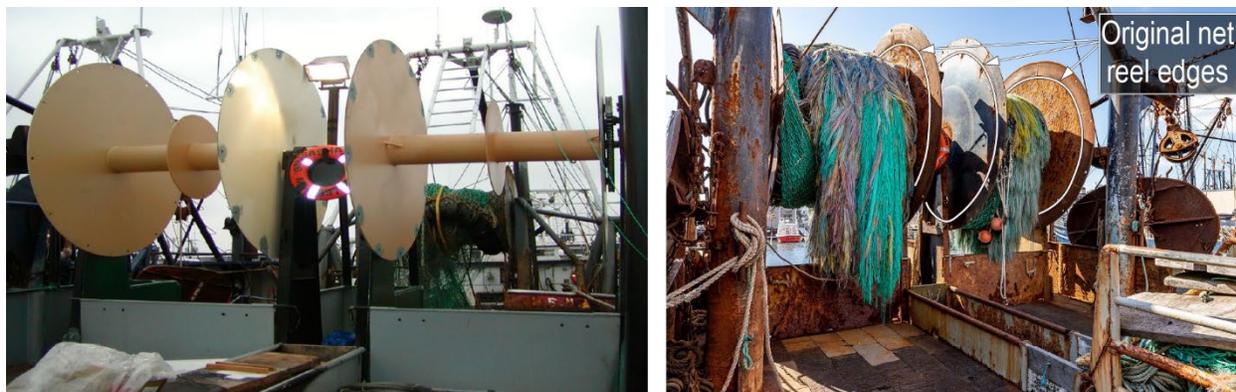
With the change in location and fishery, the *Sasha Lee* was modified to a stern trawling vessel to accommodate the regional fishery. Two 7-foot-diameter steel net drums and mounting frames were added to the stern of the vessel (drums shown in figure 6). The port and starboard walkways were closed off and the bulwarks were extended to provide the crew with protection from the elements on the aft deck. Over the next several years, other changes were made to the vessel: the diameter of the net reels was increased to allow for larger nets, an additional cargo boom was added, two storage bins filled with fishing gear were added on the top deck, and additional fishing and rigging gear was stored aboard the vessel on the working deck. There were no records of whether any of the changes altered the vessel’s lightweight displacement or the position of its vertical center of gravity (see [Appendix C](#) for principles of stability).

Figure 6. *Sasha Lee* net reels in 2001 (left) and 2019 (right). (Background sources: Farrell and Norton Naval Architects [left] and Blue Harvest Fisheries [right])

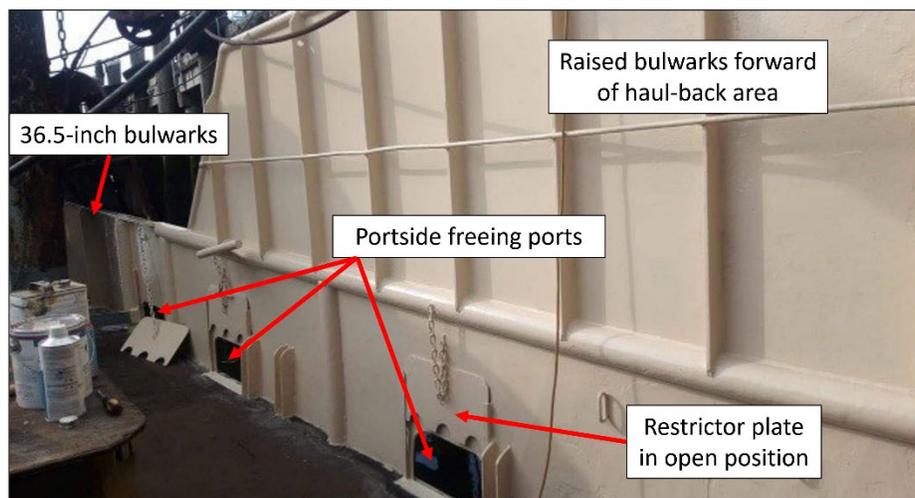
The aft portion of the working deck had 36.5-inch-high steel bulwarks. On each side of the vessel, the bulwarks were fitted with five freeing ports, each measuring 10 inches by 20 inches. A freeing port is any direct opening through a vessel's bulwarks or hull designed to quickly drain water that has accumulated on exposed decks overboard. Each freeing port had a restrictor plate that was held up in the open position by a chain. The restrictor plate could be lowered to block off the opening to prevent catch from going over the side of the vessel during landing and loading. Each restrictor plate contained three half-circle cutouts to allow limited water to drain when in the closed position (see figure 9). There were two freeing ports in the forward portion of the vessel, one on each side below the wheelhouse doors.

Figure 9. Freeing ports on portside bulwarks. (Background source: Boat Aaron & Melissa)

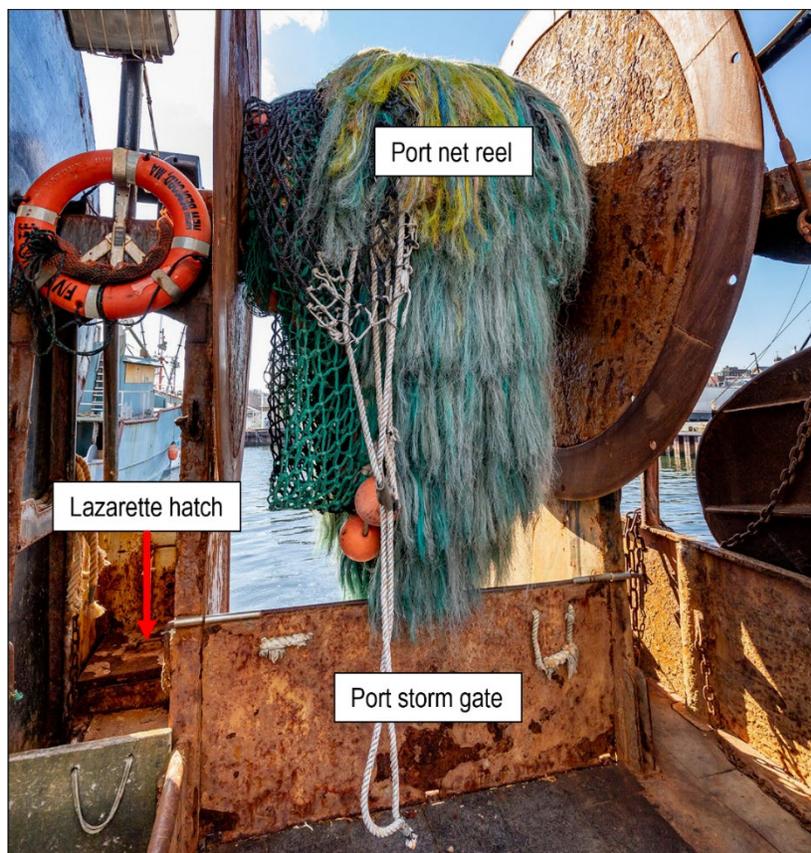
The lazarette was the farthest aft compartment and contained the rudder post and steering rams, a high-water bilge alarm, and a bilge suction. The lazarette was accessed through a 24-inch-by-24-inch hatch (see figure 11). The hatch had a 6-inch raised steel coaming and a nonwatertight steel cover, which, according to the vessel manager, did not have dogs or latches to secure it.

Figure 11. Port net reel, storm gate, and lazarette hatch of *Sasha Lee* in 2019 before its purchase by Boat Aaron & Melissa. (Background source: Blue Harvest Fisheries)

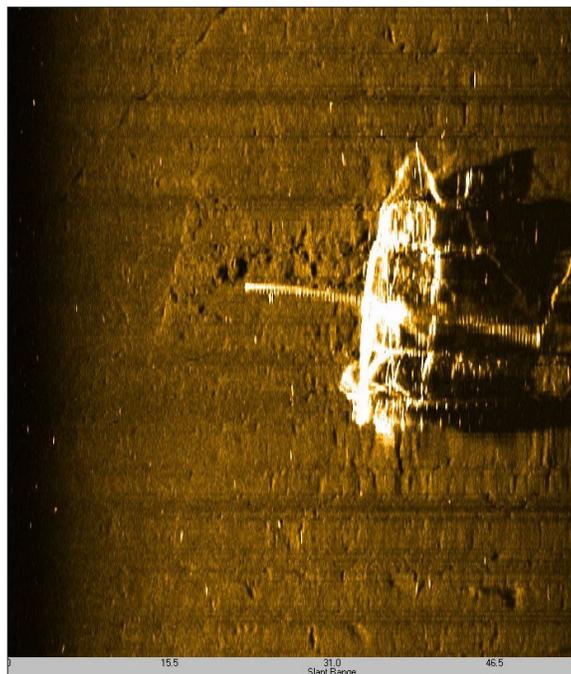
The survey report stated that the *Emmy Rose* was found "sitting upright on the seafloor with the bow oriented at 135° (southeast direction) and both outriggers fully deployed" (see figure 15). The side scan images did not detect any debris field on the seafloor near the sunken vessel. Additionally, the report stated that there was "no visible damage to *Emmy Rose* evident as the mast, wire rigging, and superstructure features all appeared to be intact. The ladders on both port and starboard outriggers were visible in the sonar imagery." Sonar images indicated that both paravanes were deployed from the outriggers. Based on interpretation of imagery, MIND Technologies specialists believed that about 203 feet of cable had been deployed from the port outrigger, and the paravane was that distance ahead of the vessel. The position of both paravanes leading forward of the vessel indicated to the specialists that "the stern sunk to the seafloor before the bow at least just before the vessel made contact with the seafloor."

Figure 15. Side scan sonar image of *Emmy Rose* from 246 feet above at 600 kilohertz. (Source: MIND Technologies)

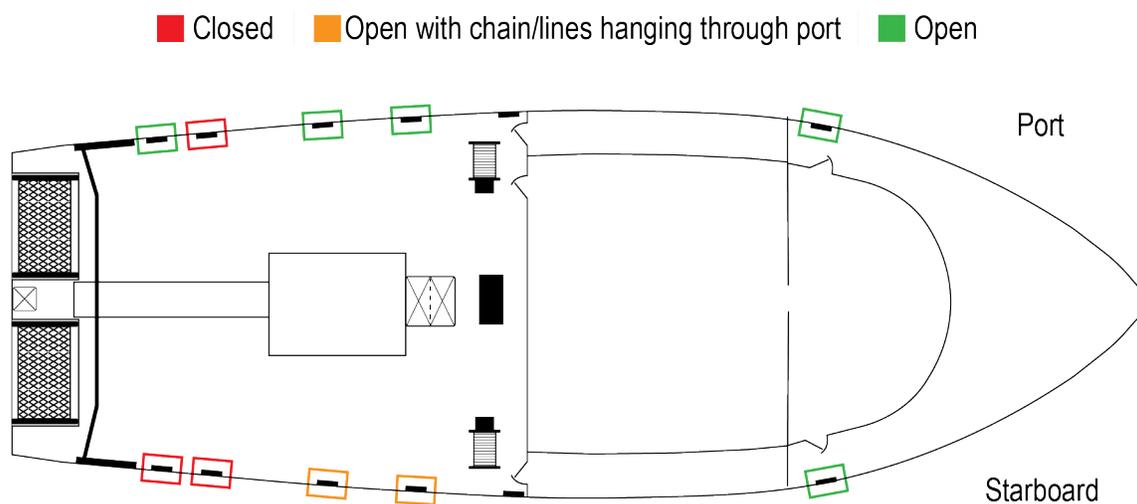
The ROV inspected the condition of the freeing ports on either side of the *Emmy Rose*. On the port side of the vessel, the aftmost freeing port was open. The next freeing port forward was closed. The next freeing port forward was partially open and had its plate hanging through the port. The remaining freeing ports on the port side were open. On the starboard side, the two aftmost freeing ports were closed. The next two freeing ports forward were open, and both had chain and lines hanging out of the ports (see figure 16). The starboard freeing port under the wheelhouse was open. The freeing ports under the outriggers were not able to be accessed by the ROV for inspection.

Figure 16. Status of *Emmy Rose* freeing ports during ROV survey.

The MSC addressed the condition of the freeing ports as found during the ROV survey of the *Emmy Rose* on the seafloor. On the starboard side of the vessel, the freeing port restrictor plates were in place on the aft two freeing ports while the middle two freeing ports had line and chain hanging out of them. On the port side of the vessel, only one aft freeing port had the restrictor plate in place and there was no debris hanging out of the other portside freeing ports. The MSC concluded that this could be indicative of a

As a result of this investigation, we recommended that the Coast Guard increase the scope of commercial fishing vessel safety examinations to include inspections of freeing port covers and hatch covers. Additionally, we reiterated Safety Recommendation M-17-45 to the Coast Guard to require personal locator beacons for personnel employed on vessels in coastal, Great Lakes, and ocean service to enhance their chances of survival.

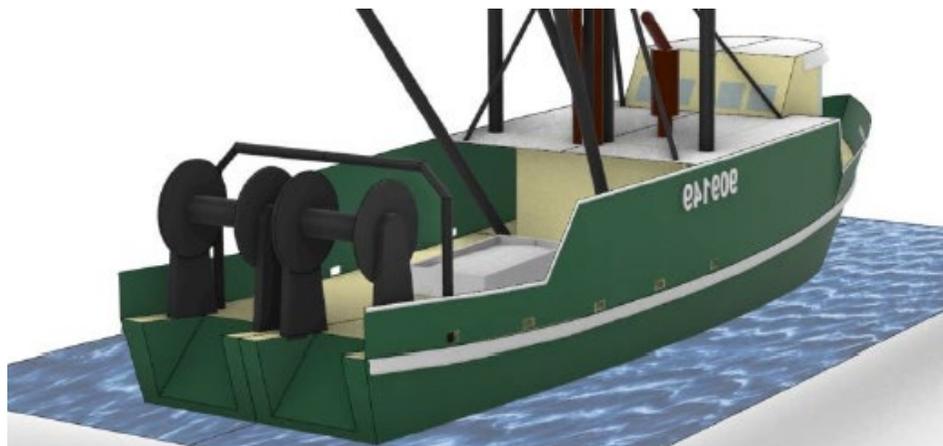
causing water to collect on the aft working deck (see figure 17). The NTSB concludes that the *Emmy Rose's* course toward Gloucester to offload its catch subjected the vessel to quartering winds and seas that likely resulted in the accumulation of seawater on the aft working deck.

Figure 17. MSC model of *Emmy Rose's* starboard quarter showing aft bulwarks and stern ramps (storm gates not shown). (Source: MSC)
