Issued August 25, 2022

MIR-22/22

Collision between *Baxter Southern* Tow and BNSF Coal Train

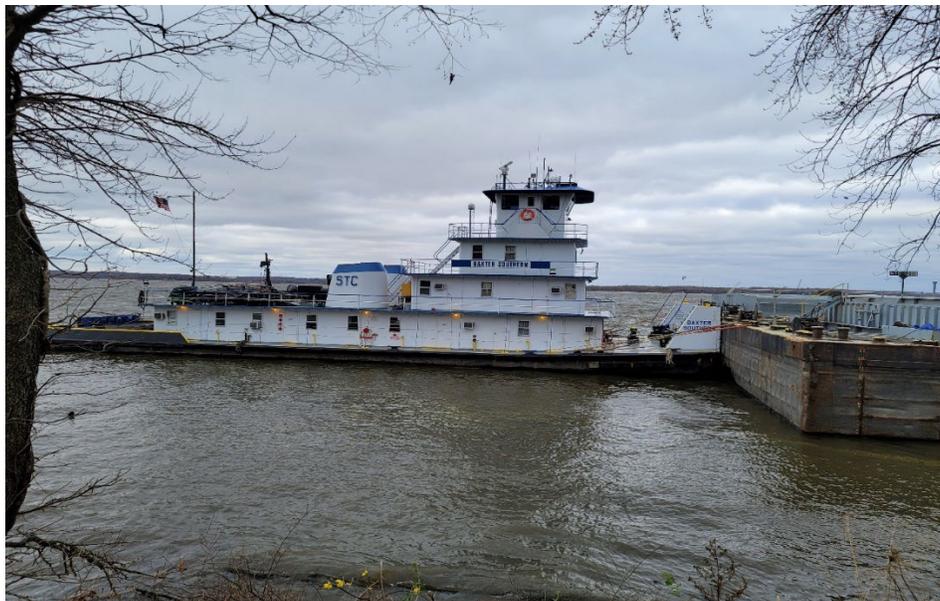
Figure 1. The *Baxter Southern* after the casualty. (Source: US Coast Guard)

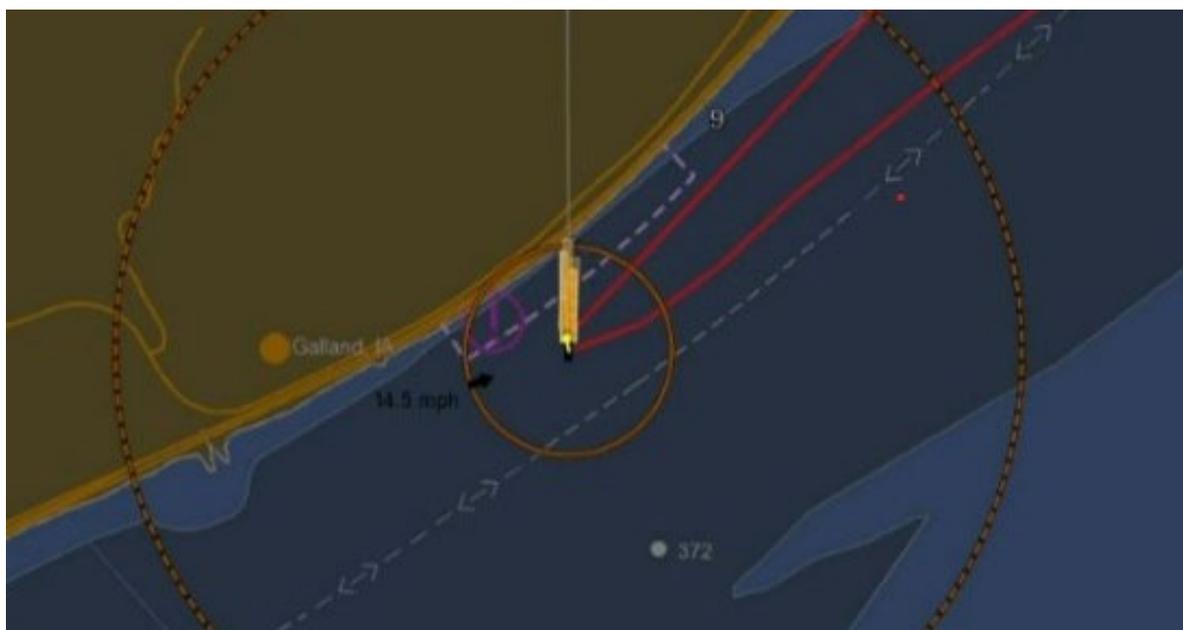
a magenta dashed line on the electronic navigation chart next to railroad tracks at mile 372, and both said they believed the area represented a fleeting area and that it would be safe to push up against the bank within it. The electronic navigation chart showed railroad tracks along the riverbank but did not provide the distance from the river to the tracks. The captain told the pilot to head to the marked area on the chart at mile 372 and place the tow up against the riverbank at that location to wait out the weather.

Figure 3. Snapshot of *Baxter Southern* ECS playback at 2336 showing the area marked by a magenta dashed line and the vessel pushed up against the riverbank. (Source: Southern Towing Company)

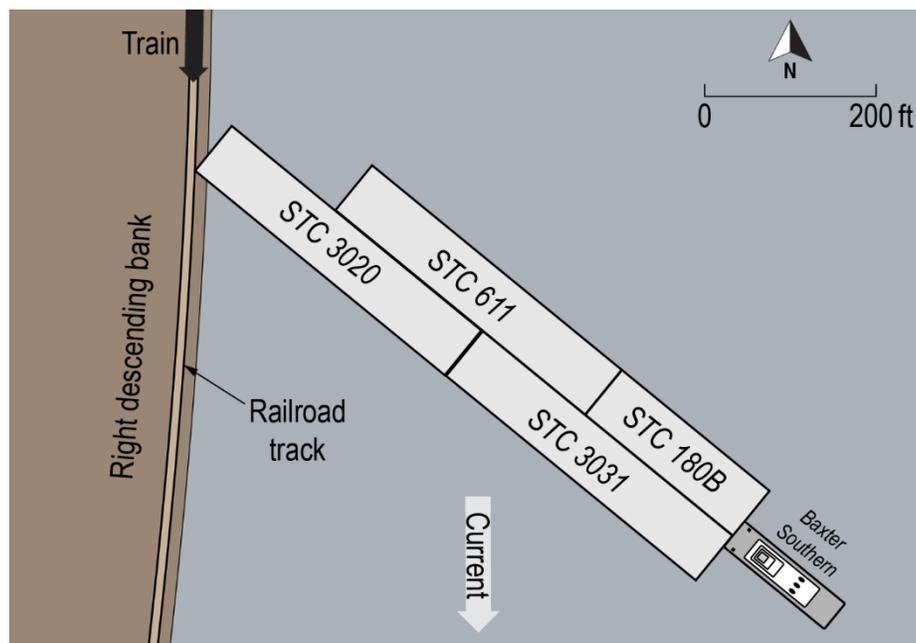
Figure 4. Approximate position of *Baxter Southern* tow pushed up against the riverbank as the train approached (scale approximate).

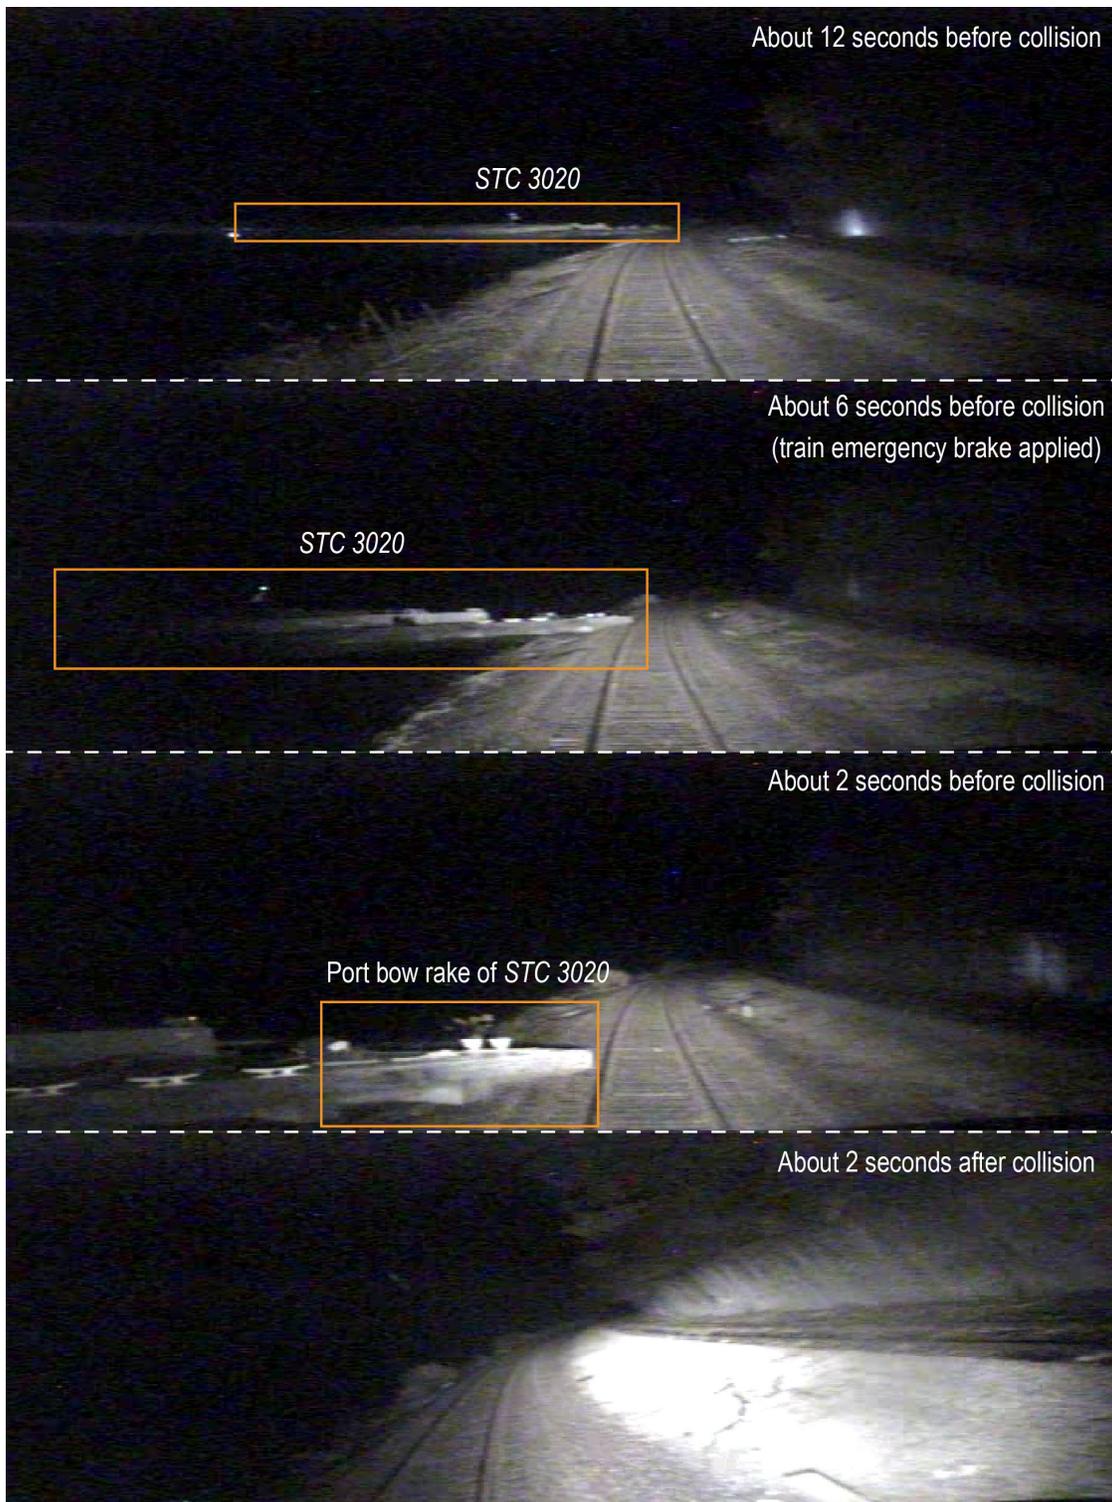
About 2343:51, the left side of the lead locomotive, BNSF 9251, collided with the port corner of the *STC 3020's* bow, and the 2-foot overhang of the train impacted the deck of the barge, pushing it into the ground. The captain, who was in the galley and had felt a "slight bump," heard the general alarm and proceeded to the wheelhouse. The first locomotive derailed and tipped over to the right, landing on its side after impacting the barge, skidding on the ground before stopping, and causing the second locomotive, BNSF 9109, and ten hopper cars to also derail. Six of the hopper cars entered the river. The BNSF train's conductor and the engineer evacuated the forward locomotive on their own but sustained minor injuries.

Figure 5. Still images of video footage from locomotive BNSF 9251's recorder as the train approached the barge and derailed after hitting the barge. The forward barge of the *Baxter Southern* tow is outlined in orange. (Source: BNSF)

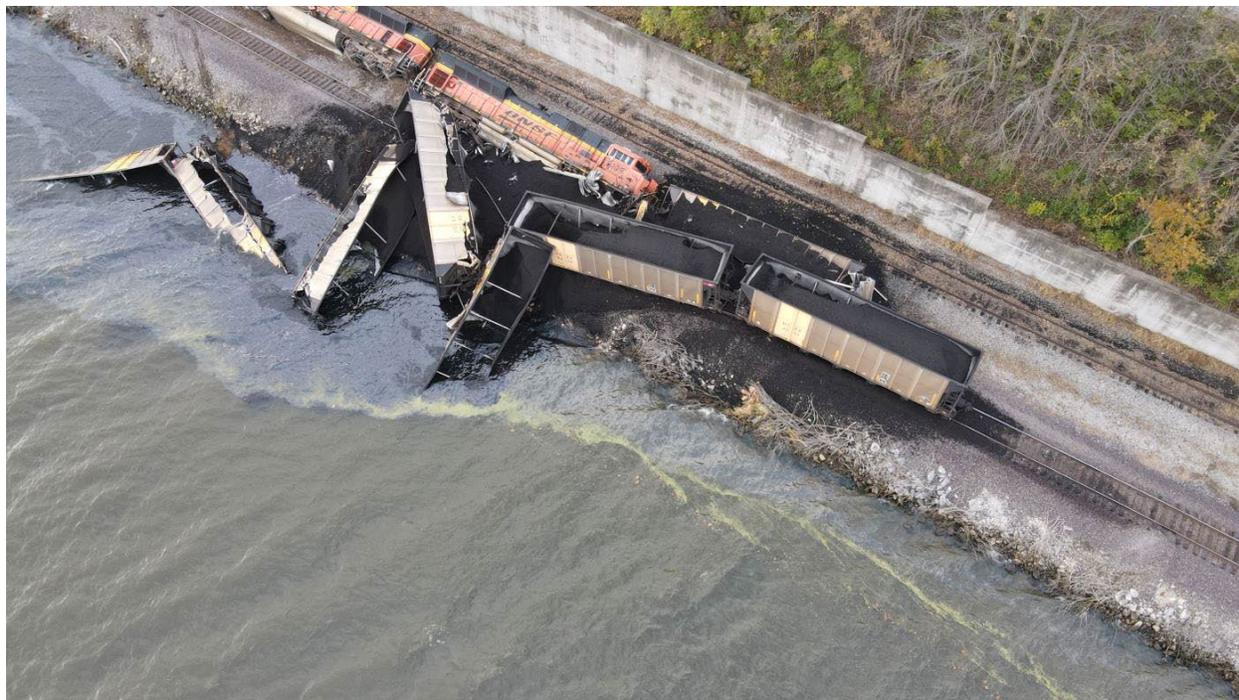
Figure 6. Aerial photo of the postcollision derailment of the two locomotives and eight hopper cars. Two additional hopper cars are submerged in the river. (Source: BNSF)

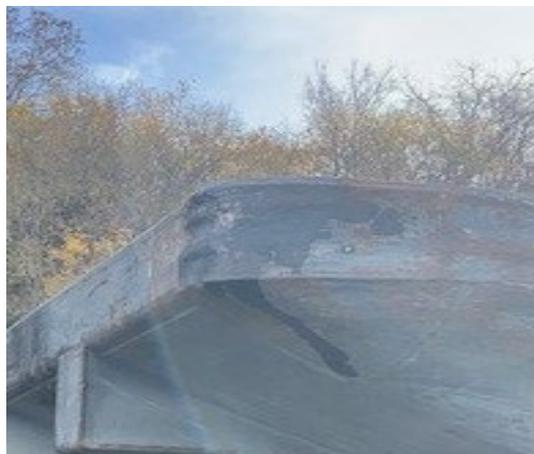
A damage survey of the barge *STC 3020* by a marine surveyor determined that damages resulting from the casualty were minor and did not appear to affect the structural integrity of the vessel. Investigators identified three horizontal indents on the forward port section of the bow rake and scraping to the deck just above the indents.

Figure 7. Postcasualty photo of the minor damage to the port bow rake of barge *STC 3020*. (Source: Coast Guard)

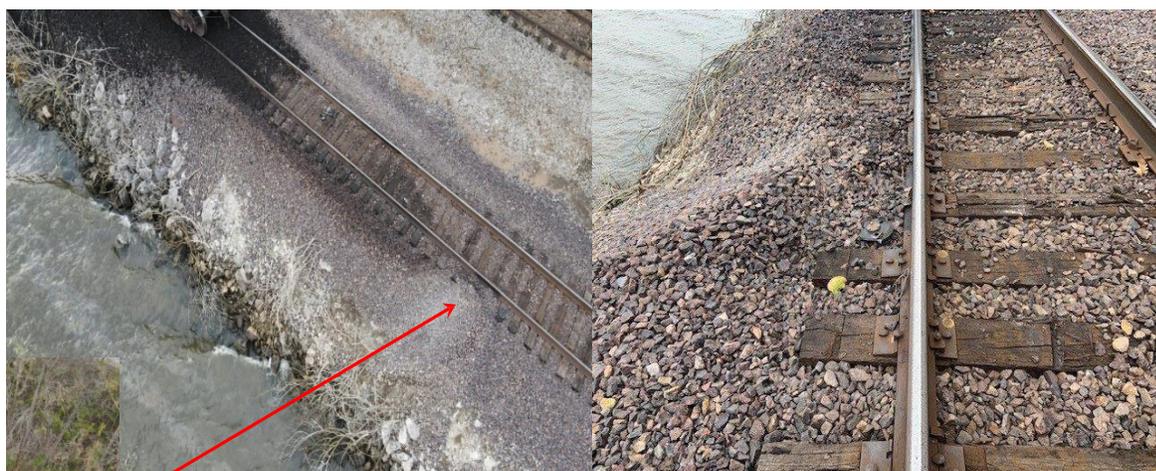
After the casualty, investigators reviewed video from the locomotive BNSF 9251. The video showed that the port bow rake of barge *STC 3020* extended about a foot over the railroad tie but did not cross over either rail. Postcasualty photos of the location showed an indentation where the barge had been pushed up against the riverbank. Coast Guard investigators determined that the distance from the railroad track to the riverbank was about 10 feet at the time of the casualty.

Figure 8. Aerial drone photo of the casualty site with a red arrow pointing to the indentation remaining in the ground where the forwardmost barge *STC 3020* was located (*left*). Close-up of the indentation from the barge in the shoreline next to the railroad track (*right*). (Sources: BNSF [*left*], Coast Guard [*right*])

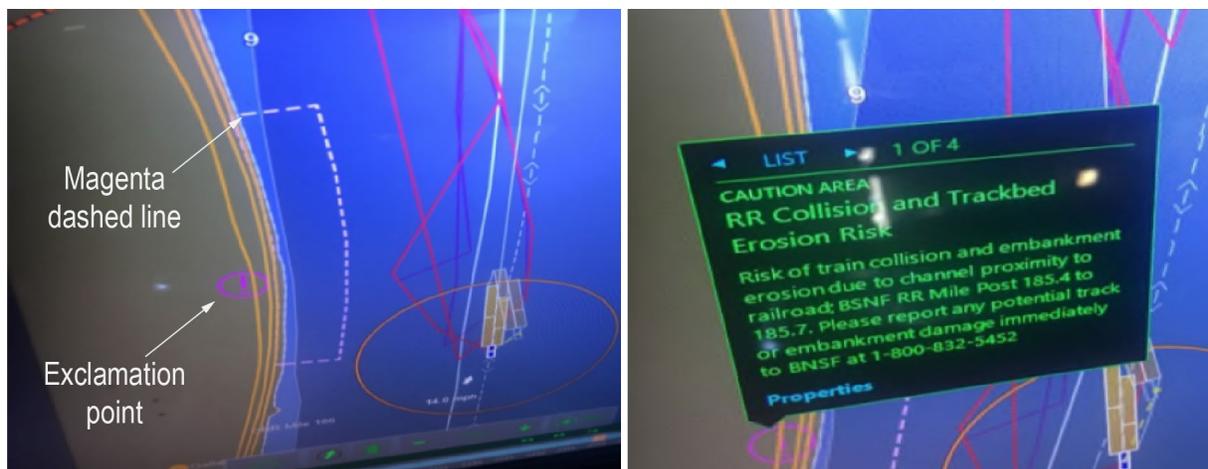
Next to the magenta dashed line near mile 372 on the electronic chart was an exclamation mark icon, which indicated that the area within the magenta dashed line was a "Caution Area" according to the ECS symbol reference table. On ECS navigational charts, magenta dashed lines with an exclamation mark show the limit of a caution area where mariners should be "made aware of circumstances influencing the safety of navigation"; there are no navigational chart symbols for a fleeting area.⁴ In Rose Point, a user could learn more information about the caution area by selecting the exclamation mark via "cursor pick" (moving the mouse pointer over the area and clicking the right button of the mouse) to read the corresponding caution note. When the exclamation mark icon next to the magenta dashed line near mile 372 was selected, a box displayed the following information: "Caution Area: RR [Railroad] Collision and Trackbed Erosion Risk" and "Risk of train collision and embankment erosion due to channel proximity to railroad." Both the captain and pilot said they had training in using the ECS, but they stated they did not see the exclamation point icon by the magenta dashed line because the screen setting was in nighttime mode, making the exclamation point difficult to see.

Figure 9. *Baxter Southern* Rose Point in nighttime display showing the area marked by the magenta dashed line and exclamation point (left, annotated by NTSB) and information contained in the corresponding caution note (right). (Source: Southern Towing Company)

The National Transportation Safety Board determines that the probable cause of the collision between the *Baxter Southern* tow and BNSF coal train was the tow's pilot and captain not correctly identifying a caution area on the electronic chart before deciding, due to the high wind's effect on the tow's empty barges, to push the tow up against the riverbank alongside a railroad track.

Mariners should ensure they understand all symbols and applicable advisories identified in their ECS, and owners and operators should ensure that their crews are proficient in the use of ECS. For more information about chart symbols, mariners should refer to [U.S. Chart No. 1: Symbols, Abbreviations and Terms used on Paper and Electronic Navigational Charts](#) or the US Army Corps of Engineers' [Inland Electronic Navigational Charts](#).
