Issued September 29, 2022

MIR-22/24

# Engine Room Fire on board Towing Vessel *Capt. Kirby Dupuis*

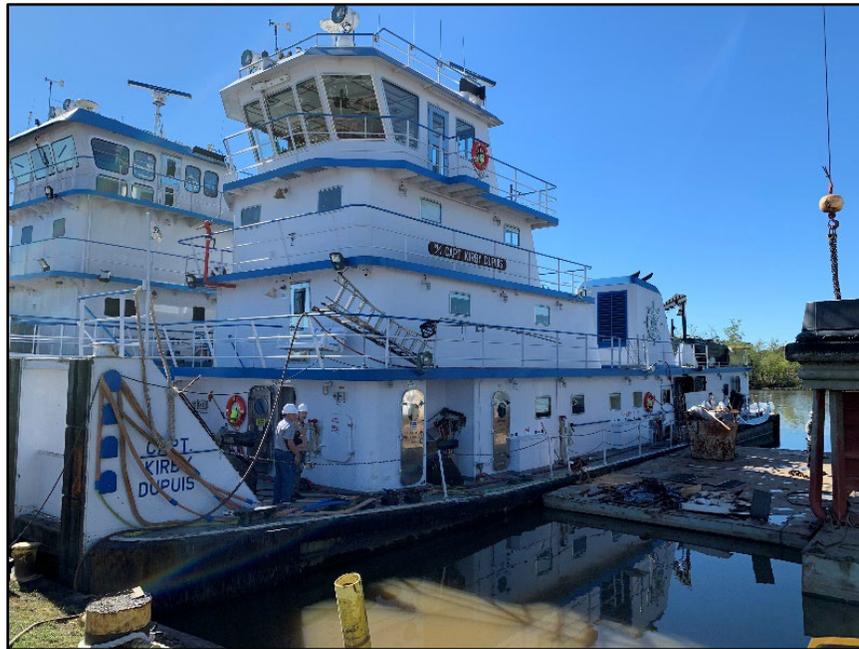
**Figure 1.** *Capt. Kirby Dupuis* docked after the casualty.

departments.<sup>2</sup> The fire caused extensive heat and smoke damage to the vessel's engine room. The upper and lower engine room bulkheads and overheads were completely burned by the fire as well as the machinery, fixtures, and equipment in the upper engine room. A marine surveyor estimated the damages to be 1.8 million dollars.

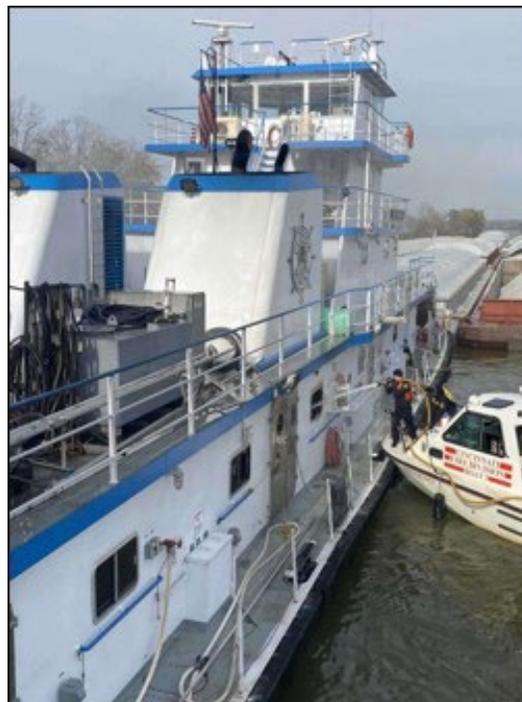
**Figure 3.** Firefighters deploying water into the engine room of the *Capt. Kirby Dupuis* through an open window. (Source: LT Meghan G. Keith, Dearborn County Water Rescue)

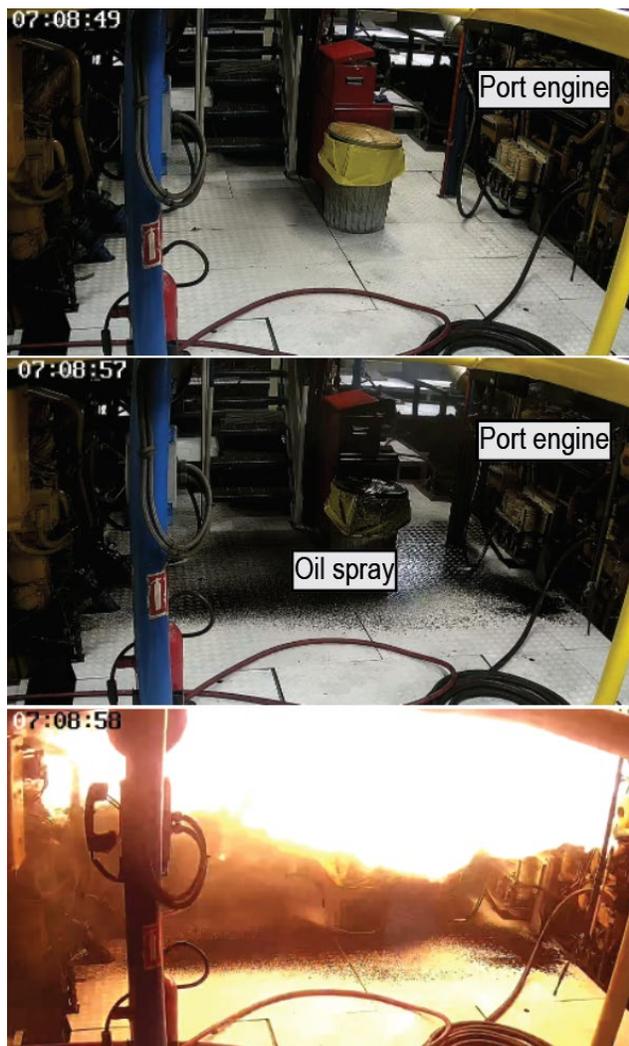
The day after the fire, investigators reviewed the vessel's video system. At 0708:50, lube oil began to spray inboard from the port main engine into the center of the engine room toward the starboard main engine. About 10 seconds later, a flame at the top of the forward part of the engine by the exhaust manifold erupted inboard toward the starboard engine. The video lasted about 1 minute, until the camera stopped recording.

**Figure 4.** Screenshots from the *Capt. Kirby Dupuis* engine room video camera (looking aft) at 0708:49-0708:58.

The engine room video showed that, within 10 seconds of the leak starting, the oil sprayed inboard into the center of the engine room and upward onto the exhaust manifold on top of the running engine. Immediately after contacting the hot surface of the exhaust manifold, the oil ignited and started the fire. Forced air from the running ventilation supply fan discharging above the engine fueled the fire with oxygen and propelled it across the engine room, damaging the starboard engine and the equipment in the upper engine room.

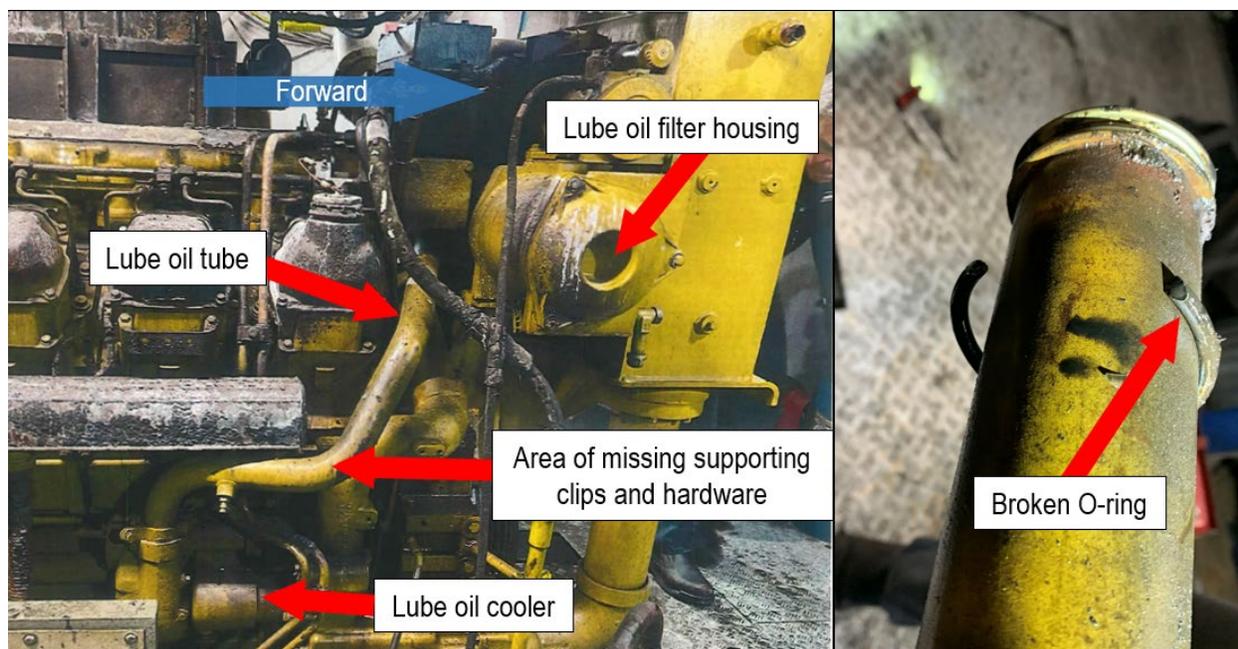
A senior technical service manager from Louisiana Cat (Caterpillar) reviewed the video and inspected the damaged port main engine. He found a broken piece of an O-ring seal on top of the front cover of the engine, directly below the upper joint area of a lube oil tube that connected the lube oil filter housing to the lube oil cooler. (The typical operating pressure of the system was about 55 pounds per square inch.)

**Figure 5.** Port main engine lube oil components (*left*). Port main engine lube oil tube with broken O-ring after removal on upper section of tube (*right*). (Source: Louisiana Cat, annotated by NTSB)

When the service manager removed the tube from the engine, he found the remainder of the broken O-ring and observed that the retaining ring, which should have been installed to secure the tube in its joint, was missing where the tube connected to the lube oil filter housing. It is unknown when the tube had last been removed from the engine. Upon further inspection, the technician discovered “wear to the seal O-ring groove lip” on the upper section of the removed tube.

The initial cause of the *Capt. Kirby Dupuis* port main engine (a Caterpillar model 3512C) fire was an oil leak from the pressurized lube oil system at the tube connection to the lube oil filter housing, which released oil that came in contact with a hot surface, likely the exhaust manifold on the engine. The retaining ring that was supposed to be installed behind the O-ring lip of the lube oil tube was missing, so the O-ring was not properly sealed nor supported in the joint for an unknown amount of time, leading to its failure. The wear found on the seal O-ring groove lip of the lube oil tube indicates that there was movement of the tube in the joint due to natural vibration of the operating engine. It is likely that at some installation, after maintenance that required removal of the tube, the retaining ring was not re-installed on the tube.

The National Transportation Safety Board determines that the probable cause of the engine room fire aboard the towing vessel *Capt. Kirby Dupuis* was a lube oil tube on the port main engine that vibrated out of a joint due to a missing retaining ring and

mounting bracket, spraying pressurized oil that made contact with a hot exhaust surface and ignited. Contributing to the severity of the fire damage was the crew's unfamiliarity with activation procedures for the fixed fire-extinguishing system, which resulted in an unsuccessful attempt to release the fire suppression fluid and extinguish the fire.

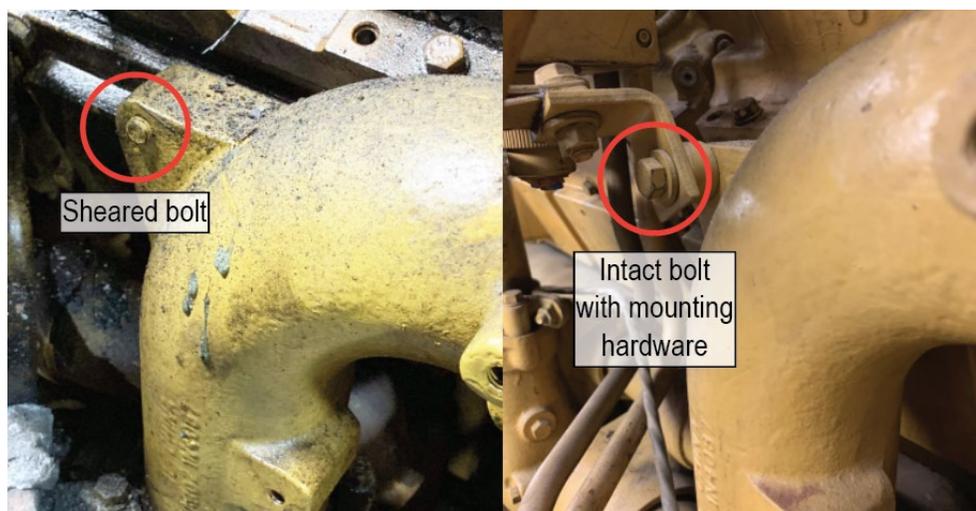
Additionally, supporting clips and mounting hardware for the lube oil tube were missing on the port main engine in the mid-section area, and the bolt that had held the supporting clips appeared to be sheared. The service manager’s report concluded that the cause of the fire was “a severe oil leak” that sprayed onto the exhaust manifold of the port main engine near the no. 1 cylinder and ignited. “Ventilating air from the air duct above the [port main] engine supplied the fire with oxygen and blew the fire across the engine room damaging the stbd. [starboard] main engine.”

**Figure 6.** Sheared bolt for lube oil tube mounting on *Capt. Kirby Dupuis* port main engine (left). Proper arrangement of supporting clips and mounting hardware on board similar FMT towing vessel *David McNemar* (right).

Additionally, the supporting clips and hardware were also missing from the mid-section of the lube oil tube, preventing it from being secured in accordance with the manufacturer's design. It is unknown how long the supporting clips and hardware had been missing from the engine. The last major work on this engine was in May 2018 when a top end overhaul was conducted, and it is possible that the oil tube was removed during that work. However, none of the parts associated with the tube were ordered at that time. A sheared bolt found postcasualty indicates that the supporting clips and hardware had originally been installed on the engine but had failed at some point. Without the supporting clips and hardware, the tube was unsupported in the mid-section area and more susceptible to vibration and associated movement.

Caterpillar 3512 main engines throughout their fleet for proper installation of supporting clips and mounting hardware on the lube oil tubes. About 10% of the inspected engines required attention and were corrected.

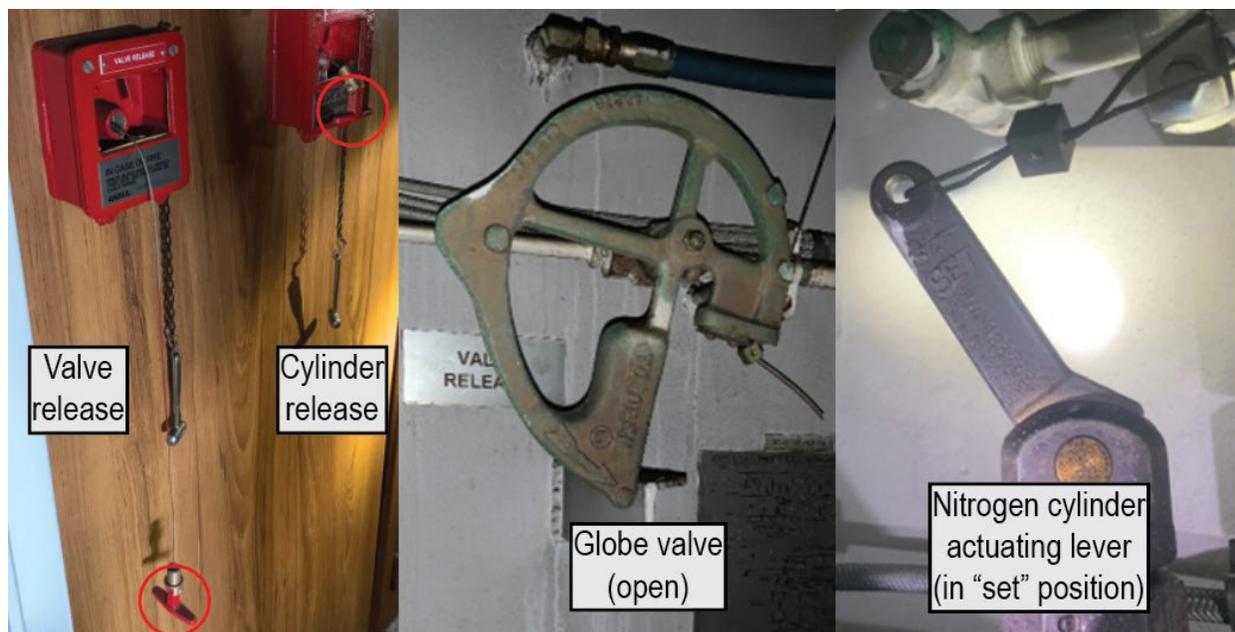
When investigators inspected the fire-extinguishing system, they observed that the “valve release” remote pull lever was pulled out as per the instructions, and its corresponding globe valve was open. However, the “cylinder release” remote pull lever was not fully extended, and its corresponding nitrogen cylinder’s actuating lever remained in the “set” position.

**Figure 8.** Remote pull stations for *Capt. Kirby Dupuis's* fixed fire-extinguishing system as found after the fire. Red pull levers are circled (*left*). Globe valve in open position after the fire (*center*). Nitrogen cylinder's actuating lever in the "set" position as found after the fire (*right*). (Source: Coast Guard).

Although the crew attempted to activate the vessel's fixed fire-extinguishing system—and believed they had successfully discharged the fire suppression fluid—investigators determined that the system was not activated during the fire. After the fire, the nitrogen pilot cylinder lever was found in the "set" position and its cylinder was still fully charged. Both suppression fluid cylinders were also found full to capacity after the fire. Despite the deckineer stating that he pulled both remote pull levers, only the "valve release" lever was found to be fully extended; its attached cable properly opened the globe valve. However, the "cylinder release" remote pull valve handle was found only slightly extended from its stowed position in the cradle; therefore, the nitrogen gas from the pilot cylinder had not been discharged. Lacking pilot pressure, the sequence for release could not activate: the siren did not sound, and the remote shutdowns of the engines and ventilation fans were not activated.

None of the drills or procedures included familiarization or training on the fixed fire-extinguishing system. As of the date of this report, FMT is developing a training video on fixed fire-extinguishing systems that will become required training for their crews.
