MIR-22/26

Capsizing of Liftboat *SEACOR Power*

Port Fourchon, Louisiana

April 13, 2021

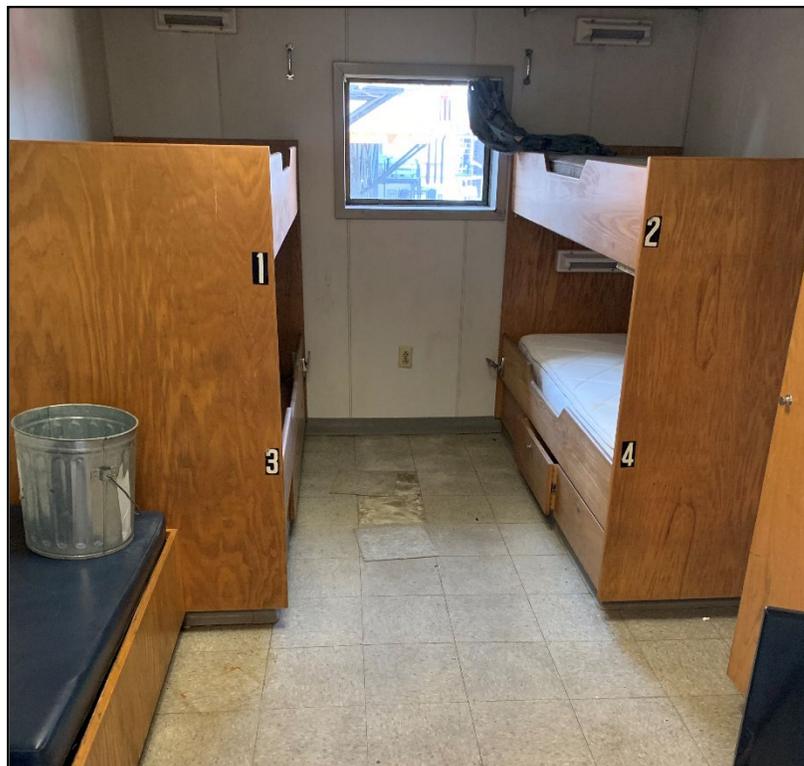
OWs 1 and 2 were asleep when the vessel capsized. Lockers on the port side of the room came loose from the bulkhead and fell inboard, blocking the inward-swinging door to the passageway. OW 2 was able to push ceiling tiles aside and egress the room via the crawl space in the overhead and into the [athwartship](#) passageway, now a vertical shaft, where he saw water already halfway up the space.⁴ OW 1 was unable to egress through the crawl space, so he donned a lifejacket, broke the window in the aft bulkhead of the room with an extinguisher while standing on the side of the bed, and exited (see Figure 5).

Figure 5. Stateroom with window on aft bulkhead, similar to the one OW 1 and 2 were in, aboard the *SEACOR Legacy* (a similar vessel). Note this vessel was not in service and outside equipment was stowed in rooms during an NTSB visit.

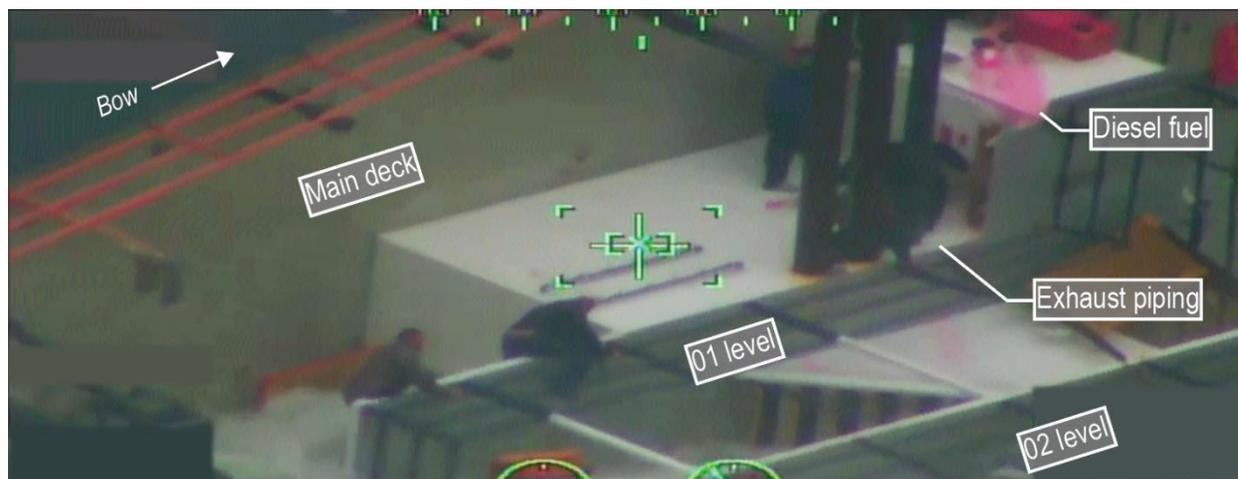
Six personnel were gathered on the port side of the *SEACOR Power*: OWs 1, 2, and 3; ABs 1 and 2; and the night cook. They were “pummeled by waves and rain,” according to one of the survivors (see Figure 6). Four of six (OW 2, the night cook, and the two ABs) did not have lifejackets. Diesel poured from tank vents, making the structure and survivors slippery, and a loose wooden bench injured OW 1’s foot. OW 2 saw the well site supervisor float by in a lifejacket but was unable to reach him. OW 1 was next swept away by the seas and drifted away from the vessel.

Figure 6. Port side of the capsized hull as seen from *Glen Harris* about 1755. Some personnel are visible. (Source: *Glen Harris*)

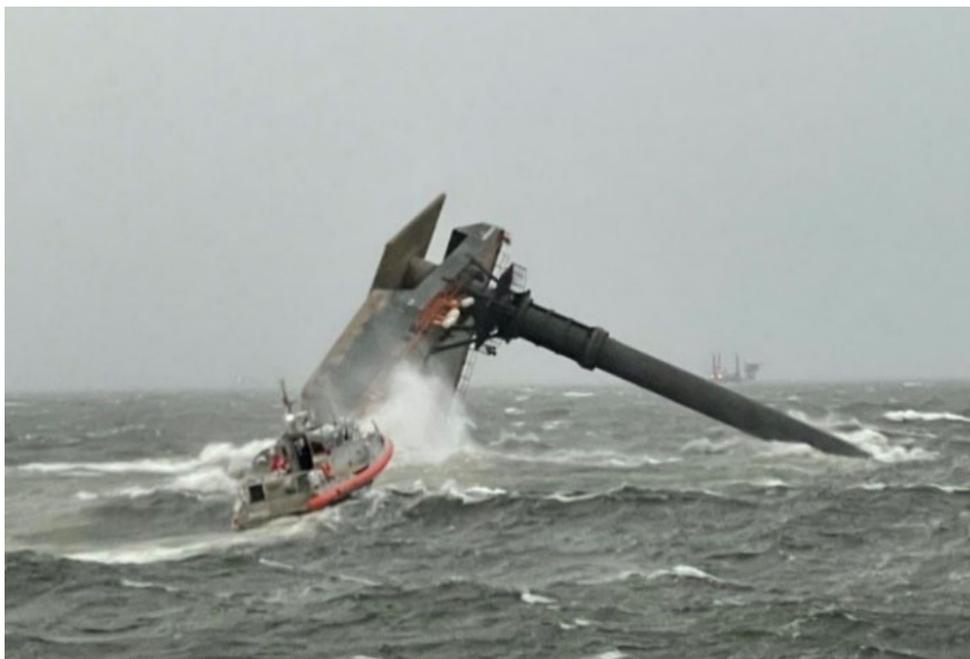
Figure 8. *SEACOR Power* capsized on its starboard side on the evening of the casualty, with a Coast Guard RB-M in the foreground and the liftboat *Rockfish* in the background. (Source: Coast Guard)

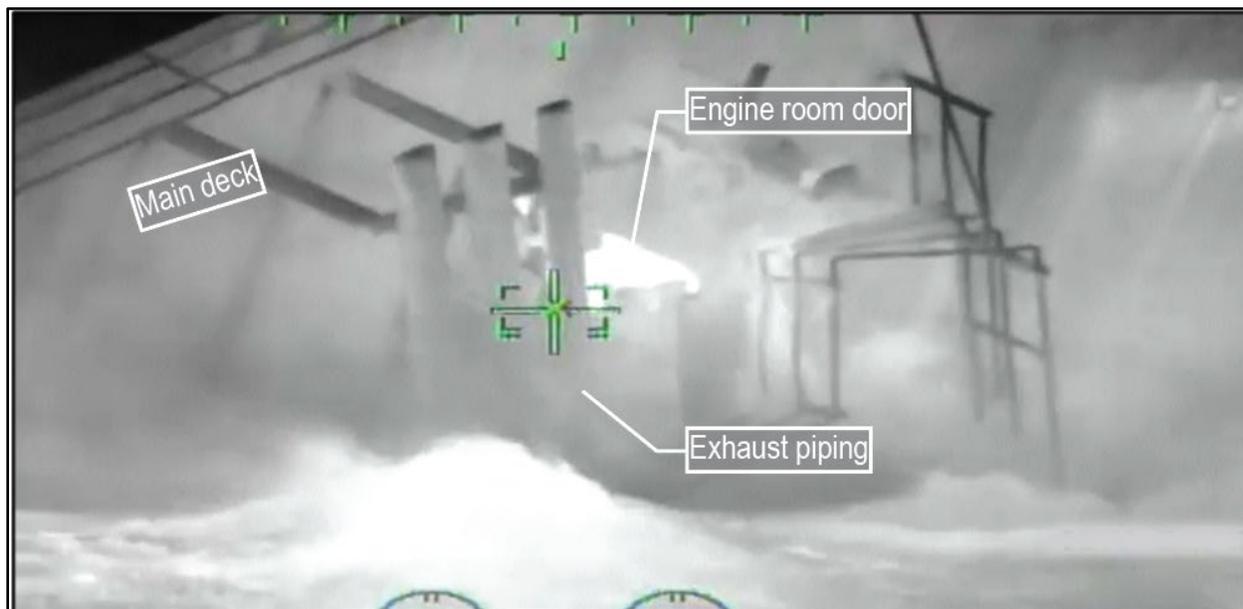
The remaining two men (OW 3 and AB 2) sheltering on the liftboat's superstructure were able to communicate with the *Glen Harris* crew using the radio supplied by the *Bristow* helicopter. They had found relative shelter in the lee of the main deck access to the engine room. However, the wind became southerly over several hours and seas continued to build, exposing the two survivors to increasingly violent conditions. The *Glen Harris* crew observed the survivors open and enter the

Figure 9. Door to engine room as it was opened at 2153, as seen by the *Glen Harris*. (Source: *Glen Harris*)

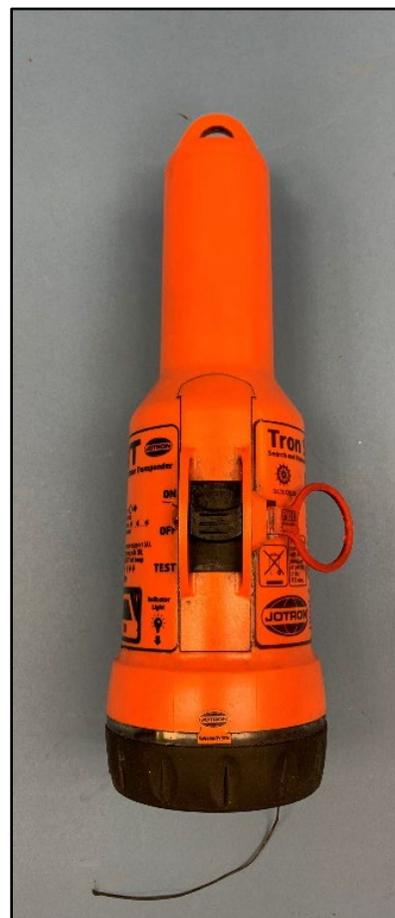
Figure 14. *SEACOR Power* SART following the casualty.

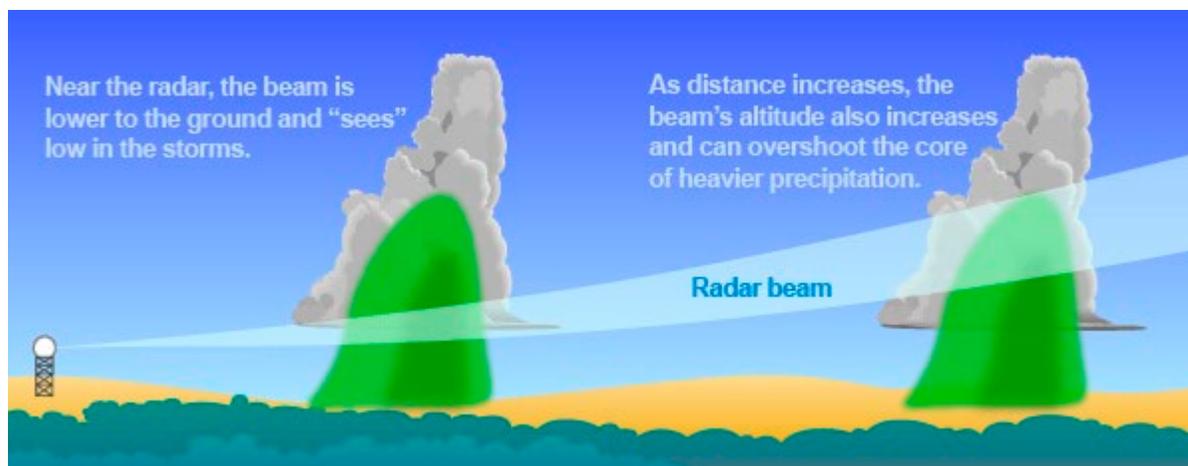
KLIX was about 82 miles north-northeast of the capsizing site at an elevation about 80 feet above mean sea level (msl). At this distance, the 0.525° upward tilt of the KLIX radar would have “seen” altitudes above the capsizing location about 5,100 to 13,300 feet above msl (see Figure 17).²⁰

Figure 17. At increasing distance, the radar is viewing higher and higher in storms, and the beam may overshoot the most intense parts. (Source: NWS)

Because the localized weather could not be detected by nearby radars due to their elevation angles (antenna angles relative to the horizon), we recommended that the National Weather Service, Federal Aviation Administration, and Air Force work together to assess coastal weather radar sites to determine if it is safe and appropriate to lower the radar angles, and then lower the angles of the lowest radar beams where appropriate.

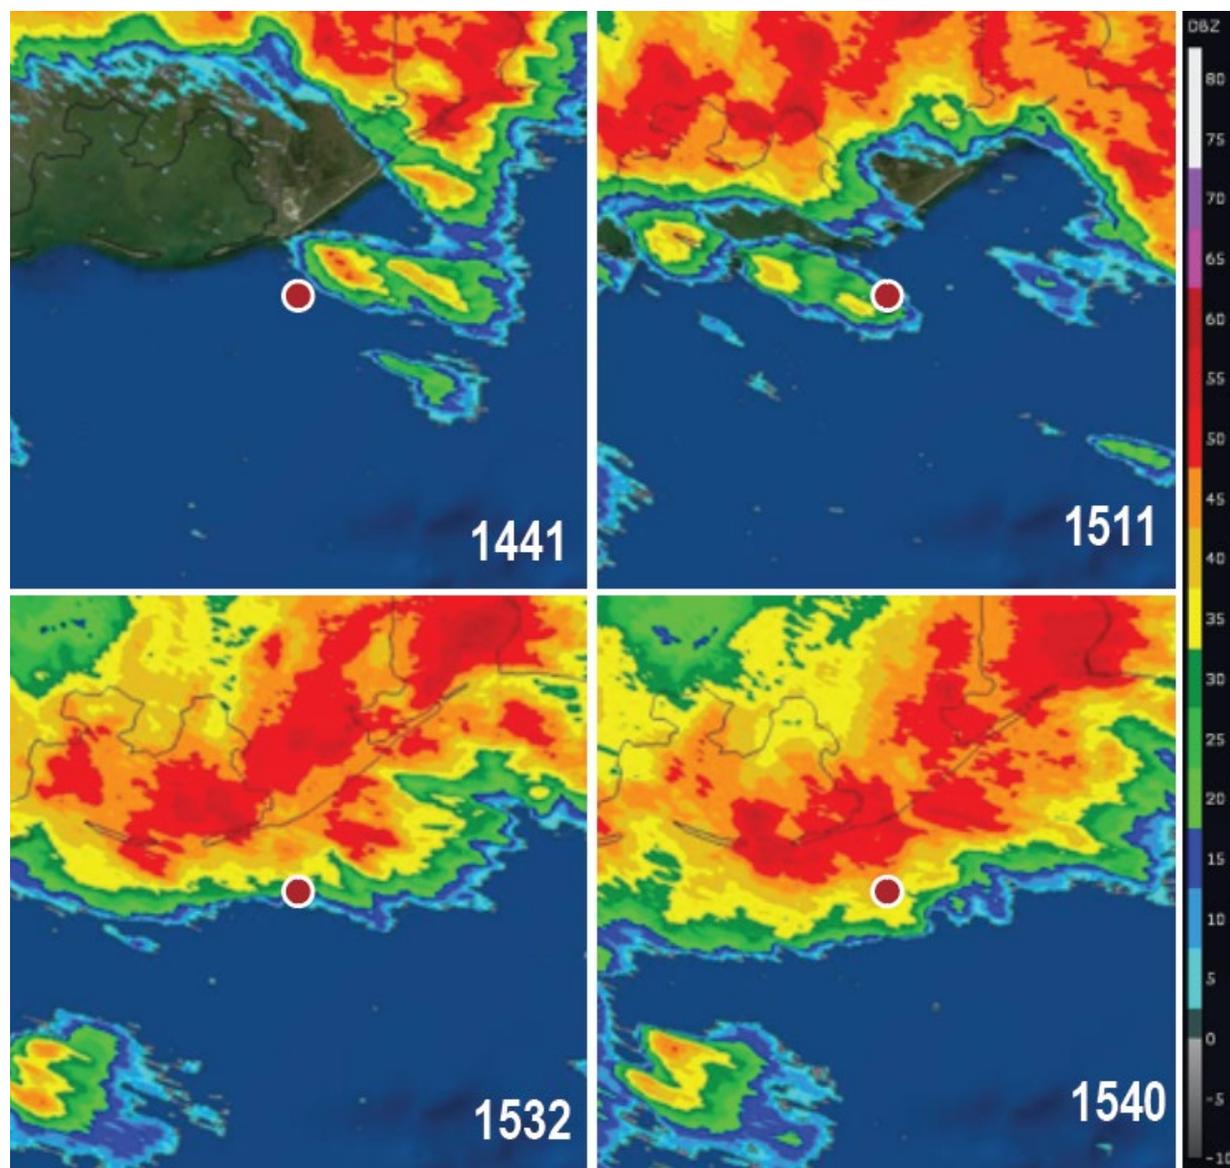
Figure 18 presents KLIX weather radar reflectivity imagery 1) about one hour before the casualty (about 1441), 2) 30 minutes before the casualty (about 1511), 3) as light reflectivity associated with the leading edge of the MCS initially moved over the vessel (about 1532), and 4) about the time of the casualty.

Figure 18. KLIX Level-II 0.525° base reflectivity images from sweeps initiated about 1441, 1511, 1532, and 1540. Casualty site is denoted by the red circle. The colors represent the strength of returned energy to the radar expressed in values of decibels (dBZ). The color scale is located to the right. Generally, as dBZ values increase so does the intensity of precipitation. (Source: NWS)

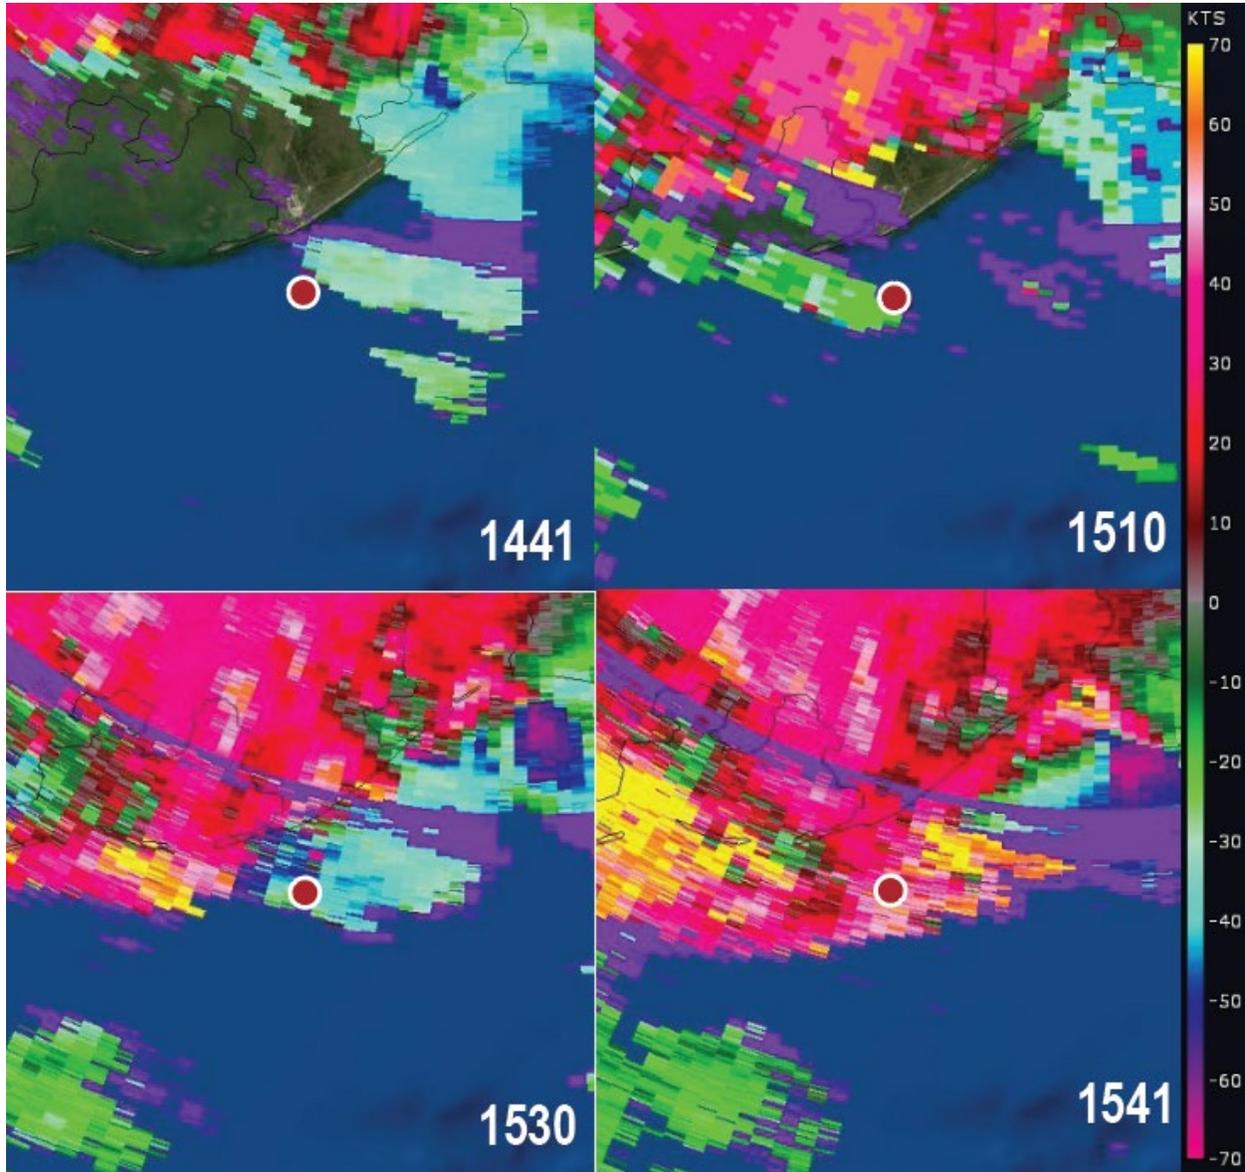
direction either directly toward the radar (negative values; more green/blue colors) or directly away from the radar (positive values; more red/yellow colors). As with the reflectivity data, KLIX's location and angle meant that the data "seen" at the capsizing location was about 5,100 to 13,300 feet above msl.

Figure 19. KLIX Level-II 0.525° base velocity images from sweeps initiated about 1441, 1510, 1530, and 1541. Casualty site is denoted by the red circle. The colors represent the calculated wind speed, in knots. (Source: NWS)

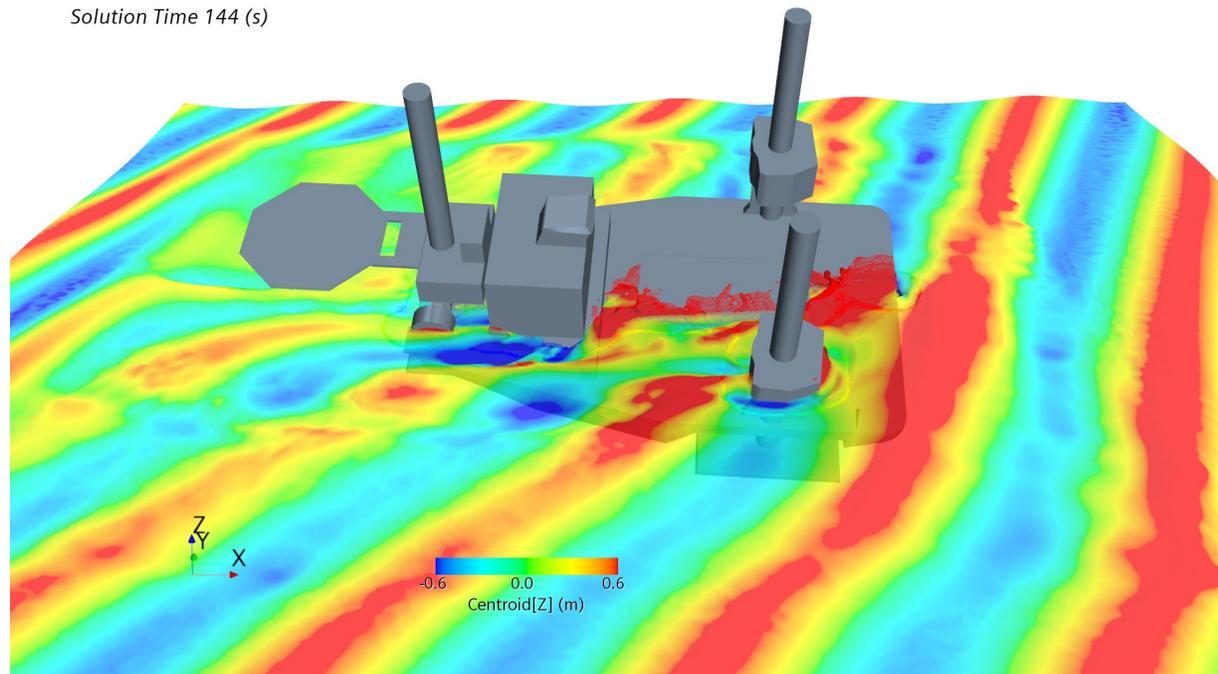
- Case 3 explored whether the model maintained stability with co-linear winds and waves from 285° and cross waves from 023°. This case was designed to simulate the effects of both swells and wind-generated waves on the *SEACOR Power* under tested wind conditions. The CFD analysis showed that the vessel capsized under these conditions.

Figure 23. Illustration of the CFD analysis for step 8, case 1, simulating the effect of wind gusts with swells. Colors indicate wave height, with blues in low areas and reds in high areas. The vessel capsized in the simulation.

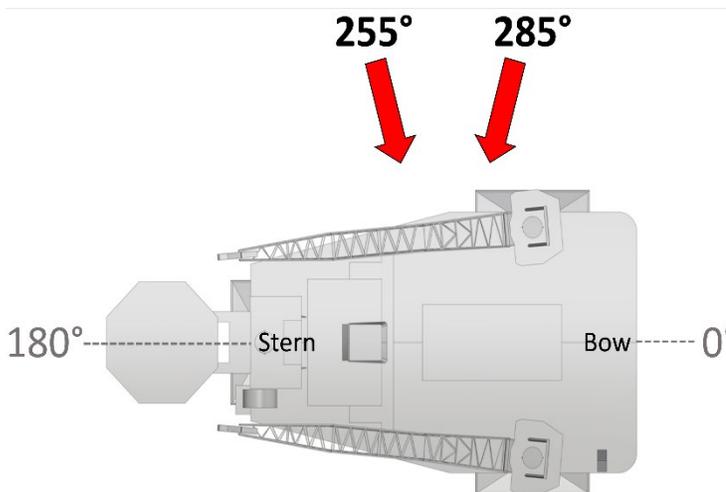
The *SEACOR Power* met stability criteria when subjected to the maximum wind thresholds in the regulations (70 knots) in calm seas, but actual winds during the capsizing were above the regulatory threshold, with gusts to 80 knots. The ABS CFD analysis found that, with the *SEACOR Power* in the casualty loading condition (9 feet 3 inches load line draft with 2.5 feet of trim by the stern; legs lowered 10 feet), the vessel was vulnerable to capsizing with winds off the beam and seas at 4 feet (see Figure 24). Although the storm initially hit the *SEACOR Power* from astern, the mate turned the liftboat to port in an attempt to put the bow into the wind and slow the vessel down to soft tag the bottom. This maneuver put the winds on the vessel's port beam. The CFD model of the vessel capsized in 80-knot winds when the wind direction was just forward of the port beam (285° relative) and swells of 4 feet were coming from off the starboard bow (023° relative). The CFD model of the vessel also capsized when these wind and swell conditions were combined with wind-generated waves moving in the same direction as the winds.

Figure 24. Most vulnerable wind direction axes for port side of the *SEACOR Power* as determined by CFD analysis.
