Issued November 3, 2022

MIR-22-28

Grounding of Towing Vessel *Marquette Warrior*

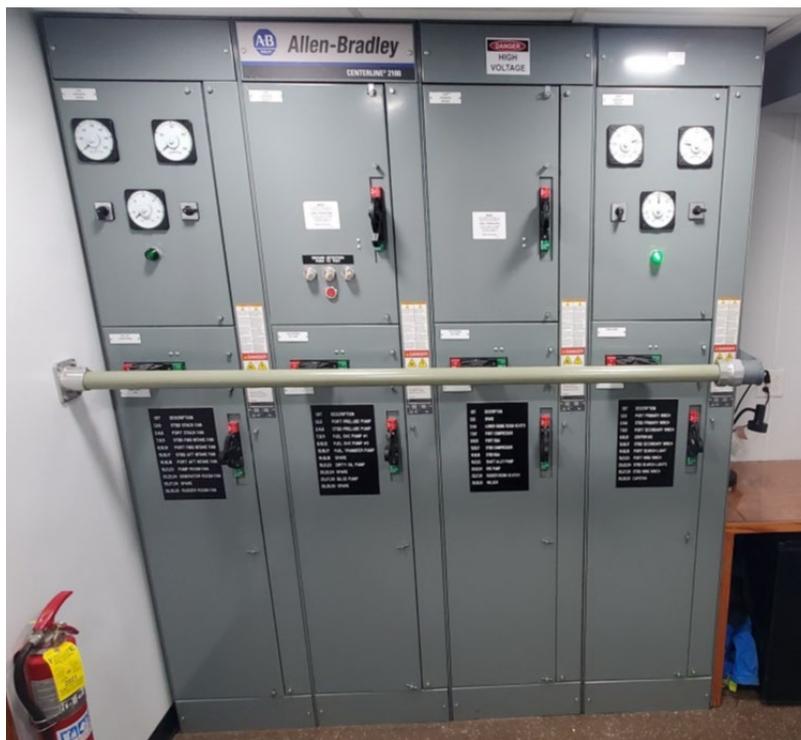
investigate. He observed a ground fault indication on the switchboard and suspected that the fault might have been the reason for the flickering lighting.³

Figure 3. Main switchboard located in the engine control room aboard the *Marquette Warrior*. (Source: Marquette Transportation Company)

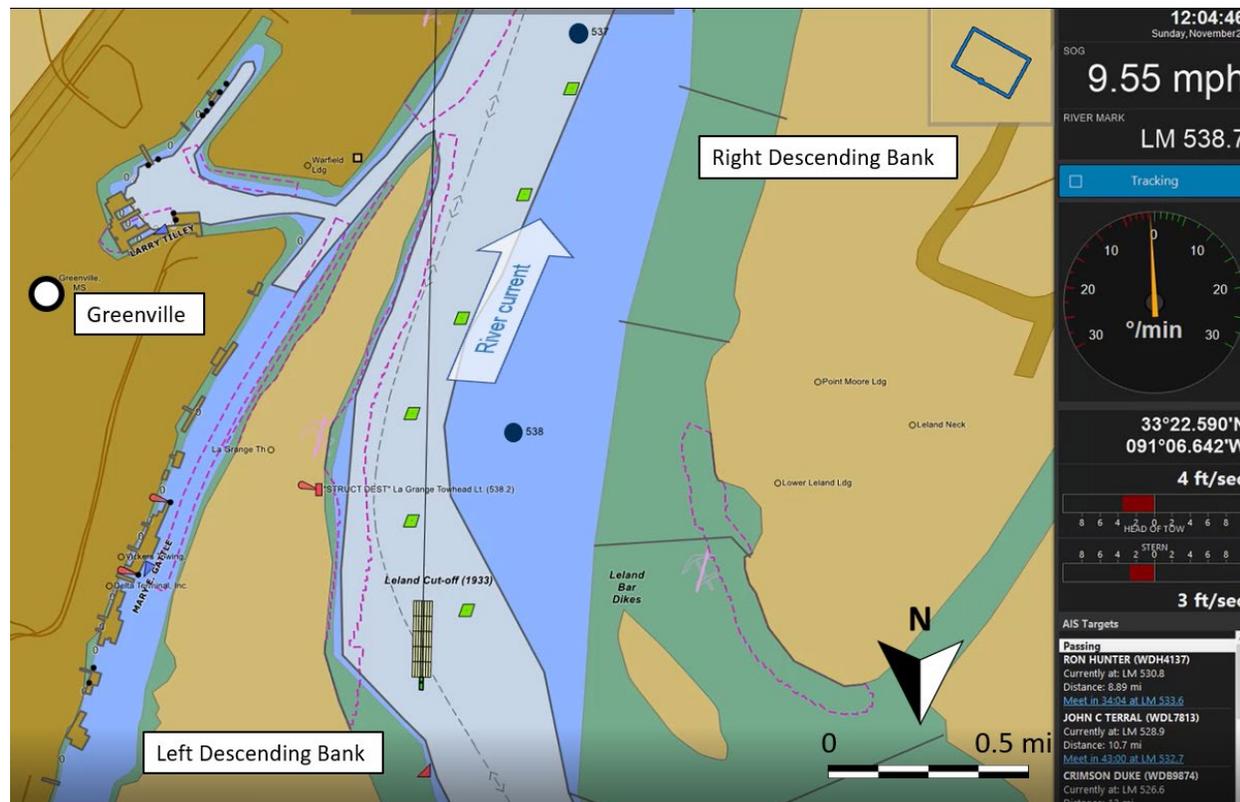
About 1205, 5 minutes after the engineer first notified the pilot of an electrical issue, the pilot attempted to initiate a turn to starboard at the La Grange Towhead Light and realized that the rudders were not responding. The pilot immediately radioed the mate, who was with the engineer, and informed them that the vessel had lost steering. After sounding the general alarm, the pilot attempted to change over the hydraulic steering pumps using a switch in the wheelhouse, but it had no effect. Using the main engine throttles in the wheelhouse, the pilot brought the engines astern to slow the vessel's speed.

Figure 4. Electronic chart system screenshot from the *Marquette Warrior* during the casualty, showing the tow about 1205, when the vessel lost steering. (Source: Marquette Transportation Company)

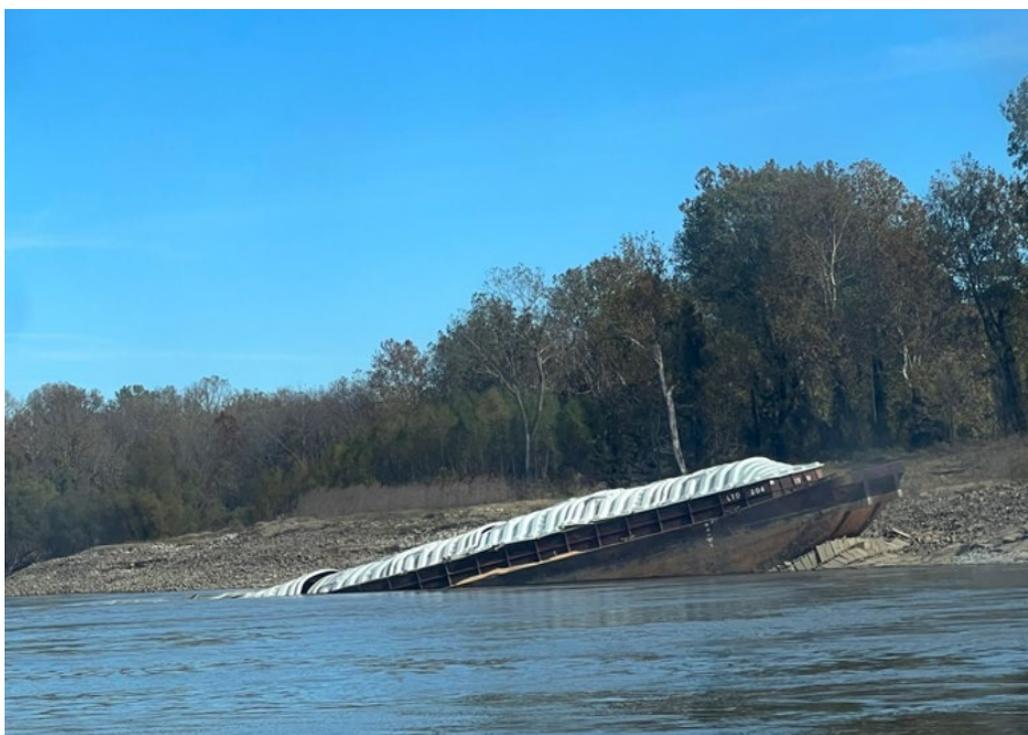
Following the grounding, the *Marquette Warrior*, aided by several nearby Good Samaritan vessels, corralled the scattered barges and rebuilt the tow. Four of the barges sustained damage, mostly to their rake bottoms and side shell plating, with the steel plating being dented or inset. One barge partially sank and was later salvaged; its bean cargo was contaminated with water and was declared a loss. The total damage to the barges was estimated to be \$215,000, and the lost cargo was estimated to be worth \$1,020,000. The *Marquette Warrior* also sustained an estimated \$7,500 in damage as a result of the casualty.

Figure 5. A barge that grounded and partially sank following the casualty. (Source: Marquette Transportation Company)

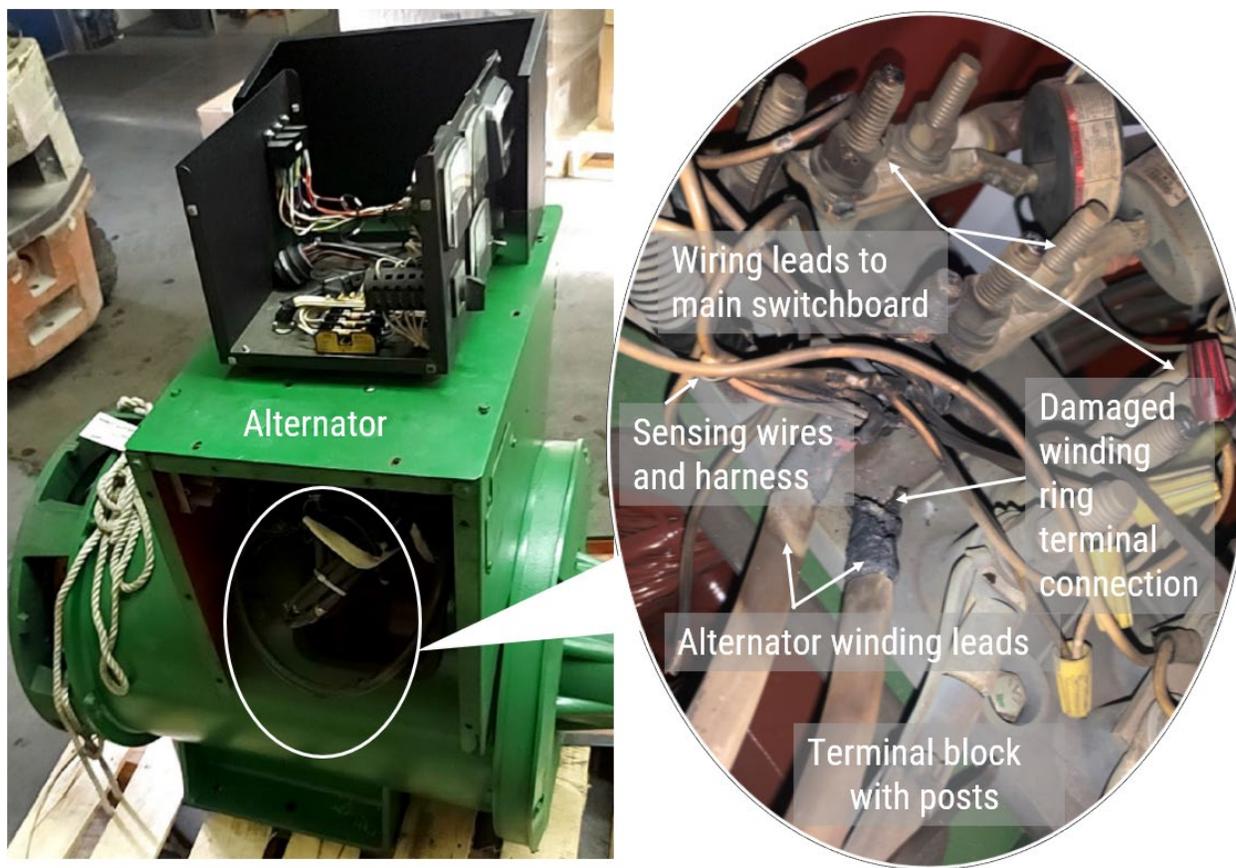
Suspecting an issue with the port genset, the vessel's engineer notified the company's port engineer, who arrived on board within a few hours of the casualty with a new alternator. The port genset's alternator was changed out and shipped back to the company's facility for inspection. The port engineer who assisted the vessel's engineer with the replacement indicated that he observed "burnt terminals" on the terminal block within the alternator and determined this to be the cause of the failure. The fiber terminal block had threaded steel studs (posts) where the leads from the alternator's windings, the main switchboard, sensing wires, and current transformers were secured with 1/2-inch nuts and lock washers. Once the damaged alternator arrived at the company's facilities, it was inspected by a supervisory port engineer, who also said he observed multiple burnt wires. He suspected that a loose wire may have been the reason for the alternator failure.

Figure 6. Port alternator with side cover removed (*left*) and close-up of terminal block (*right*), after being taken from the *Marquette Warrior* postcasualty. The control box (with cover removed) is mounted on the top panel. (Sources: Warden Electric [*left*], Marquette Transportation Company [*right*])

The company then sent the failed alternator to the same company that had refurbished the unit several months prior for inspection and repair. The repair facility personnel observed a burnt winding lead terminal connection (ring terminal connection) that had become separated from the terminal block post (also identified by the port engineers). They also identified that three of the center posts on the terminal block had arcing residue built up on their tops, indicating that an item had been coming in contact with them. Further, a wiring harness containing sensing wires, which led from the terminal block up into the control box, mounted on the top panel of the alternator, was “blown completely in half.” They suspected that this wiring harness, normally routed clear of the terminal block posts, had been lying across the posts, rubbing through the jacketing of the harness and eventually through the wires’ insulation. Once the bare sensing wires contacted the posts (studs), arcing occurred. They compared this arcing to a welding arc, where small bits of the metal wire would be deposited onto the posts. An electrician from the repair facility also explained that, along with the arcing, excess heat would deteriorate the insulation for the wires attached to the terminal block. The repair

facility personnel suspected the wire insulation deteriorated over a prolonged period, until a point where the arcing and heat became severe enough to cause the winding terminal connection to fail. The electrician suspected that, during this period, there would have been flickering lights and fluctuations in the vessel's voltage and amperage.

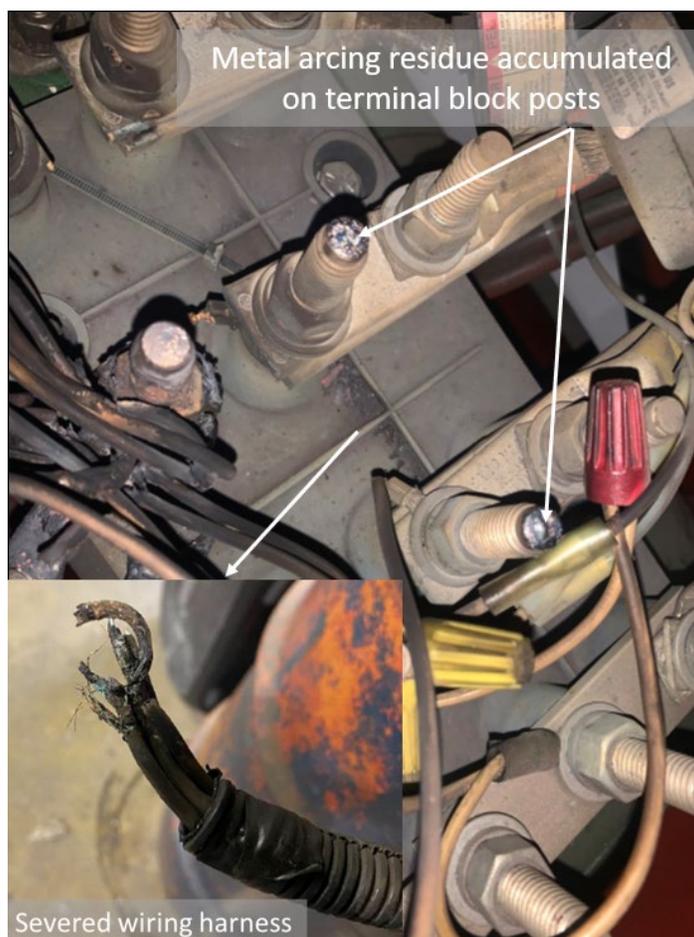
An electrical supervisor from the shipyard who reviewed pictures of the burnt and disconnected winding lead terminal connection after the casualty suspected that once the alternator terminal connection failed and became separated from the terminal block post, the alternator would no longer be able to supply 3-phase power. He expected that there would have been heavy fluctuations of the alternator's voltage and amperage output, as well as the flickering of the vessel's lights. Additionally, the 3-phase electric motors for the steering pumps (and all other 3-phase equipment) would not have been able to produce any torque and would have stopped (a condition known as single-phasing motor).

Figure 7. Port alternator terminal block showing metal arcing residue on the terminal block posts. Inset shows the severed wiring harness. (Source: Marquette Transportation Company)

failed, causing the alternator to lose one of its phases and the steering pump motors (and all other 3-phase equipment) to stop due to a lack of available torque. Electricians from the company that had recently refurbished the alternator also observed the burnt and damaged ring terminal, and in addition they discovered arcing metal residue on three terminal block posts and a severed wiring harness. According to the electricians, this indicated that the wiring harness had been lying across, rubbing against, and eventually arcing to the terminal block posts for a prolonged period. All parties involved agreed that the way the alternator failed would have caused fluctuations in the alternator output voltage and amperage and that the vessel likely would have experienced flickering lights.

The November 7 preventive maintenance performed by the vessel's engineer required the removal of the port genset alternator's cover panel to inspect "all wires/connection" for wire fray, chaffing, and loose connections. Electricians' analysis of the alternator following the casualty indicated that the most likely cause of the failure was rubbing or chaffing of the sensing wiring harness, which led to arcing between terminal block posts, heat buildup, insulation failure, and eventual winding ring terminal failure. Because the onboard engineer did not notice any damage within the terminal box or to the sensing wiring harness during his inspection, it is likely the chaffing of the wiring harness took place over the 72 hours the genset ran between the November 7 maintenance inspection and the casualty on November 21. While it is possible the wiring harness could have shifted onto the terminal posts due to vessel vibrations, it is more likely that the wiring harness was inadvertently displaced during the vessel engineer's preventive maintenance inspection on November 7 and went unnoticed during his reinstallation of the cover panel.

The National Transportation Safety Board determines that the probable cause of the grounding of the towing vessel *Marquette Warrior* was a loss of steering, likely due to a wiring harness within an electrical generator that was improperly positioned during a maintenance inspection, resulting in the harness contacting the terminal posts, eventually causing the loss of 3-phase electrical power to the steering pump motors.

Proper operation and maintenance of electrical equipment is required to avoid damage to vessel critical systems and prevent potentially serious crew injuries, particularly for electrical systems with high and medium voltage and equipment with uninsulated and exposed components. Electrical equipment should be installed, serviced, and maintained by qualified personnel familiar with the construction and operation of the equipment and the hazards involved.
