Issued February 1, 2023

MIR-23-02

Engine Room Fire aboard Passenger Vessel *Natchez*

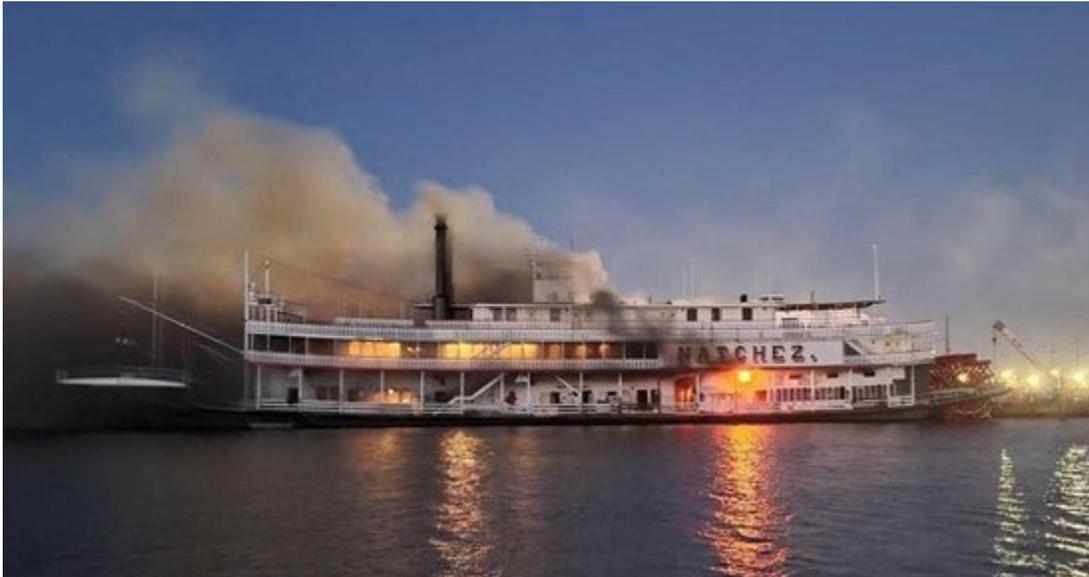
About 1945, while the deckhand was in the captain's salon, he saw smoke passing the window. He exited the space to investigate, looked aft, and saw "a big puff of smoke coming from the overhead of the bottom [main] deck." The deckhand moved down the gangway and along the dock toward the vessel's stern to investigate the source of the smoke. He saw small flames that were growing and expanding inside the open

starboard-side engine room doors. From his cell phone, he immediately called 911, and then he called the captain and additional company personnel to inform them of the fire.

Figure 5. The *Natchez* on fire. (Source: Unidentified witness via US Coast Guard)

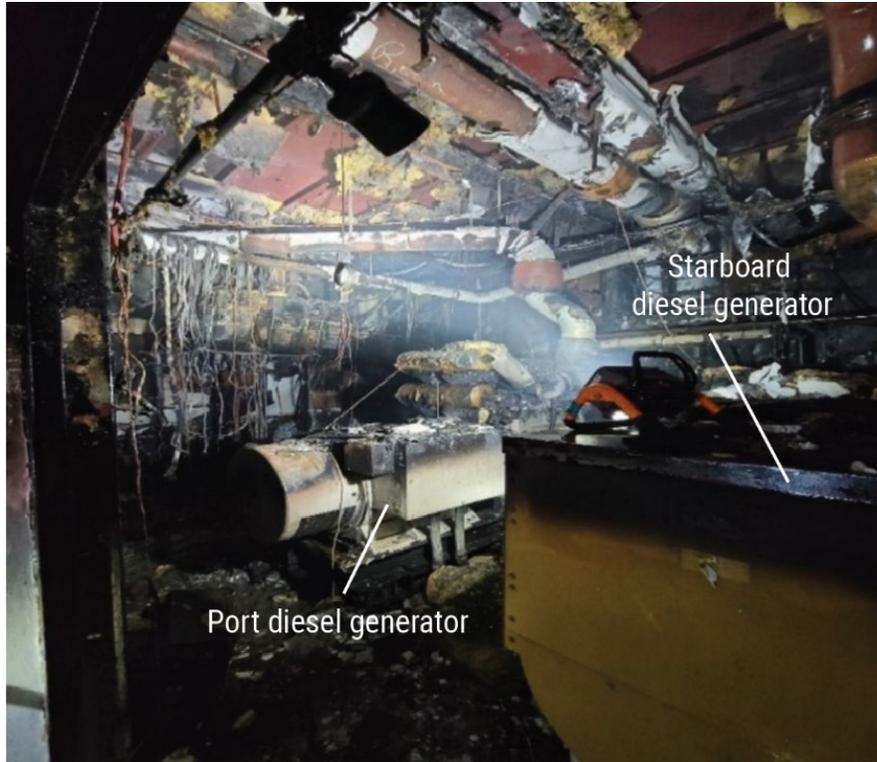
The New Orleans Fire Department arrived on scene about 2025, and the fire was reported extinguished about 2139. Most fire damage was contained within the generator space, with minor heat damage to the engine room and minor smoke damage to the external passenger decks located directly above the fire.

Figure 6. Looking forward in the fire-damaged generator space. The electrical panel foundation where hot work occurred before the fire is in the background, behind the port diesel generator. (Background source: New Orleans Steamboat Company)

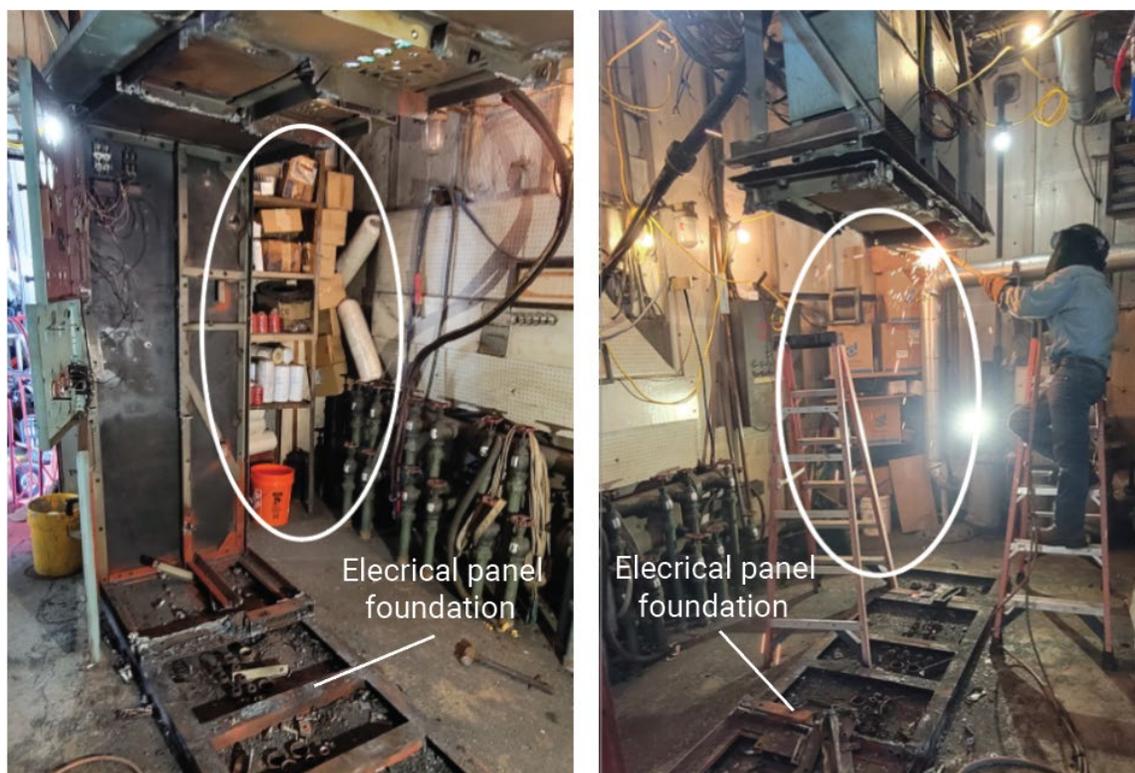
Figure 7. The *Natchez* generator space before the fire. Left photo, looking aft, shows exposed boxes and plastics (circled in white) stored aft of the metal foundation for the electrical panel that was removed during the hot work. Right photo, looking forward, shows exposed boxes (circled in white) forward of the foundation. (Background source: New Orleans Steamboat Company)

During the postfire examination of the generator space, investigators determined that the approximate distance between the area where the hot work was performed and the storage areas that contained combustible materials (forward and aft) was 2-3 feet.

During the examination of the generator space following the fire, ATF fire investigators noted a distinctive V-shaped fire pattern on the forward bulkhead of the generator space, which indicated that this was most likely where the fire started. Based on the photos provided to investigators, combustible materials (cardboard boxes) were stored in the ignition area (forward storage area in the generator room), which was located about 2 feet from where the hot work occurred. Although the electrical panel removal work had stopped about 1545, a smoldering hot spot had most likely formed within the boxes from the sparks generated from the acetylene torch cutting the metal electrical panel. Between 1545 and when the fire was discovered at 1945, the hot spot expanded and eventually ignited. The combustible materials provided ample fuel for the fire as it expanded within the generator space.

A smoldering fire can long outlast the time a fire watch observes an area following hot work. Therefore, it is critical to evaluate work areas for fire hazards and ensure that combustibles are relocated or protected with flameproofed covers/curtains or otherwise shielded with sheet metal. In addition, crewmembers involved in hot work should be trained to identify hazards such as combustibles and to take action to remove or protect them from hot work.

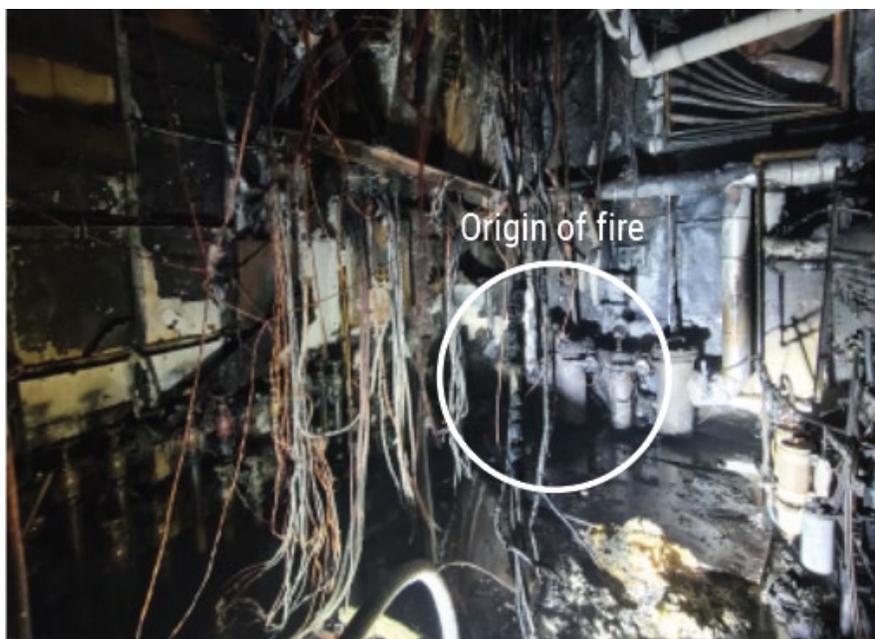
As the ATF fire investigators examined the generator space to identify the location of the initial fire, they discovered a “distinctive V-shaped” fire pattern on the forward bulkhead that was 2 feet away from the forward section of the electrical panel framing. The fire investigators also observed clean burn patterns on the forward bulkhead above the V-shaped pattern and below the vent fan. Based on their observations and examinations, the ATF fire investigators determined that the clean burn patterns were consistent with the type and size of available fuels: the combustible materials that were located along the forward bulkhead as shown in the photos taken the same day before the fire. The fire patterns found within the generator space were determined by the ATF fire investigators to be consistent with a fire originating near the deck along the forward bulkhead, adjacent to where the hot work was performed. Except for the hot work conducted before the fire, no other potential source of ignition was discovered.

Figure 8. The generator space postfire, looking forward, showing the location on the forward bulkhead identified by the ATF as the fire's origin. (Background source: New Orleans Steamboat Company)

The National Transportation Safety Board determines that the probable cause of the fire on board the passenger vessel *Natchez* was the failure of contractor and vessel personnel to identify and then either remove or adequately protect combustible material near hot work.
