Issued February 9, 2023

MIR-23-04

Contact of *Miss Mollye D* Tow with Route 182 Bridge

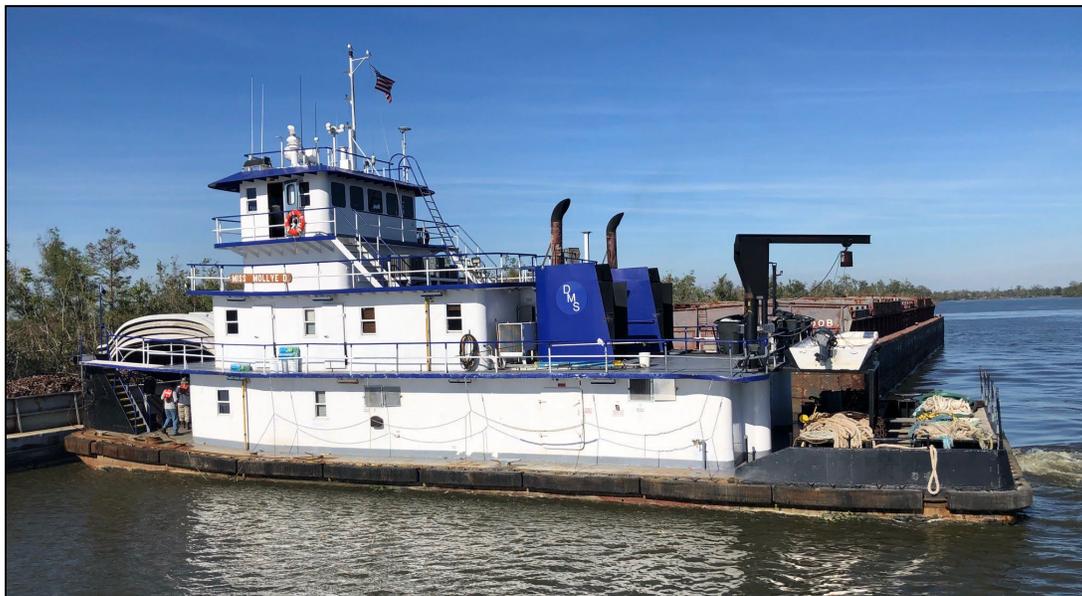
Figure 1. *Miss Mollye D* moored following the casualty. (Source: US Coast Guard)

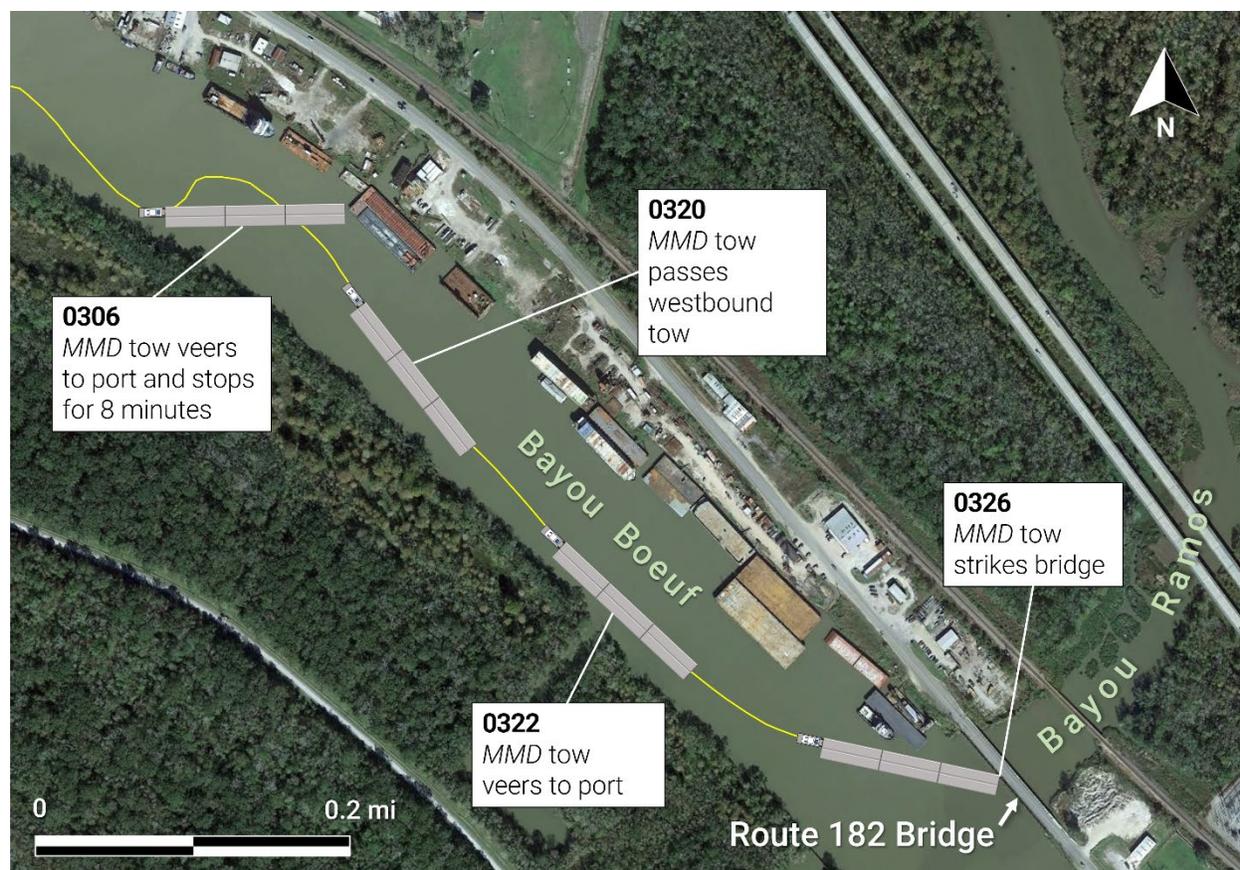
The Bayou Boeuf section of the Intracoastal Waterway is about 500 feet wide for most of its length, with a charted depth of 12 feet. There is no significant current in the waterway, and on the night of the casualty, winds were light. Just after 0300, the pilot on the *Miss Mollye D* was working the tow around a gradual bend at a speed of about 2 mph. According to data from the vessel's automatic identification system (AIS) and ECS, the tow moved to the starboard (south) side of the channel, and then, at 0303, began veering to port. It continued veering to port until the pilot stopped the tow as the head of the port lead barge, the *FJC 70B*, approached the north bank, leaving the stern of the *Miss Mollye D* near the south bank. The tow remained positioned across the width of the channel for 8 minutes. The pilot told investigators that he had heard reports over the radio of fog ahead and had stopped to consider whether to continue. He did not call the relief captain or the company to seek advice or ask for assistance. At 0314, the pilot worked to straighten the tow back in the channel, and then the tow began heading eastbound again.

Figure 4. Track of the *Miss Mollye D* (MMD), shown in yellow, as it pushed the tow before the casualty. Photo is not from the time of the casualty. Vessels shown moored along the northern bank are typical for the waterway. (Background source: Google Maps)

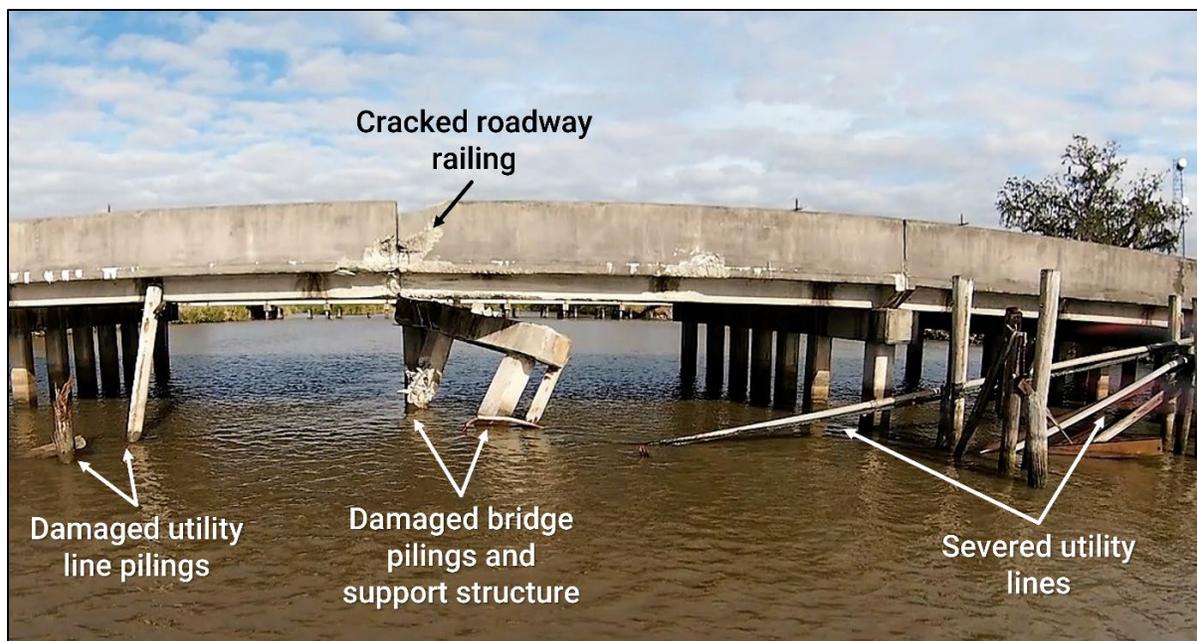
The Route 182 bridge sustained damage to several pilings, both above and below the waterline, as well as the concrete pile cap, girder, deck, bearing, and bridge railing above pilings. Water, electrical, and gas utility lines south of the bridge that were supported by separate timber pilings and cross bracing were severed when the tow made contact. The bridge was closed to traffic following the casualty; the north lane was reopened about 3 weeks later for one-way traffic alternating between east and westbound. The south lane remained closed until repairs could be made. Repairs to the bridge were estimated at \$2 million.

Figure 5. Route 182 bridge damage. (Background source: Cajun Drone Photography, Jim Pierce Jr.)
