Fire aboard Towing Vessel *Mary Dupre*

On June 26, 2022, about 0930 local time, a fire broke out in a stateroom on board the towing vessel *Mary Dupre*, which was pushing one barge of bio-diesel fuel (pyrolysis fuel oil) on the Gulf Intracoastal Waterway near Freeport, Texas.¹ Nearby Good Samaritan towing vessels retrieved the barge from the *Mary Dupre*, extinguished the fire, and evacuated the four crewmembers. There were no injuries, and no pollution was reported. The towing vessel was deemed a total constructive loss estimated at \$1 million.

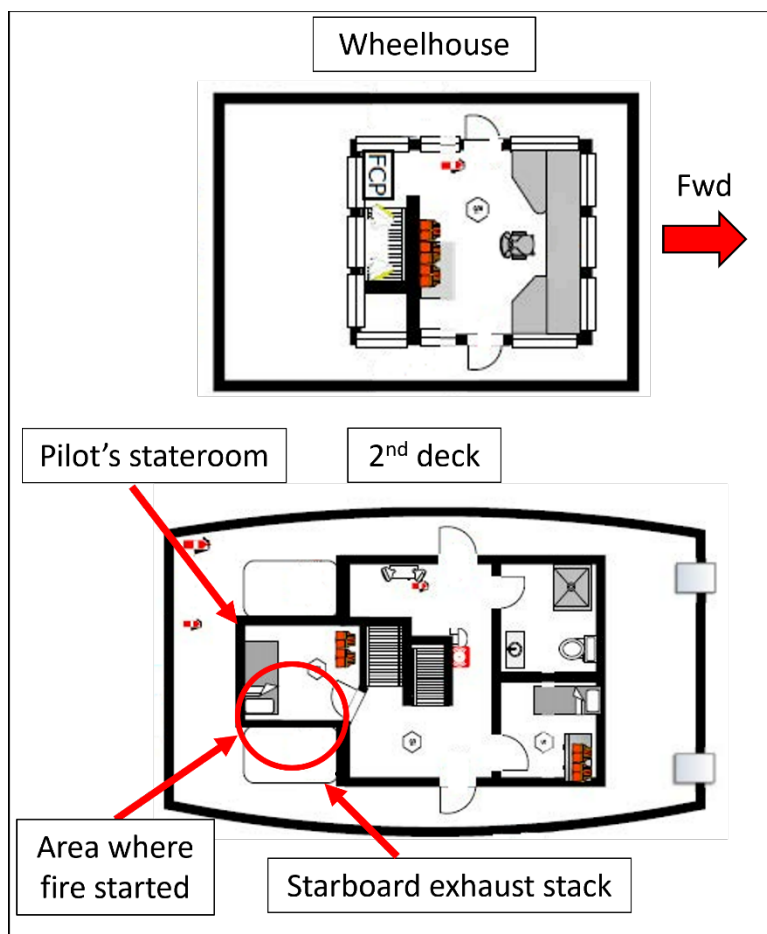
About 0930 on June 26, while the vessel was underway eastbound on the Gulf Intracoastal Waterway near mile marker 408, the off-watch pilot of the *Mary Dupre* was in his stateroom, which was located on the second deck (one deck below and aft of the wheelhouse) between the vessel's stacks—structures that contained the port and starboard engine exhaust mufflers and piping and allowed engine room ventilation air to exhaust to open atmosphere. He was awakened by a smoke alarm and the smell of smoke. About the same time, the captain, who was on watch in the wheelhouse, "heard a smoke detector beep" (but didn't smell smoke) in the wheelhouse, and the other sleeping deckhand woke up to "a burnt smell." The pilot and the deckhand went to the wheelhouse to notify the captain of the situation.

Figure 3. Layout of the *Mary Dupre* second deck and wheelhouse. The red circle identifies area where fire started. (Background source: Dupre Marine Transportation)

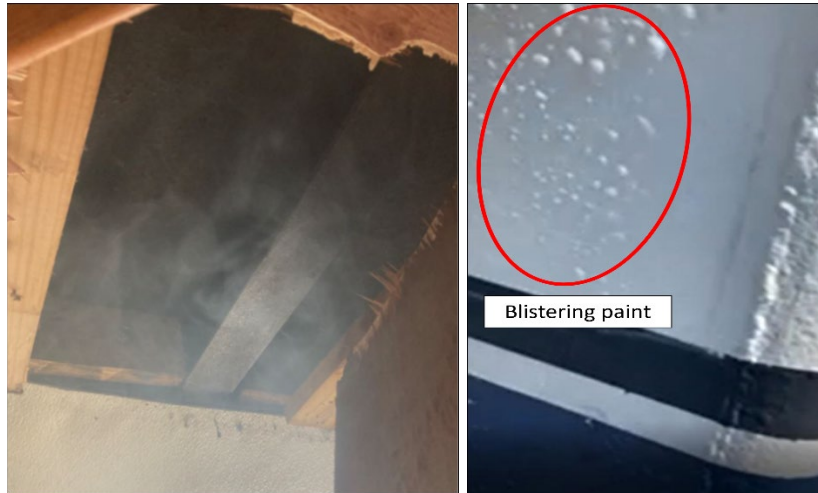
About 1000, they tore open a wooden panel from the overhead to further investigate, and, using their cell phones, recorded a video of the smoke in the overhead. After the wooden panel from the overhead was removed, the smoke intensified. The crewmembers stated that the wood was “charred” and “smoldering.” A deckhand looked into the open overhead and observed “small flames coming out [of] the walls,” and he discharged a dry chemical fire extinguisher into the opening in the overhead. The crew was unable to access the fire behind the wooden bulkhead of the stateroom, and additional interior spaces began to fill with smoke.

coming from the starboard stack's engine room ventilation air outlet that typically discharged clean engine room air. They also noticed blistering paint on the exterior surface of the stack.

Figure 4. Smoke in area of the removed overhead panel in the pilot's stateroom (*left*). Blistering white paint on steel bulkhead of starboard stack during the fire (*right*). (Source: *Mary Dupre* crewmembers)

Investigators also reviewed the crewmember's video recorded during the fire, which showed blistering paint on the exterior steel surface of the starboard stack. The manufacturer's data sheet for the paint indicated the paint's maximum temperature resistance rating was 750° F.

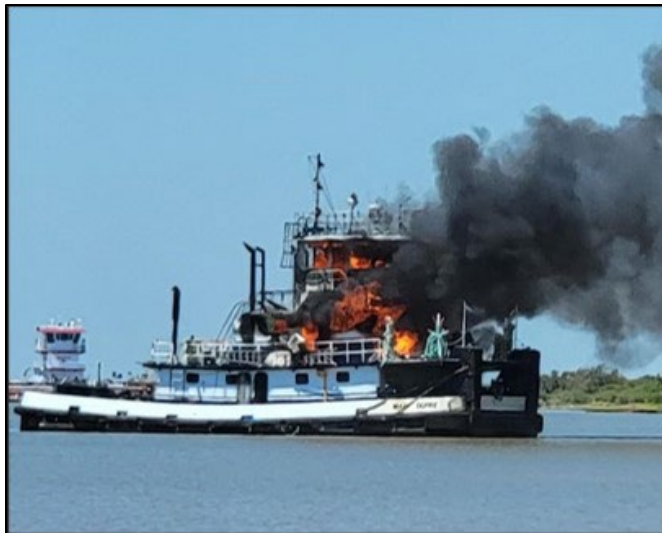
Figure 5. Fire aboard *Mary Dupre* minutes after crewmembers abandoned the vessel. (Source: Coast Guard)

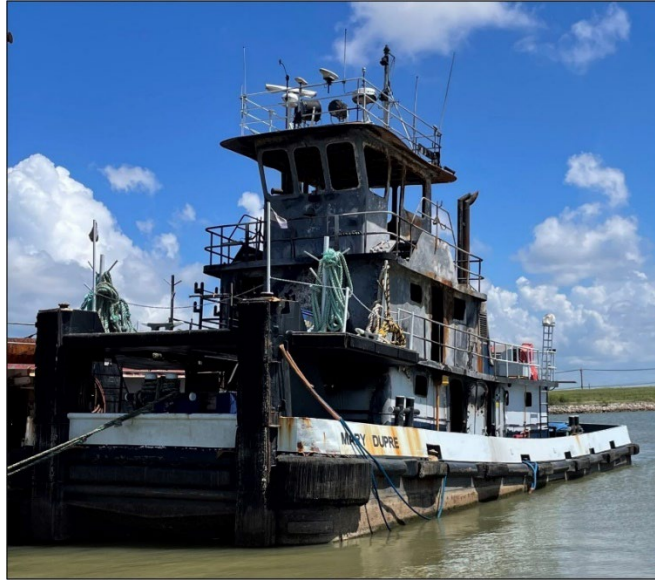
After the *Mary Dupre* was docked at the shipyard, a local fire marshal, Coast Guard investigators, and a National Transportation Safety Board (NTSB) investigator inspected the damaged vessel. Investigators observed fire and heat damage to all three decks of the superstructure. The degree of damage increased moving upward and forward on the vessel.

Figure 6. The *Mary Dupre* after the fire.

There was little to no fire and heat damage observed on the aft section of the main deck. In the engine room below the main deck, there was no damage to the main engines, generators, or other machinery. In both the wheelhouse and on the second deck, all wood framing, furniture, paneling, and joinery, as well as all paint and combustibles, were destroyed, completely consumed by fire and heat. On the main deck, combustible materials in the galley and crew quarters were partially burned. Due to the severity of the damage, the vessel was declared a constructive total loss and scrapped in October 2022.

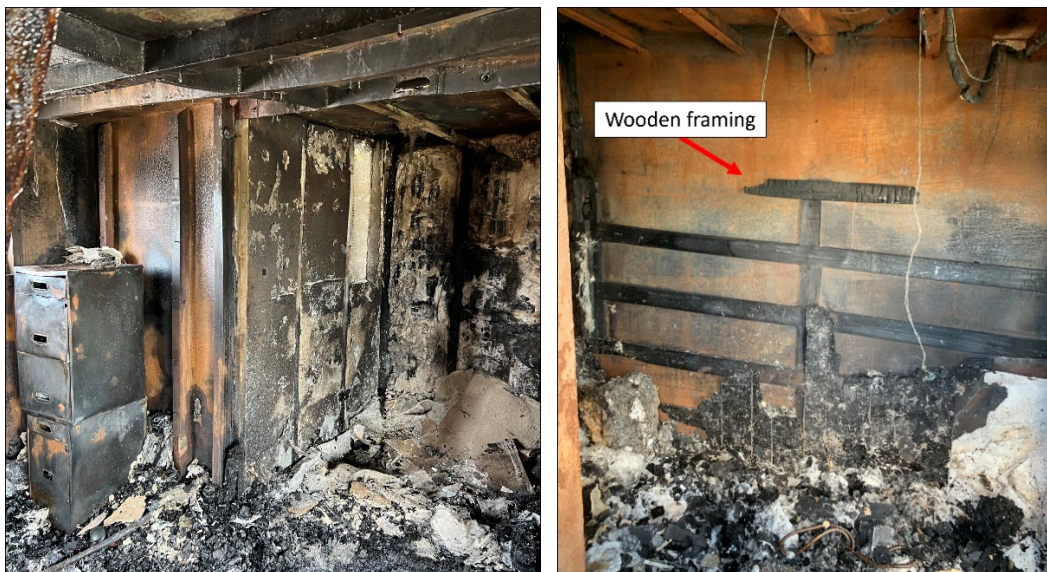
Figure 7. Pilot's stateroom adjacent to the starboard stack where the fire started (*left*), and charred wooden framing attached to steel bulkhead (*right*).

multiple fire patterns produced by both the movement and intensity of the fire indicate that the fire originated in the aft crew sleeping quarters on the second deck. This area presented with a V pattern on the aft wall

(bulkhead) within the insulation material that was located between the steel hull and wooden interior paneling. This area presented with the only area of low burning and the highest degree of thermal damage.

The significant combustibile load in the *Mary Dupre's* interior areas, including wooden framing, joinery, paneling, and other outfitting materials, indicates that the vessel was not designed with structural fire protection. As such, these materials served as both the ignition source and a fuel source for the fire. Once the wooden framing in the pilot's stateroom ignited, the fire spread to the attached wooden paneling on the bulkheads and overheads, then spread quickly throughout the vessel.

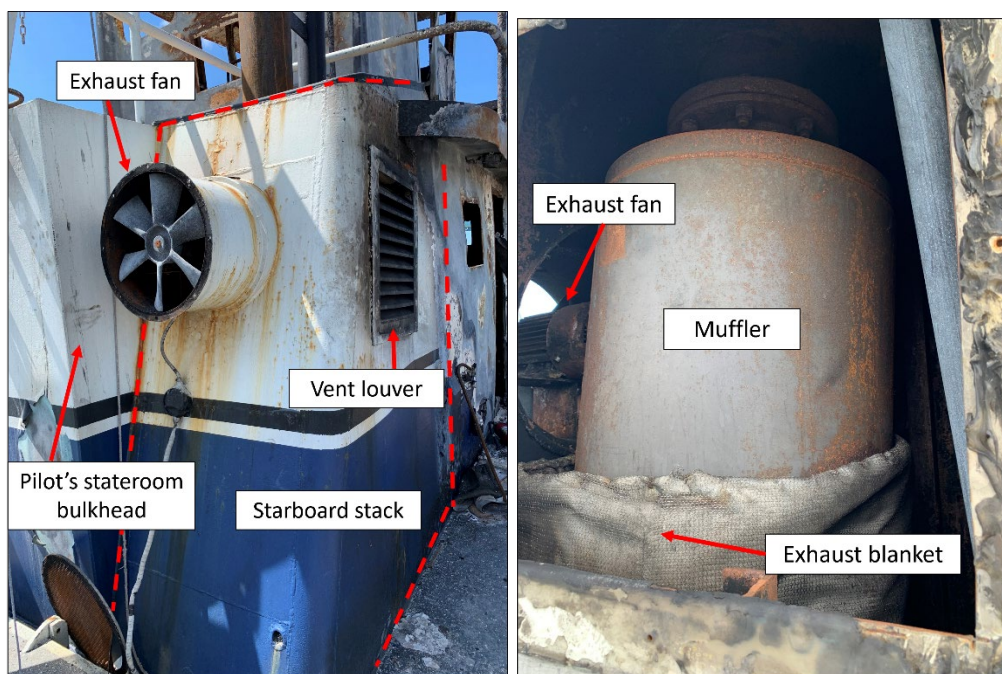
Figure 8. Exterior view of the starboard stack (outlined in red dashes) after the fire (*left*). The starboard muffler's outboard side, as seen through the removed vent louver, and upper exhaust blanket removed after the fire (*right*).

After the casualty, investigators found cracks in the welds on the upper section of the starboard engine muffler (inside the starboard stack) under the outlet flange around more than half of its circumference. Additionally, an exhaust blanket was found disconnected on the inboard side of the muffler in the direction of the pilot's stateroom, exposing the bare steel of the muffler towards the common steel bulkhead whose inboard side had wooden framing with attached paneling bolted directly to it.

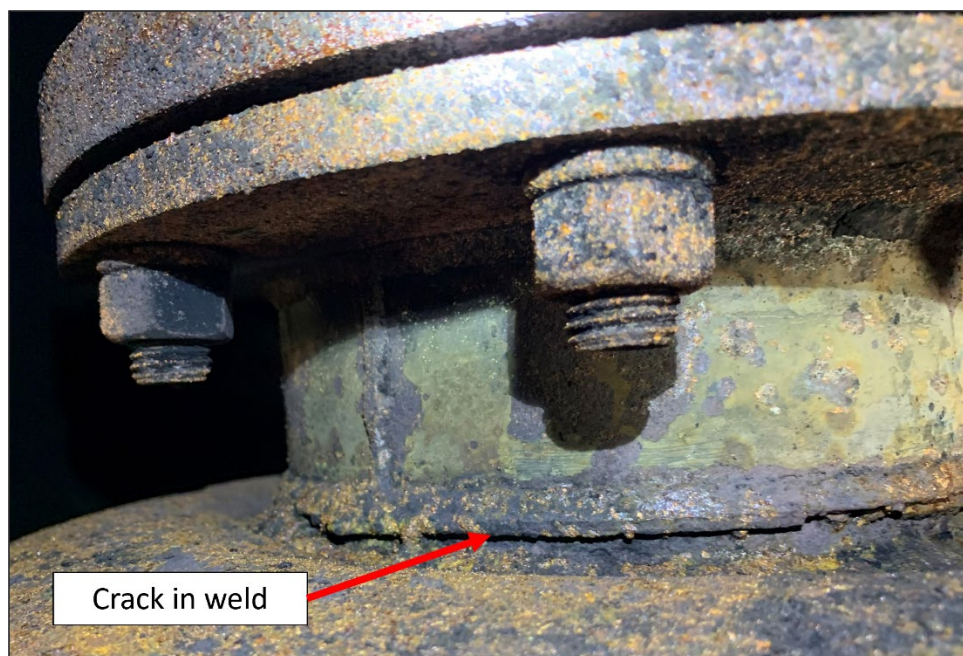
Figure 9. Crack in weld below the upper (outlet) flange of the starboard muffler aboard the *Mary Dupre*.

While the towing vessel *Mary Dupre* was underway on the Gulf Intracoastal Waterway near Freeport, Texas, a fire started behind the wood-paneled bulkheads in the pilot's stateroom. The pilot's stateroom was located between the vessel's two stacks, which contained engine exhaust mufflers and piping. After the casualty, investigators identified cracks in the welds on the upper section of the starboard muffler located inside the starboard stack. Although the cause of the cracks is unknown, they may have been caused by a latent issue, such as a defect in the muffler during construction or the exhaust system design's allowance for thermal expansion and contraction of exhaust piping above the muffler outlet. Vibration and movement during vessel operation over the years also may have caused or exacerbated the cracks.

The cracks in the exhaust muffler outlet allowed the hot exhaust gases from the operating starboard engine to escape into the stack area and increase the temperature of the space and its bulkheads. Additionally, after the casualty, investigators found the muffler's exhaust blanket was disconnected and not fully wrapped around its entire circumference (although investigators could not determine how long the exhaust blanket had been disconnected). The disconnected blanket left a section of the muffler uninsulated, allowing heat to radiate into the stack area. Because the inboard steel bulkhead of the starboard stack was common with the wooden outboard bulkhead of the pilot's stateroom (which displayed the "highest degree of thermal damage" according to the postcasualty fire report) and was just 10 inches from the uninsulated part of the muffler radiating heat, the elevated temperature of the stack's steel bulkhead increased the temperature of the wooden studs bolted directly to the shared bulkhead above 480°F—the temperature required to ignite wood by short term heating—causing the studs to smolder and ignite.⁵ In fact, the temperatures within the stack were likely much greater. Video recorded on crewmembers' cell phones showed that the paint on the exterior bulkhead of the starboard stack began to blister, indicating that the leaking exhaust gases from the crack in the muffler and the radiated heat from the uninsulated portion of the muffler raised the temperature in the stack above the maximum temperature resistance of the exterior paint, which the manufacturer stated was 750°F.

The National Transportation Safety Board determines that the probable cause of the fire aboard the towing vessel *Mary Dupre* was undetected cracks in the starboard muffler that allowed exhaust gases from an operating engine to escape and ignite wooden structures affixed to the common bulkhead of an accommodation space. Contributing to the extent of the fire damage was the substantial use of combustible materials in the joinery, outfitting, and furnishings in the accommodation spaces.

After the fire, the operating company completed an investigation report, developed lessons learned, and instituted corrective actions. The company emailed the lessons learned to all vessels in their fleet and discussed them during management visits to the vessels. The items for discussion included a description of the event aboard the *Mary Dupre*, fire prevention methods, a review of Dupre Marine Transportation's fire response procedures, and procedures for testing smoke detectors. Managers from the company stated that they did not have any other vessels that had staterooms adjacent to stacks similar to the *Mary Dupre* but their drydocking procedures for any vessel they acquired with a similar arrangement would be revised to include muffler inspections within the stack spaces.

Engine and other machinery exhaust systems generate heat—which can radiate from exhaust components—and are potential ignition sources. These systems often run through tight spaces that are difficult to access and inspect and are often located near materials or equipment that obstruct entry and direct observation. It is good practice to include these areas in periodic fire safety inspections. When conducting inspections of these systems, vessel owners and operators should consider using handheld equipment—such as inspection mirrors, video equipment, or thermal imaging equipment—to detect deficiencies.
