Flooding and Sinking of Fishing Vessel *Grace Marie*

¹ (a) In this report, all times are eastern daylight time, and all miles are nautical miles (1.15 statute miles). (b) Visit [nts.gov](https://www.nts.gov) to find additional information in the [public docket](#) for this NTSB investigation (case no. DCA22FM027). Use the [CAROL Query](#) to search investigations.

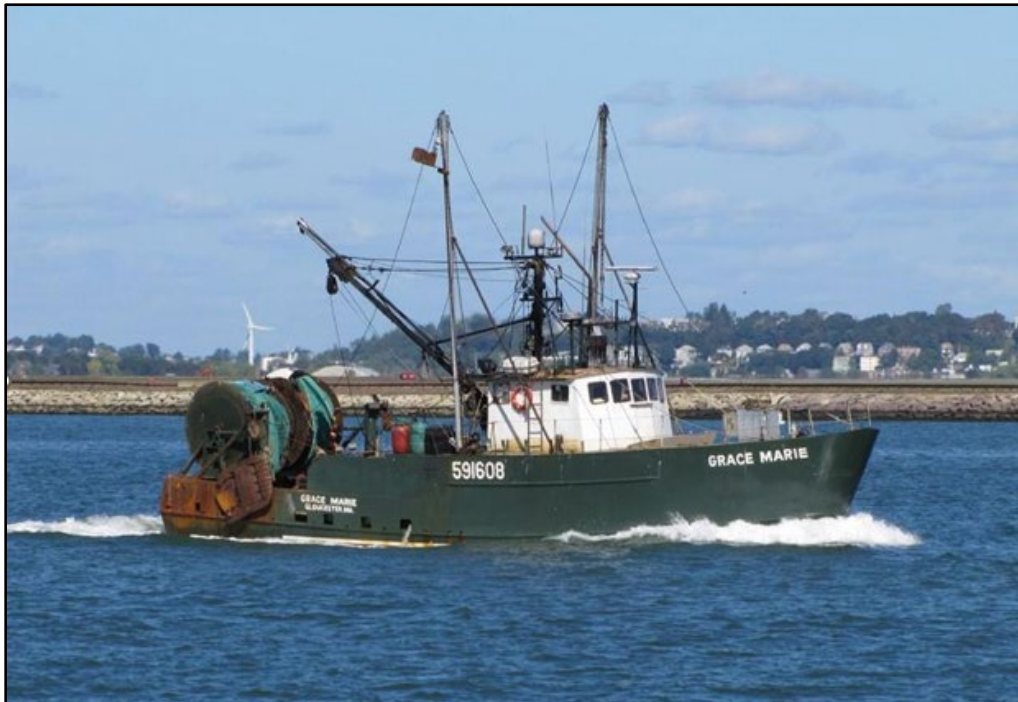
Figure 1. *Grace Marie* underway before the sinking. (Source: Paul Spillane)

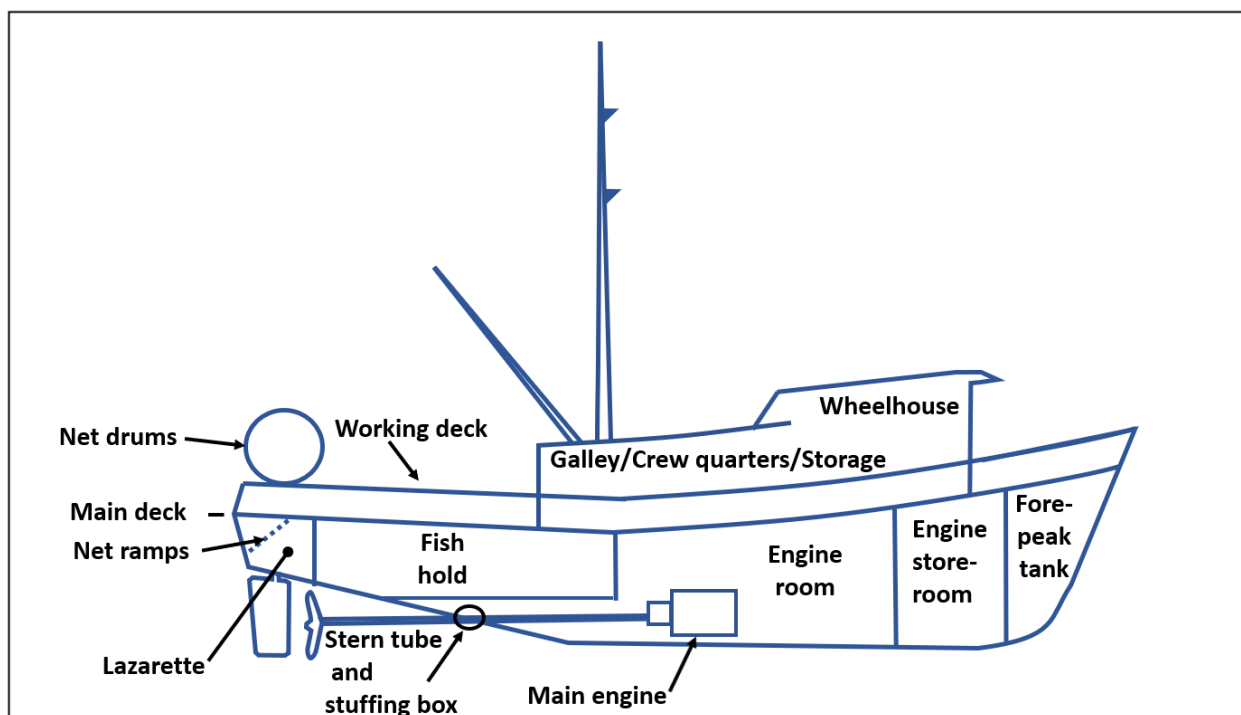
The *Grace Marie*, a steel-hulled stern trawler previously named the *Paul & Dominic*, was built in 1978 by Rhode Island Marine Services in Snug Harbor, Rhode Island. The current owner, AGV Company, purchased the vessel in 1997 and renamed it the *Grace Marie*. Homeported in Gloucester, Massachusetts, the *Grace Marie* was an uninspected commercial fishing vessel used exclusively for groundfishing. It was powered by a single 565-hp Caterpillar engine. The vessel's main deck had a working deck aft, rigged with dual net drums set above net ramps, and a deckhouse consisting of crew quarters, a galley, and storage areas forward. The wheelhouse was located above the deckhouse. Below-deck areas from forward to aft were divided into a forepeak tank, engine storeroom, engine room, fish hold, and lazarette. There was a roughly 18-inch crawl space between the bottom of the fish hold and the engine room bilge. This crawl space provided a "shaft alley" for the vessel's propeller shaft, which extended from the main engine aft about 8 feet under the fish hold and out of the vessel's hull through the stern tube and shaft stuffing box.

Figure 3. Simple profile of the *Grace Marie*.
