Issued July 11, 2023

MIR-23-15

Collision between Tugboat *George M* and Containership *MSC Aquarius*

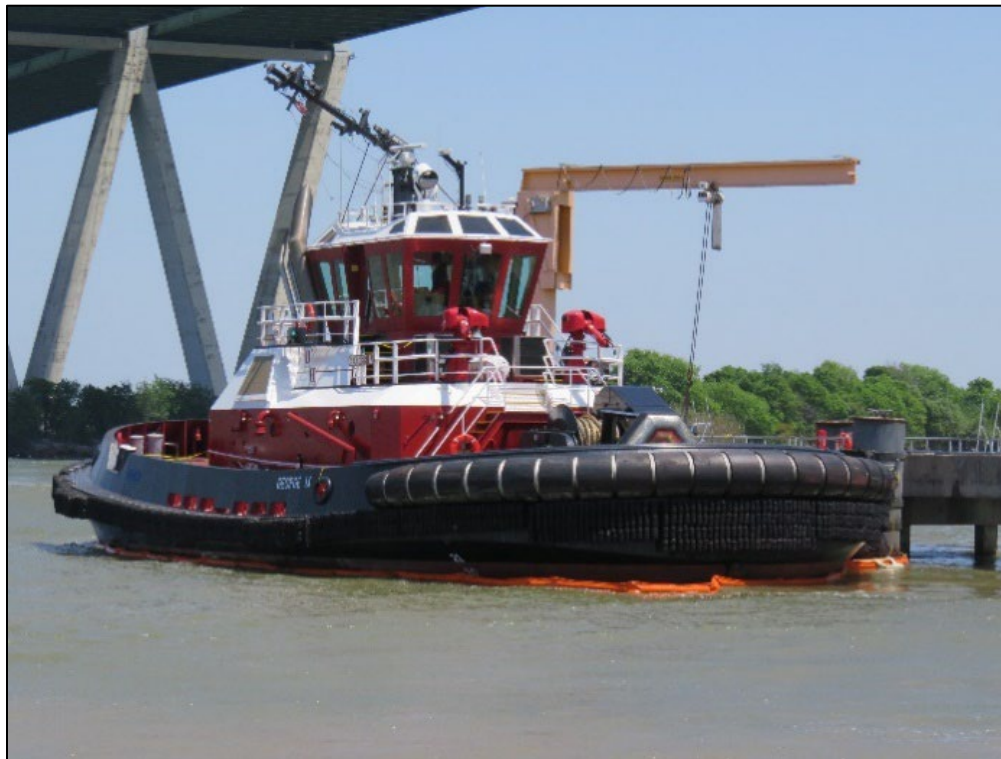
Figure 1. Tugboat *George M* postcasualty. (Source: US Coast Guard)

The lower unit of the *George M*'s port Z-drive (the portion of the drive unit below the hull) separated from the upper unit when it struck the *MSC Aquarius*'s bulbous bow. The lower unit dropped until it became caught on the tugboat's hull, preventing it from being lost. The tugboat also sustained a collapsed mast, damaged railings, and indentation of the deck above the wheelhouse. The cost of repairs to the *George M* was estimated at \$750,000.

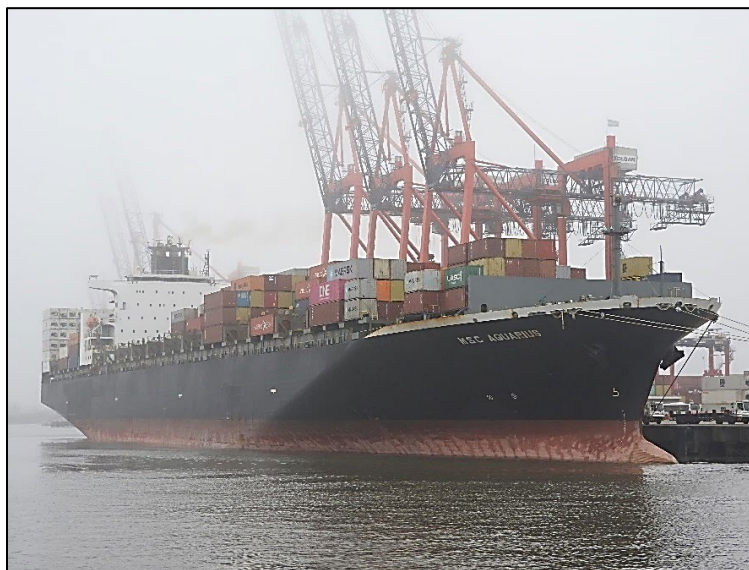
Figure 3. The *MSC Aquarius*, September 2022. (Source: Osvaldo Traversaro)

The *MSC Aquarius* experienced a breach in its portside hull plating beginning 4.9 feet (1.5 meters) aft of the forward end of the bulbous bow, with inset plating in the surrounding area. The 5.6-foot (1.7-meter)-long breach was 1.6 feet (0.5 meters) wide forward, narrowing to 0.2 feet (0.1 meters) aft. The cost of repairs to the hull of the *MSC Aquarius* was \$183,665.

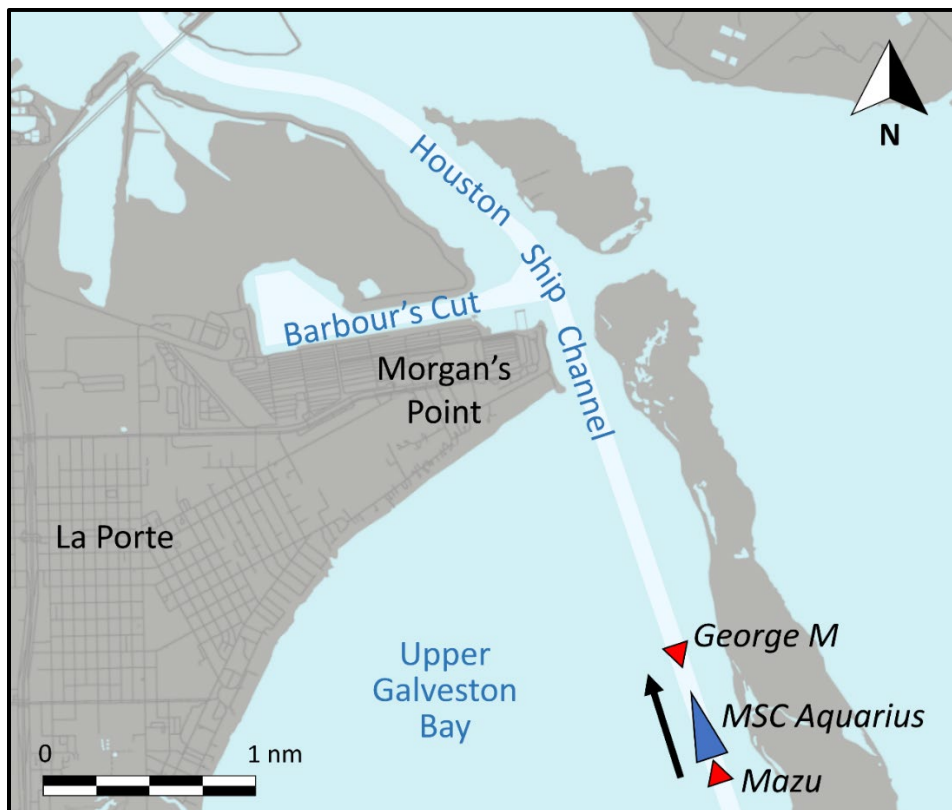
To make up the *George M*'s hawser to the bow of the *MSC Aquarius*, the tugboat had to maneuver into position ahead of the containership, bow-to-bow, and rig its hawser through the ship's forward, centerline chock (the "bullnose"), a maneuver referred to by the operators as a "stem job." To prepare for the job, the *George M* mate positioned the tugboat directly ahead of the *MSC Aquarius*, with its bow facing the containership's bow, moving in the astern direction, while the containership continued to transit north in the channel. The mate said that, once in position ahead of the *MSC Aquarius*, he "paced" the containership—transiting at the same course and speed—and concluded that he had enough reserve power to safely conduct the stem job maneuver. The speed of both vessels at the time was 9.7 knots.

Figure 4. Positioning of the tugboats *George M* and *Mazu*, forward and astern of the *MSC Aquarius*, before the casualty (vessels not to scale).

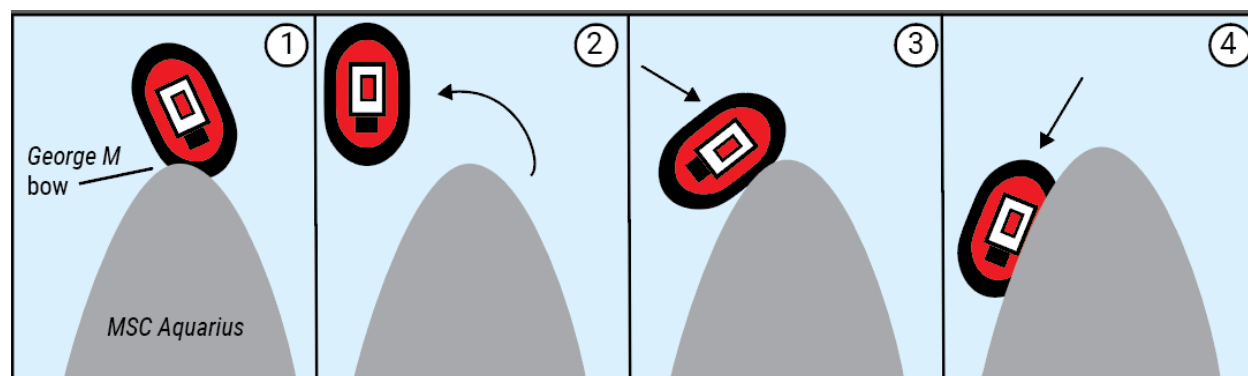
Figure 5. Sequence of events in *George M*/*MSC Aquarius* collision. 1) After moving to the starboard side of the *MSC Aquarius*, the *George M* moved back to port and the starboard bow of the tugboat collided with the bow of containership; 2) the *George M* accelerated and moved to a position to port and ahead of the *MSC Aquarius*; 3) the *George M* moved toward the centerline of the *MSC Aquarius*, the tugboat's speed decreased, and the vessels collided again; 4) the *George M* slid aft along *MSC Aquarius*'s port side until it became lodged in the flare of the containership's port bow. (Illustration not to scale.)

The mate said that the *George M* was "a little slower to get that [propulsion engine] power" than the tugboat he had previously been on, so he added more engine speed to regain position. He stated, "I kept powering it up and angling over, powering up and angling over, and it—I wasn't getting what I was... expecting out of it." He stated that he continued to add power until the propulsion power suddenly took effect. When that happened, the *George M* crossed the bow of the *MSC Aquarius*, and the tugboat's starboard bow struck the starboard bow of the containership.

the tug away from the ship, but the tug did not respond quickly. Consequently, the *George M* collided with the *MSC Aquarius* again. During the collision, the tugboat's port Z-drive struck the ship's bulbous bow, disabling the propulsion unit.

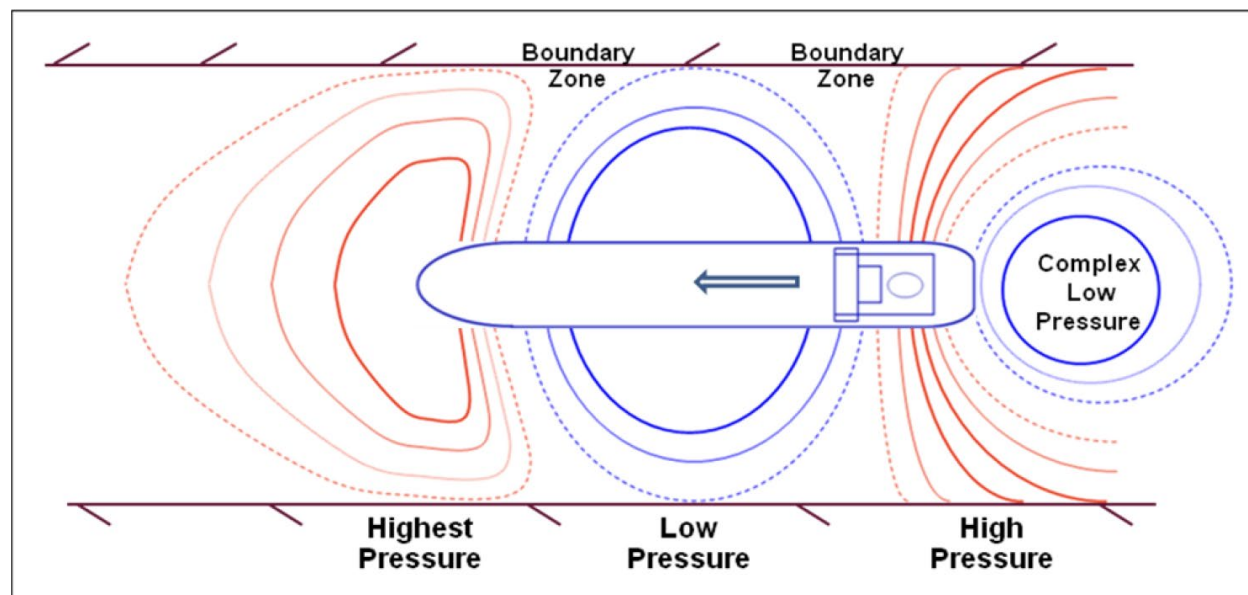
When a ship is moving through the water in the forward direction, a high-pressure area forms around the bow. When a tugboat is in the center lead forward position (a stem job), it is subjected to the hydrodynamic forces created by the high-pressure area created by the ship it is assisting. The pressure increases with decreasing distance to the bow, and therefore the hydrodynamic forces are greatest when a tugboat is very close to the ship's bow while making up the hawser.³ The *George M* captain explained, "As the ship is breaking through the water, it creates... a cushion. So, if you're... in line with the ship, in front of the ship, it tends to... throw you one way or another." The towing company's director of operations described a stem job as "one of the more advanced

Figure 6. Ship-generated pressure fields for a vessel navigation in enclosed/confined water. (Source: P. J. McArthur)

Hydrodynamic forces created by a ship increase exponentially with speed, and therefore an increase of even a few knots will have a significant effect on the forces acting on a tugboat in the center lead position.⁷ The increased forces acting on a tugboat at higher speed require more reserve power, maneuverability, and operator skill to overcome. When the *George M* approached the *MSC Aquarius*, the speed of the containership was 2.7 knots above the towing-company-directed limit of 7 knots for the bow-to-bow maneuver and 3.7 knots above the 6-knot limit preferred by pilots, tugboat captains, and ship masters surveyed by an International Tug Masters Association/Nautical Institute working group. Hydrodynamic forces also increase with decreasing distance to the bow, and, consequently, the forces acting on the *George M*
