# Collision between Cargo Ship *Damgracht* and Cargo Ship *AP Revelin*

<b>Casualty type</b>	Collision
<b>Location</b>	Sabine Pass, Port Arthur, Texas 29°37.52' N, 93°49.3' W
<b>Date</b>	August 21, 2022
<b>Time</b>	1045 central standard time (coordinated daylight time -5 hrs)
<b>Persons on board</b>	16 ( <i>Damgracht</i> ), 19 ( <i>AP Revelin</i> )
<b>Injuries</b>	None
<b>Property damage</b>	\$3.4 million est.
<b>Environmental damage</b>	None
<b>Weather</b>	Visibility 10 mi, mostly cloudy, winds from the south at 8 kts, air temperature 88°F, humidity 72%, morning twilight 0623, sunrise 0648
<b>Waterway information</b>	Channel, depth about 40 ft at casualty site

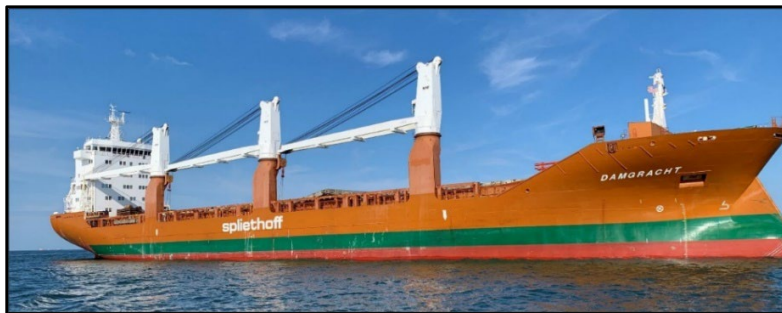
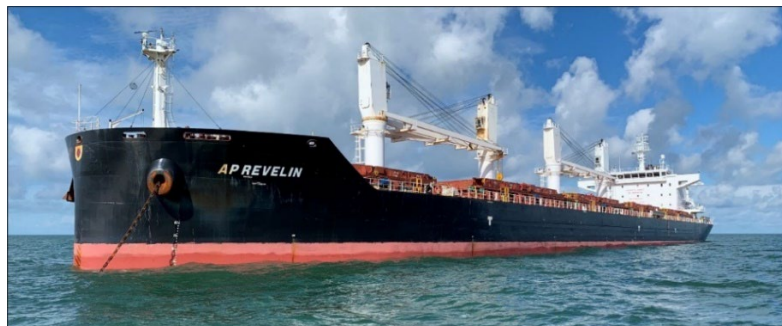
On August 21, 2022, about 1045 local time, the cargo ship *Damgracht* was inbound in the Sabine Pass Outer Bar Channel en route to Beaumont, Texas, and the cargo ship *AP Revelin* was outbound when the two vessels collided near Port Arthur, Texas.<sup>1</sup> There were no injuries to the *Damgracht*'s 16 crewmembers nor to the *AP Revelin*'s 19 crewmembers, and no pollution was reported. Damage to the *AP Revelin* was estimated at \$3.4 million, and there were no reported damage costs for the *Damgracht*.

**Figure 1.** Cargo ships *Damgracht* (above) and *AP Revelin* (below) anchored after the collision.

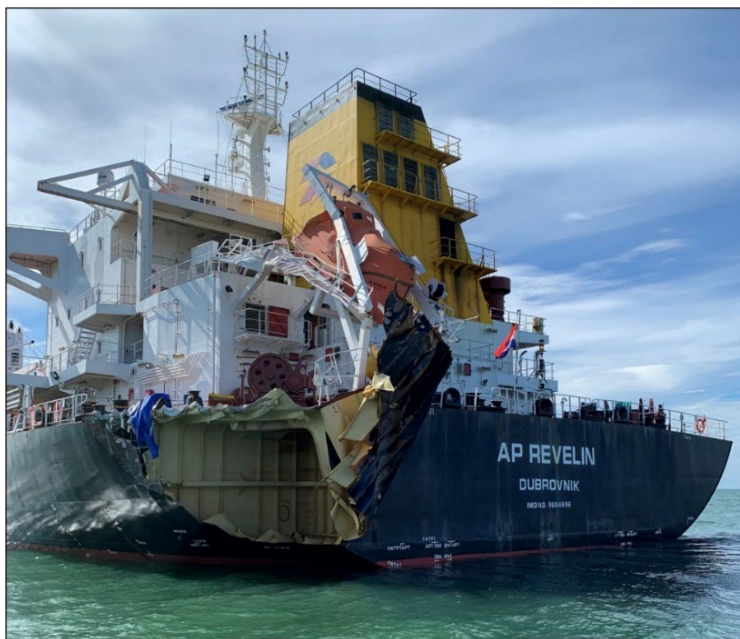
Following the collision, surveyors conducted damage assessments on both vessels. The *AP Revelin* sustained damage on the port, aft section of the stern deck, the freefall lifeboat and its davit structure, engine room store bulkhead, side shell and transom plating, and portside freshwater tank.

**Figure 5.** Damaged stern area of the *AP Revelin* after the collision.

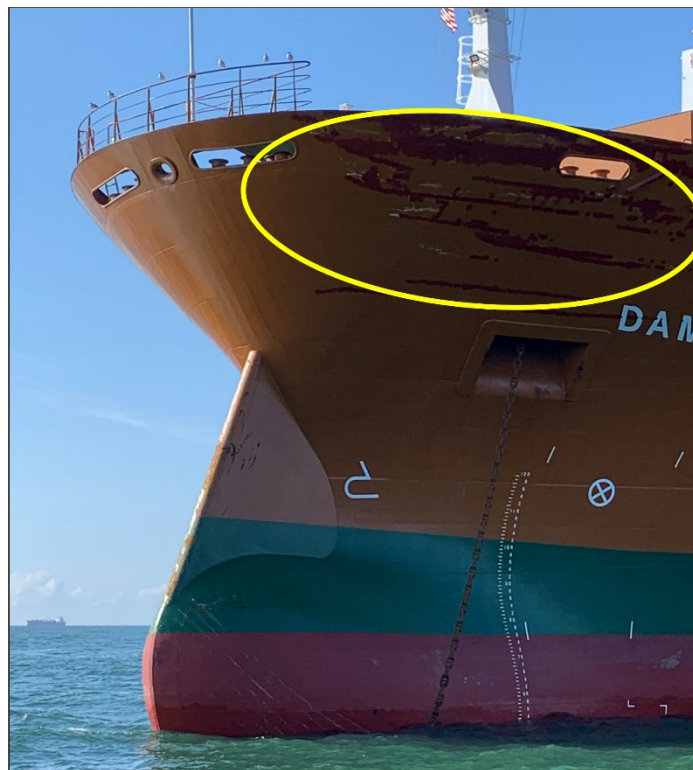
Surveyors inspected the bow of the *Damgracht* and found that the upper port side of the bow above the anchor pocket had indents that were “smooth without sharp knuckles” and that no cracks were revealed. They “evaluated and found acceptable” the damage in the supporting structure.

**Figure 6.** Port bow of the *Damgracht* after the collision with damage circled in yellow.

Surveyors also reported that the *Damgracht*'s engineering crew "clean[ed] and thorough[ly] examined" the main engine crankcase and replaced air flow filters on the OMD. The main engine was tested by the engine crew in the presence of a class surveyor from the local control station and remote bridge station with satisfactory results. The main engine was considered fully operational from both control stations and normal vessel maneuverability was restored.

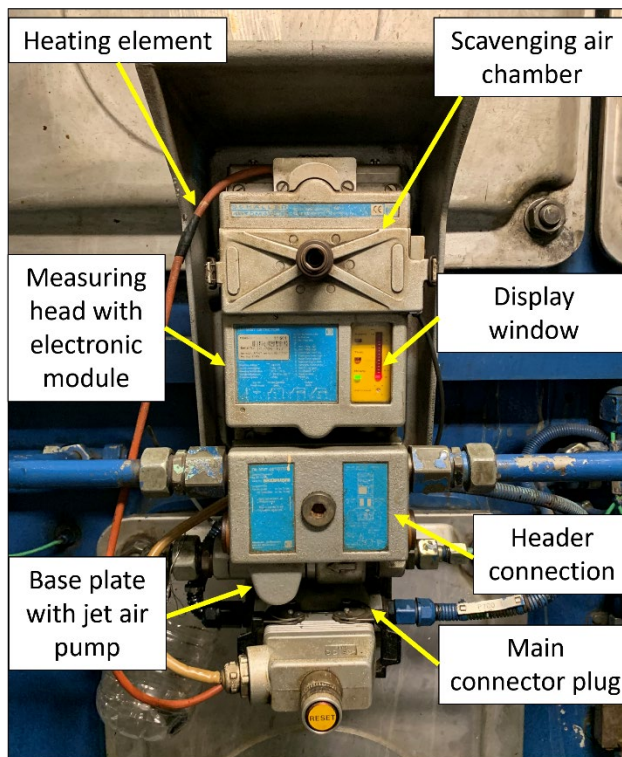
**Figure 7.** Main engine oil mist detector aboard the *Damgracht*

According to the manufacturer, condensation of water could “trigger a false high oil mist alarm when small droplets of water were detected by the optical measuring track” and subsequently, the engine would shut down. The manufacturer stated that excessive oil was also a reason for false alarms, especially when oil drops fell through the measuring head across the infrared light beam (the detector reacted to turbidity caused by oil drops).

The National Transportation Safety Board determines that the probable cause of the collision between the cargo vessel *Damgracht* and the cargo vessel *AP Revelin* was the *Damgracht*'s loss of propulsion caused by an automatic shutdown of the main engine due to a false alarm, likely triggered by water vapor sensed by the oil mist detector shortly after engine maintenance was completed to replace a failed cylinder head gasket during high-humidity conditions.

Once anchored after the collision, the *Damgracht*'s engineering crew conducted maintenance on the OMD: they cleaned the unit, replaced the filters, and adjusted the air flow. The chief engineer verified that the air pressure to the OMD air jet had been set within the correct range (60–80 millimeters of water). The engine crew did not find any irregularities nor any evidence that the OMD had malfunctioned or required repairs. The crew also inspected the lube oil purifier after the collision

When certain engine components, such as cylinder head gaskets, fail, cooling water can be introduced into engine lube oil systems. Ambient air conditions, such as high humidity or extreme cold temperatures, can also increase the water content within engine lube oil sumps. The elevated quantity of water in lube oil systems can trigger false alarms in engine crankcase oil mist detectors (and lead to an engine shutdown) due to water droplets passing through the measuring track or the filter glass detecting condensation (mistaking it for oil mist). After an engine's crankcase is opened and exposed to these conditions during maintenance and repair, it is good practice for engine crews to inspect and test the lubricating oil system for water intrusion and ensure lube oil purifying equipment is functioning properly to remove any water or other contamination in the lube oil.
