Issued September 7, 2023

MIR-23-19

Grounding of Tugboat *CC Portland*

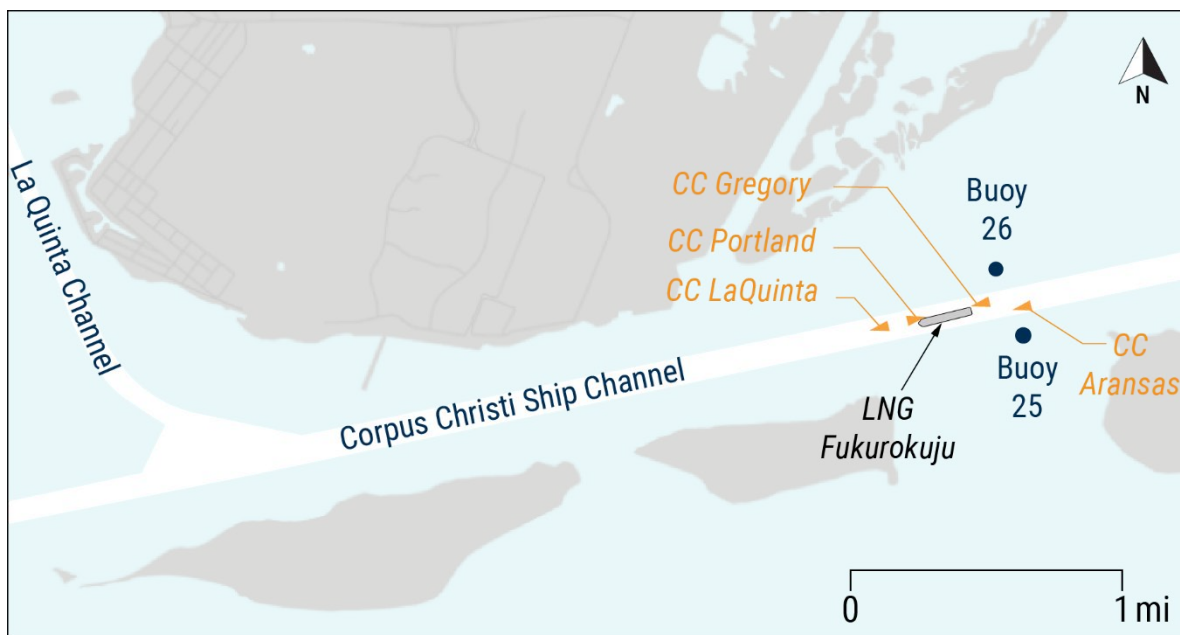
Figure 4. Approximate vessel positions when the *CC Portland* made up to the inbound *LNG Fukurokuju* (vessels not to scale). (Background source: Google Maps)

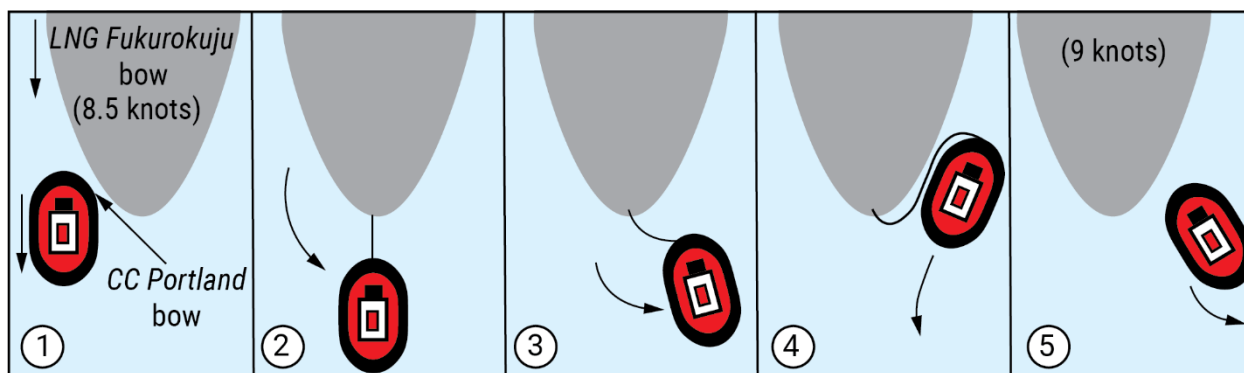
Figure 5. Sequence of events in the *CC Portland* grounding. 1) The *CC Portland* took a position underneath the starboard bow of *LNG Fukurokuju* (while moving astern with the ship) as the heaving line was lowered and the tow line was passed up. 2) As the tow line was pulled in by the crew on the *LNG Fukurokuju*, the *CC Portland* accelerated to reposition the tug ahead of the *LNG Fukurokuju* along the centerline. 3) While attempting to maneuver to the centerline, the *CC Portland* moved out of position to the port side of the *LNG Fukurokuju*. 4) As the mate attempted to correct the *CC Portland*’s position to the centerline of the LNG carrier, the tug lost speed and stabilized along the port bow of the *LNG Fukurokuju*. The position of the tug pulled the tow line to the stern and into the water as the heaving line parted. 5) As the *CC Portland* accelerated astern to regain position, the tug lost speed and directional control as it continued moving to starboard before leaving the channel and running aground. (Illustration not to scale.)

As the mate attempted to reposition the *CC Portland*, his inputs directed more thrust laterally, and the tugboat therefore lost speed astern. As the *CC Portland* lost speed, the tugboat began to move down the port bow of the *LNG Fukurokuju*. This movement pulled the tow line (attached at the bow), to the stern of the tugboat, causing the heaving line to snap and sending the tow line into the water. As the mate increased propulsion astern to regain position, the port Z-drive was fouled by the submerged tow line, thus significantly impacting the tugboat's maneuverability. At the time, the mate and training master were unaware that the port Z-drive was fouled as the mate continued to attempt to maneuver the tugboat back to the LNG carrier's centerline. With only the starboard Z-drive operational, the mate was unable to regain position, and as a result, the tug departed the ship channel and ran aground.

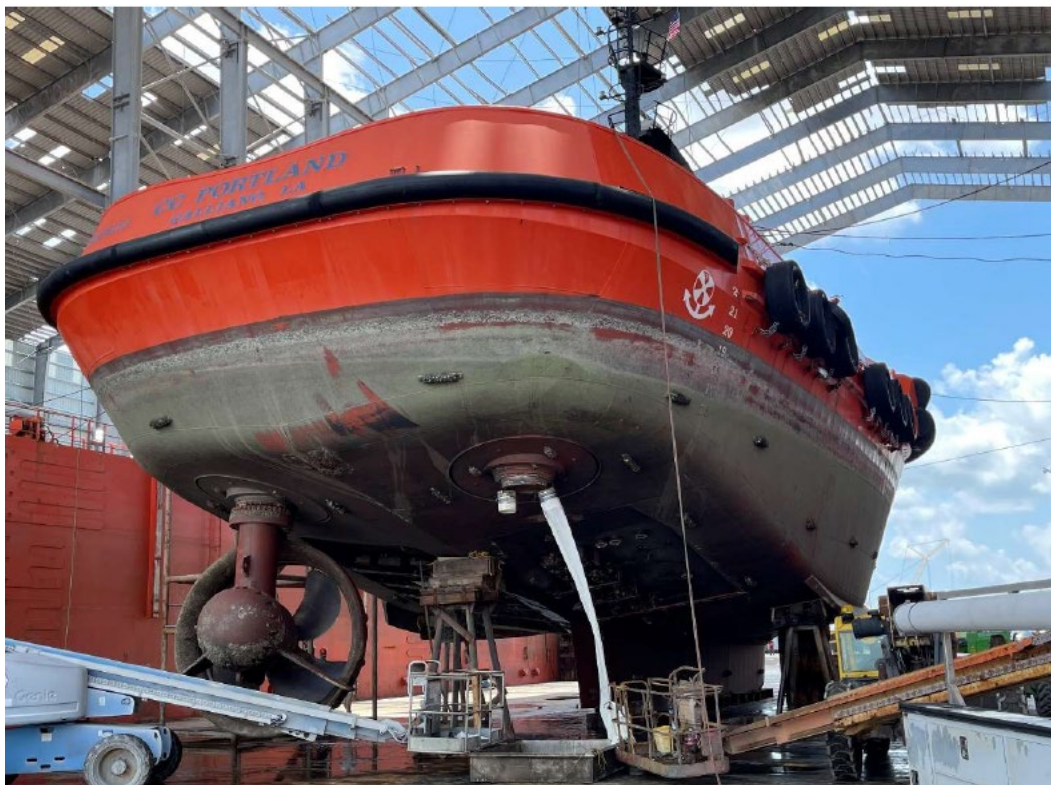
On August 8, divers examined the *CC Portland*. They discovered that the starboard Z-drive had been sheared off at the bolts connecting the drive to the flange. The port Z-drive was intact, but it had been fouled by the tugboat's tow line. The divers found extensive damage to three starboard keel coolers. Additionally, they reported that one keel cooler support bracket had been ripped from the hull, leaving a hole measuring 4 inches by 3 inches in the no. 2 day fuel tank.

Figure 6. The *CC Portland* in drydock showing the missing starboard Z-drive unit. (Source: Coast Guard)

After temporary repairs were made, the *CC Portland* transited under its own power from Corpus Christi to Port Fourchon, Louisiana, to be drydocked for permanent repairs, including replacement of the starboard Z-drive unit with a new unit. The total cost to repair damages was about \$1 million.

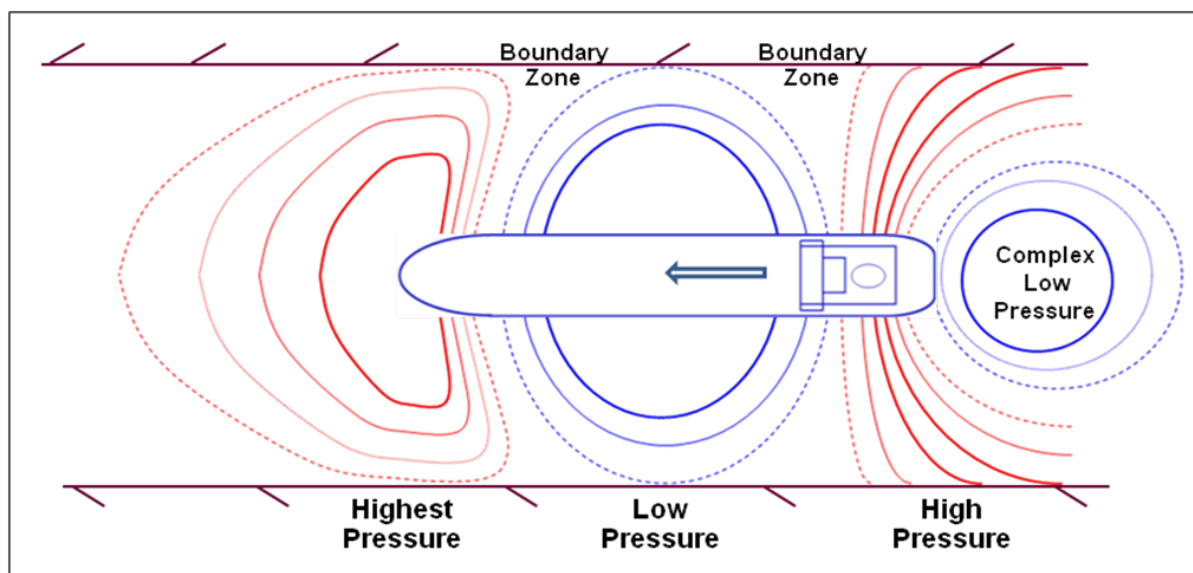
When a ship is moving through the water in the forward direction, a high-pressure area forms around the bow. When a tugboat is in the center lead forward position, it is subjected to the hydrodynamic forces created by the high-pressure area of the ship it is assisting. The speed of the vessel also increases these hydrodynamic forces exponentially. The pressure increases with decreasing distance to the bow, and therefore the hydrodynamic forces are greatest when a tugboat is very close to the ship's bow while making up the hawser. According to the Pilot's Pocket Guide and Checklist, "The position in front of the ship's (bulbous) bow is one of the most dangerous for the tug."⁵

Figure 7. Ship-generated pressure fields for vessel navigation in enclosed/confined water. (Source: P.J. McArthur)

Automatic identification system data from June 2022 showed that other LNG carriers had transited an average of 8.5 knots nearest buoys 25 and 26, where the *CC Portland* attempted to make up to the *LNG Fukurokuju*. Therefore, the speed of the *LNG Fukurokuju* was typical for the area. However, hydrodynamic forces created by a ship increase exponentially with speed and with decreasing distance to the bow. Consequently, the forces acting on the *CC Portland* were even greater as it approached the bow of the *LNG Fukurokuju*, given the speeds of both vessels and the tugboat's proximity to the LNG carrier's bow when the mate attempted to re-position the tugboat off the bow of the *LNG Fukurokuju*, and these forces hampered the mate's ability to control the tugboat.
