Marine Investigation Report MIR-23-22

Engine Room Fire Aboard Passenger Vessel *Spirit of Norfolk*

Elizabeth River
Norfolk, Virginia
June 7, 2022

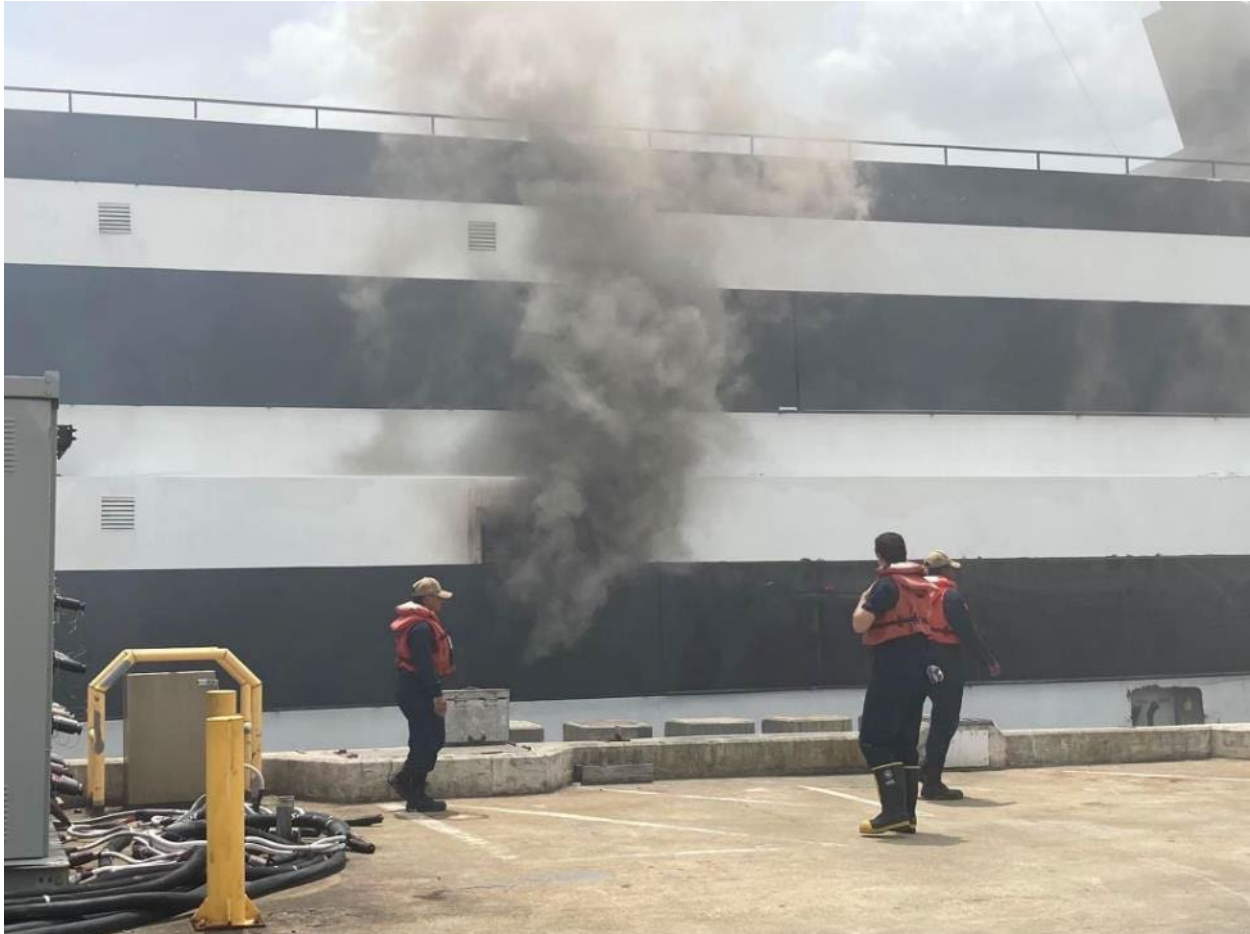
During the casualty, air continued to enter the engine room, and fire and smoke continued to exit the engine room from both the port and starboard exterior exhaust hull ventilation openings after the captain secured the air supply fan (see Figure 8).

Figure 8. Smoke from the engine room starboard exhaust ventilation opening. (Source: Coast Guard)

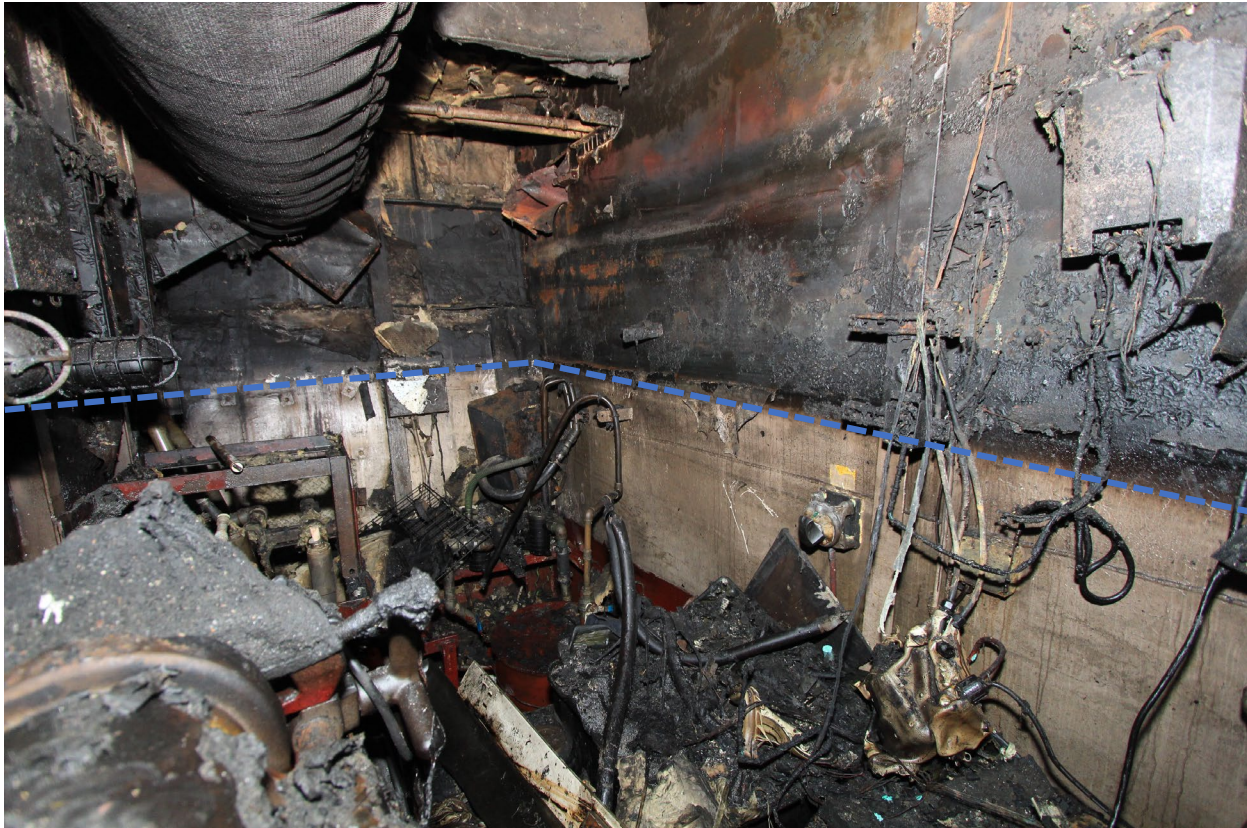
Fire damage was observed throughout the engine room compartment, with the most severe damage concentrated at ceiling height where structural members were deformed and, in some instances, fractured due to thermal expansion. The overhead thermal damage was mostly uniform throughout the engine room. The thermal damage to the engine room exhibited a gradient of thermal damage from the overhead toward the deck, with the most severe damage overhead. The gradient of thermal damage also exhibited a sharp line of demarcation below which the thermal damage abruptly stopped (see Figure 9).

Figure 9. Portside engine room bulkhead exhibiting demarcation line (*dashed blue*) between thermally damaged and undamaged area.

The NTSB assessed the damage in the engine room and identified a line of demarcation, consistent with a water line resulting from the firefighting efforts introducing water into the engine room. Any thermal damage found below the line of demarcation would indicate damage that occurred early in the event. The area outboard of the port main engine exhibited fire damage below the overall line of demarcation extending down to the deck, indicating this damage occurred before firefighting efforts began. The NTSB also observed similar low-lying fire damage on the bulkhead forward of the port main engine—near where the throttle controller for both main engines was located. A photograph taken on June 22, 2022, showed metal shelves attached to the hull outboard of the port main engine. Fire completely consumed these shelves from the overhead down to the deck; thus, this area had also been on fire before the firefighting response.

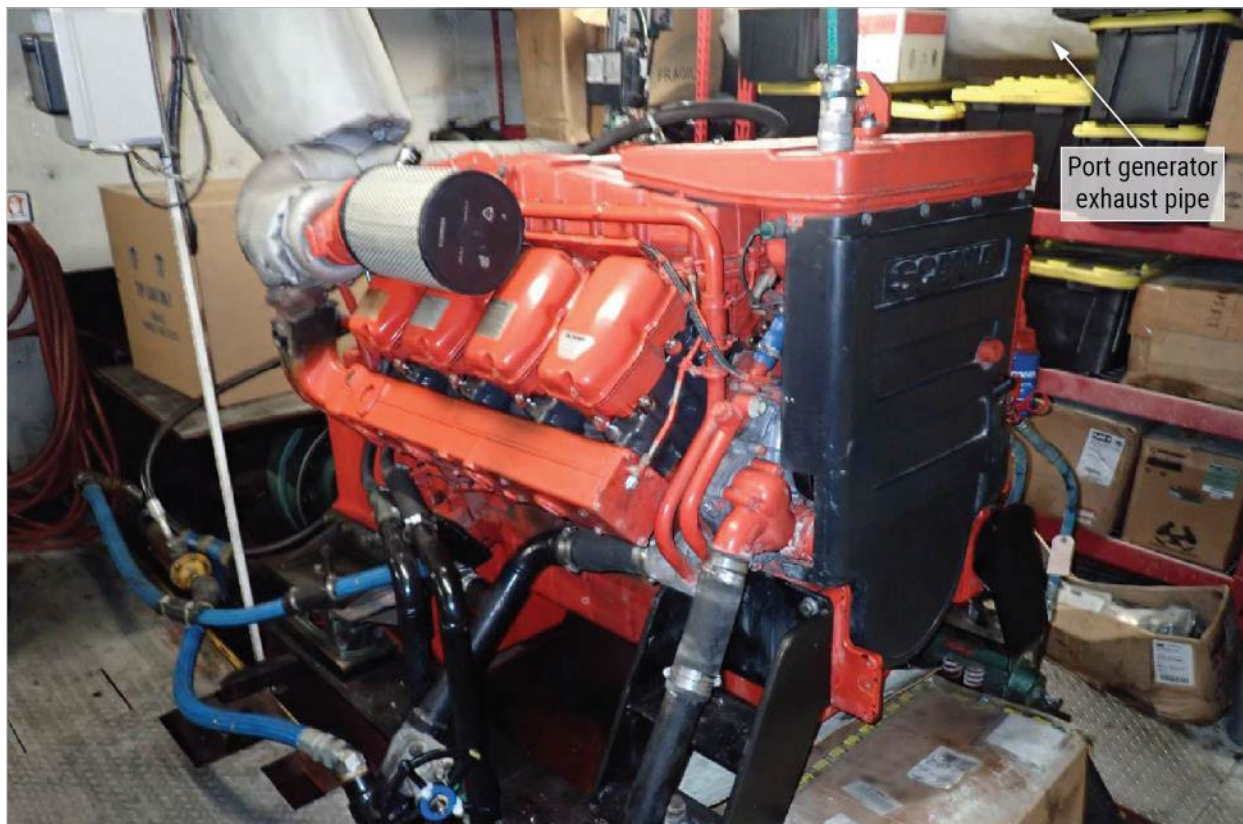
The hull outboard of the port main engine had metal storage shelves. A photograph from a marine survey on June 2, 2022, showed numerous cardboard boxes and plastic totes (see Figure 11). The captain told investigators that they've "always" had shelves there and "always" kept spare items on those shelves, including plumbing parts, filters, air filters, HVAC pumps, and a starter for one of the generators. The photo from the marine survey also showed that the insulated exhaust pipe from the port generator was routed through the top shelf of the storage rack and next to the materials on the shelf.

Figure 11. Photo from survey on June 2, 2022, showing port main engine (*foreground*) and storage shelf. The white port generator exhaust pipe is visible behind some of the boxes on the shelves. (Source: Knox Marine Surveyors & Consultants)

Because the damage assessment indicated the fire likely started outboard of the port main engine, the NTSB focused on the shelves attached to the port hull in this area. The photograph from the June 2022 marine survey showed the presence of combustible items, including cardboard boxes and plastic tubs, stored on the shelves. The captain told investigators that they “always” kept spare items on those shelves, including plumbing parts, filters, air filters, HVAC pumps, and a starter for one of the generators, so it is likely those items were still present at the time of the fire. Further, the insulated exhaust pipe from the port generator was routed through the top shelf of the storage rack and next to the materials on the shelf.

Although the survey photograph showed the pipe was insulated, the fire damage precluded an assessment of the pre-fire condition of the insulation. The insulation may have shifted or been damaged, and any gaps, discontinuities, or other conditions could have allowed heat transfer from the exhaust to the adjacent combustible materials, which could have then ignited. Therefore, the NTSB concludes that although a definitive ignition source cannot be determined, the most likely cause of the fire was the ignition of combustible materials stored near the exhaust pipe of the operating port generator.

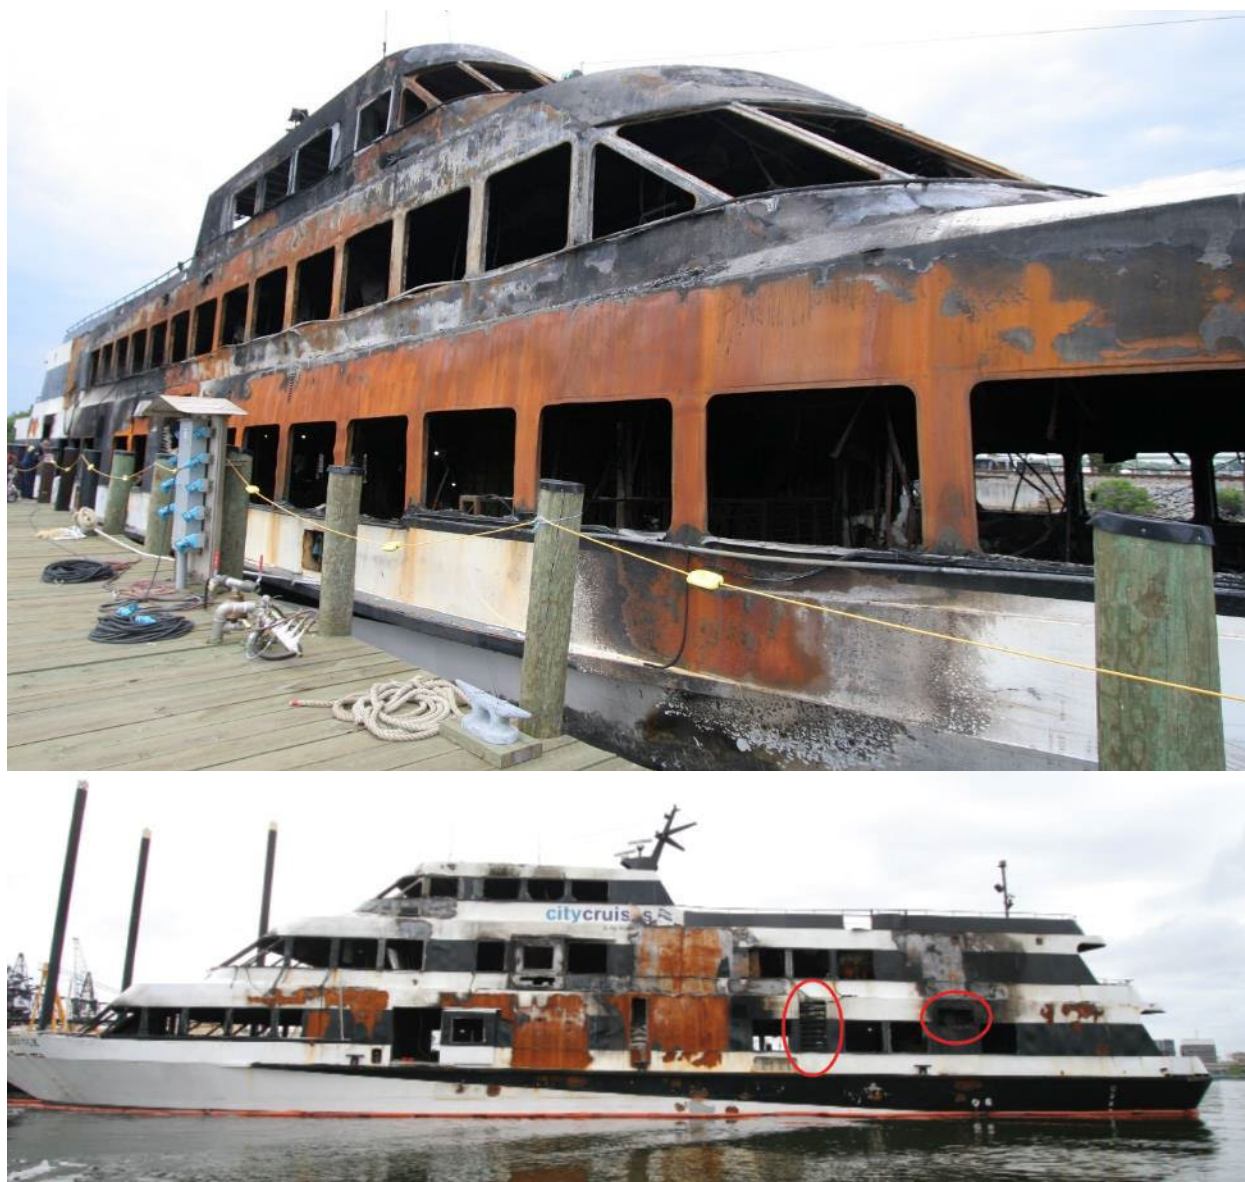
The vessel, valued at \$5 million, was a total constructive loss. The vessel sustained fire damage throughout all the decks, and the exterior had thermal discoloration and charring. The engine room exhaust ventilation system exhibited soot around the ventilation openings and patches of charred and burned-off paint above the openings. On the port side exterior, an area of charred/burned-off paint was at a height on the hull that corresponded with the location of the engine room ventilation air supply and exhaust openings (see Figure 13).

Figure 13. Exterior damage to the *Spirit of Norfolk*, starboard side (*upper*), and port side (*lower*) The engine room ventilation openings are circled in red.

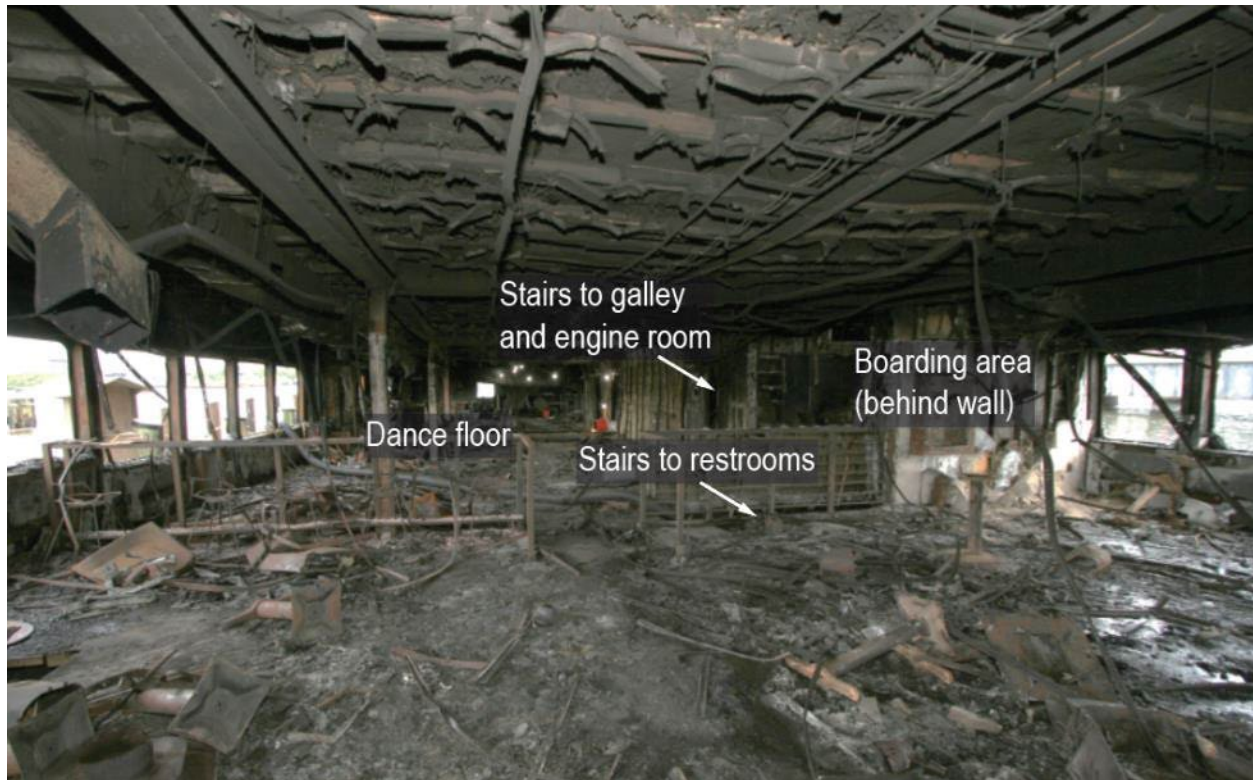
The interior of the main and second decks, and interior stairwells were completely consumed by the fire (see Figure 14, Figure 15). Exterior areas on the stern of the main deck were not fire damaged but did exhibit some sooting. The pilothouse was completely consumed by fire. Below deck, the engine room and galley sustained extensive fire damage.

Figure 14. Main deck interior looking aft.
