February 6, 2024

MIR-24-03

Capsizing and Sinking of Fishing Vessel *Hotspur*

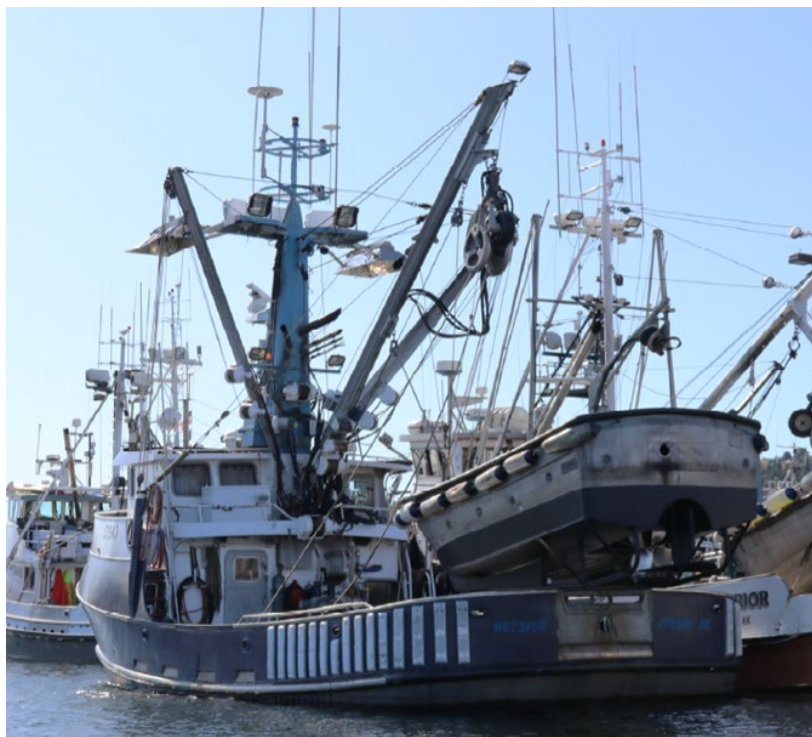
Figure 1. *Hotspur* pierside precasualty in Ketchikan, Alaska. (Source: US Coast Guard)

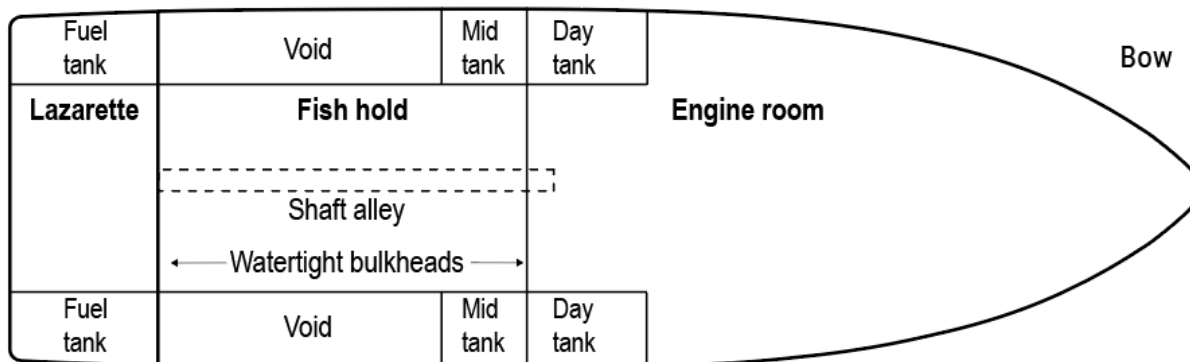
The vessel had a single fish hold that remained filled with seawater during transits. Outboard of the fish hold were void spaces and tanks. The vessel had six fuel tanks positioned outboard: two “day tanks” in the engine room, two “mid tanks” just aft of the day tanks separated by a watertight bulkhead, and two fuel tanks near the stern (see figure 3). The total carrying capacity of fuel oil was 8,000 gallons. There was one 100-gallon-capacity lube oil tank and one 150-gallon hydraulic oil tank in the engine room. The vessel had a single rudder and a single propeller driven via a reduction gear by a diesel engine rated at 1,050 hp.

Figure 3. Layout of *Hotspur* lower level, based on owner's drawing (not to scale).

When the vessel first listed, the captain checked the engine room and did not see any flooding. The fish hold was full of water at departure, and the captain had checked the fuel tank levels and found nothing abnormal, leaving the source of water ingress limited to the port and starboard void spaces or the lazarette. Because the senior deckhand did not see any engine room flooding or experience a loss of steering or unintended reduction in speed, investigators ruled out a failure or issue with the vessel's rudder stock or propeller and shafting (which would have allowed water to enter the shaft alley and then the engine room). Therefore, the list was likely a result of flooding into the lazarette (which would have allowed flood water to shift to the port side) or into the port void space.
